**REPORT OF THE  
INVESTIGATION INTO  
THE DEATH OF  
MR JOHN BUCKLEY  
ON LOUGH DERG, CO. CLARE.  
22nd JANUARY 2006.**

The Marine Casualty Investigation Board was established on the 25<sup>th</sup> March, 2003 under The Merchant Shipping (Investigation of Marine Casualties) Act 2000

Published by The Marine Casualty Investigation Board  
5th December 2006

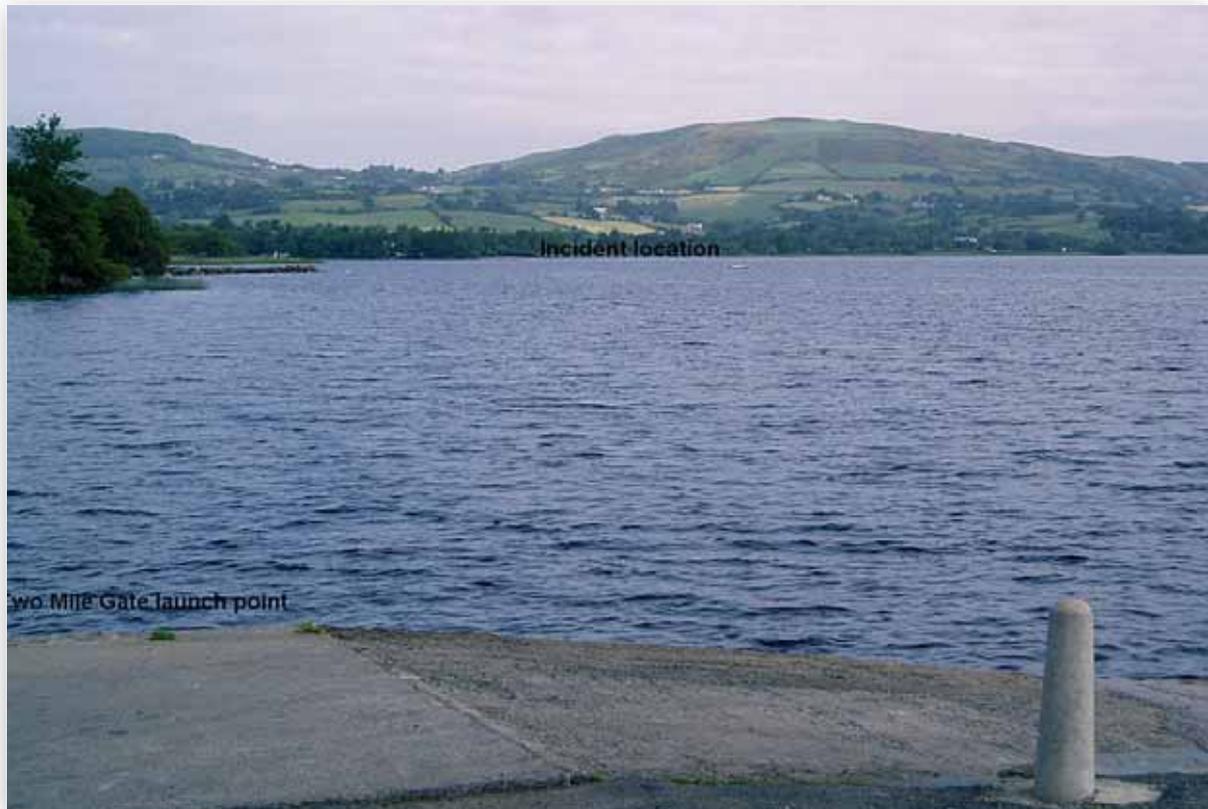
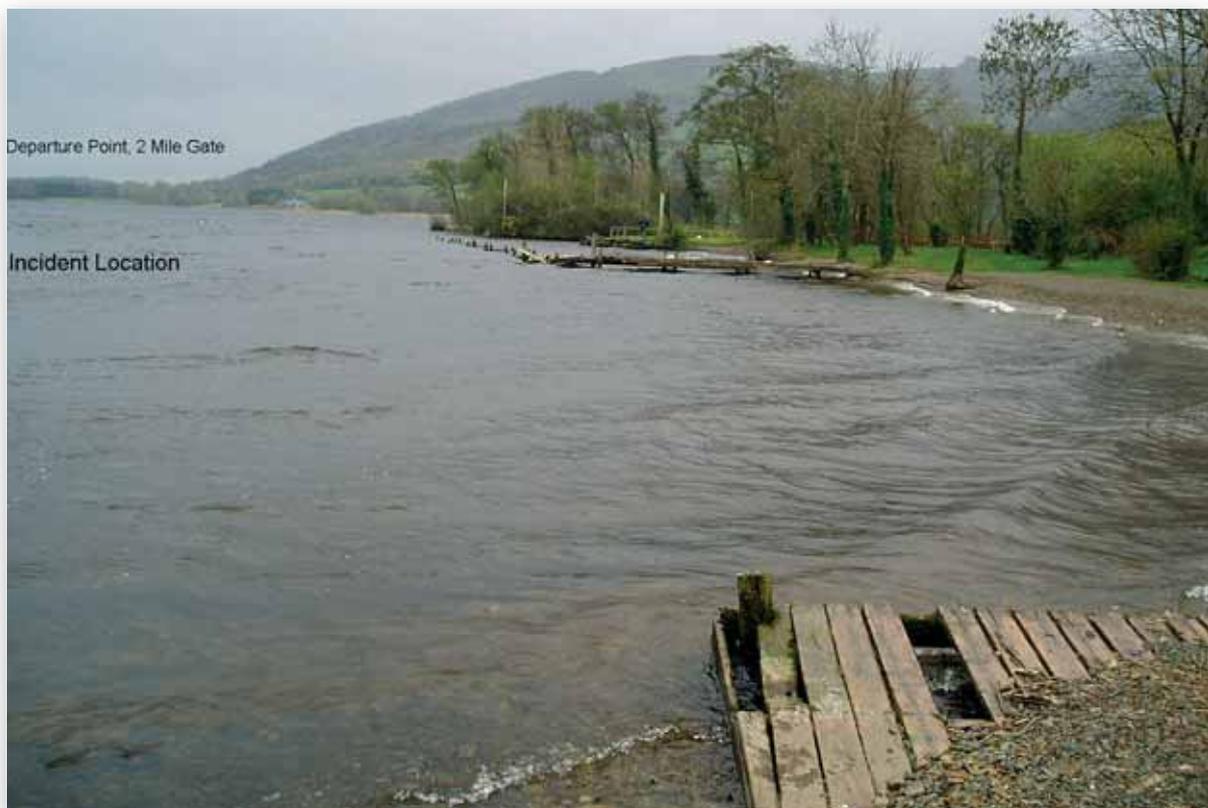
Appendix 8.2 Photographs of the incident location.

- 4.1 Prior to recommencing, both were relaxed and rested. The canoe was stationary, some 25m off the shoreline adjacent to the Lough Derg Holiday Cottages Complex.
- 4.2 There was a brief discussion as to where to go next, Mr. Buckley wanted to move further out into the lake and away from the shore. It was agreed to do so.
- 4.3 At approximately 14.40 hours, prior to getting under way, the sudden unplanned movement of one of the occupants caused the canoe to capsize, throwing both into the water.
- 4.4 The canoe ended in an inverted position, some 3 meters from the occupants, with Miss Murphy's dog trapped under the hull.

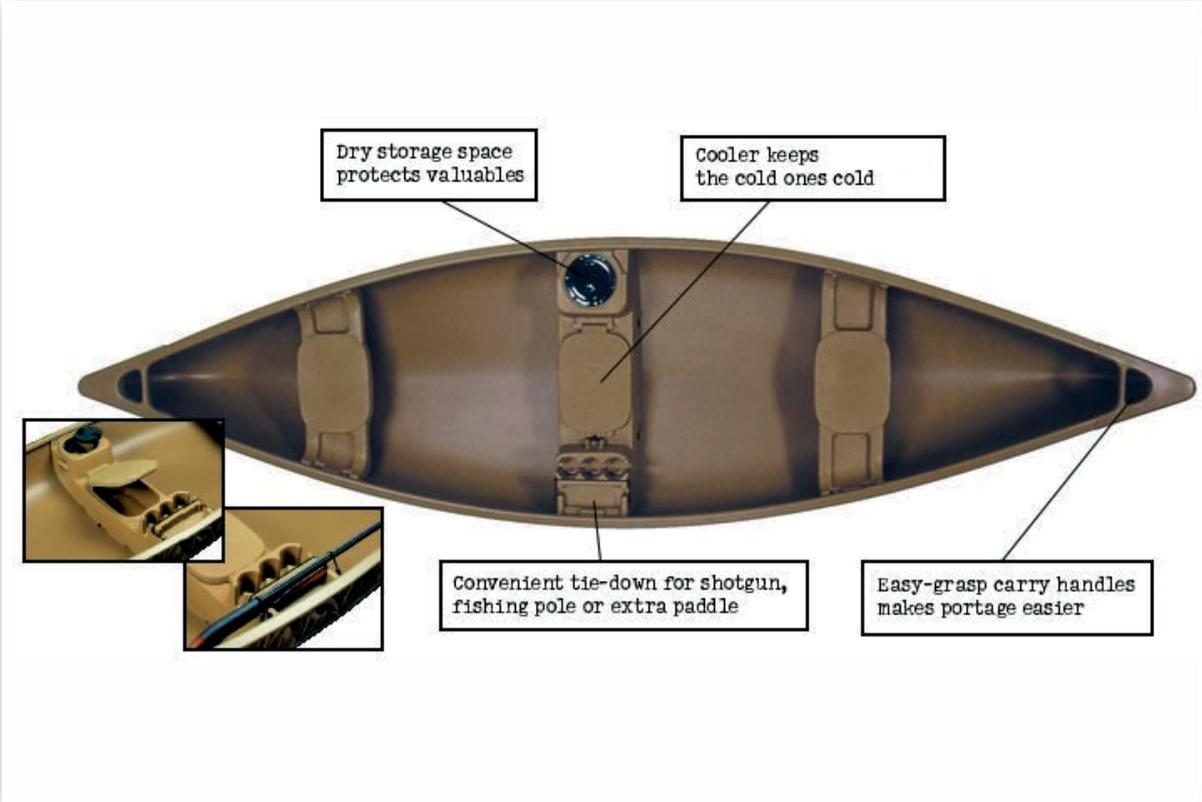
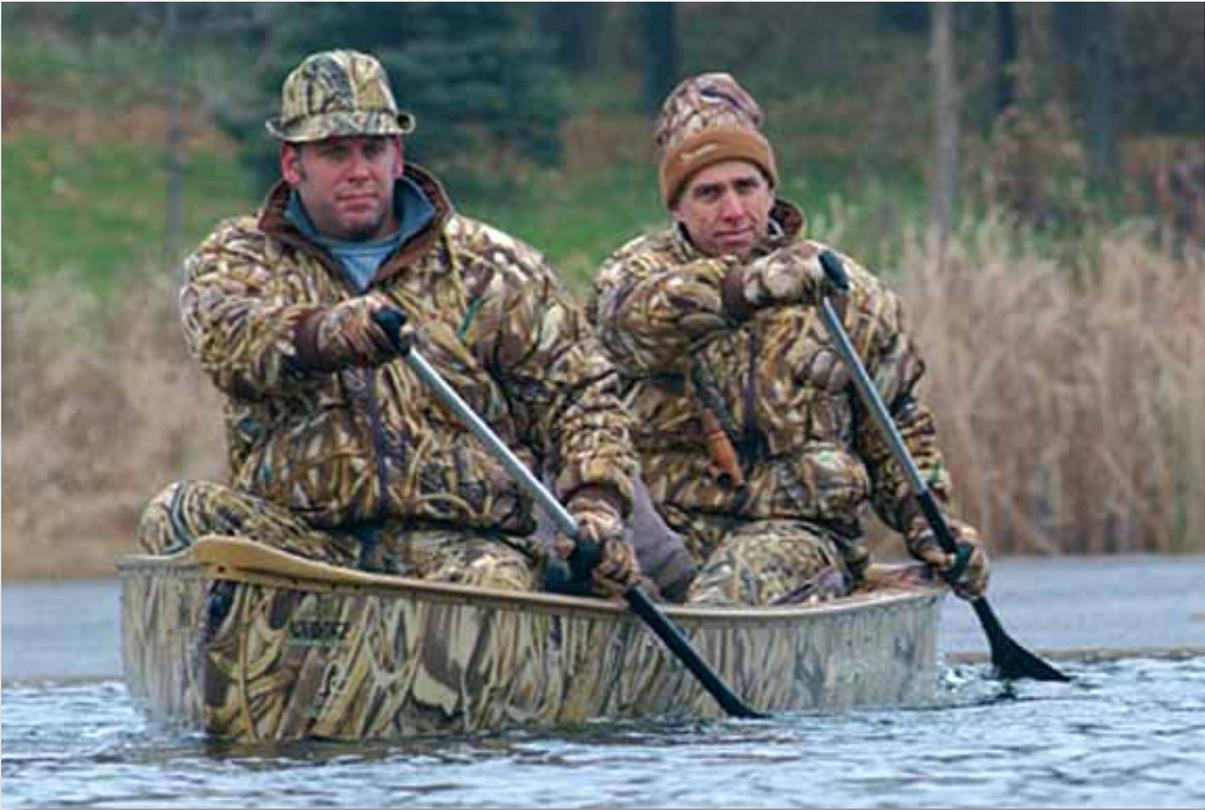
Appendix 8.3 Layout of the Water Quest 14C Canoe.

- 6.1 Neither occupant of the canoe had any prior experience or instruction in the safe use and handling of this type of open Canoe.
- 6.2 In inexperienced hands this type of canoe can prove to be unstable, it is essential that weight is correctly distributed throughout its length, and that the correct method of paddling is used. Any sudden movement may result in the craft capsizing suddenly.

- 6.4 The canoe was inspected subsequent to the incident, it was noted as being in good condition, with the hull intact and undamaged.
- 6.5 There was only a single lifejacket carried on the canoe. It is a legal requirement, that lifejackets be worn by all occupants in a recreational craft of this size. S.I. 921 of 2005, Pleasure craft (Personal Floatation Devices and Operation)(Safety) Regulations. The lack of a suitable lifejacket by one of the occupants was a contributory factor in the loss of life.

- 7.1 A suitable PFD/Lifejacket must always be worn by occupants on this type of craft.
- 7.2 Such craft should not be used by the public unless they have been suitably trained in their use, or accompanied and supervised by competent personnel, who are trained and equipped to undertake a rescue in the event of a capsized.
