**REPORT OF
INVESTIGATION INTO
THE LOSS OF
F.V. "KINDRED STAR II"
OFF THE COAST OF
EAST CORK
ON
9th APRIL 2010**

**REPORT No. MCIB/181
(No.3 of 2011)**

Report MCIB/181 published by The Marine Casualty Investigation Board
Published

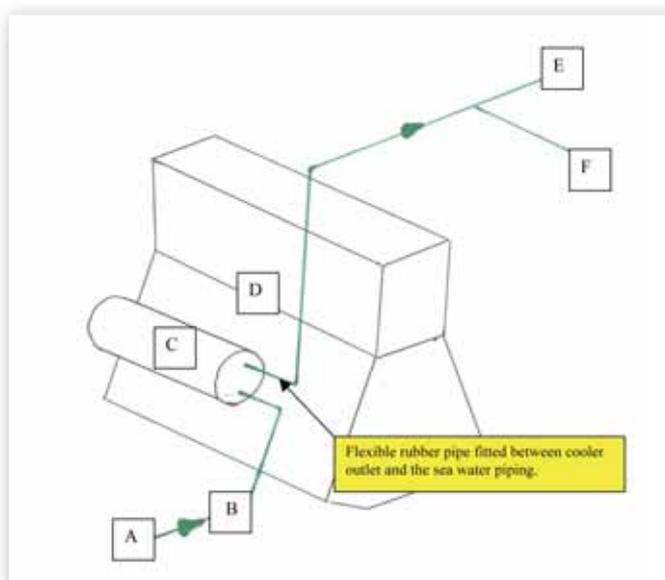
- 6.1 The primary cause of the accident was the failure of the connection of a section of flexible pipe fitted on the outlet side of the jacket water cooler on the seawater side of the cooler; this had come off one of the pipes, permitting the main engine seawater cooling water to pump directly into the engine room.

- 6.3 The Investigation was unable to fully establish the exact configuration of the system that was fitted on "Kindred Star II". However, from a description provided by Mr. O'Riordan, the most likely configuration of the system is reproduced at Fig.1.

- 6.4 The seawater piping was made of 2" diameter stainless steel pipe with electrical bonding strip in way of the flexible connections and is depicted in green.

- 6.5 Seawater was drawn into the system via a sea suction connection 'A' on the hull of the vessel, by the seawater pump 'B'. The pressurised seawater was then pumped through the cooler 'C', thus cooling the jacket water of the engine 'D'. The seawater outlet pipe from the cooler exited horizontally, turned 90°, then rose vertically, crossed over the top of the engine and was discharged overboard at 'E'. There was also a branch 'F' for cooling the gearbox.

- 6.6 There was a flexible rubber pipe connection between cooler outlet and the piping. The location is indicated in Fig. 1.

Fig 1. Likely configuration of the seawater cooling pipe system.

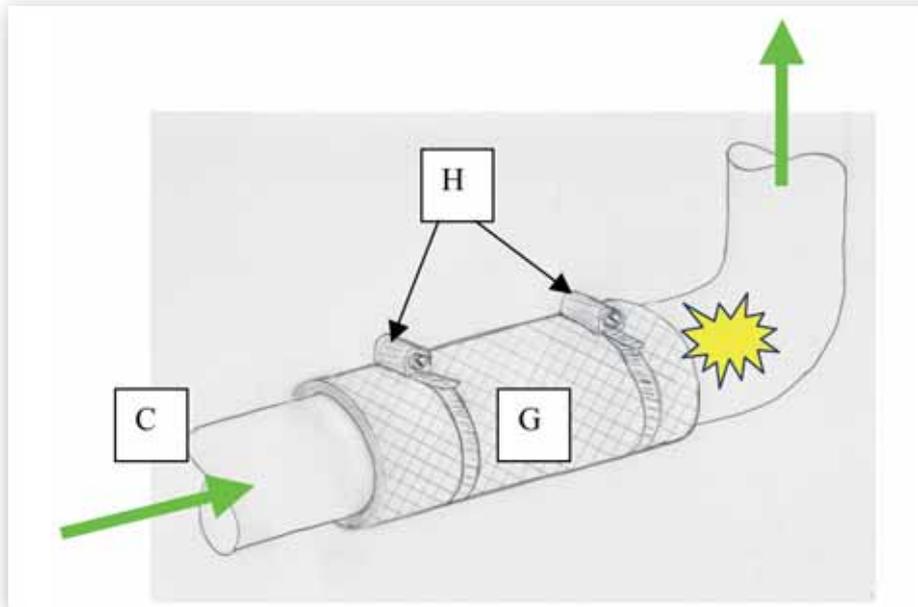
- 6.7 Mr. O’Riordan’s recollection is that the failure was at the connection between the flexible rubber pipe ‘G’ and the 2” stainless steel pipe ‘C’, indicated by the yellow star in Fig. 2 below, and that the pipe was ejected from the connection and free to move. The clips ‘H’ were intended to hold the arrangement in place.

Fig. 2. Arrangement of pipe clips and flexible rubber pipe.

Mr. O’Riordan recounted that the vertical section of 2” stainless steel piping that had parted from the flexible rubber pipe was “flopping-around” and was free to move once it had become free of the connection. This would indicate that it was not held in place by pipe brackets or that the brackets were ineffective. The arrangement relied on the connection to the flexible rubber pipe to hold it in place.

The hazards associated with the failure of seawater piping systems in an engine room are well recognised and the efficacy of using pipe clips and a section of flexible rubber pipe to join the cooler outlet to the piping system is questionable.

Proprietary flexible expansion joints approved by the major classification societies are available and suitable for this purpose.
