**REPORT OF THE INVESTIGATION  
INTO THE FIRE AND SINKING OF  
FV “KINGFISHER”  
ON  
25th NOVEMBER 2012**

**REPORT No. MCIB/228  
(No.15 of 2013)**

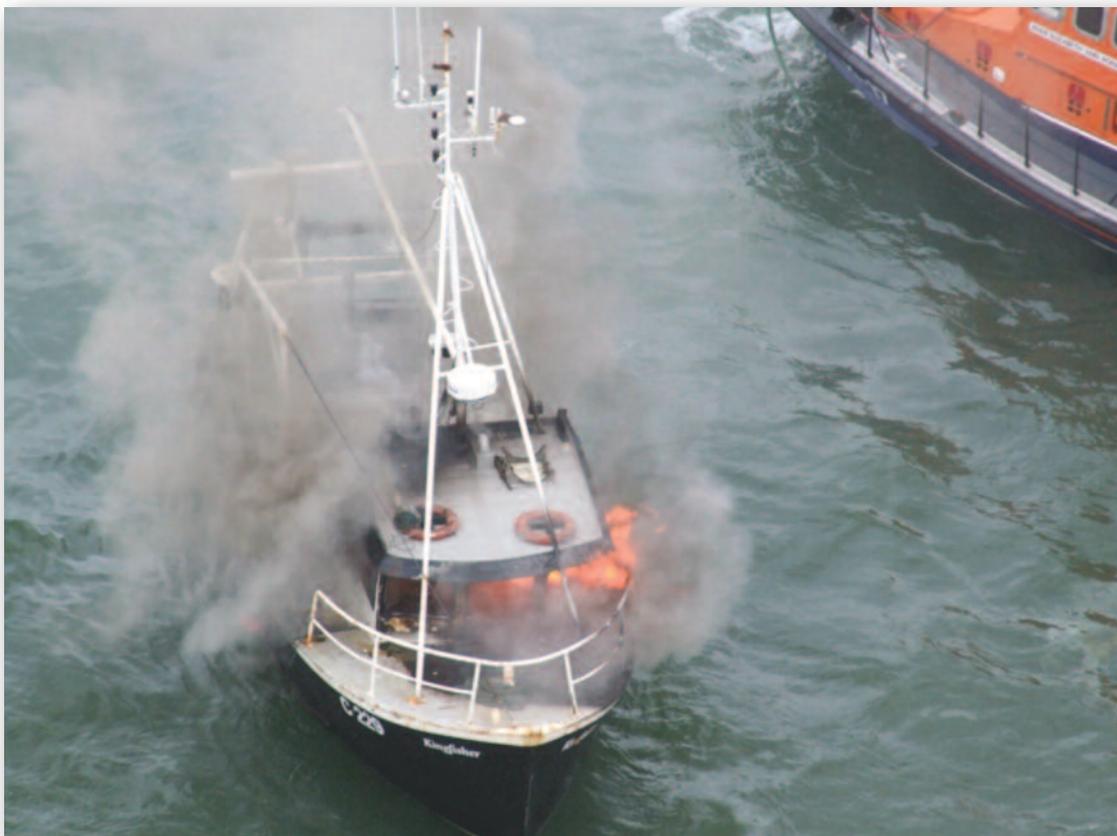
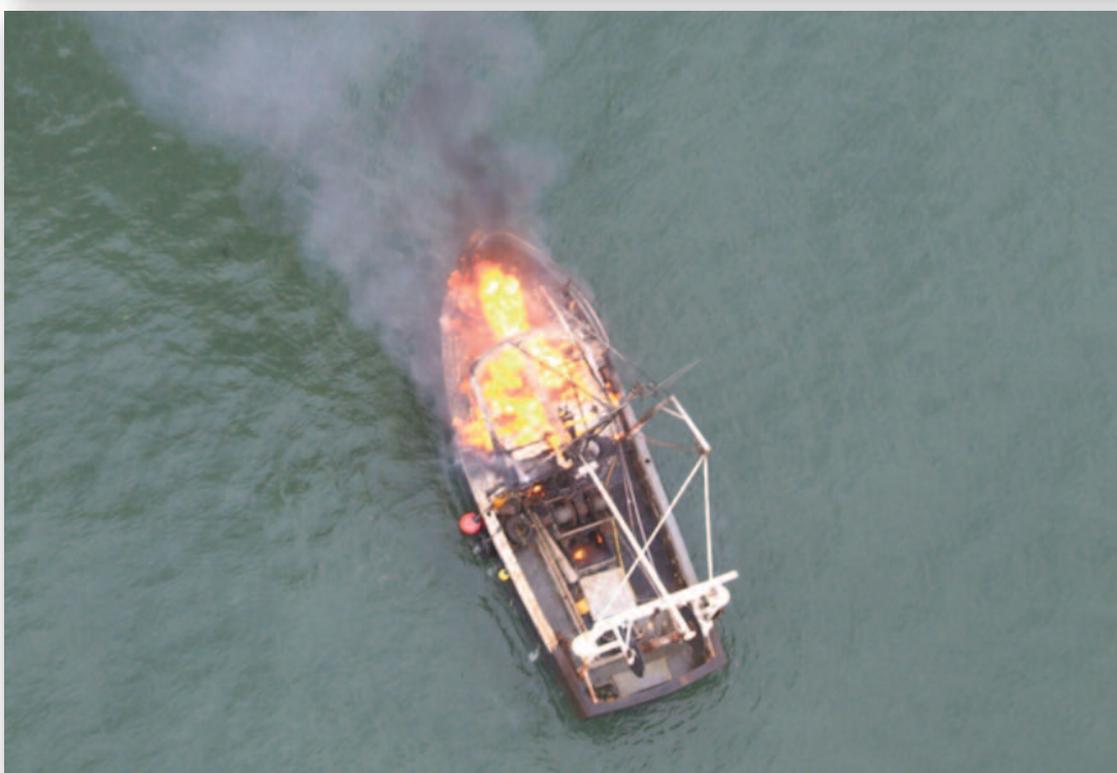
Appendix 7.1 Photos of Boat Burning.

- 3.14 The Dunmore East Lifeboat arrived on the scene at 08:18hrs and attempted to extinguish the fire by playing a fire hose on the casualty vessel. They were assisted in this by SAR helicopter R117 who, by using an infrared camera, were able to pinpoint the hot spots of the fire. The fire spread below deck, and kept re-igniting despite the best efforts of the crew of the Lifeboat. (See Appendix 7.1 Photos of boat burning during incident).

- 4.1.1 The source of the fire is unknown. However, in view of the speed at which the fire and its associated smoke spread, it is almost certain that the fire was already well established with a good supply of fuel when the Skipper became aware of the fire.

- 4.1.2 The onset of thick black smoke indicates that the fire was predominantly oil-based, suggesting it could be diesel oil, lubricating oil or hydraulic oil.

- 4.1.3 Given that smoke was being emitted from the exhaust trunking when the Skipper first arrived on the deck, and that smoke emitted from the engine room hatch when opened, it is most probable that the fire started in the engine room, possibly as a result of leaking oil coming into contact with one of the several potential heat sources available. Alternatively it is possible that a fire could have commenced in the engine room possibly from an electrical source, the fire then melting either a hydraulic hose or fuel hose giving a fuel supply to the fire.

- 4.1.4 Once an oil-based fire was established in the engine room, it would spread rapidly through the vessel assisted by the airflow through the engine room hatch situated in the wheelhouse. In view of the intensity of the fire, the vessel's fibre reinforced plastic construction and notwithstanding the best efforts of the lifeboat crew to extinguish the fire, FV "Kingfisher" continued to burn until foundering.

- 6.1 It is recommended that the Minister for Transport, Tourism and Sport amend the Code of Practice making it a mandatory requirement for fishing vessels less than 15m in length to be fitted with smoke/fire detection system in engine rooms and for fuel and hydraulic oil pipes be constructed out of fire resistant material.

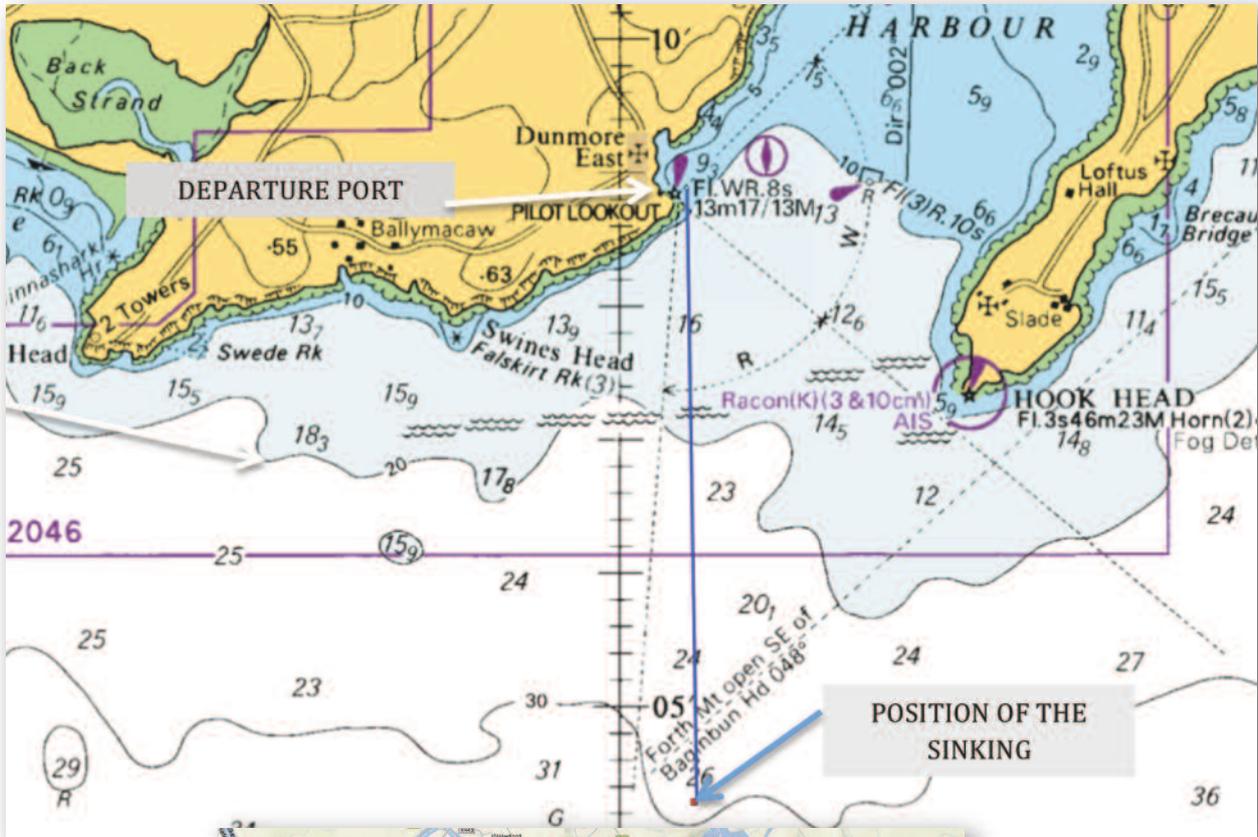
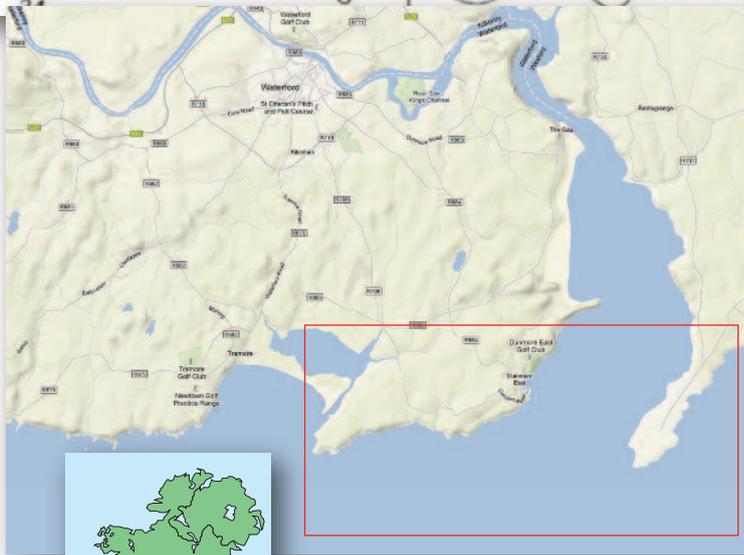
Appendix 7.2 Position of the Sinking.

- 3.15 The casualty vessel was deemed to be beyond safe recovery and the Lifeboat was stood down at 10:07hrs and returned to Dunmore East.
- 3.16 At 10:43hrs sight of the vessel was lost from ashore and it was assumed to have foundered at position 52.04.17N : 06.59W. A search of the area was undertaken by helicopter R117 at 11:39hrs, no vessel or pollution was sighted. (See Appendix 7.2 Position of sinking).
