Marine Casualty Investigation Board

**REPORT OF THE  
INVESTIGATION INTO  
THE LOSS OF  
A PERSON OVERBOARD  
FROM THE  
PASSENGER VESSEL  
“KU-EE-TU” ON LOUGH DERG  
NORTH OF BALLINA  
CO. TIPPERARY ON  
9TH JULY 2005.**

**REPORT No. MCIB/113**

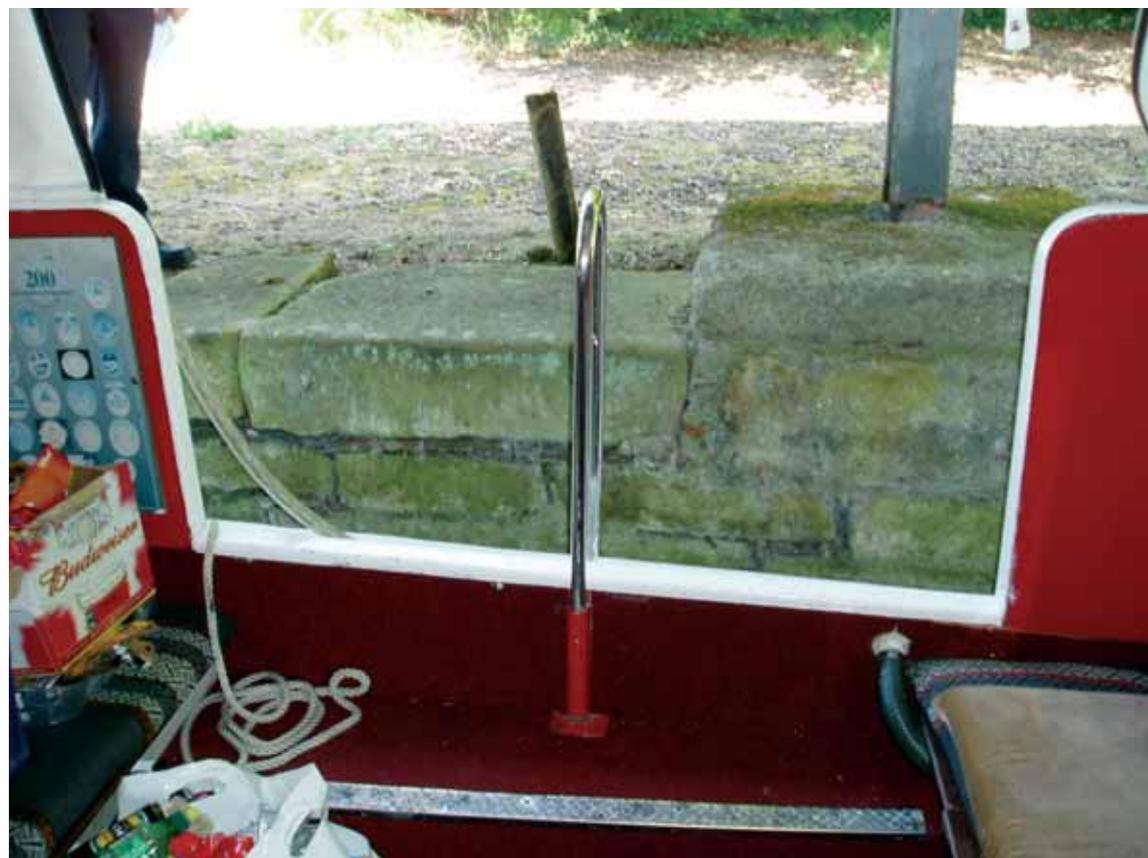
Appendix 9.1 View of embarkation area - starboard side.

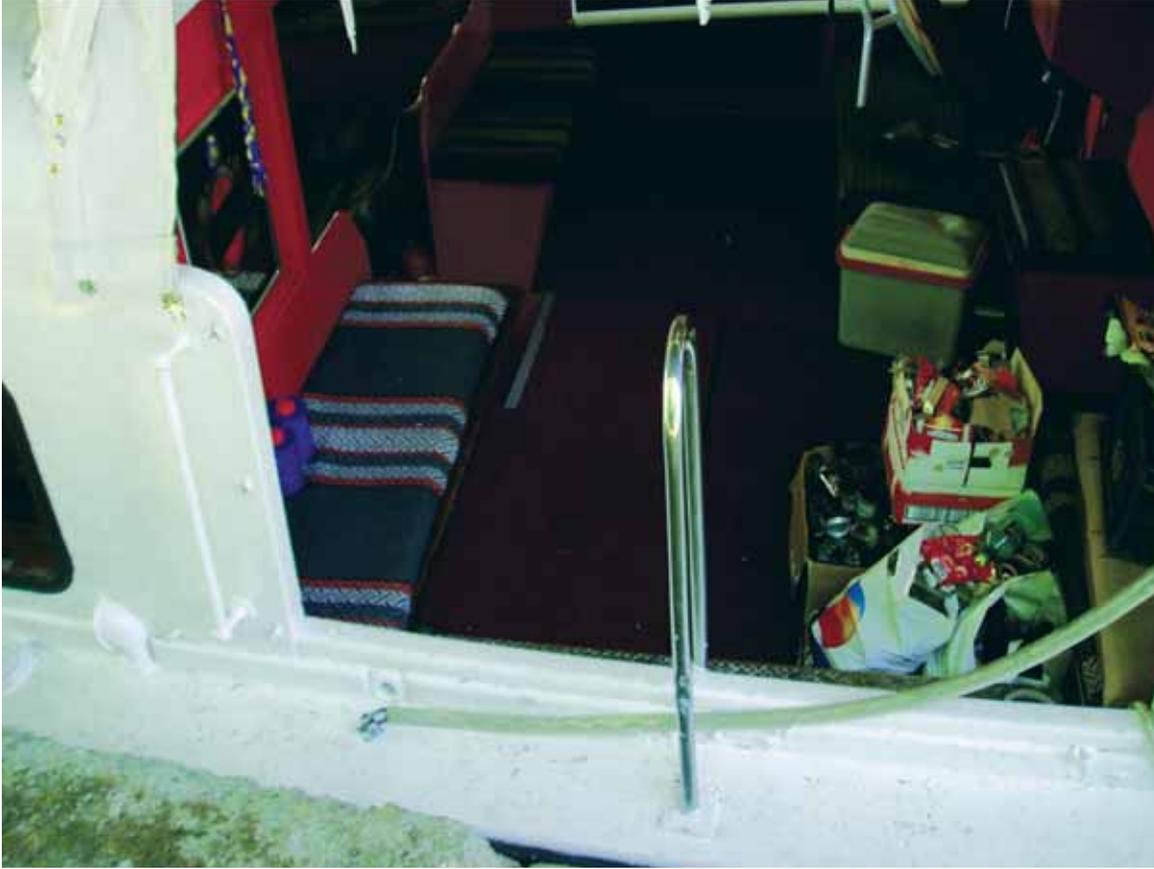
## APPENDIX 9.2

- 6.1 The “Ku-Ee-Tu” was inspected at Killaloe on the 10th July 2005. The results of this inspection are: -
- (1) The guard chain arrangement at the embarkation position amidships on the starboard side had broken. One of the brackets, with the chain clipped to it, was detached from the cabin side and hanging off, being held on by the forward fixing bracket only. (See Photos in Appendices 9.2, 9.3 & 9.4)

Appendix 9.2 View looking into vessel from quay on starboard side showing broken guard chain.

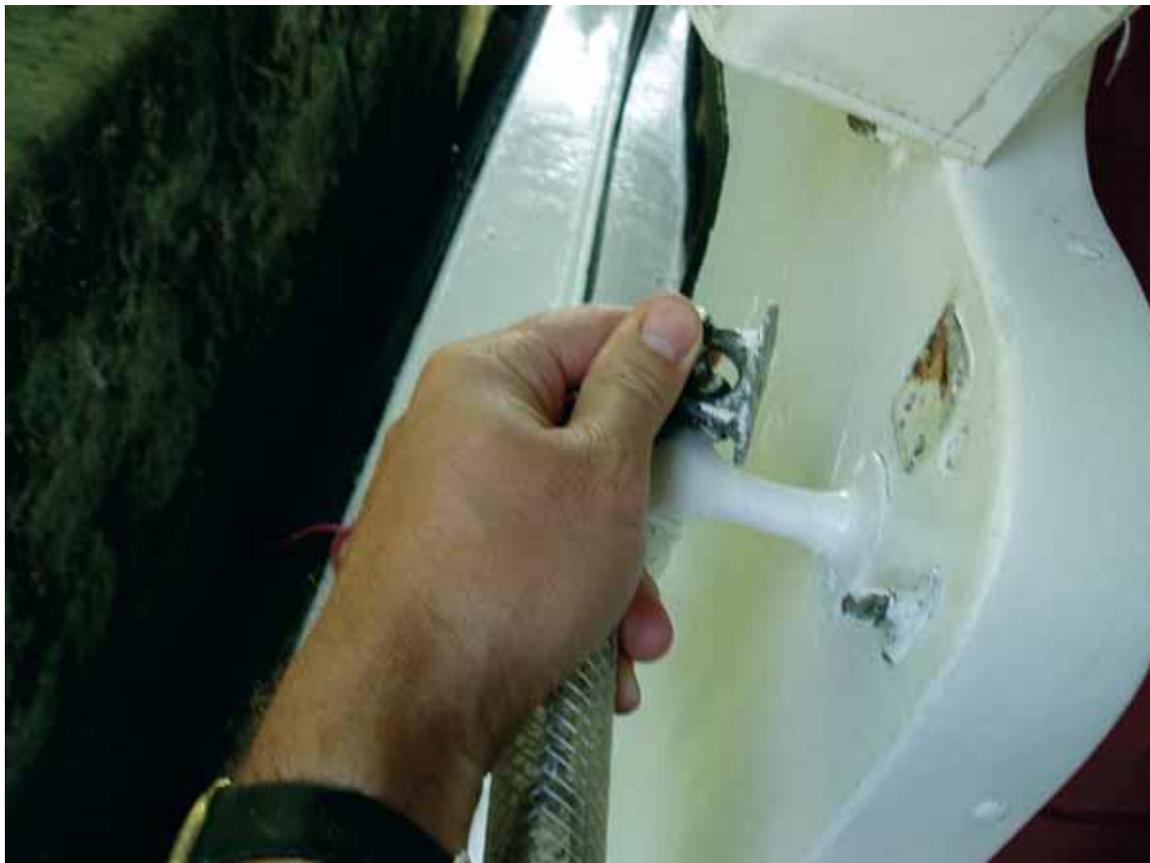
- 7.1 Mr. Dalton fell overboard after the screws securing the chain guard on which he was sitting broke. The purpose of the chain was to act as a guard protecting people from falling out through the opening in the vessel's side at the embarkation position. It was not designed to take the full weight of a person sitting on it, although the presence of the plastic hose covering the chain and the presence of the step underneath did unfortunately make it more "comfortable" to sit on.  
A number of passengers were gathered in the area and obscured Mr. Knight's view of where Mr. Dalton was sitting. Mr Knight, would have asked Mr. Dalton to move if he had spotted him sitting on this chain.

Appendix 9.3 Close-up view of chain bracket location.

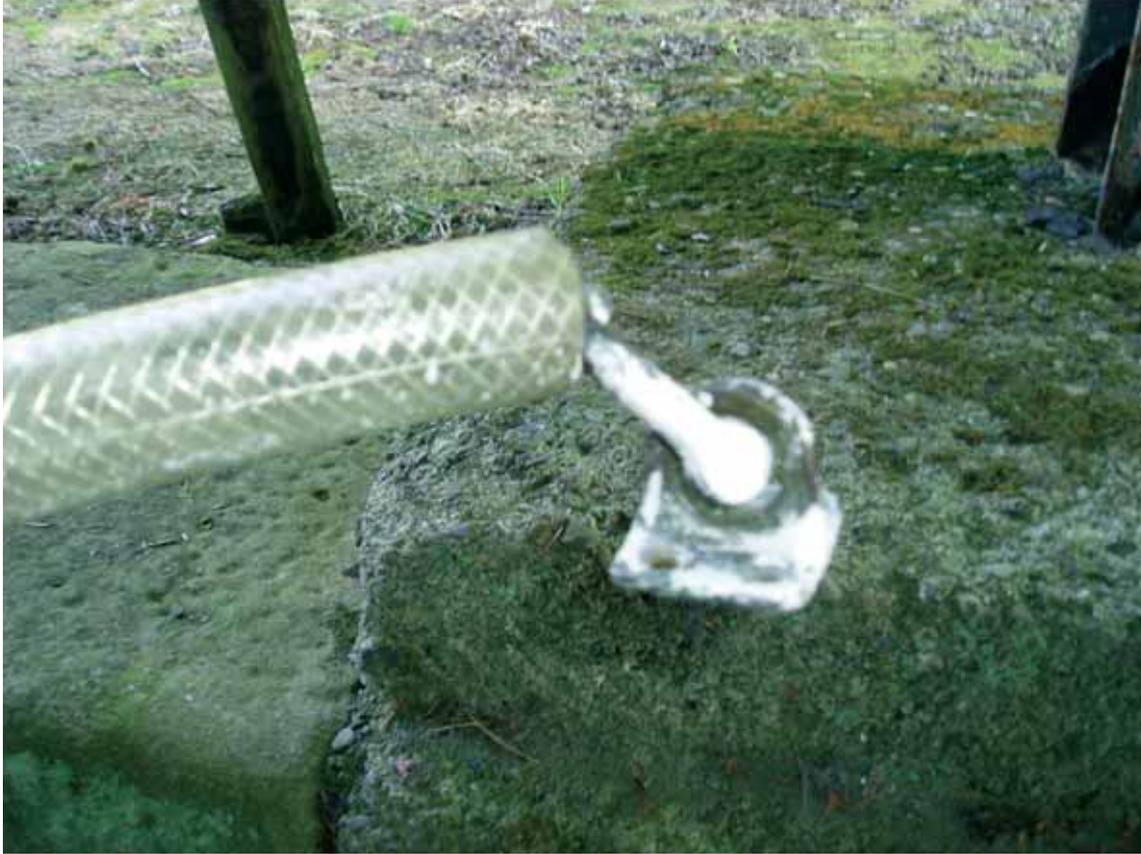
## APPENDIX 9.4

Appendix 9.4 Close up of the chain end and bracket.

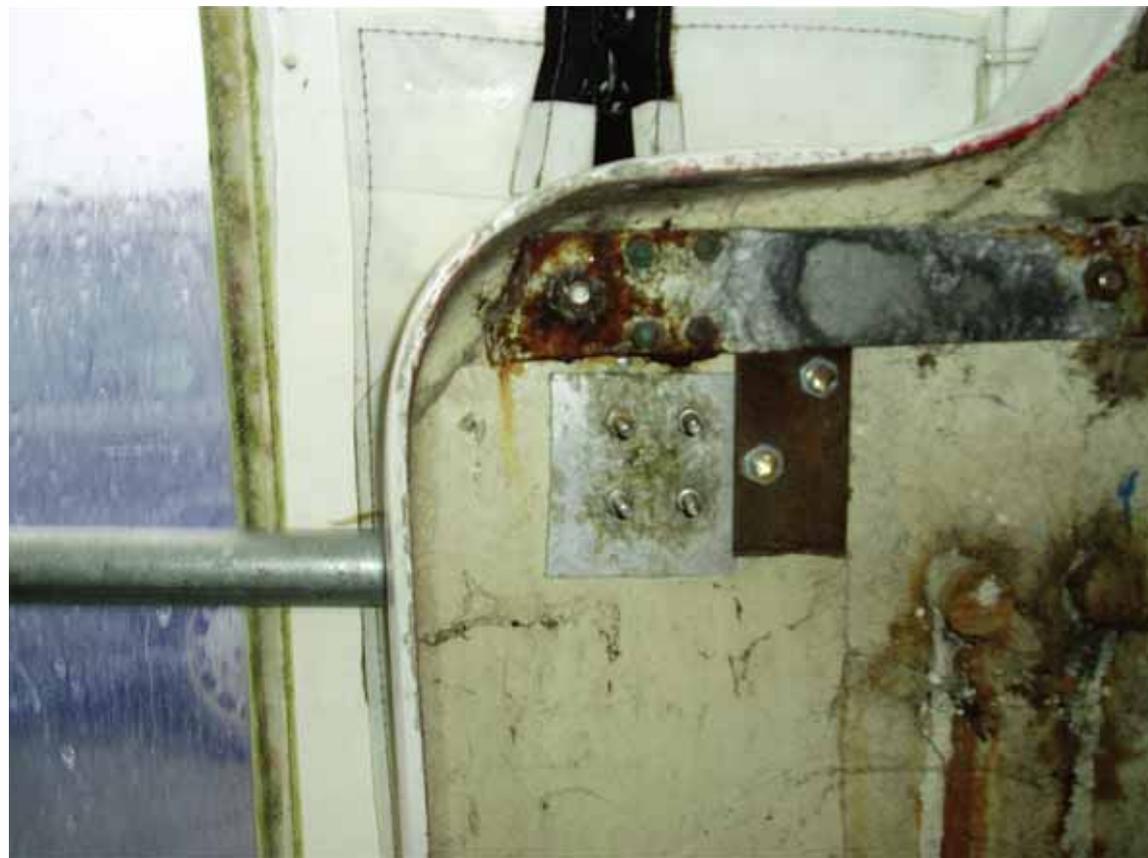
- (2) The bracket had been secured with four screws. These screws passed through the g.r.p. cabin structure and then through a backing plate on the inboard side and were secured with nuts on the inner face of this backing plate. (See photo in Appendix 9.5). These screws had all broken just below the “head” under the load of Mr. Dalton as he sat on the chain. The screws were not recovered by the MCIB.

Appendix 9.5 View of inside of cabin structure showing backing plates for fixing to glass fibre.

- Securing brackets and fixing devices, screws, bolts nuts etc should be made of suitable material for use in the marine environment and be of adequate size. Fixing arrangements should be subject to periodic inspections. Protection arrangements for embarkation positions should be given special consideration. The number of these openings should be restricted to the minimum number required to provide for the safe evacuation of the vessel in an emergency. Owners should be advised of the above and should carry out any necessary improvements in consultation with the Department of the Marine Surveyor's Office.

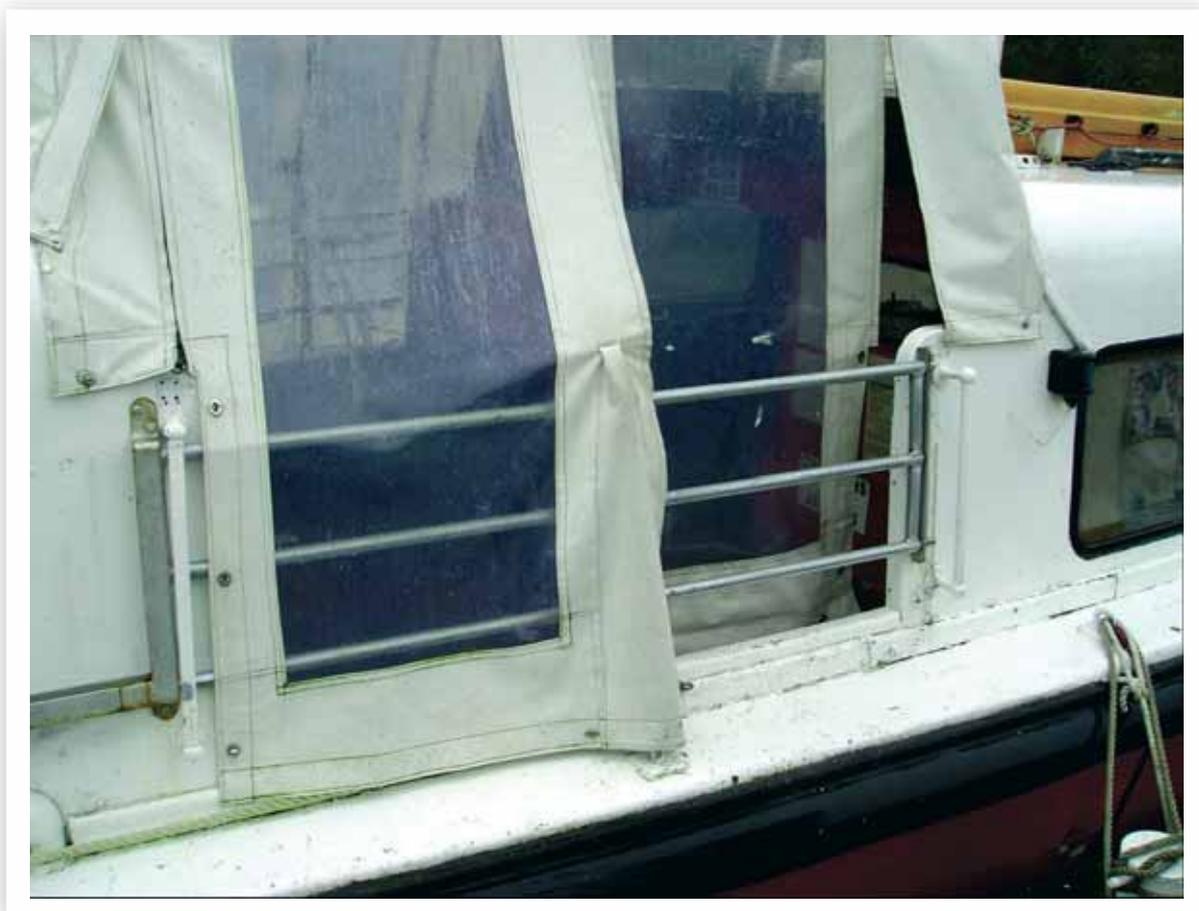
## APPENDIX 9.6

Appendix 9.6 New gate arrangement installed following incident.

- Since this incident the owners of “Ku-Ee-Tu” have carried out improvements to the vessel in respect of the guards across the embarkation openings. (See photos in Appendices 9.6, 9.7 & 9.8).

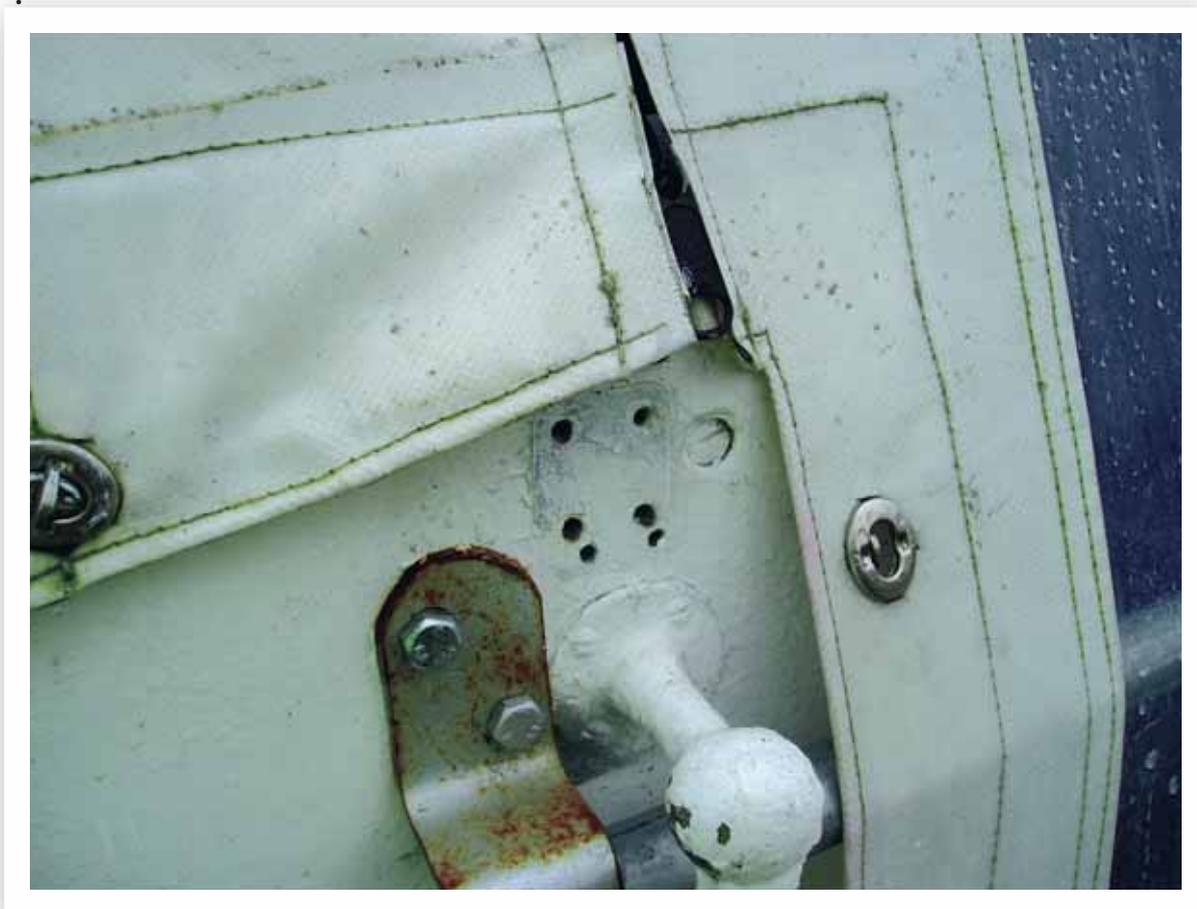
Appendix 9.7 Close up of the new gate bracket fixings with substantial through bolts fitted after the incident.

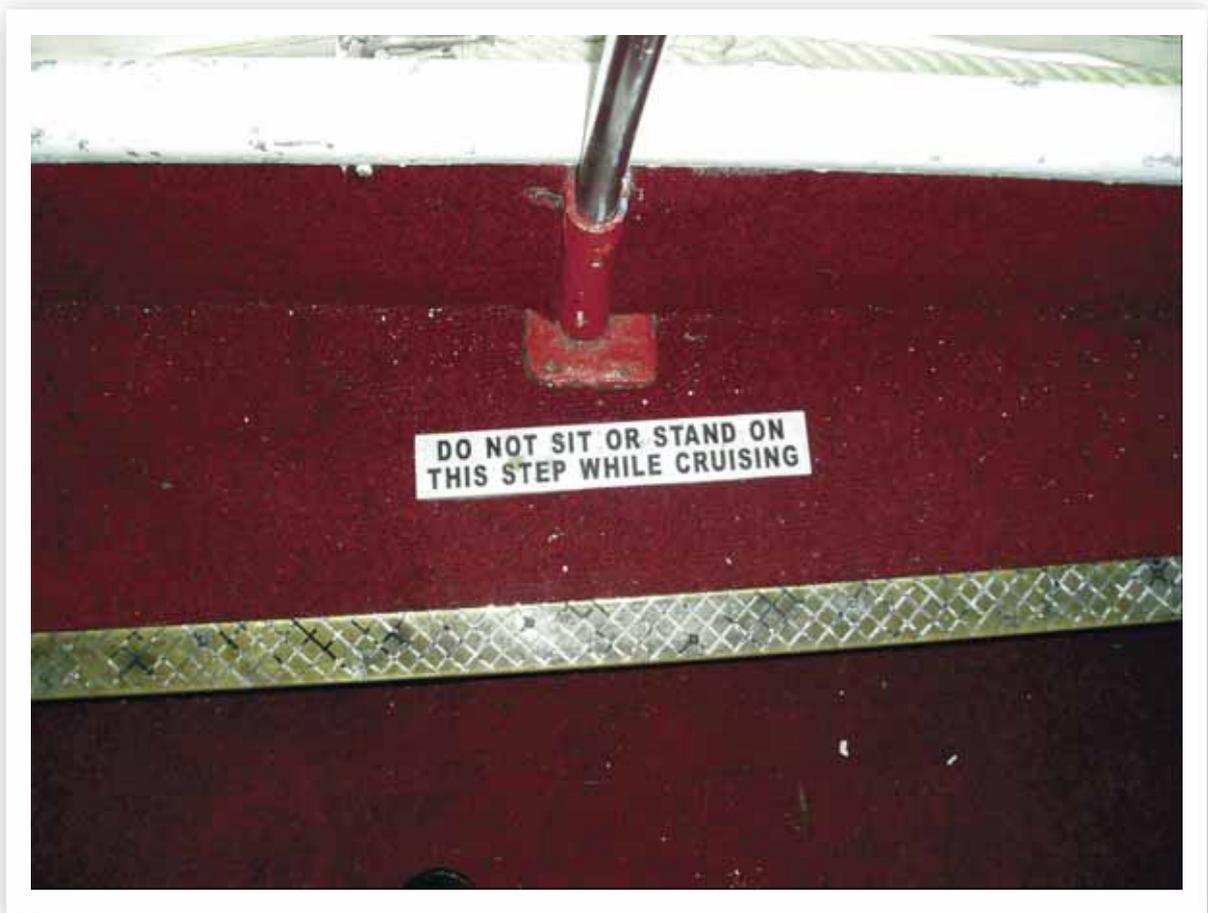
## APPENDIX 9.8

Appendix 9.8 New warning sign placed on steps since incident.

8. The wording of the new notice is clear and precise. The Marine Survey Office should consider making recommendations to the owner regarding extra signs although there is no Statutory Requirement to carry signs warning people not to sit on bulwarks or guardrails on the sides of vessel.
