**REPORT INTO THE SINKING OF
FV “LADY EILEEN”
ON
13th AUGUST 2012**

**REPORT No. MCIB/223
(No.8 of 2013)**

Report MCIB/223 published by The Marine Casualty Investigation Board
Printed 24th May 2013.

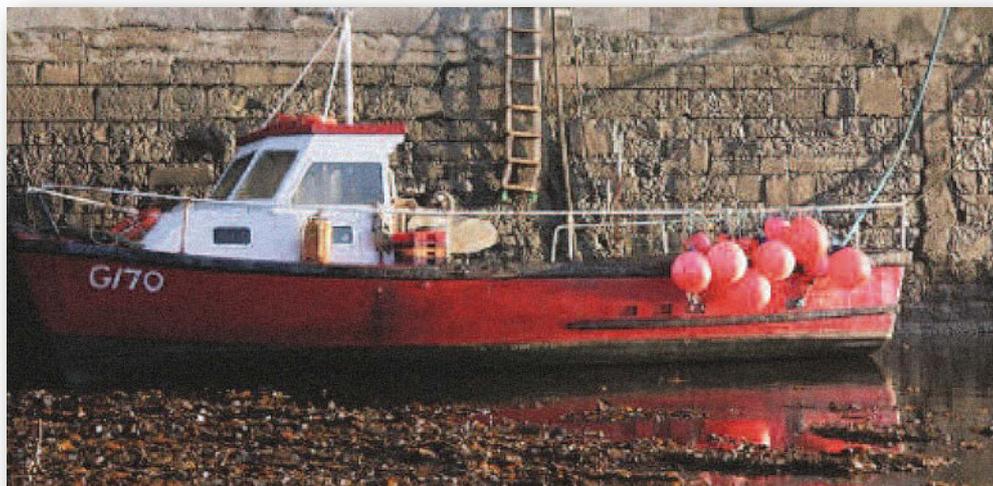
General View of the F/V “LADY EILEEN”

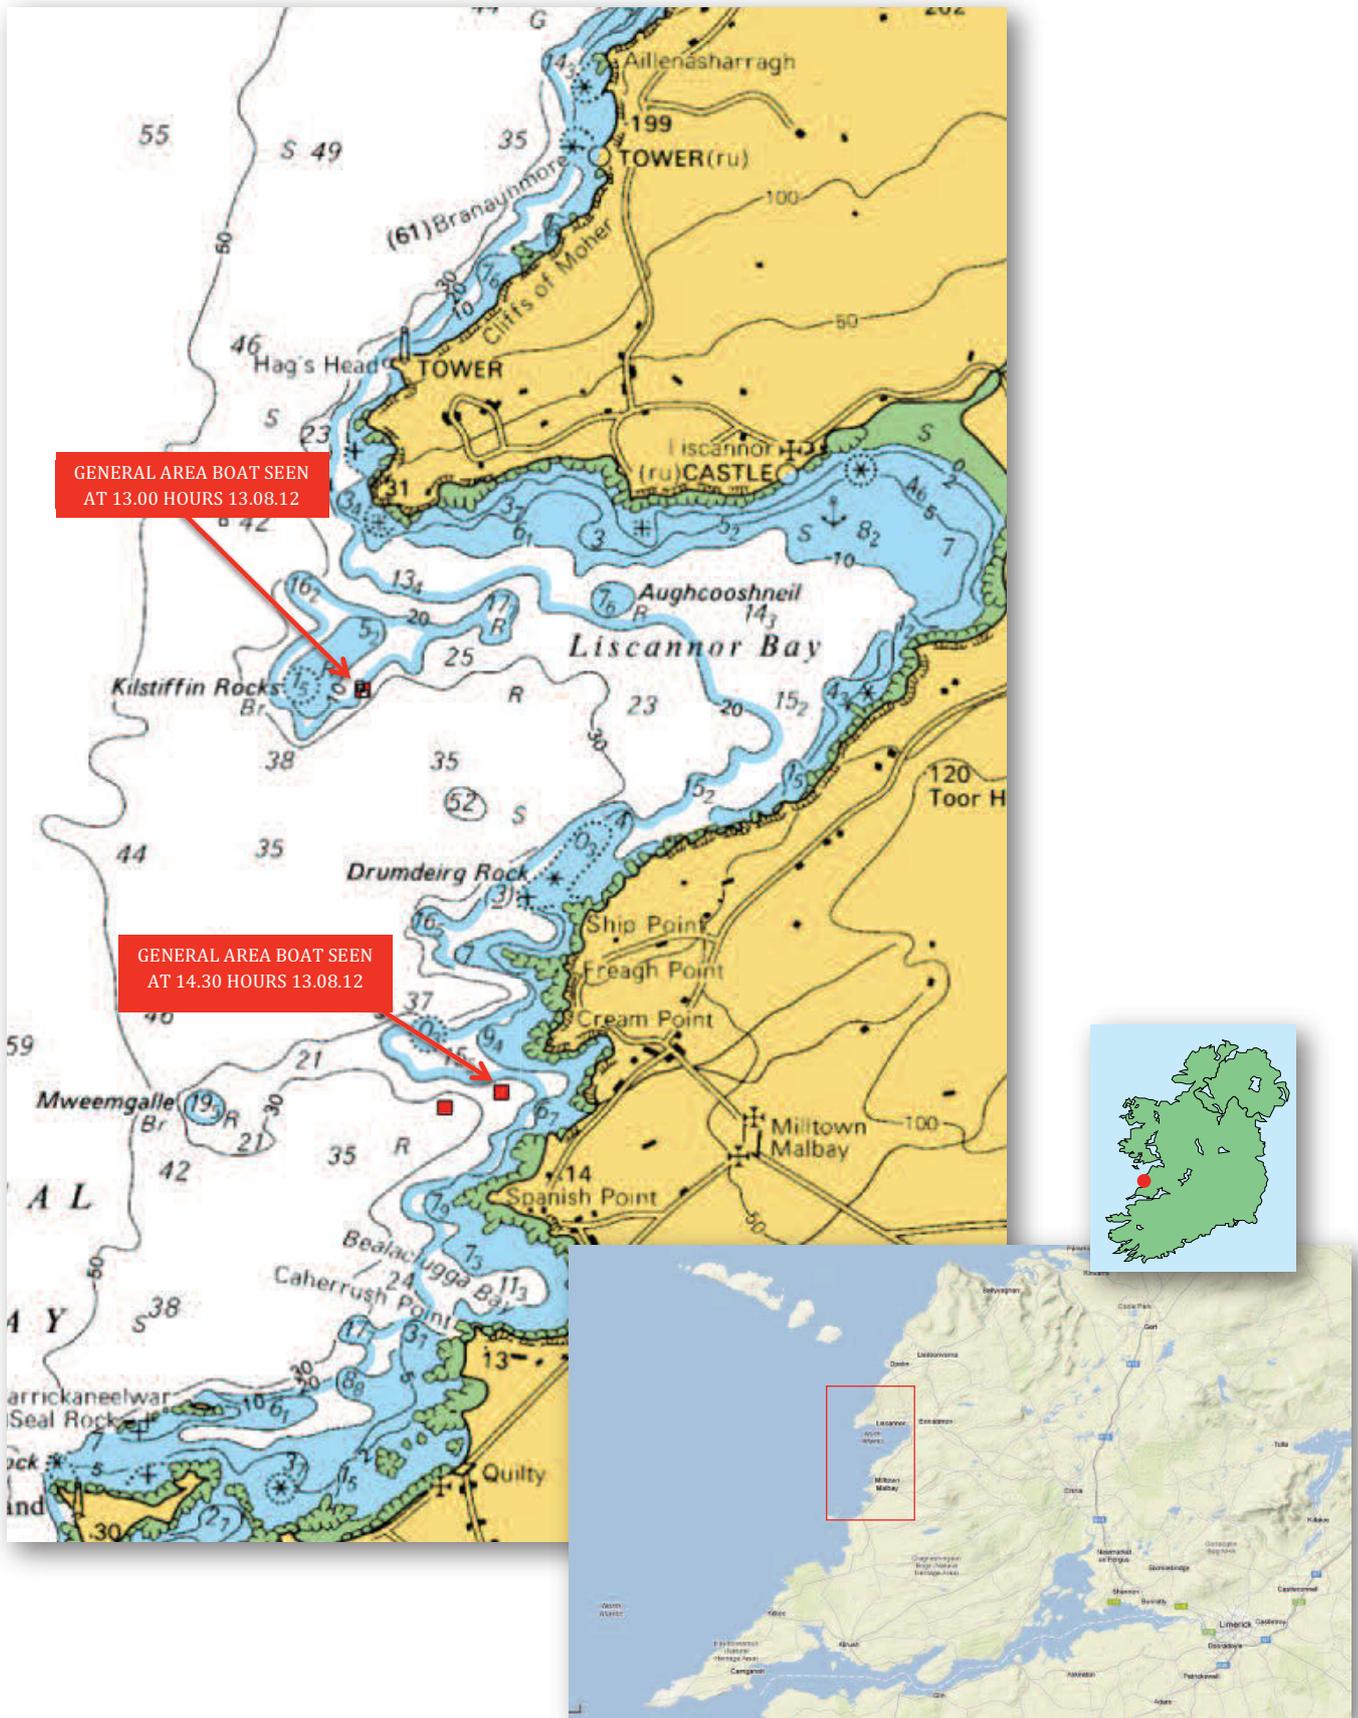
Appendix 7.2 Map showing last sighting of Lady Eileen.

3.1.4 The boat was sighted again from the shore at approximately 14:30hrs North East of Spanish Point. This was the last known sighting of the craft. (See appendix 7.2)

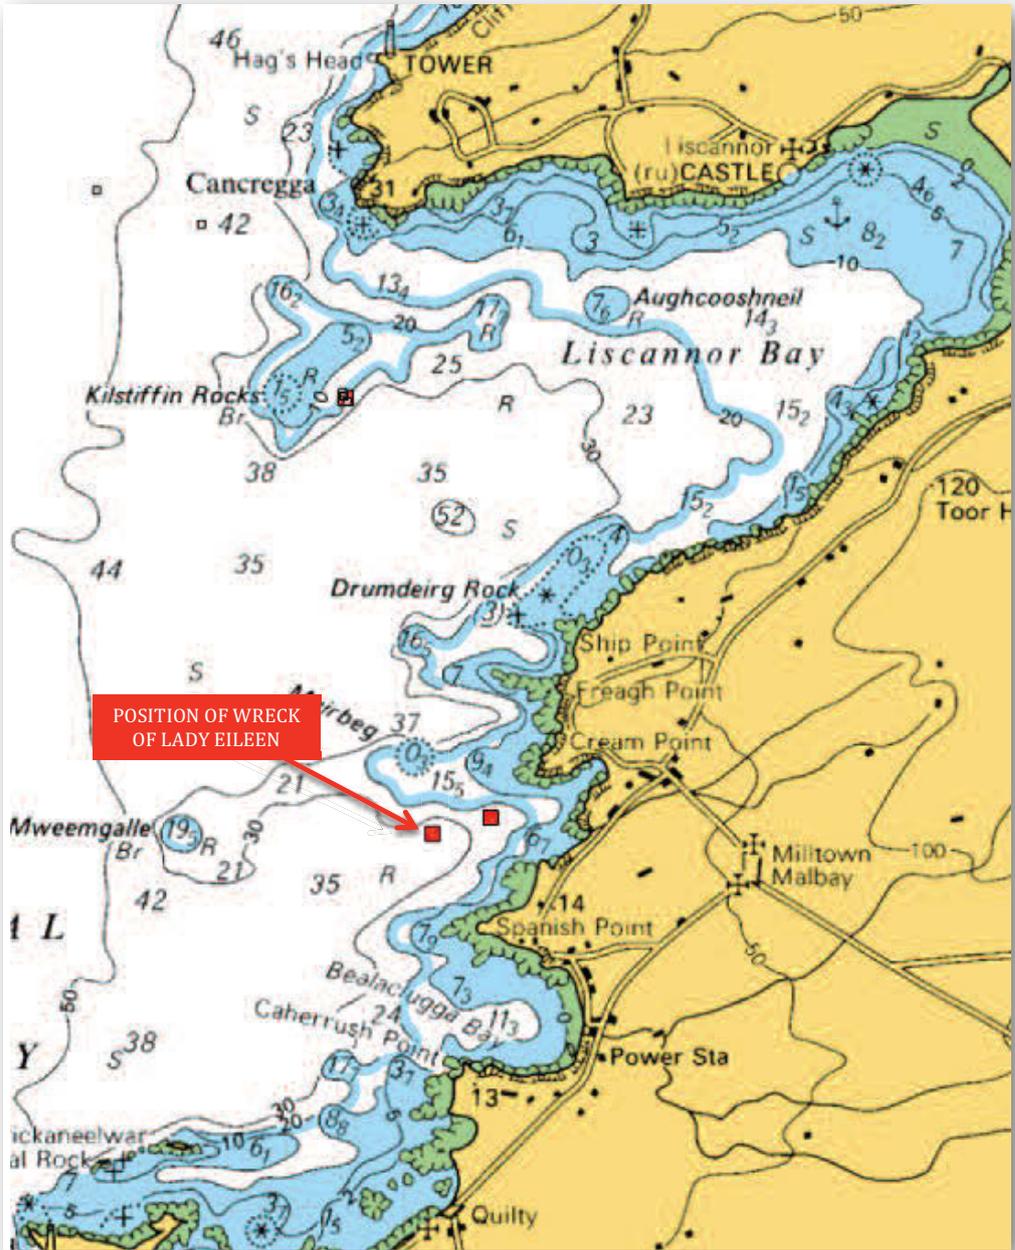
Appendix 7.3 Map showing position of wreck of Lady Eileen.

- 3.3.8 Shortly before 12:00hrs on the 14th August 2012 members of the Burren Rescue team dived on to the “*Lady Eileen*” and located two bodies in the vicinity of the wheelhouse of the vessel. The body of Michael Galvin was found inside of the wheelhouse and the body of Noel Dickinson was found to be partially in the wheelhouse. (see appendix 7.3)

- 3.3.11 On the 14th August a dive team dived on the wreck and noted the wreck to be lying at an angle of approximately 30° to starboard, no apparent damage was noted on the hull. The dive team recovered the vessel’s EPIRB, which was still attached to its holder in the wheelhouse. When the EPIRB was brought to the surface the battery commenced to give off fumes.

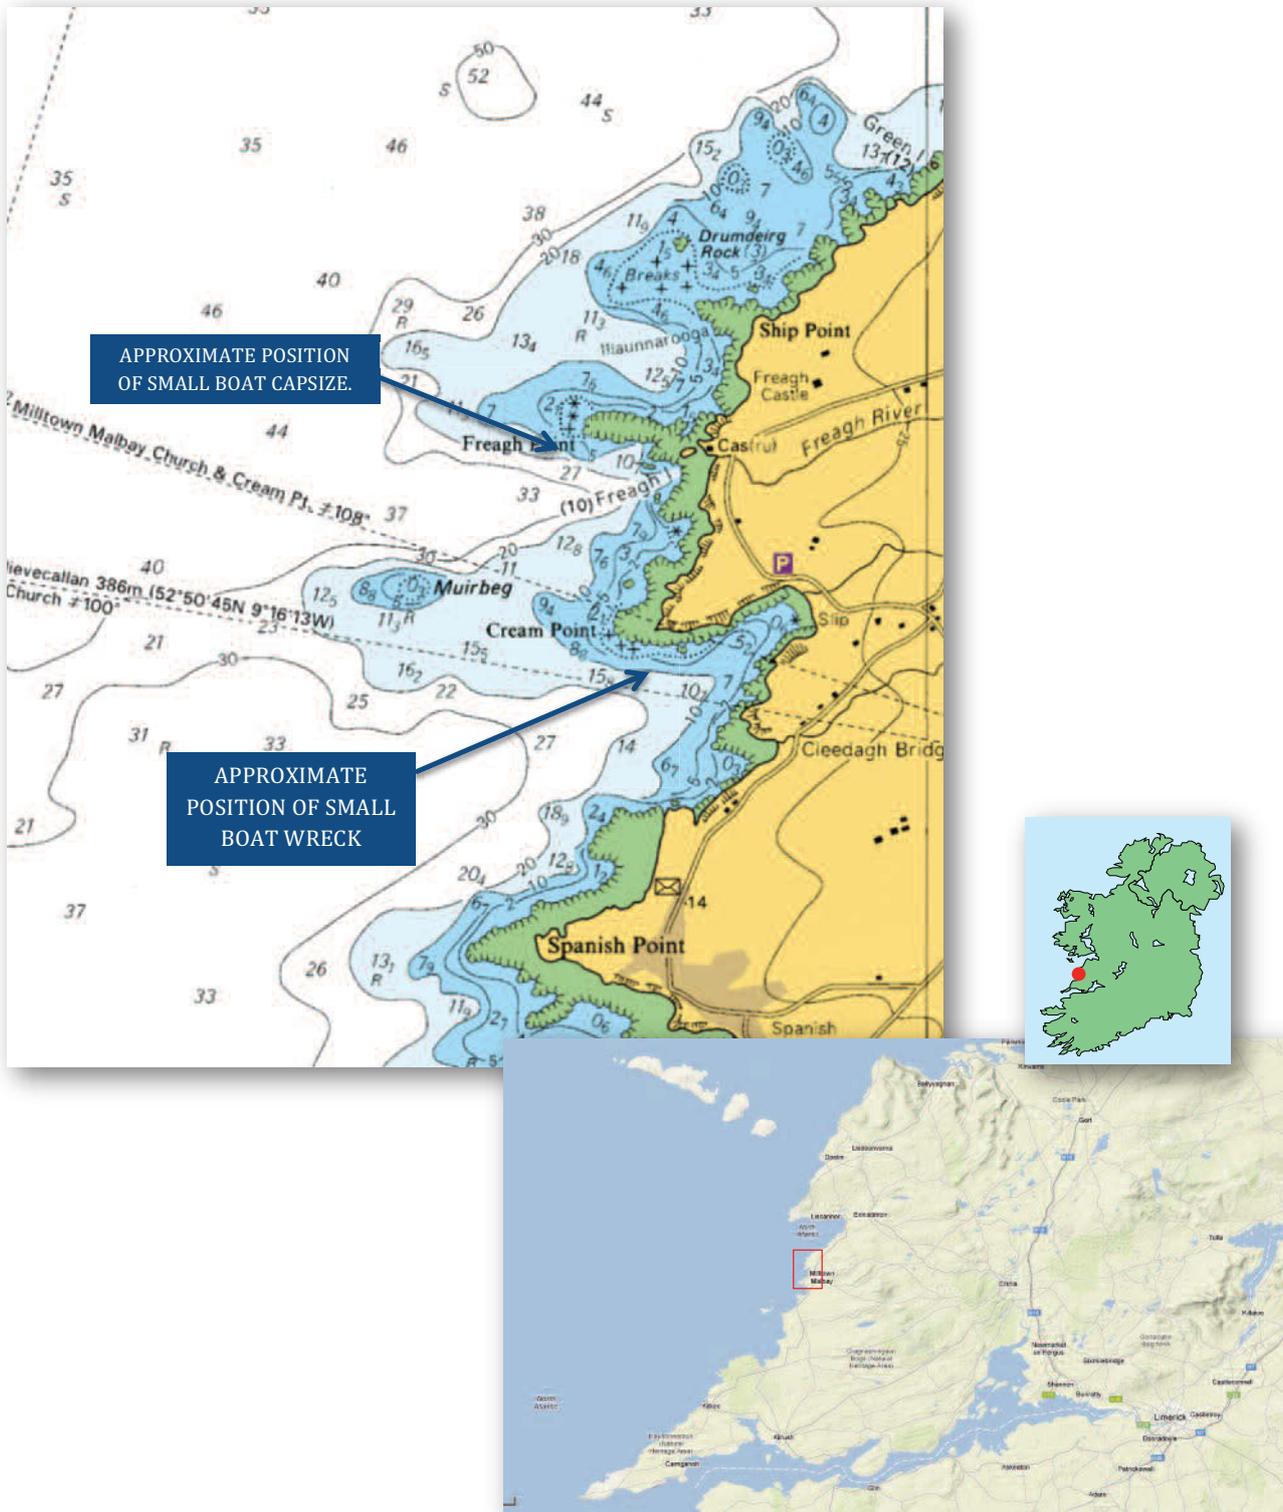
Appendix 7.4 Map showing area where small boat capsized during search operations.

- 3.3.17 At approximately 12:30hrs on the 14th August whilst the vessel was proceeding in the area of Freagh Point the vessel was caught and swamped by two waves,

the first wave causing the outboard engine to fail. The second wave capsized the boat, tipping the three occupants into the water.

- 3.3.18 Whilst all three persons were wearing PFDs, only one inflated. Fortunately the three persons were quickly rescued and brought ashore, where one person received oxygen from the Garda Divers who were in the vicinity.
- 3.3.19 The boat was later washed up on rocks in the vicinity of Cream Point, where it broke up. (see appendix 7.4)
- 3.3.20 The two PFDs that did not inflate were not available to the MCIB Investigator; therefore it was not possible to establish why the PFDs failed to operate.

- 6.5 The Board has noted that in large scale search and rescue operations, volunteers and their boats arrive at the incident scene. These volunteers should report to the appointed on scene SAR co-ordinator in order to be co-ordinated and managed in accordance with the needs of the SAR operation.
