**REPORT OF INVESTIGATION  
INTO THE SINKING OF THE  
FISHING VESSEL  
'LÉIM AN BHRADÁN'  
ON 30th OCTOBER 2010**

**REPORT No. MCIB/193  
(No.8 of 2011)**

Report MCIB/193 published by The Marine Casualty Investigation Board  
Published 20th July 2011

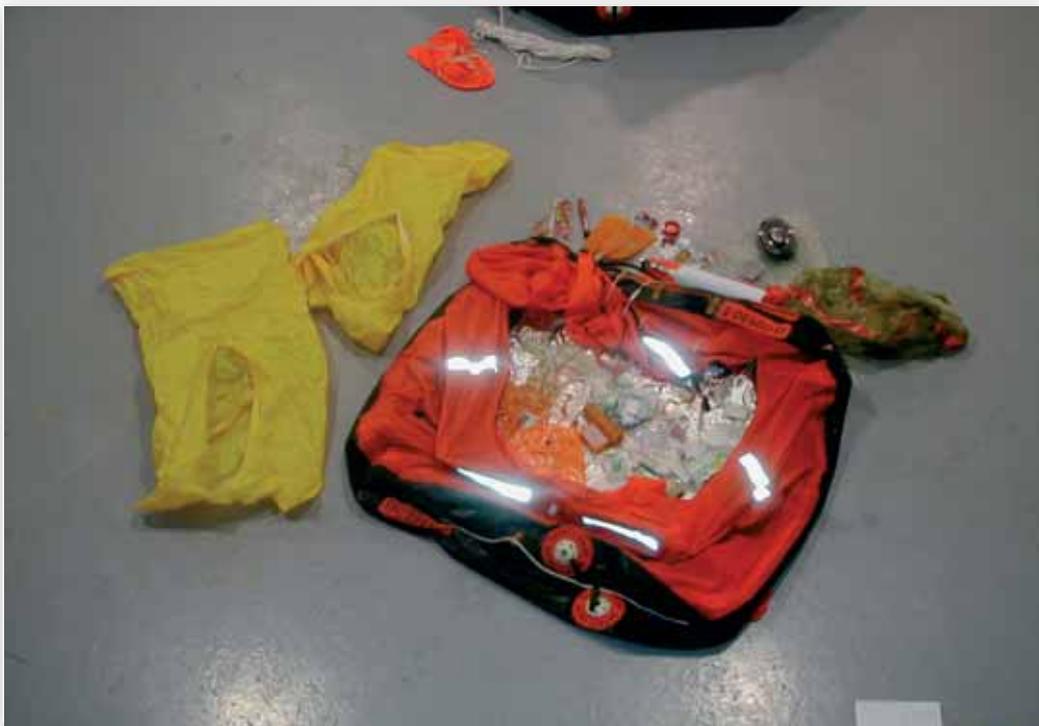
Appendix 9.10 Liferaft after deflation.

- 4.7 Mr. O'Donnell and Mr. Flannery each took it in turns to hold the canister whilst the other pulled on the painter in an attempt to operate the gas release mechanism. However, because there was nothing to brace against, the one pulling the painter was effectively 'towing' the liferaft canister and his companion through the water. After approximately 5 minutes, they finally succeeded in pulling the painter sufficiently to partially operate the gas release mechanism, which relies on the painter triggering a pin which opens the top of the CO<sub>2</sub> gas cylinder allowing the gas to escape into the raft. Unfortunately on this occasion, because Messrs. O'Donnell and Flannery could not give the painter the required sharp tug, the release mechanism only partially operated in that the pin opened the valve but did not withdraw as it is designed to do and effectively partially blocked the passage of the gas such that it seeped into the liferaft slowly instead of the usual rapid gush. This resulted in the slow inflation of the

raft which was insufficient to cause the canister securing strap clips to fail as they are designed to do.

- 4.8 As the liferaft slowly inflated, the canister began to swell. Fearing that the securing straps on the canister would prevent the raft from fully inflating, Mr. Flannery found a key in his pocket and used it to cut through the thin nylon straps. This allowed the canister to fall away and the liferaft inflated fully, albeit more slowly than it was designed to due to the partially blocked valve. As soon as the liferaft was fully inflated, Messrs. O'Donnell and Flannery climbed aboard. They estimated the time to be approximately 14.00 hrs.

- 6.6 The liferaft was not secured to the vessel, nor was the painter.
- 6.7 Had the liferaft been secured to the vessel or had Messrs. O'Donnell and Flannery been in a position to pull the painter with sufficient force, the liferaft inflation valve would have operated correctly and the raft would have inflated immediately and fully as it was designed to do.

- 7.2 Had the liferaft been secured to the top of the wheelhouse with an approved hydrostatic release unit fitted with a weak link tether for the painter, it would have floated to the surface and automatically inflated allowing Messrs. O'Donnell and Flannery to board it immediately.

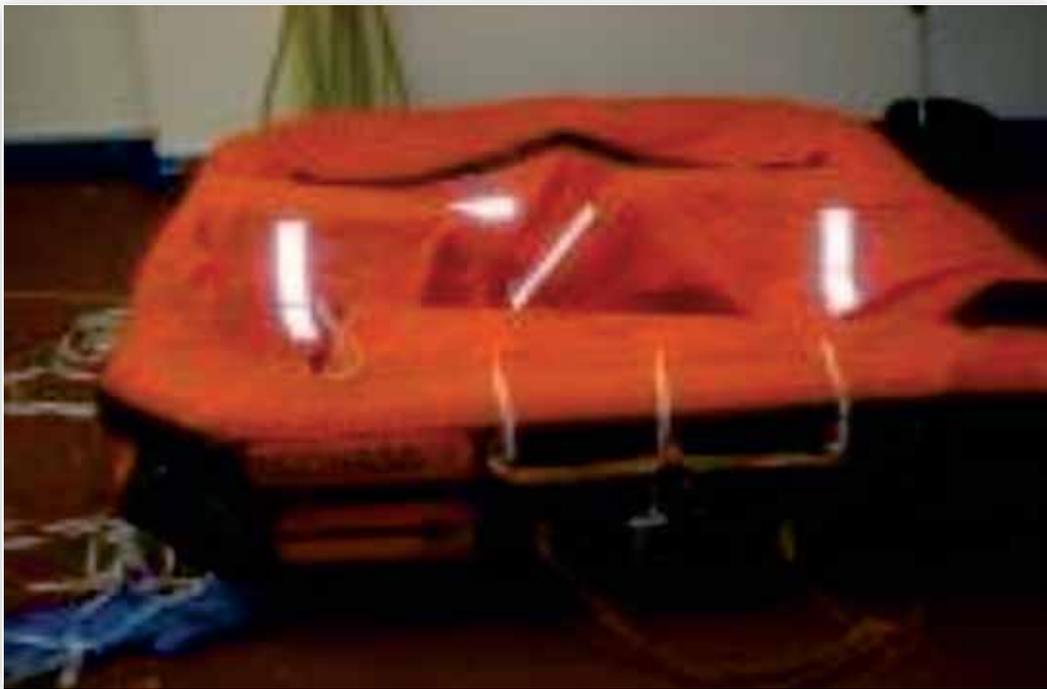
Appendix 9.11 Liferaft as picked up by the Ballyglass Lifeboat

- 5.10 At 23.47 hrs., MRSC Malin tasked Ballyglass lifeboat and at 23.54 hrs. tasked R118 rescue helicopter to search for the missing vessel.
- 5.11 At 01.36 hrs., R118 located the liferaft approximately 12 nautical miles north north east of Porturlin, Co. Mayo and guided the Ballyglass lifeboat to its location.
- 5.12 At 01.55 hrs., the Ballyglass lifeboat arrived at the liferaft and Messrs. O'Donnell and Flannery were transferred safely to the lifeboat. R118 returned to base.
- 5.13 At 03.15 hrs., the Ballyglass lifeboat returned to Ballyglass and put Mr. O'Donnell and Mr. Flannery ashore at the pier where they were met by Mr. Caden O'Donnell and members of their families from where they returned home. Neither Mr. O'Donnell nor Mr. Flannery were injured or required to be hospitalised.
