**REPORT INTO
THE LOUGH BELTRA TRAGEDY
WITH RESULTANT
LOSS OF LIFE**

The Marine Casualty Investigation Board was established on the 25th March, 2003 under The Merchant Shipping (Investigation of Marine Casualties) Act 2000

Published by The Marine Casualty Investigation Board
23rd February 2008

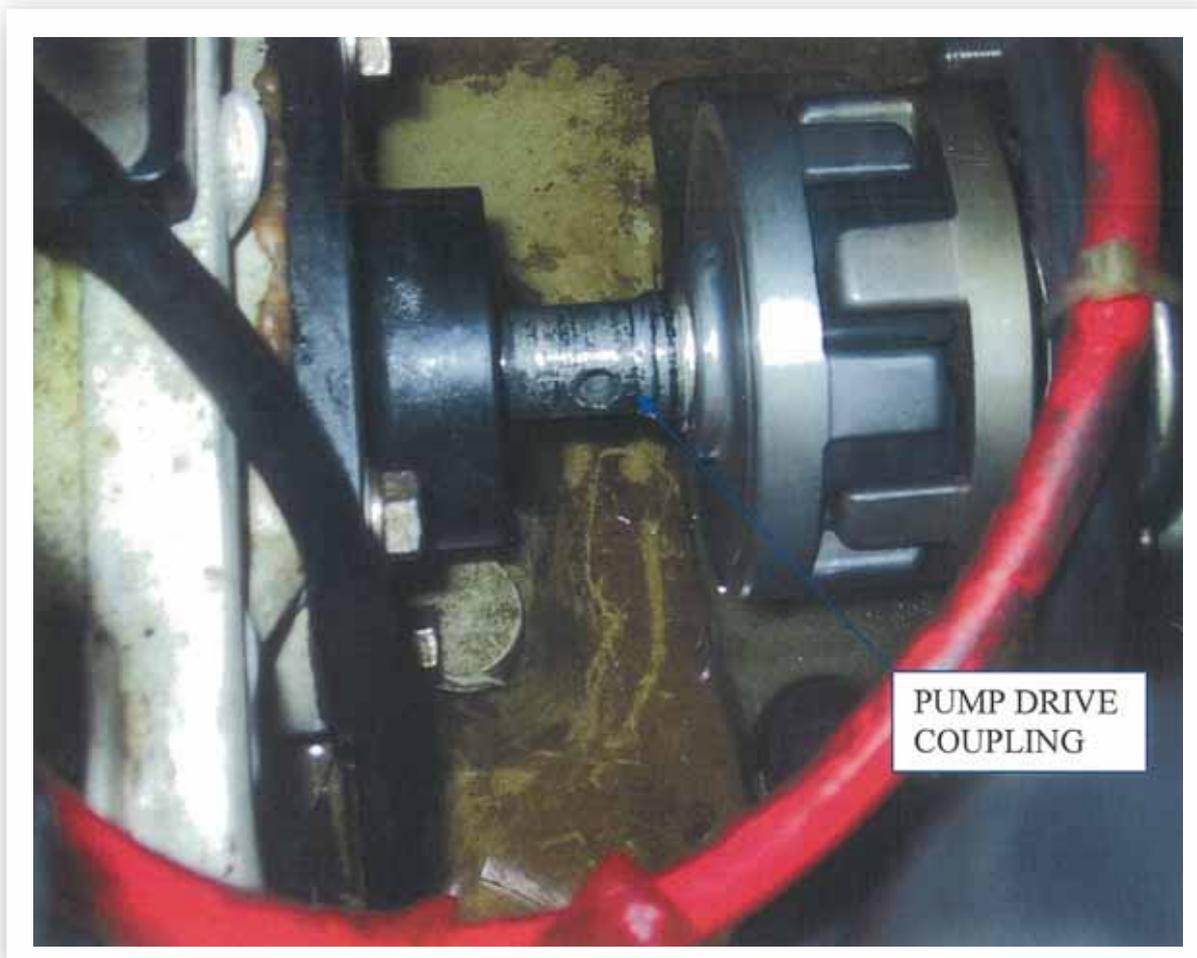
Appendix 8.4 Photograph of the pump drive coupling.

The craft was tested on Wednesday the 2nd of August in Lough Beltra when it developed a mechanical problem with the pump drive shear pin, which was repaired by a local agent on the same date.

- 3.4 The jet ski was examined and repaired by Mr. Arnold Menier, a local mechanic who identified the problem as being the pump drive shear pin, which was later replaced.

Mr. Arnold Weiner repaired the damage to the coupling drive (See Appendix 8.4). Mr. Thomas McLoughlin and Mr. Aiden Fenton subsequently ran the jet ski at Lough Beltra. The pump drive tested satisfactorily.

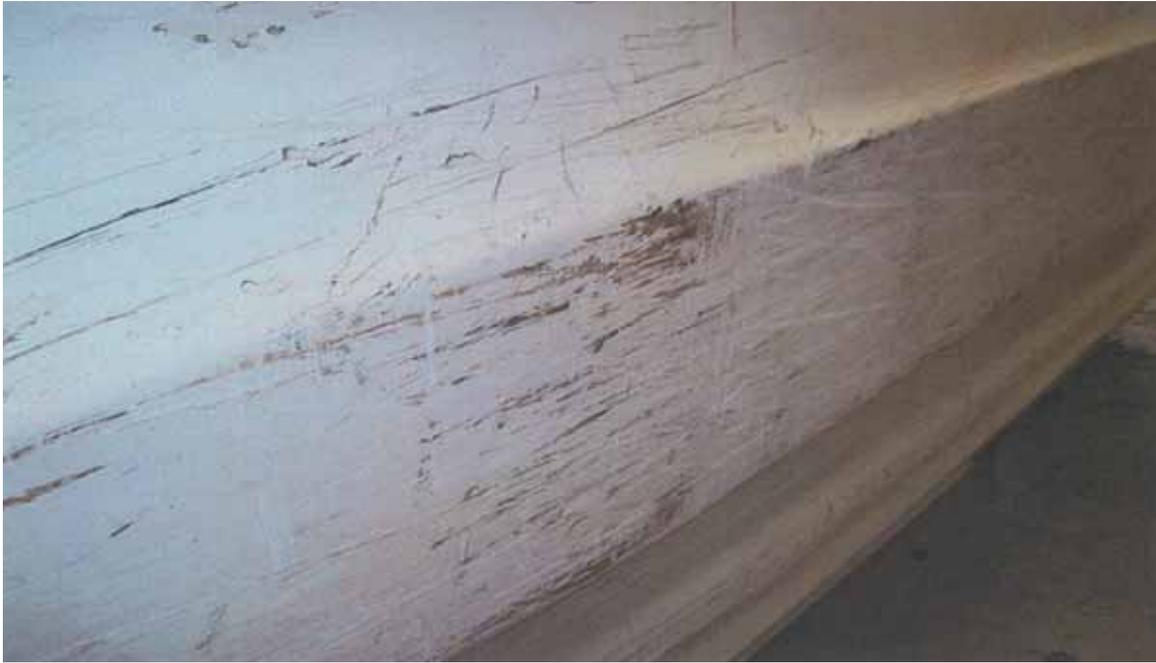
Appendix 8.5 Photograph of the hull section.

The crafts external shell construction material consisted of a process known as SMC (Sheet Moulding Compound), fibreglass sheet and resin which is then pressed into a mould (See Appendices 8.5 and 8.6).

On inspection of the crafts stern and main section, no indentation or structural damage was noted. The hull was in an intact state, with slight gel coat abrasion damage, which would not affect the stability or buoyancy of the craft.

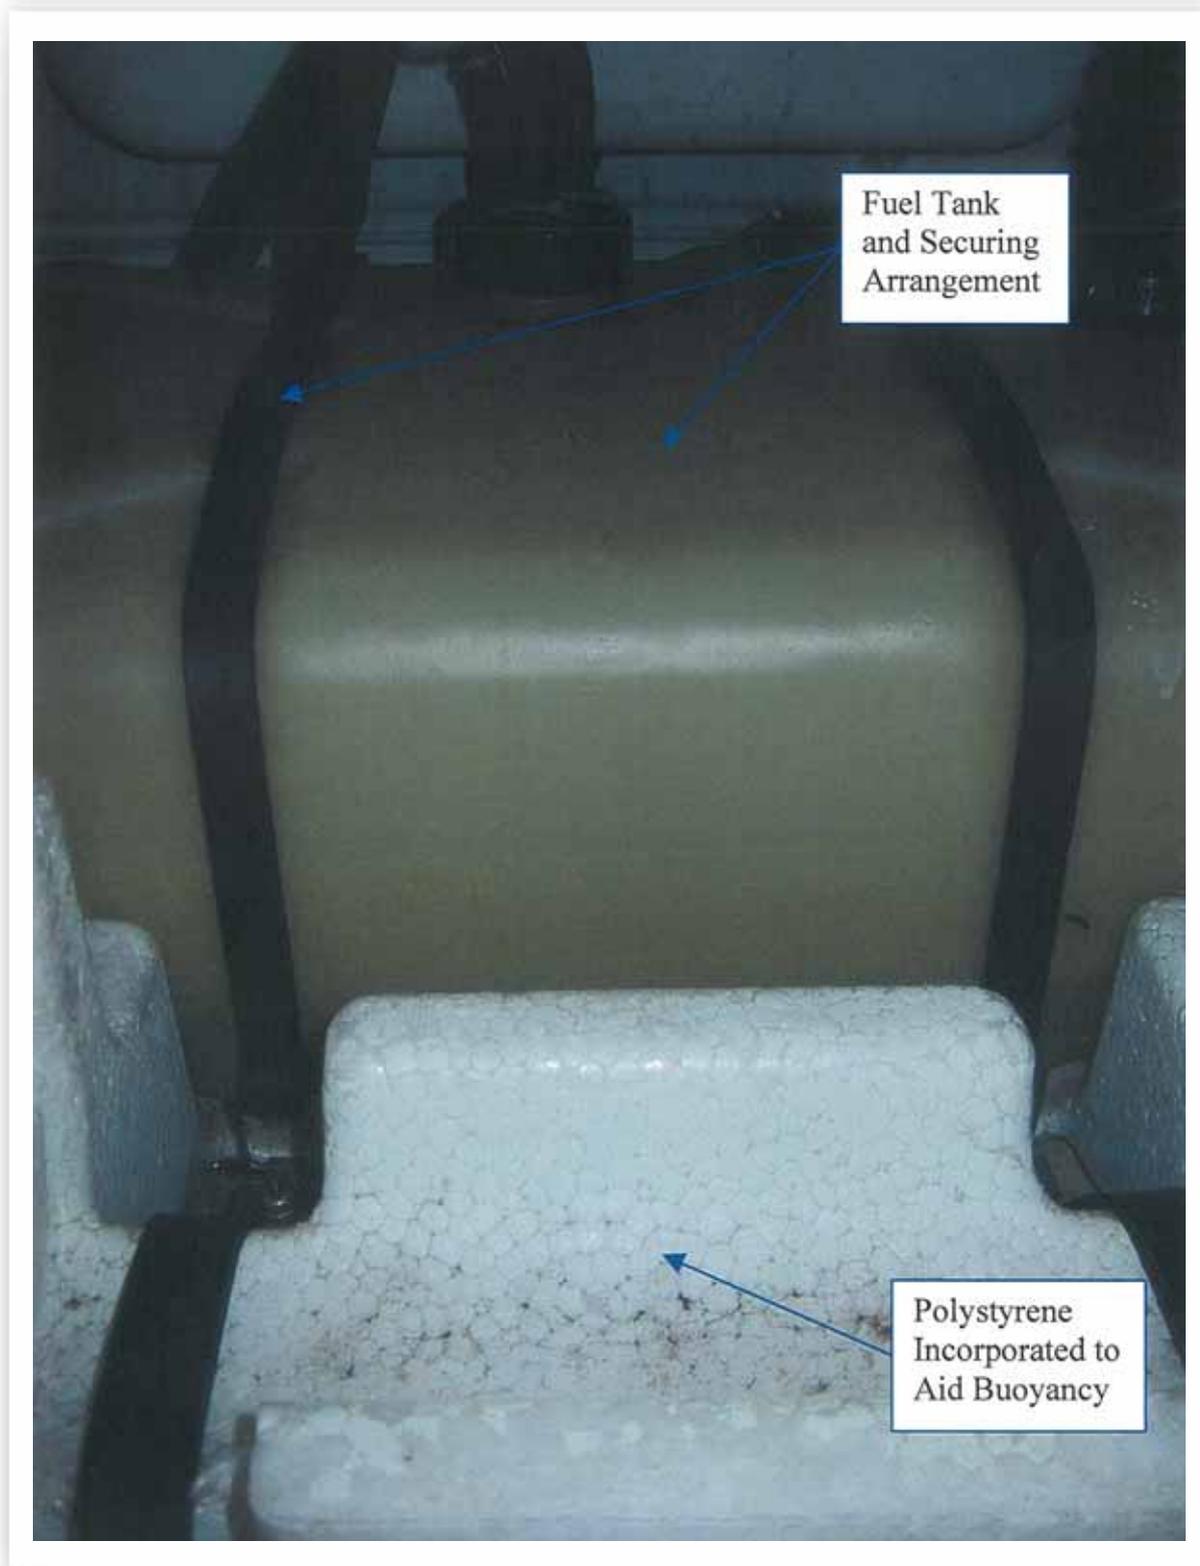
Appendix 8.7 Photograph of the forward compartment.

The compartments of the hull, not used for storage, engine or pump components, have either expandable foam or polystyrene incorporated to aid buoyancy. All securing straps were in place at the time of inspection (See Appendix 8.7).

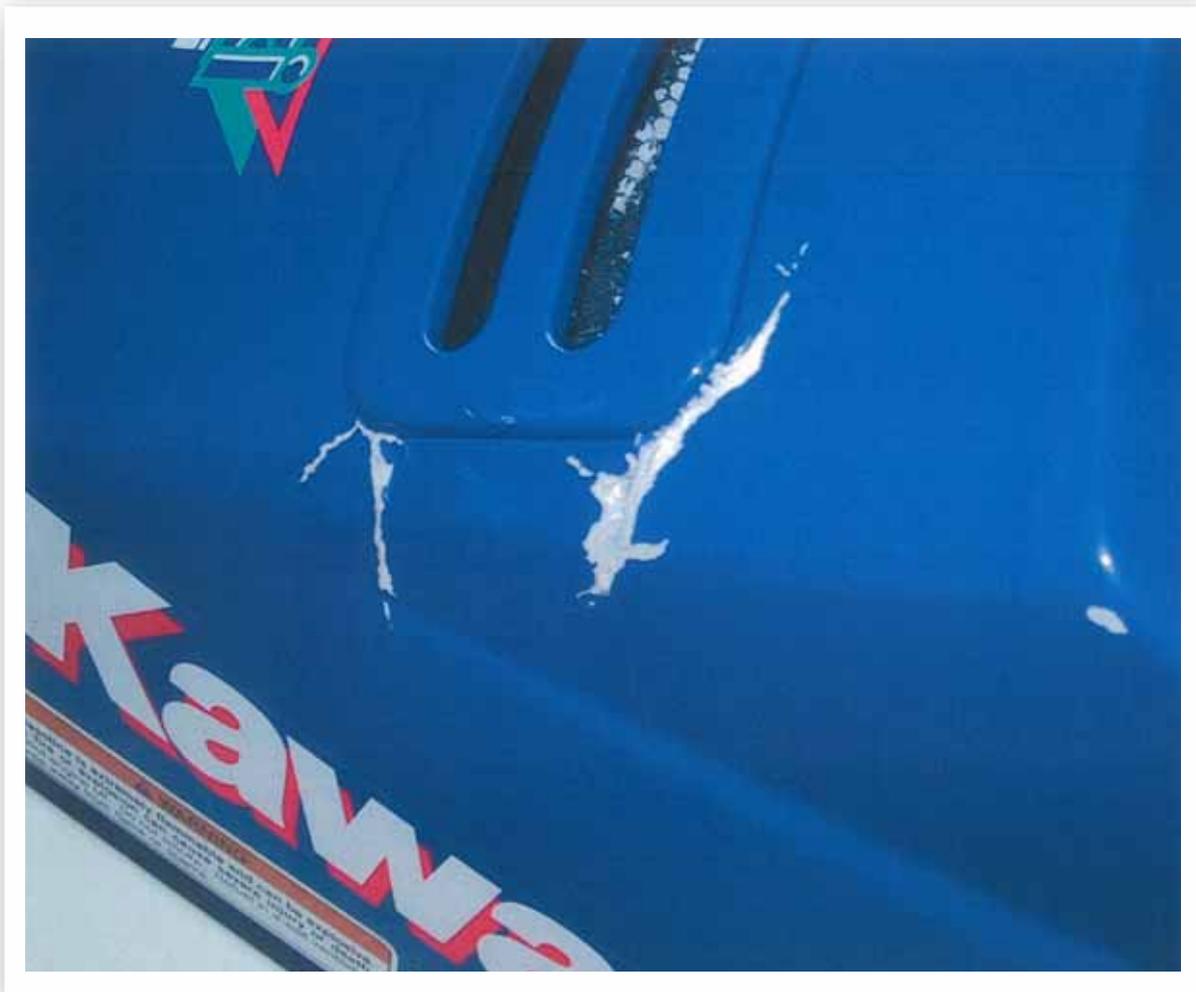
Appendix 8.8 Photograph showing the damage caused in portside upper side.

Damage to the port side upper hull in way of the steering consul. This damage may have been caused during the recovery operation (See Appendix 8.8).

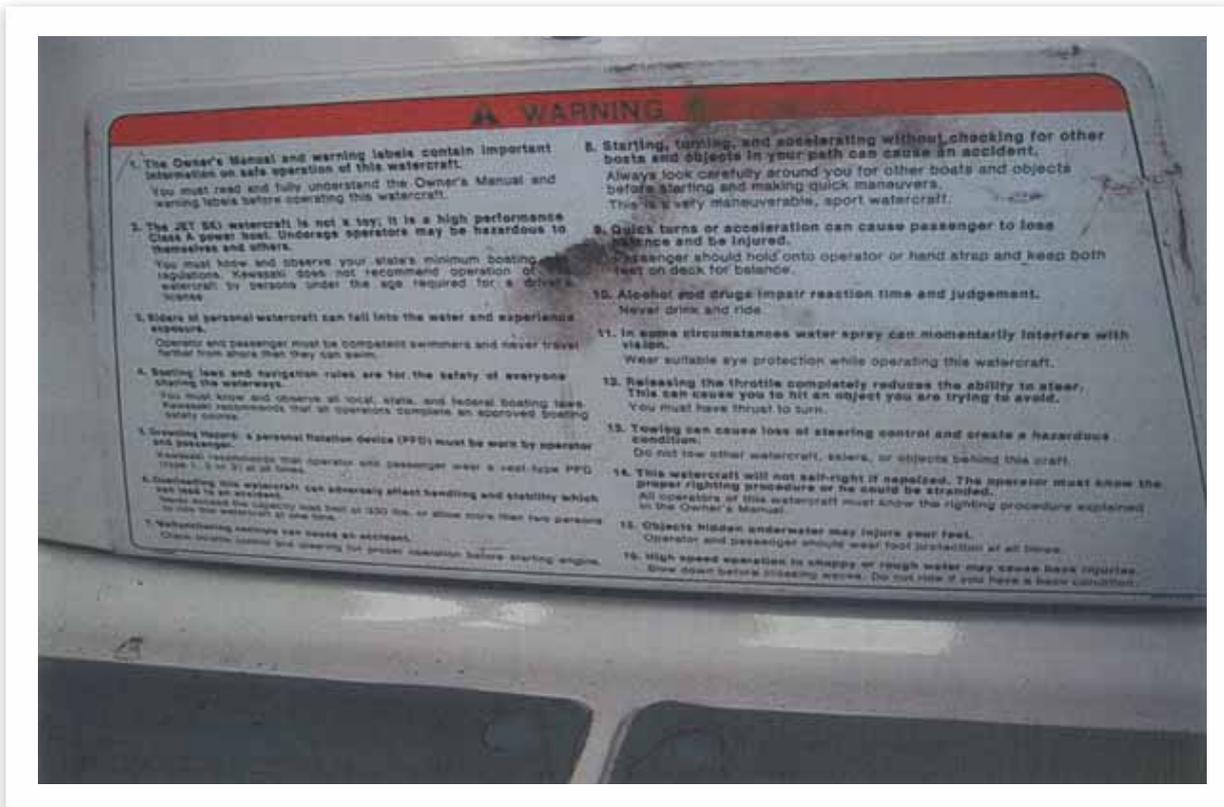
Appendix 8.9 Photograph of the crafts safe operation signage

Note: Operational Warning No. 12, which states that:

“Releasing the throttle completely reduces the ability to steer, you need thrust to steer” (See Appendix 8.9).

- 6.5 The investigation highlights the fact that the two young men were not familiar with the operation of jet skies. This is evident in so far as the men were unaware that the craft must maintain a certain speed in order to create momentum and thus remain upright during manoeuvres. (Refer Fig 8. Operational warning # 12).
