**REPORT INTO A FATAL INCIDENT
ON LOUGH DERG
CLOSE TO THE SHORE NEAR
GARRYKENNEDY
2nd AUGUST 2012**

**REPORT No. MCIB/221
(No.13 of 2013)**

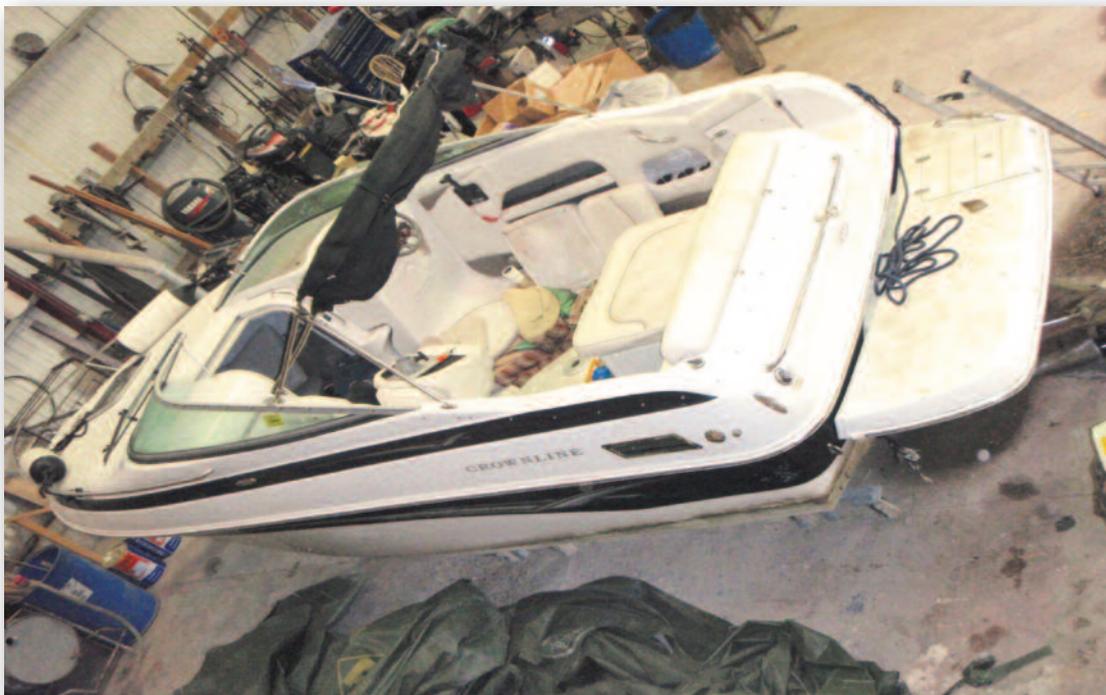
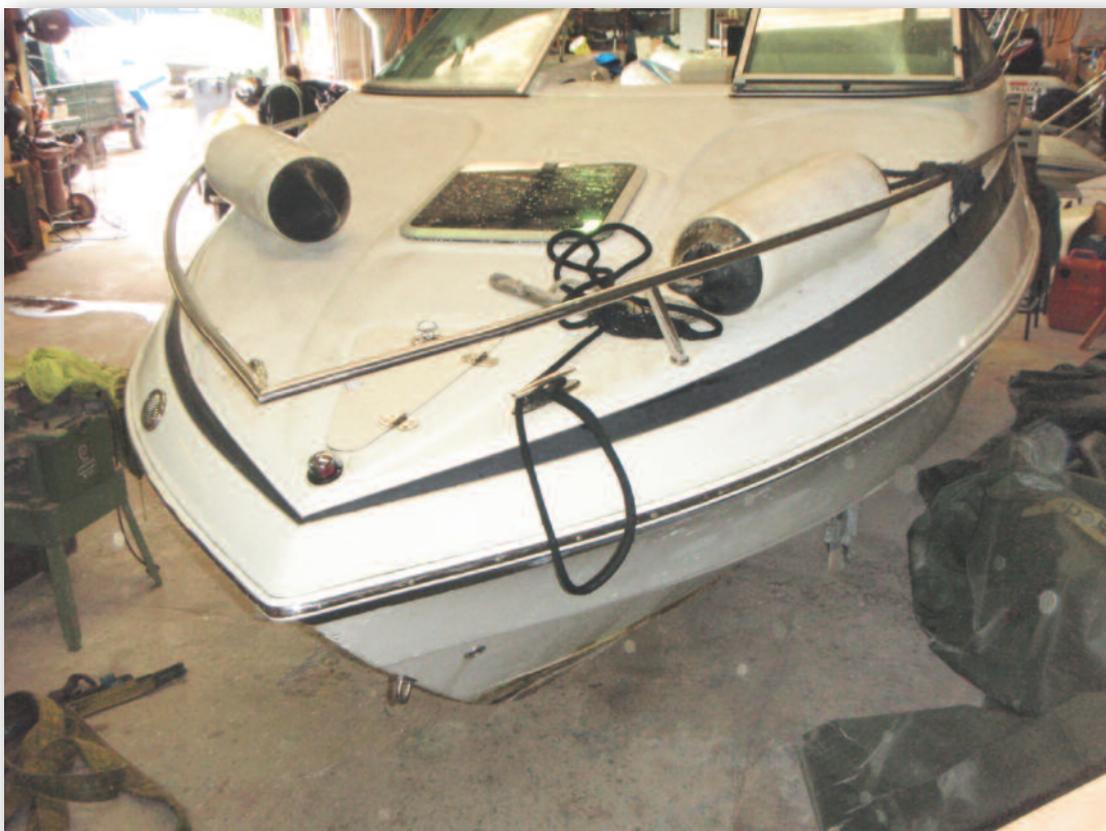
Photo 8041319 & 8041320. Taken on 04/08/12 at the premises of Shannon Sailing Ltd., Dromineer where the boat was stored after the incident

- 3.1 Information provided to the investigation concludes that Mr Danaher was a regular visitor to the Youghal Bay / Garrykennedy area and that he had a good knowledge of that part of Lough Derg.
- 3.2 Examination of the boat revealed that it was in good condition. It is understood that Mr Danaher maintained his boat well.
- 3.3 Information provided to the investigation concludes that Mr Danaher made regular use of the boat. This is borne out by the fact that the engine management system record shows that in the 16 months between April 2011 and the date of the incident there were 378 engine starts and the engine had accumulated 125.72-operating hours.
- 3.4 The maintenance manual calls for specific items to be attended to yearly or every 100 hours, whichever comes first. Thus, the boat was somewhat overdue for scheduled maintenance in respect of the engine and outdrive.

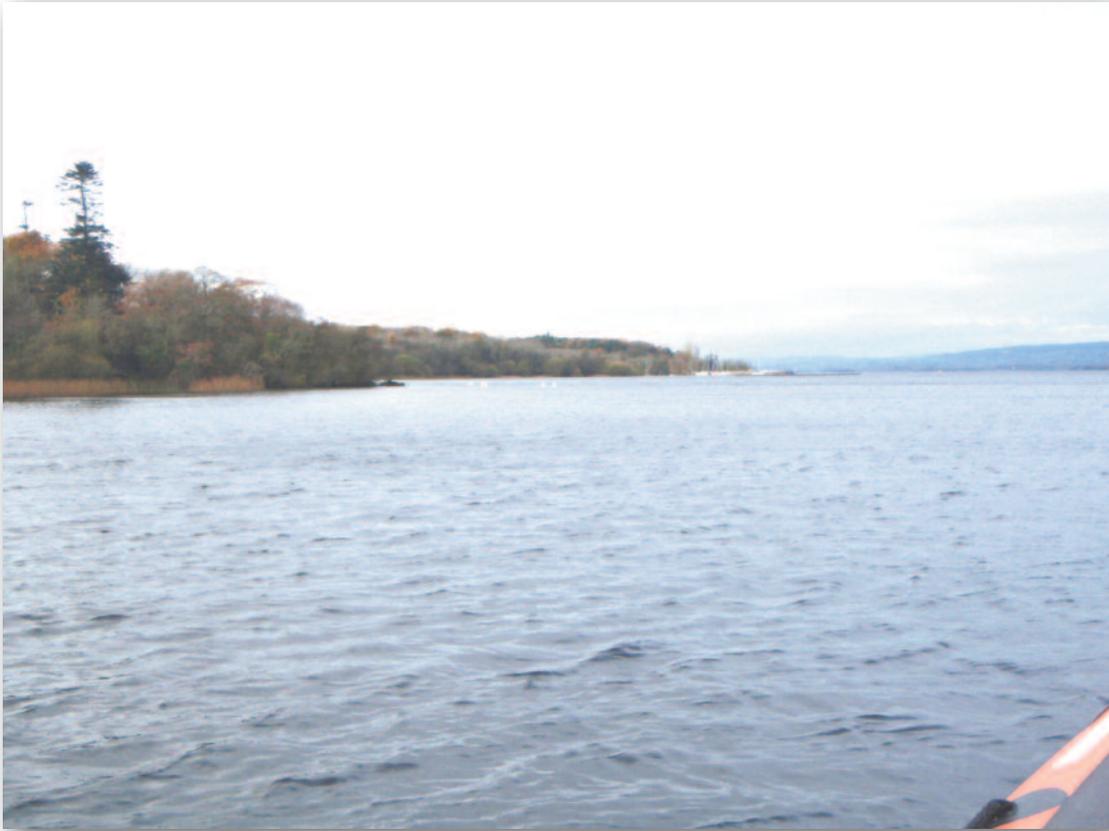
- 3.5 As stated previously, from the impact marks on the submerged rocks it was concluded by the rescue teams that the boat was travelling from East to West on the lake towards Garrykennedy. The submerged rocks that the boat struck are within about 5m of the shoreline at a small headland.

Lough Derg looking West towards Garrykennedy showing small headland off which boat struck submerged rocks. Photo taken 14/11/12.

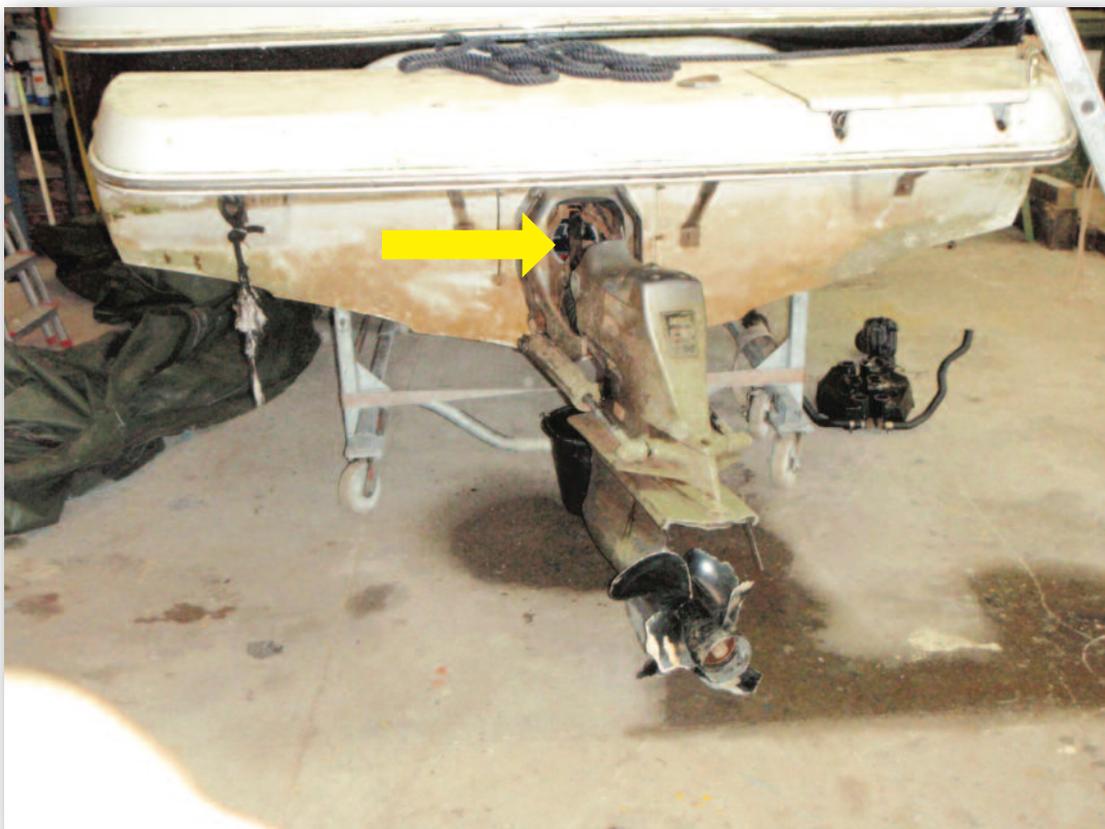
Photo P8041328. Taken on 04/08/12 at the premises of Shannon Sailing Ltd. Dromineer where the boat was stored after the incident.

- 4.2 The boat was travelling at high speed very close to the shoreline. The outdrive impacted with submerged rocks. The force of the impact caused the transom shield to break away from the transom of the boat and to pull the drive shaft and seals out of place. This allowed the free ingress of water into the boat causing it to sink.

The yellow arrows on above photo and photo on next page indicate area where outdrive pulled away from the transom stern allowing water to flow into the boat causing it to sink.

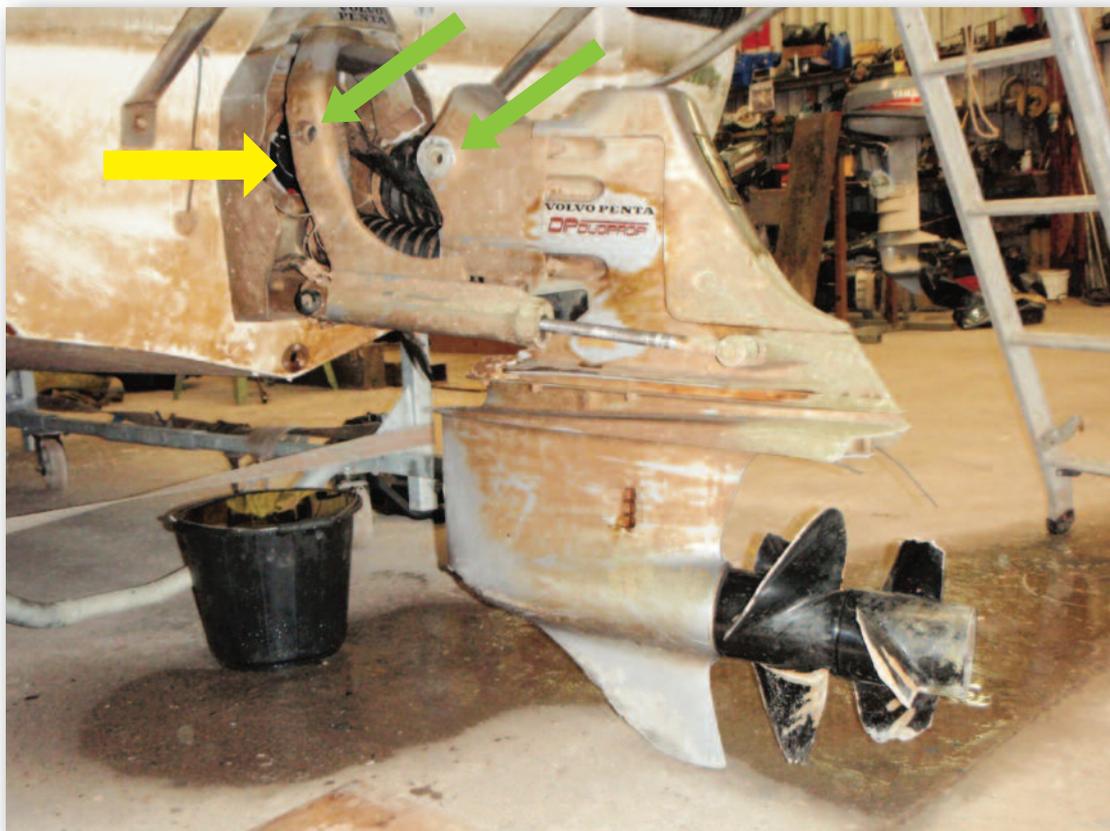
Photo P8041395. Taken 04/08/12 at the premises of Shannon Sailing Ltd. Dromineer where the boat was stored after the incident.

- 3.11 Inspection of the damaged outdrive components revealed that the pivot pin on the port side of the outdrive had been loose, and that it had not been in its correct position for some time as the threads in the pivot housing were corroded. Impact damage to the port side housing that shields the gimbal ring suggests that the pivot pin was ejected in the course of the incident.

- 3.12 On impact, the port side pivot arrangement offered little resistance to being forced backward whereas the starboard side took the impact and was fully broken away. See Appendix 7.6 Photo P8041395. The two green arrows indicate the pivot housing having moved away from the gimbal ring and the absence of the pivot pin.

- 4.3 Examination of the outdrive revealed that the pivot pin on the port side of the outdrive had been loose and not correctly in place before the incident. The degree of damage to the outdrive as a consequence of the impact indicates to the Board that, even if the pivot pin had been correctly in place, it would not have been able to sustain the force of the impact. Thus it would not have prevented the damage to the outdrive and the subsequent breaching of the transom of the boat.

The two green arrows indicate the pivot housing having moved away from the gimbal ring.

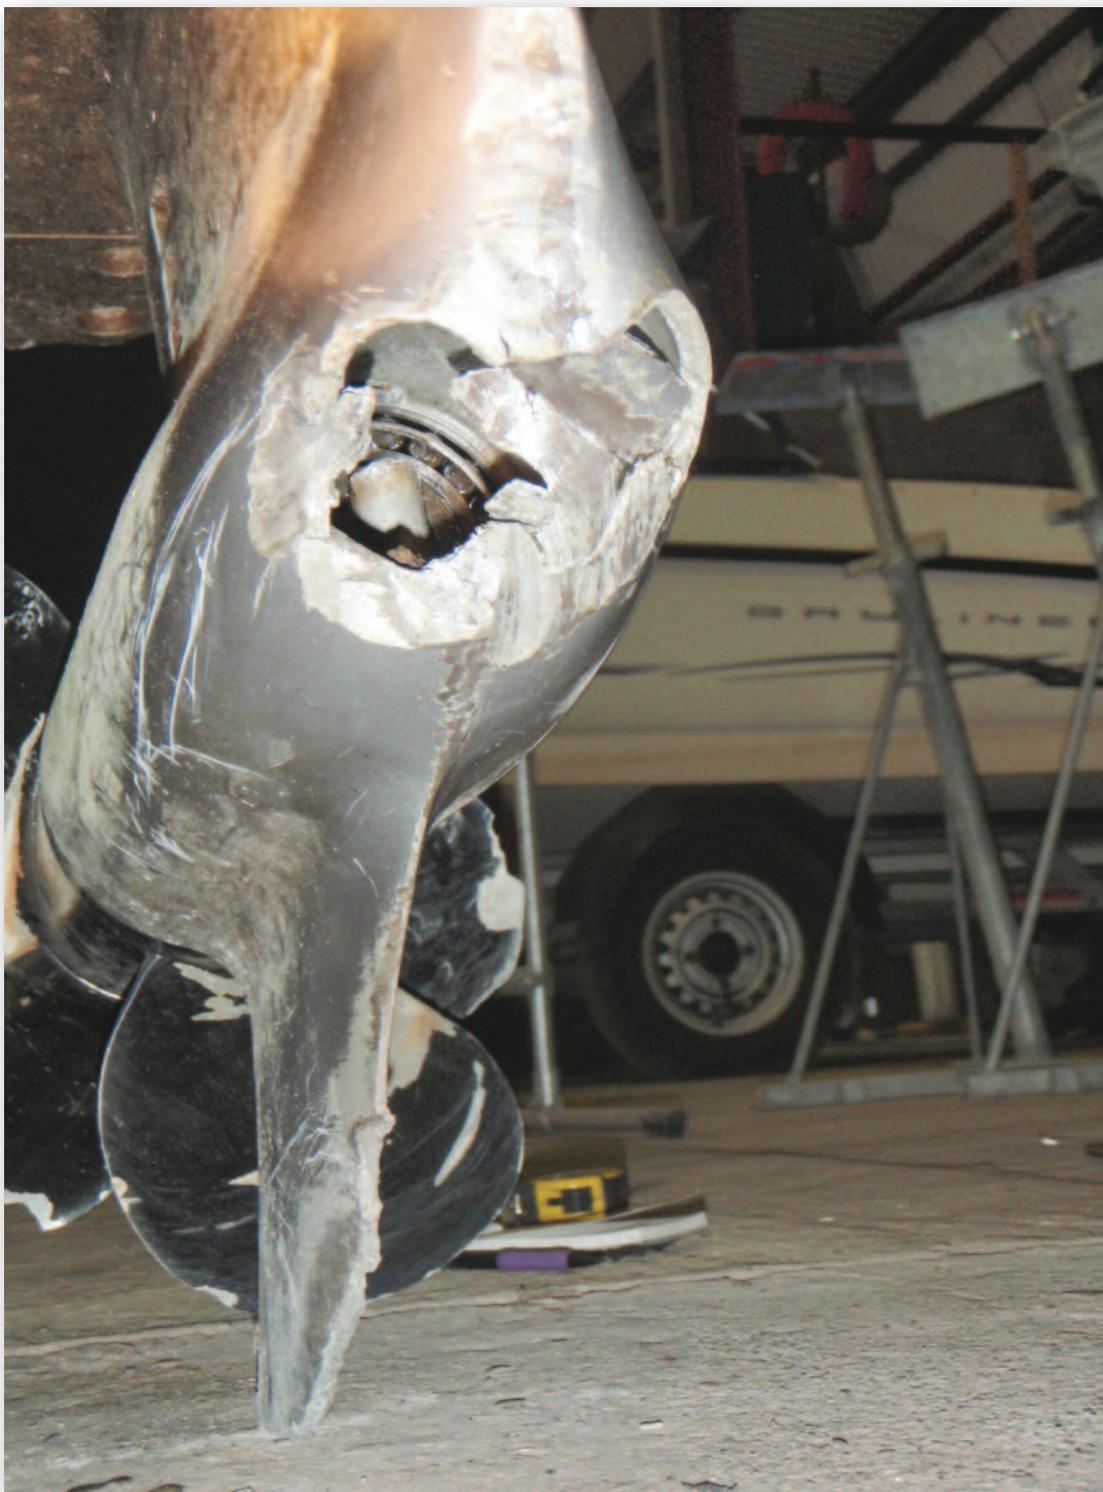
Photo P8161474. Taken 16/08/12 at the premises of Shannon Sailing Ltd. Dromineer where the boat was stored after the incident.

- 3.8 The main impact point is at the front of the outdrive casing at propeller shaft, at a level of 226mm above the tip of the skeg and 280mm below the bottom of the hull. The impact damage to the propellers and the skeg is also evident.
- 3.9 The resulting damage centres around the outdrive unit, it was broken away from the hull at the transom shield where the drive shaft from the engine connects to the outdrive. The impact pulled the drive shaft and seals out of place, creating a hole in the transom allowing water to flow freely into the stern of the boat and into the engine compartment causing the boat to sink by the stern. There was sufficient buoyancy at the bow to prevent the boat sinking fully and it remained floating with the bow protruding out of the water until it was seen and the alarm was raised.

The main impact point is at the front of the outdrive casing at propeller shaft at a level of 226mm above the tip of the skeg and 280mm below the bottom of the hull.
