**DRAFT REPORT OF THE  
INVESTIGATION INTO THE  
INCIDENT AT LOUGH MASK,  
CO. MAYO,  
WITH THE RESULTANT LOSS  
OF LIFE ON 9th MAY 2007**

**REPORT No. MCIB/141**

Report MCIB/141 published by The Marine Casualty Investigation Board  
5th December 2008

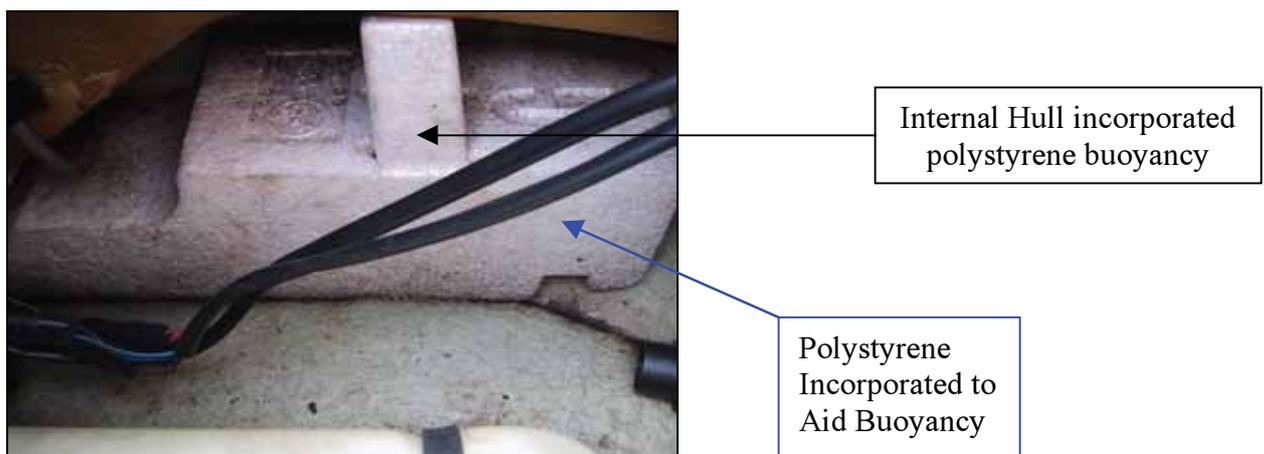
Figure 3. Buoyancy

On inspection of the crafts stern and main section, no indentation or structural damage was noted. The hull was in an intact state, with slight gel coat abrasion damage.

The compartments of the hull not used for storage, engine or pump components had either expandable foam or polystyrene incorporated to aid buoyancy. All securing straps were in place at the time of inspection.

The Forward compartment contained the fuel tank, which was integrated with the reserve fuel tank and was half full at the time of inspection.

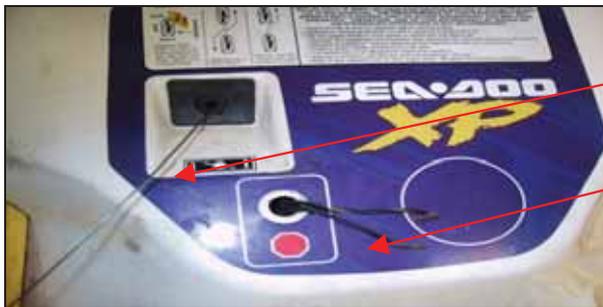
Figure 4. Consol

The choke cable was disconnected

Engine control switch electrically shorted

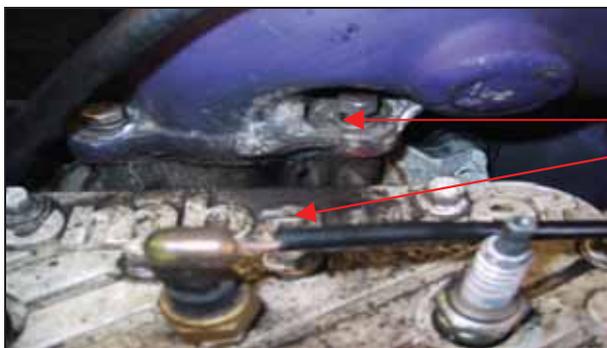
Figure 5. Engine and exhaust manifold

Exhaust damage due to loose retaining bolts

- A. Excessive exhaust fumes in the engine bay entering the air intake thus reducing the effective components constituents necessary for combustion, i.e. air mixture not correct to support combustion, thus stopping the engine. (Figure 5)
- B. Water from exhaust manifold entering the engine through the exhaust ports due to the manifold being loose, causing the engine to hydraulically lock thus stopping the engine. (Figure 6)
- C. The condition of the crafts electrical system, with respect to the control system associated with combustion. (Figure 4)

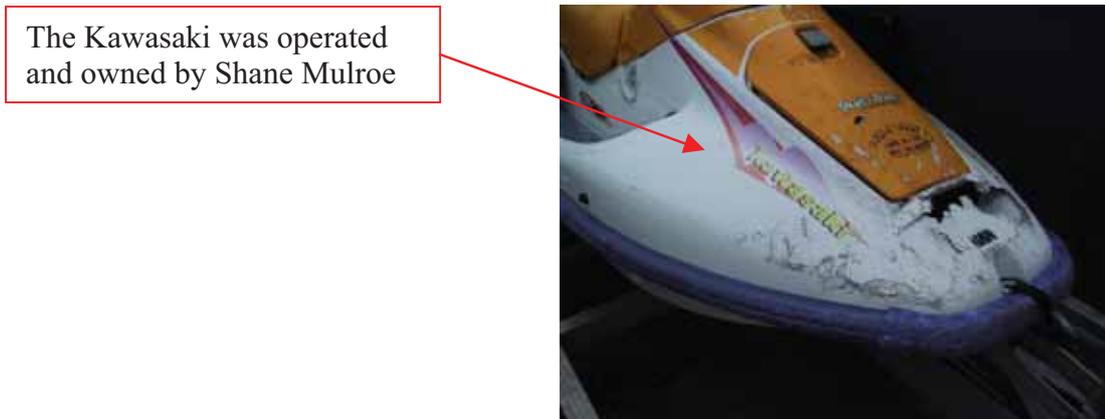
Figure 7. Kawasaki

After examination of Shane Mulroe’s Kawasaki, it was impossible to determine the cause of failure due to the ingress of water to engine and electrical systems. (Figure 7)
