The Marine Casualty Investigation Board was established on the 5th, June 2002 under The Merchant Shipping (Investigation of Marine Casualties) Act 2000

**INVESTIGATION INTO
THE LOSS OF THE
“PISCES”
AT
FETHARD-ON-SEA,
CO. WEXFORD
ON 28th JULY, 2002.**

1. The following is the final draft report on the investigation carried out by the Marine Casualty Investigation Board into the foundering of the vessel "PISCES" with the loss of five lives on 28 July, 2002 near Fethard-on-Sea, Co. Wexford.
2. The investigation was carried out in accordance with Section 26 of the Merchant Shipping (Investigation of Marine Casualties) Act, 2000.
3. The purpose of this investigation is to establish the cause, or causes, of this incident and to make recommendations for the avoidance of similar marine casualties in the future.
4. The Marine Casualty Investigation Board is precluded by law from attributing blame or fault.
5. The Marine Casualty Investigation Board would like to express its appreciation and gratitude to all who assisted in this investigation, and in particular:

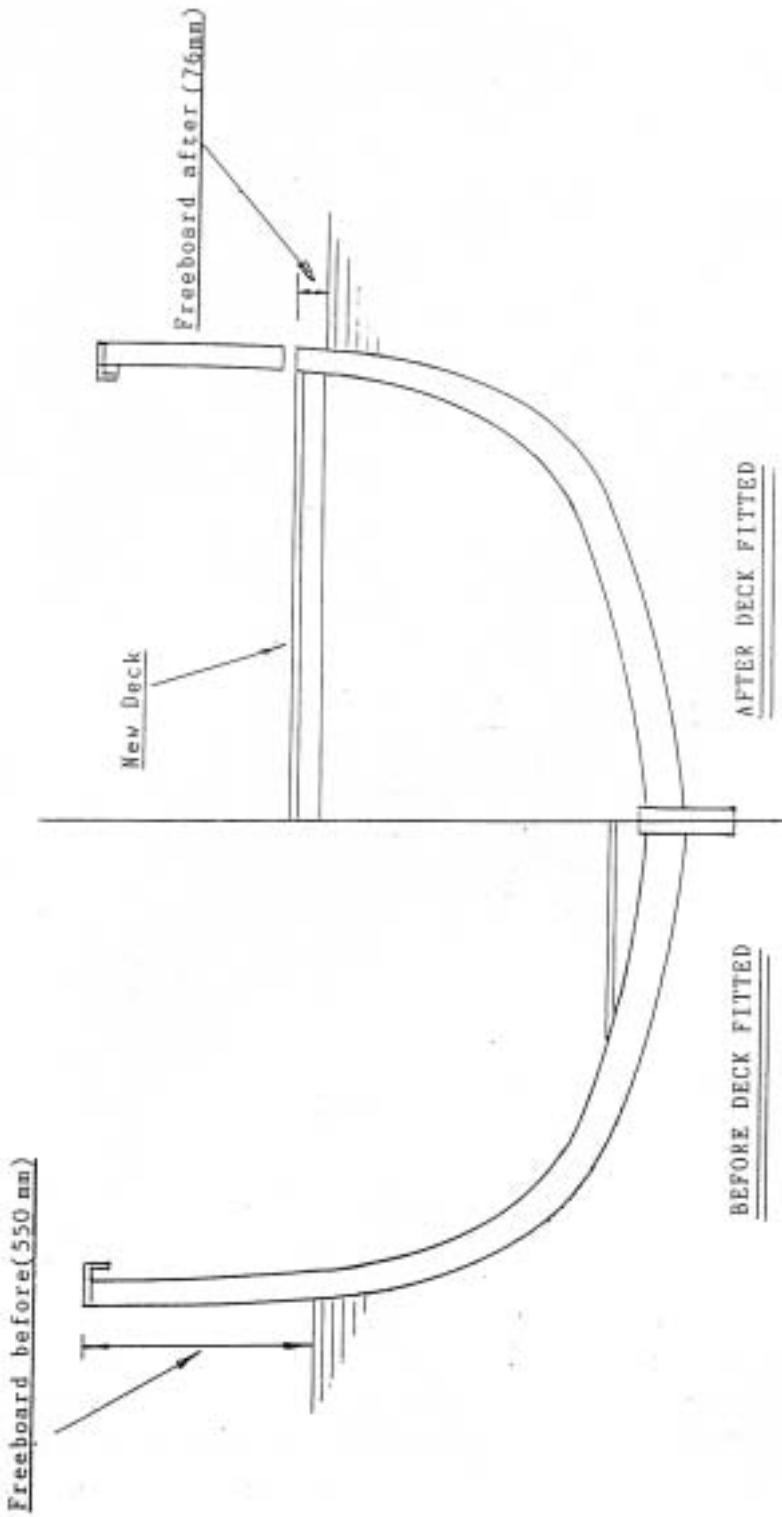
Appendix 3: Freeboard before deck fitted and after deck fitted.

The "Pisces" had originally been built as an open boat in the area aft of the wheelhouse and the sides of the vessel would have been intact from the gunwhale to the waterline. This arrangement ensured that the vessel had more than adequate "freeboard", (i.e. the distance measured from the top of the gunwhale to the waterline) which provided good protection from water entering the vessel as it rolled in a sea way or rough weather conditions. However, the vessel was later modified by the addition of a new working deck in the area aft of the wheelhouse. It is understood that this modification was carried out between 1991 and 1993.

When this new deck was fitted, six freeing ports (drainage openings) were cut in the sides of the vessel at the level of this new deck to facilitate the run-off of any water on the deck. However, this modification changed the effective freeboard from the original distance of bulwark to waterline of 550mm (about 22 inches) to a new distance of deck edge to waterline of 76mm (about 3 inches) (see Appendix 3). It should be noted that this arrangement would also permit water to flow on to the deck through these openings as no arrangements were fitted to prevent this backflow.

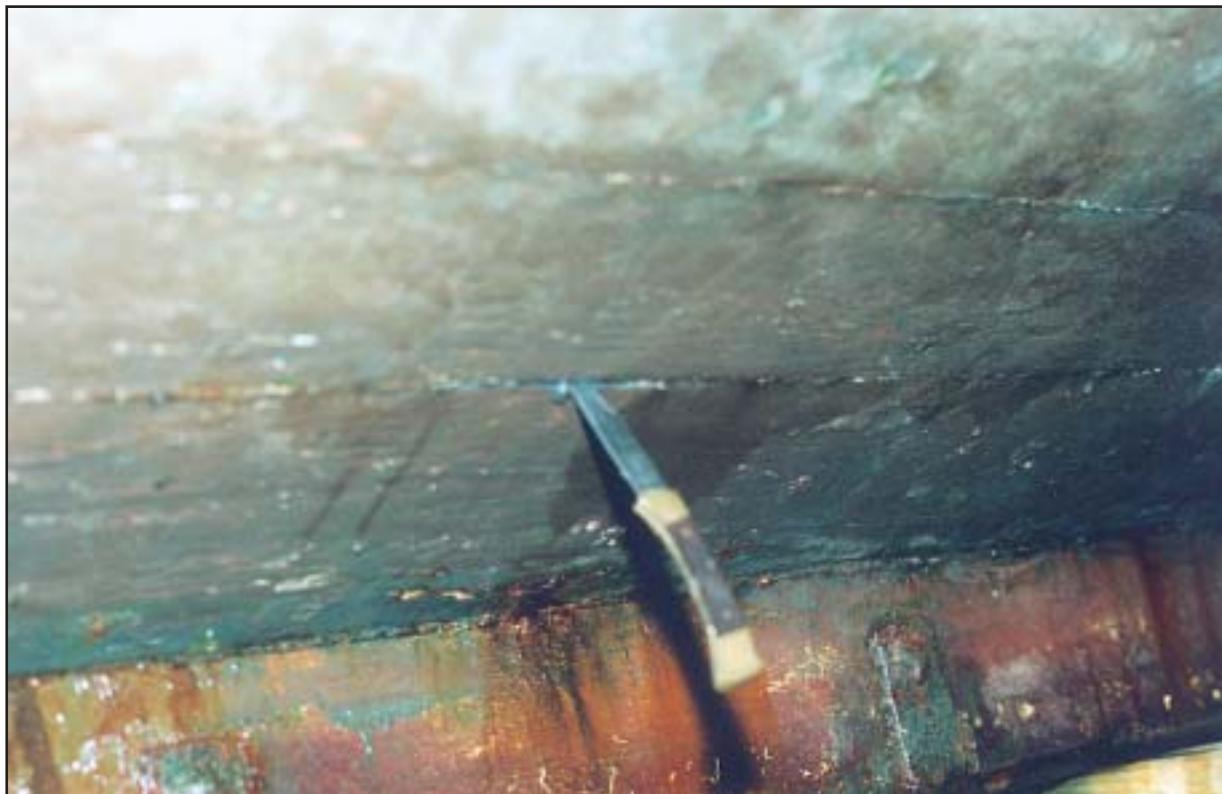
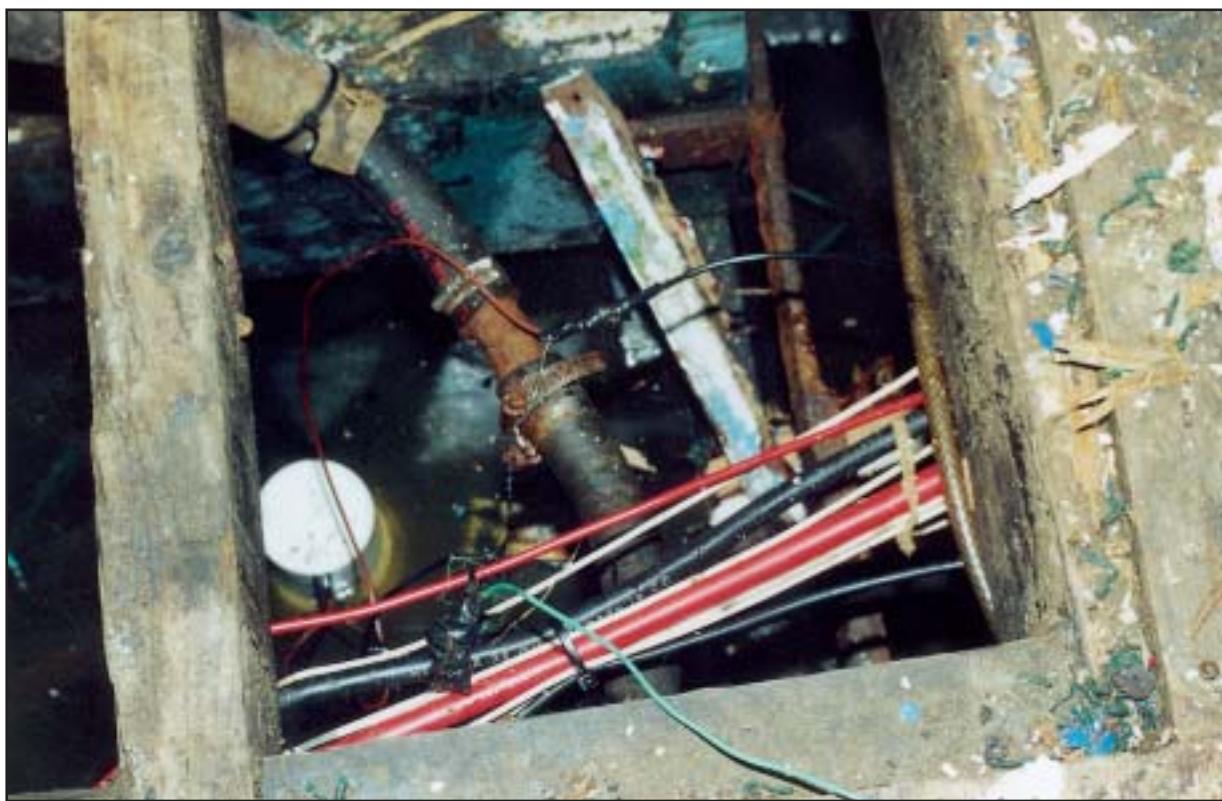
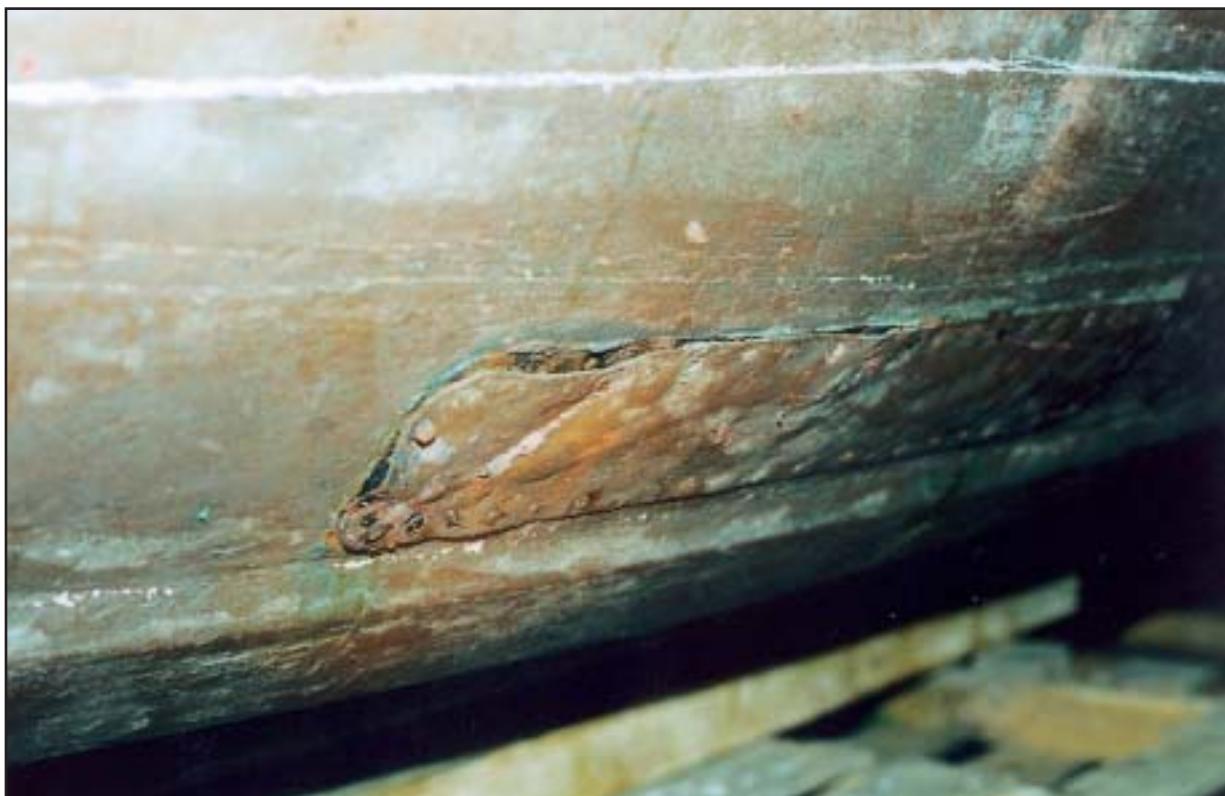
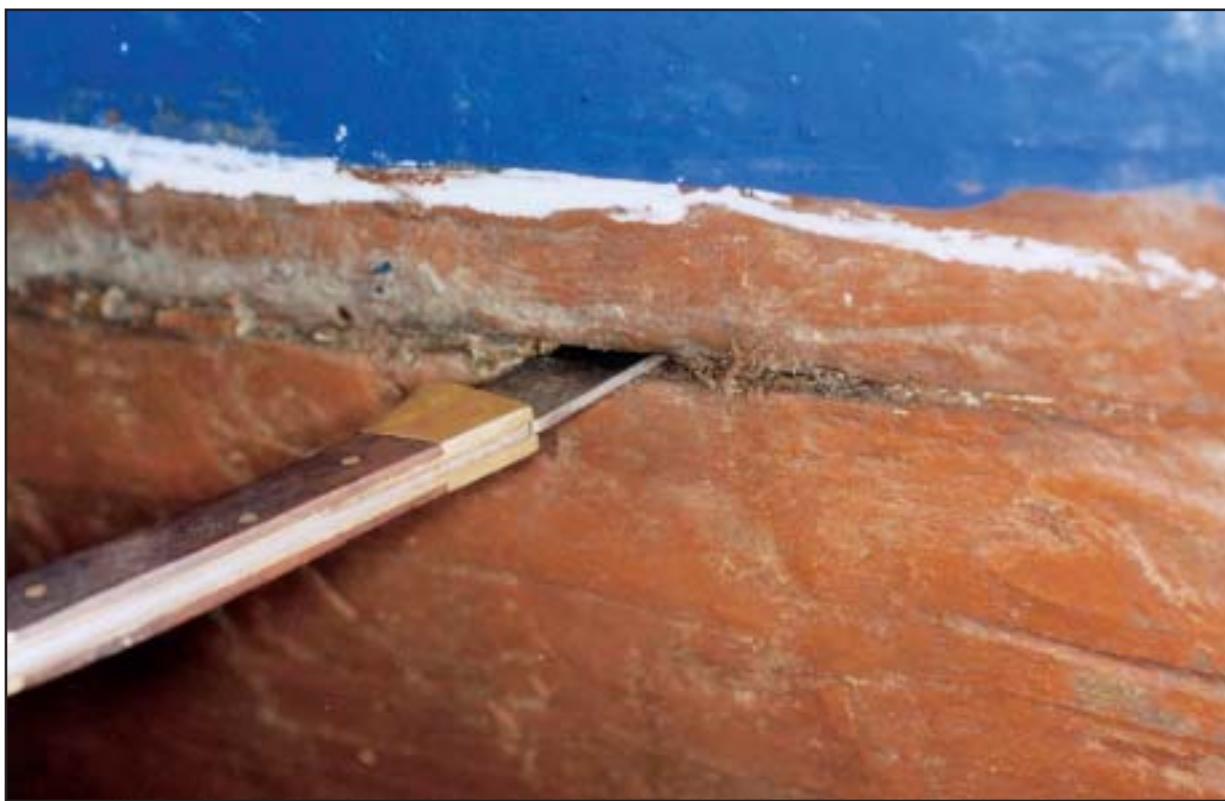
Photographs of "Pisces".

The planking, in some areas of the hull, was in a poor condition with some sections rotten. Repairs had been undertaken, utilising metal patches, in a number of underwater locations. On the port side of the bottom planking, about 1 metre forward of the propeller (see photographs in Appendix 11), the condition of the timber and the caulking (sealing between planks) was such that it was suspected that the hull would not be watertight in this area. This suspicion was subsequently confirmed when the vessel was placed back in the water in Dunmore East.

The caulking was found to be in poor condition in a number of areas and missing altogether in the area of the starboard side just under the forward freeing port, leaving an open gap between planks (see photographs in Appendix 11). It was calculated that, with the vessel loaded with weights equivalent to the number of persons on board on the day of the incident, the water ingress through this gap would have been about 490 litres per hour.

These defects were of a long-standing nature and had become progressively worse over time.
