**REPORT OF INVESTIGATION
INTO THE
LOSS OF CREWMEMBER
OVERBOARD
FROM THE MFV "MDAC"
ON
15th JULY 2009**

**REPORT No. MCIB/173
(No. 8 of 2010)**

Report MCIB/173 published by The Marine Casualty Investigation Board
19th July 2010

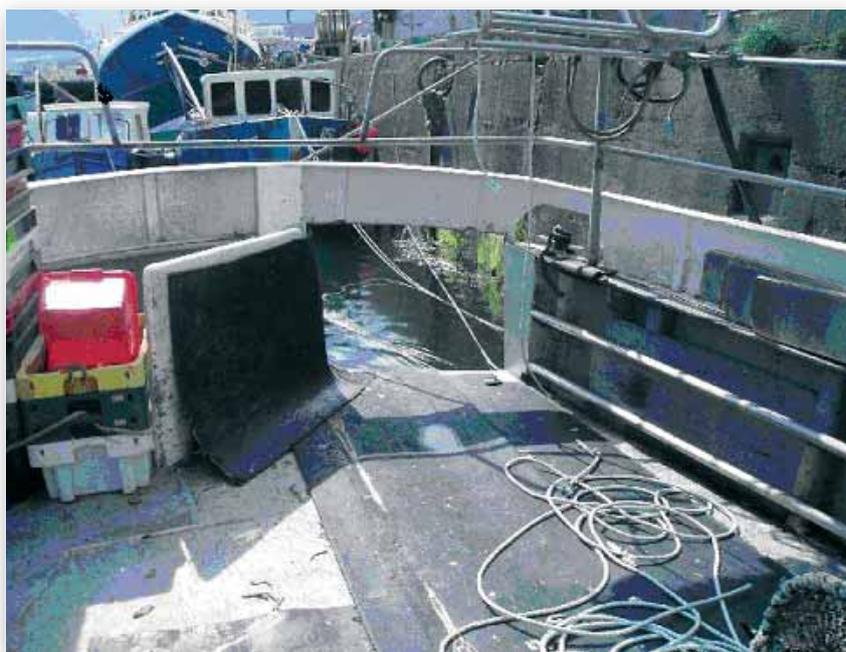
- 3.2 The vessel has a substantial working deck and is rigged to handle strings of lobster pots.
- 3.3 The vessel is equipped with a hydraulic pot stacker to aid in the retrieval of pots and the stern of the vessel has a purpose built door in the bulwark to allow the pots to run straight over the side. (see Photo No. 1).

Photo No. 1: Working deck and open stern door on the MFV "MDAC".

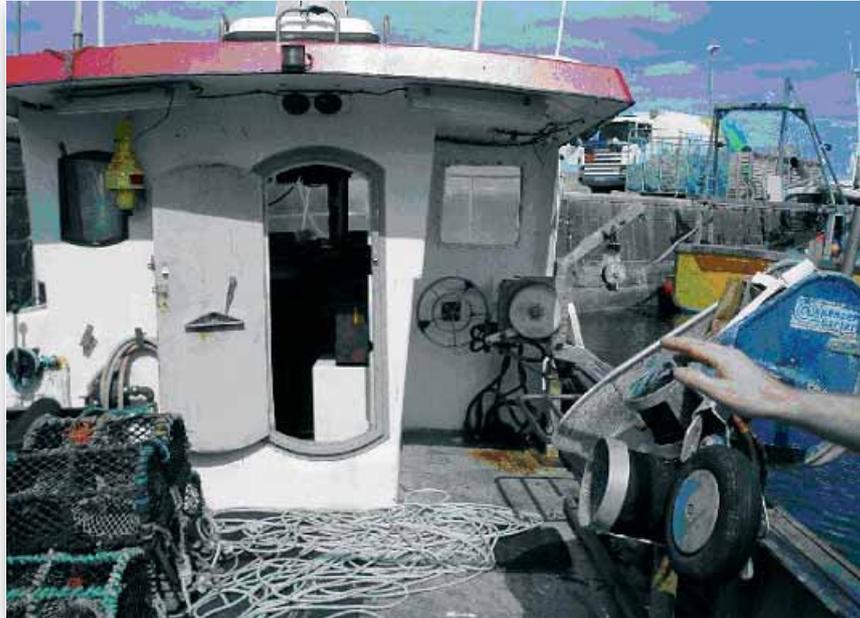
- 4.1 The 5th string had almost been shot when Mr. Williams, who was in the wheelhouse, heard Mr. Egan cry out. Mr. Williams saw Mr. Egan sliding across the deck towards the stern. (see Photo No. 2).

Photo No. 2: View of the wheelhouse from aft. Mr. Egan was standing on the starboard (right side) of the wheelhouse. The pot ropes have been disturbed after Mr. Egan was pulled over the side but the potential for a fisherman to be snared can be clearly seen from this photograph.

- 7.1 The Minister for Transport should enforce the wearing of lifejackets/PFDs by all persons engaged in fishing activities.
- 7.2 The Minister for Transport should consider developing a Safety Management System for fishing vessels.

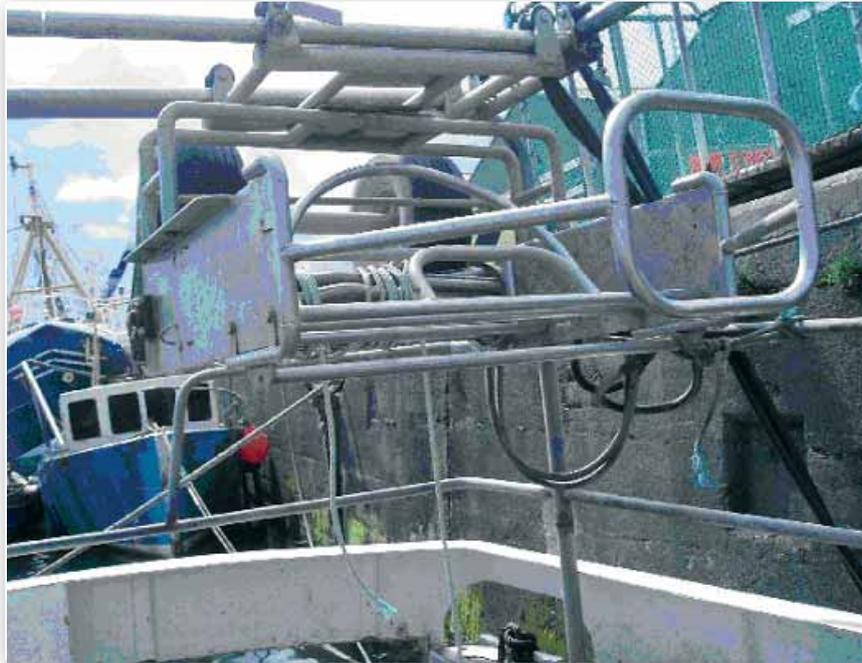
- 4.6 Mr. Egan's leg appeared first with a turn around his Wellington boot. Mr. Williams fearing that the boot would come off, attached another line above Mr. Egan's knee and tied this off to the boat's handrail.
- 4.7 Mr. Williams experienced some difficulty hauling Mr. Egan through the stern door with the remaining string of pots pulling astern, the pot stacker pulling overhead and the rope around Mr. Egan's knee tied off to the handrail. (see Photo. No. 3).

Photo No. 3: The pot stacker. Two rope ends can be seen trailing from the hauling drum. This was the means by which Mr. Egan was recovered.
