**REPORT OF INVESTIGATION
INTO FATAL INCIDENT ABOARD
THE MFV 'MARK AMAY II'
OFF ACHILL, CO. MAYO
ON
10th MAY 2011**

**REPORT No. MCIB/202
(No.10 of 2012)**

Report MCIB/202 published by The Marine Casualty Investigation Board.
Printed 2nd November 2012.

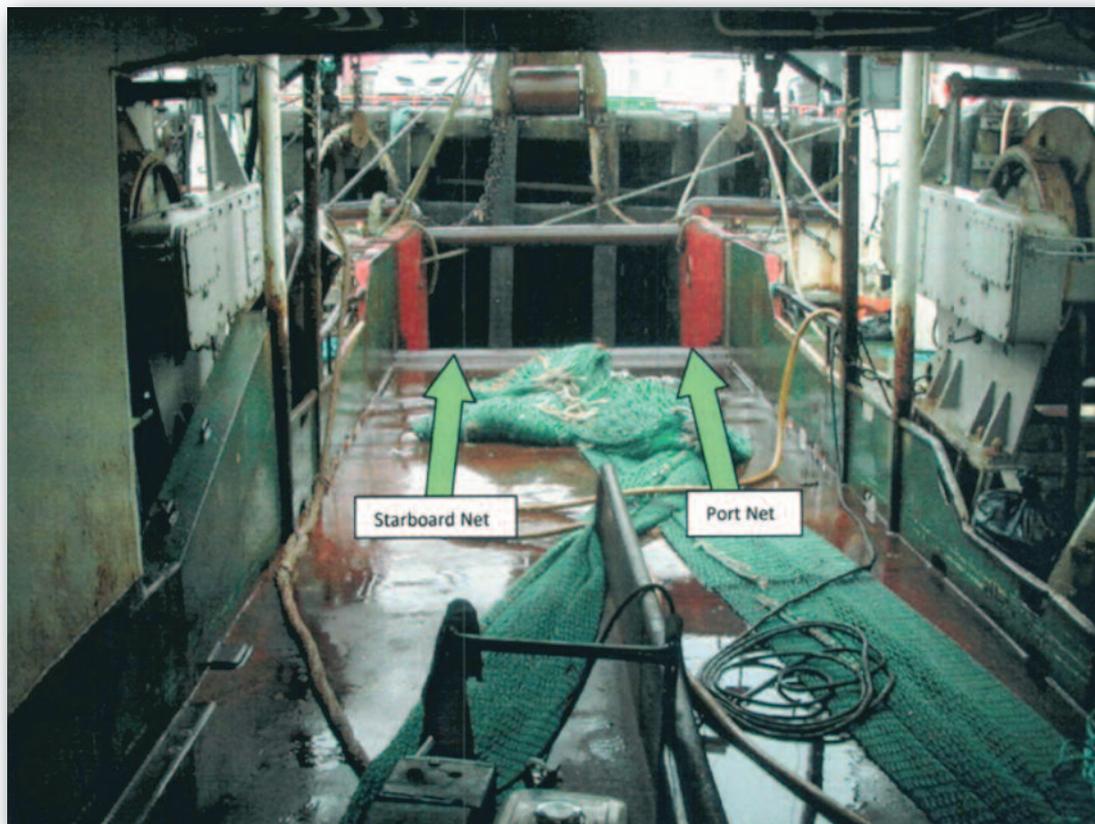
Appendix 9.5 Photo of Trawl Deck Showing Nets.

- 3.6 The weather conditions at this time were poor with force 5 to 6 South Easterly winds and 4 to 5 metre high seas. As a result, the 'Mark Amay II' was rolling and pitching quite severely. The stern of the vessel was rising and falling on the swell to a height of several metres and the nets were sliding from side to side on the trawl deck.

- 4.1 As Mr. Cathal McDaid crossed over the port net on his way to the rail, he stumbled and lost his footing as the net slid around on the deck, and fell on top of it. He clung to the net to prevent himself from falling further.

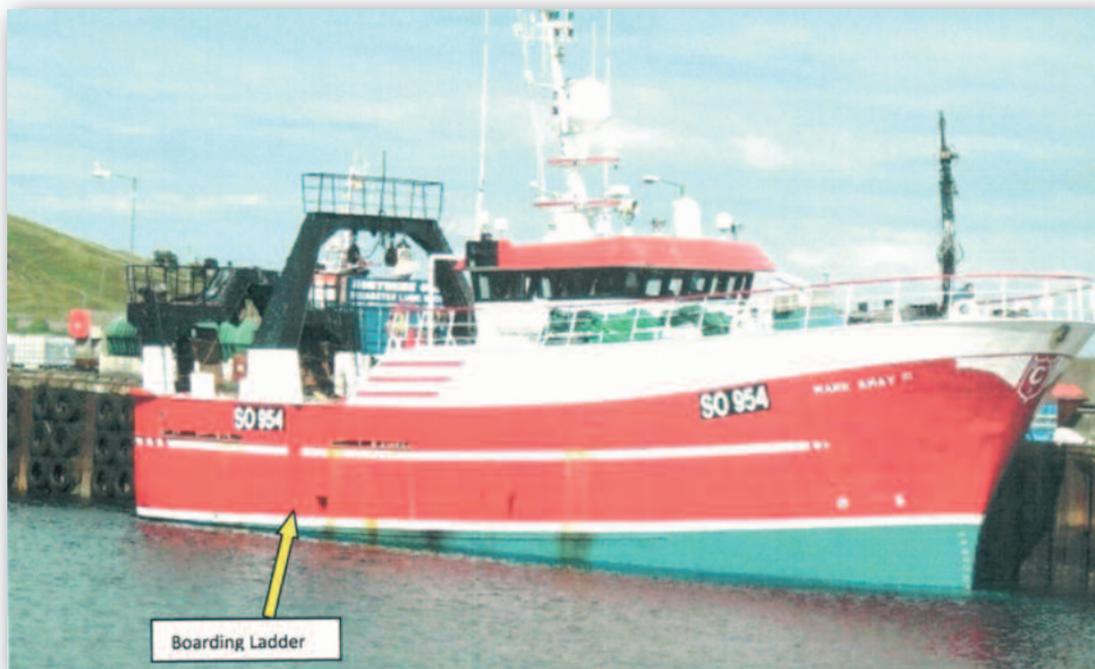
Appendix 9.6 Photo of Vessel Showing Boarding Ladder.

- 5.9 Mr. da Silva attempted to grab hold of the boarding ladder (Appendix 9.6); however, the vessel was surging approximately 4 metres on the swell making it impossible for him to hold on to both Mr. Cathal McDaid and the ladder.

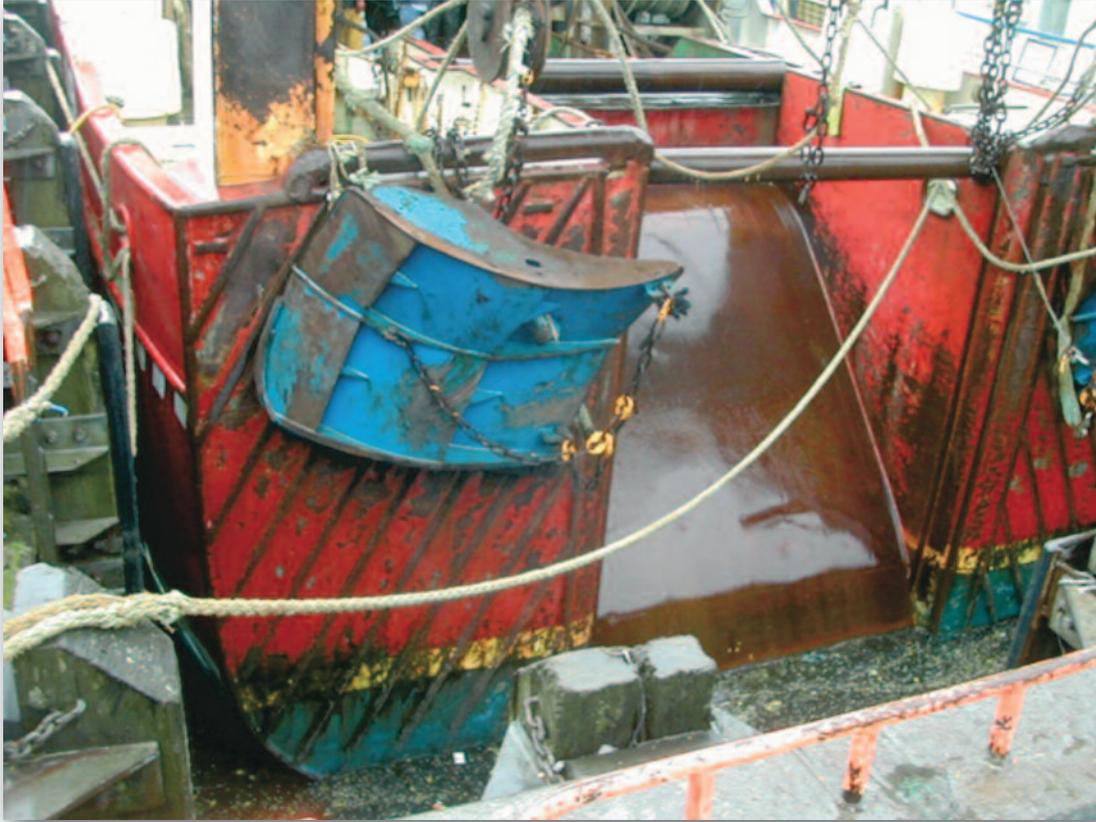
Appendix 9.7 Photo of Vessel Showing Stern Ramp.

- 4.2 As the vessel surged on the swell, the port net ran further over the stern ramp and carried Mr. Cathal McDaid overboard with it. As he was carried over the stern ramp, the pitching of the vessel bounced both the net and Mr. Cathal McDaid against the ramp. At this point, Mr. da Silva saw Mr. Cathal McDaid's head strike the stern ramp.

- 6.3 Although Mr. Cathal McDaid was wearing a hard hat at the time of the incident, it fell off and failed to protect him as he appears to have hit his head against either the stern ramp or the hull of the vessel which may have rendered him unconscious and prevented him from reaching one of the lifebelts put into the water for him. It also prevented him from keeping his head above water.

- 7.5 Had Mr. Cathal McDaid been equipped with a safety harness, correctly worn and with a lanyard secured to a strong point on the vessel, he may have been prevented from being dragged over the stern ramp by the net when he fell.
