**REPORT INTO  
A FATAL ACCIDENT ABOARD  
THE "MARK AMAY" ON 20TH  
FEBRUARY, 2002.**

**The Marine Casualty Investigation Board was established on the 23<sup>rd</sup>, May 2002 under The Merchant Shipping (Investigation of Marine Casualties) Act 2000**

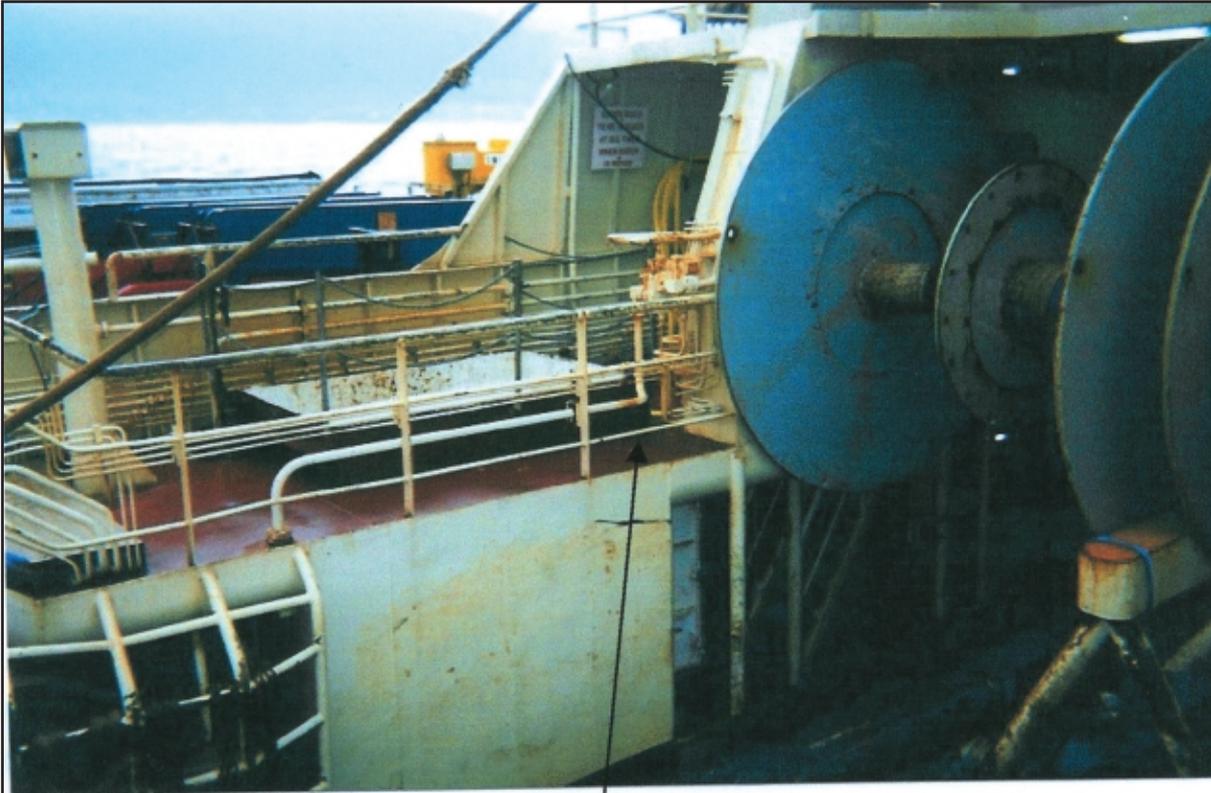
### 8.1 Photo of shelterdeck hatch and main deck fishroom hatch

- 5.3 The Hatchway on the shelter deck has a small coaming of approximately 0.7 of a metre.
- 5.4 The hatchway on the shelter deck had a facility with stanchions and ropes that could be rigged to afford personnel protection against falling into the space. This protection was not in place at the time of the accident.

Mr. Flaherty was standing about here prior the accident.

- 6.1 The accident to Mr. Flaherty could have been prevented if the protective stanchions and ropes were in place.
- 6.2 The policy of using proper safe working gear on board at the time of the accident was either not in place or not being followed.
- N.B. since the incident warning signs are now in place to indicate to the crew that protective stanchions and chains should be in place prior working. The vessel has developed a detailed safety statement indicating areas and degree of risk.

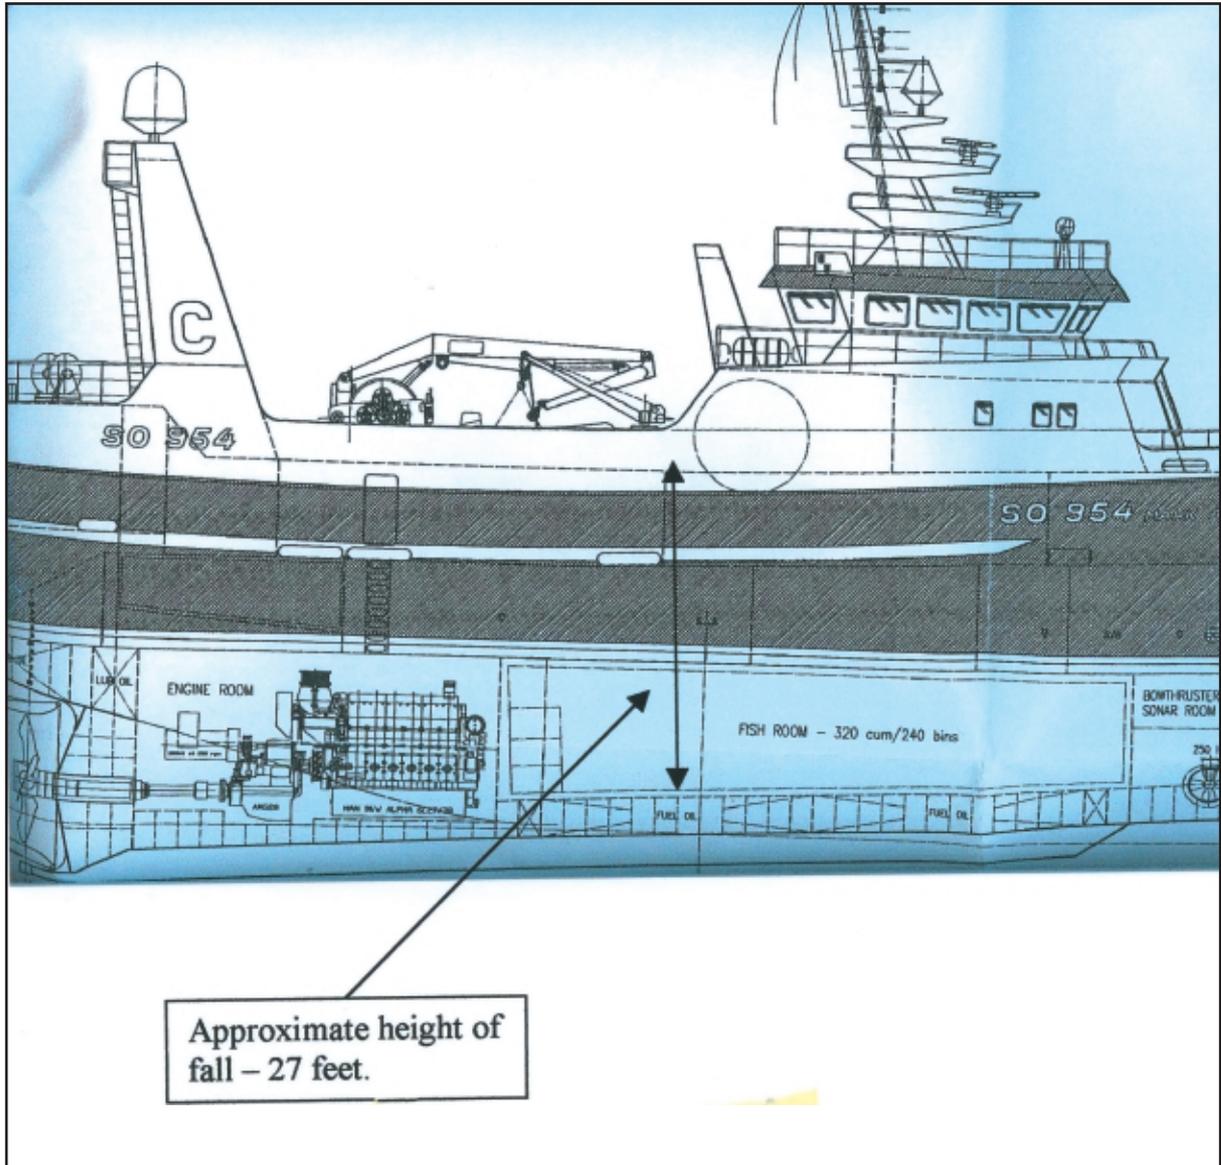
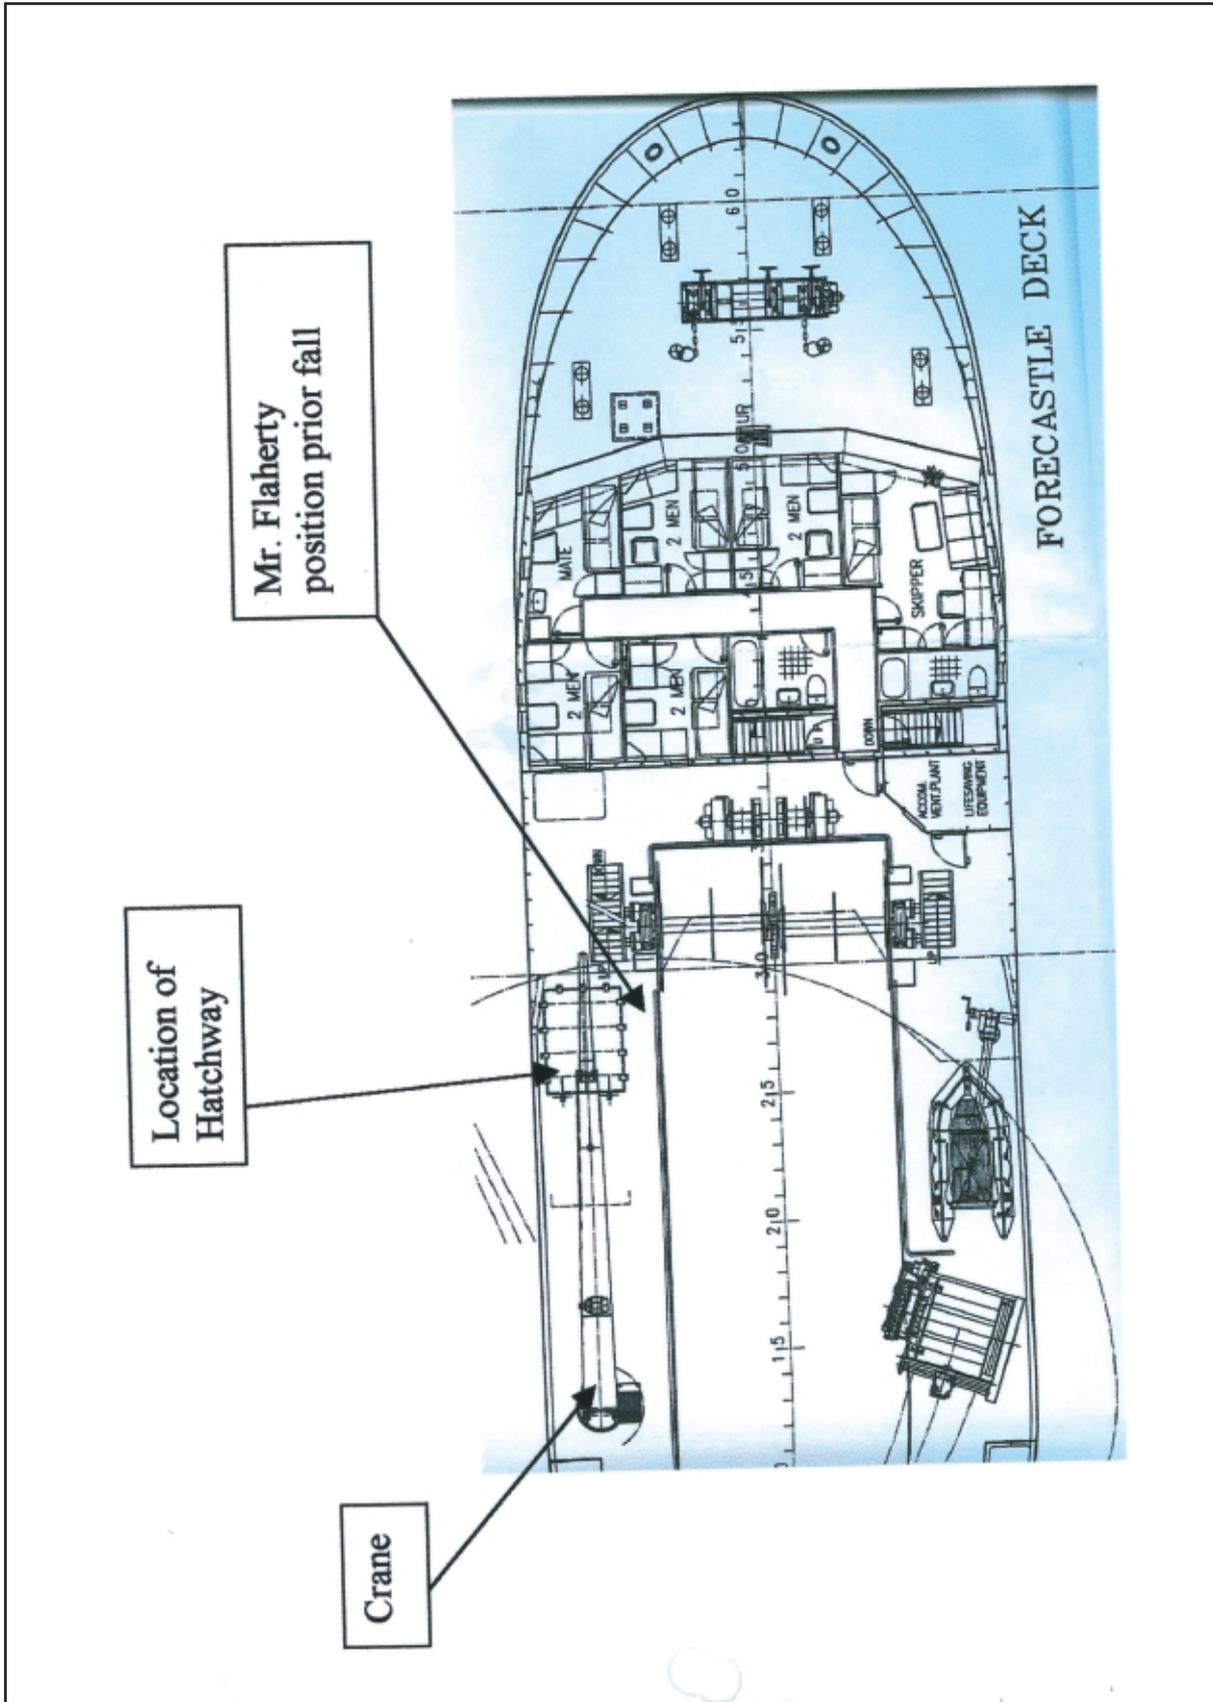
8.2 Position of Crane

- 3.5 Prior to discharge of the catch it is necessary to remove the shelter deck hatch and open the main deck fish room hatch. (See Appendix 8.1)
- 3.6 The crane used to discharge the catch is located on the portside of the deck. The crane is located approximately 6 metres aft of the access hatch on the shelter deck. (See Appendix 8.2)

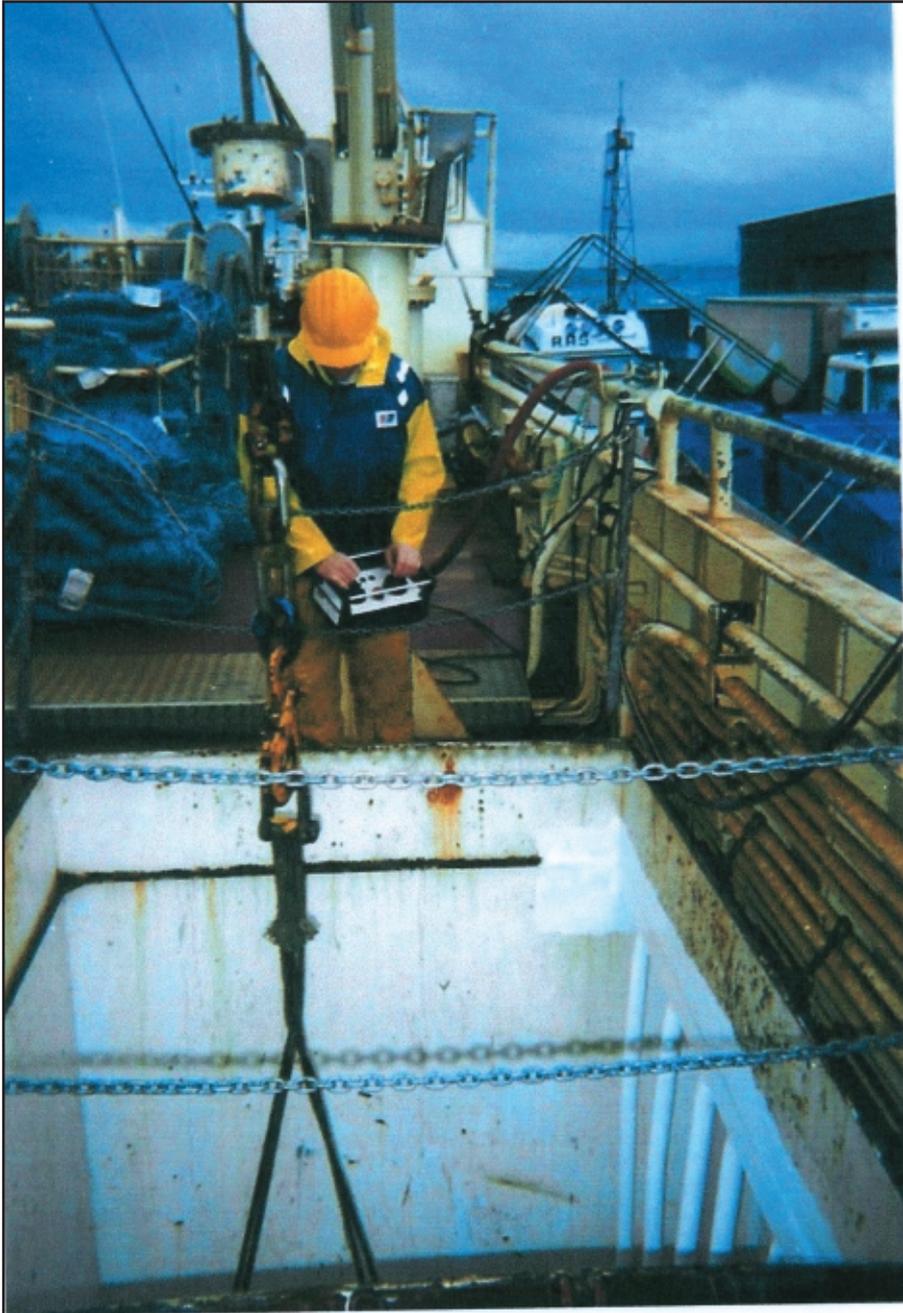
8.3 Photo of one-man operation crane.

- 3.8 In the normal course of events the operation of the crane would be a one-man operation (See Appendix 8.3) but the remote control for the crane that enables the operator to stand at the hatchway was not operational.

Picture shows discharging crane with one-man locally operating the crane (in background) with a clear view of the fish room below.
