**REPORT OF INVESTIGATION
INTO THE SINKING OF THE
GLEOITEÓG “*McHUGH*”
ON
5th SEPTEMBER 2009**

**REPORT No. MCIB/176
(No. 12 of 2010)**

Report MCIB/176 published by The Marine Casualty Investigation Board
12th November 2010.

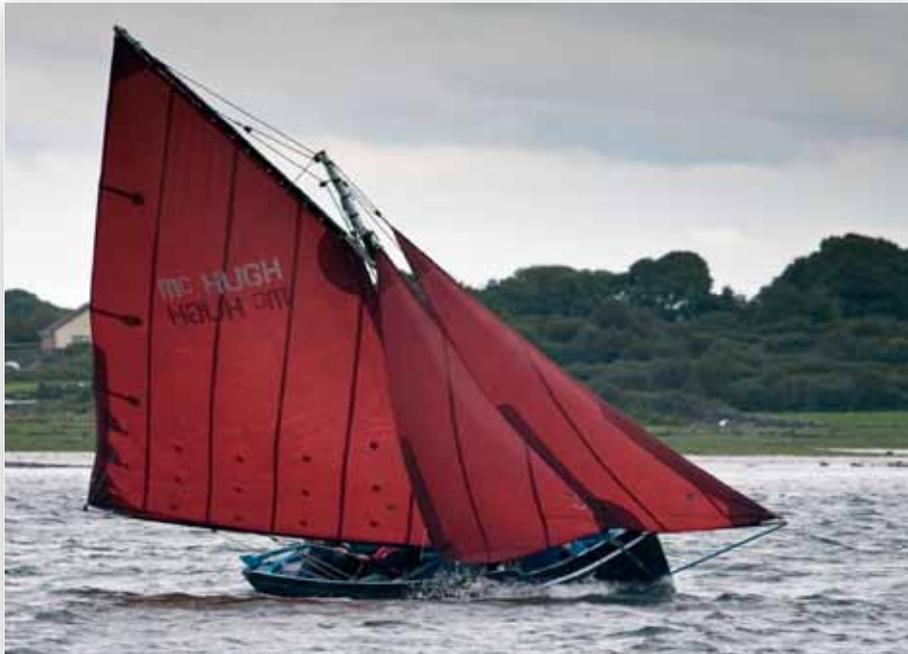
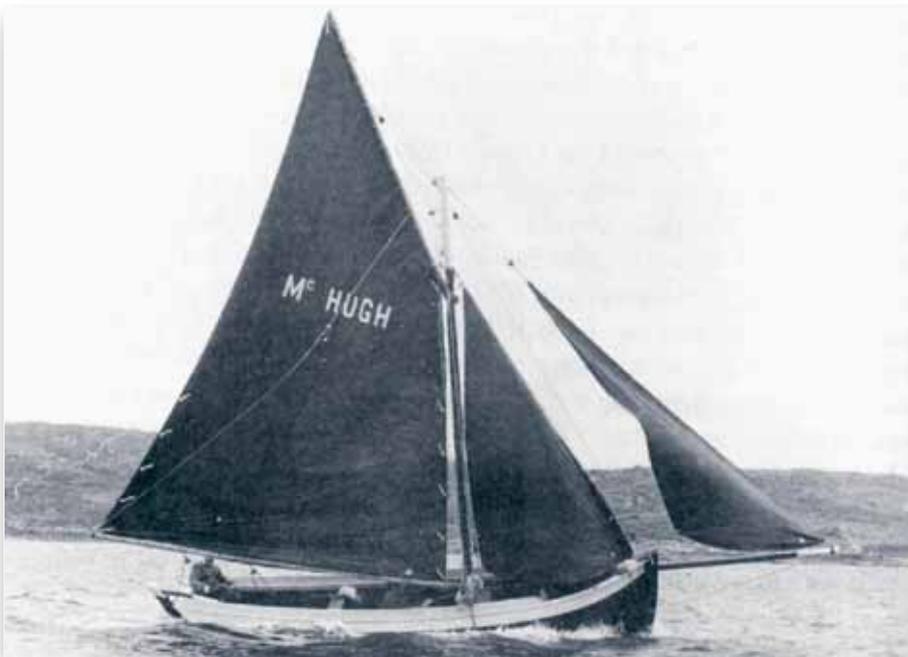
- 3.8 Over the years, it appears that the size of sails used on the gleoiteógs has increased and the sail technology has advanced leading to a situation where the

traditionally built vessels are easily becoming over powered in a way that hitherto would not have been the case. Not only has the sail area increased to provide more power and thus greater speed, but battens have been introduced to improve sail shape and further increase power. It can be seen, when comparing photographs of vessels today with those taken during their working days that the spars have increased in length and the sails have a more aerodynamic shape.

Above are two photos of the 'McHugh', the top taken in 2009 and the bottom in 1990. Whilst the difference in sail and spar size is not dramatic, although the boom and gaff appear longer - both photos were taken post restoration - the 2009 photo clearly shows the more modern sails displaying considerably better shape with battens in the mainsail leading to significantly increased power

- 7.5 There are a number of factors that contributed to the sinking of the *'McHugh'* including:-
- The large and powerful sail area combined with the increasing wind speed and sudden squalls as the vessel entered open waters.

- 8.4 It is recommended that vessel owner/operators should give consideration to the use of delivery sails (sails of smaller size and easier to handle than racing sails) when making passage, especially when shorthanded.

- 8.5 It is recommended the Galway Hooker Association, the body running the hooker regattas, should give consideration to introducing a racing handicap system that is based on factors other than vessel overall length to include maximum sail sizes, minimum crewing, minimum equipment levels and other details perhaps drawing from the experience of other yacht racing handicap systems such as ECHO, IRC etc. This would allow vessels to compete on an even basis without the need to maximise sail area in order to increase speed and power.

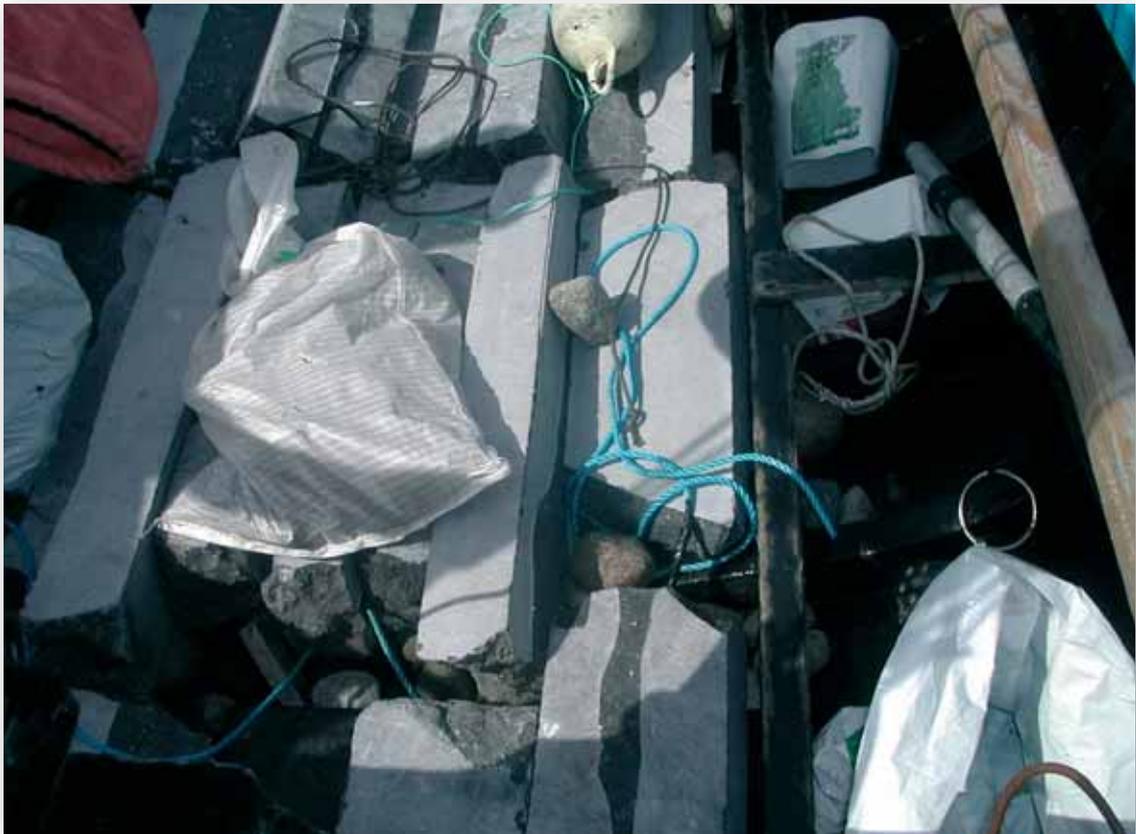
- 3.2 The '*McHugh*' was ballasted with approximately 14 cwt approx. (710 kg) of stones distributed on the floor and well secured in place. The ballast rocks, some of them 50 lbs approx. (22 kg) or more in weight, were carefully chosen for their shape so that they locked securely in place. The tumblehome of the hull prevented the rocks and stones from moving as the vessel heeled. In this incident, the ballast was further held in place with boards.

Ballast wedged in place between stringers in the bottom of the hull.
