**REPORT OF THE
INVESTIGATION INTO A
FATALITY THAT OCCURRED ON
BOARD A RO/RO CARGO SHIP
"MERCHANT BRAVERY"
DURING MOORING OPERATIONS
AT DUBLIN PORT ON
SATURDAY EVENING
25th JANUARY 2003.**

Published by The Marine Casualty Investigation Board
11th March 2005

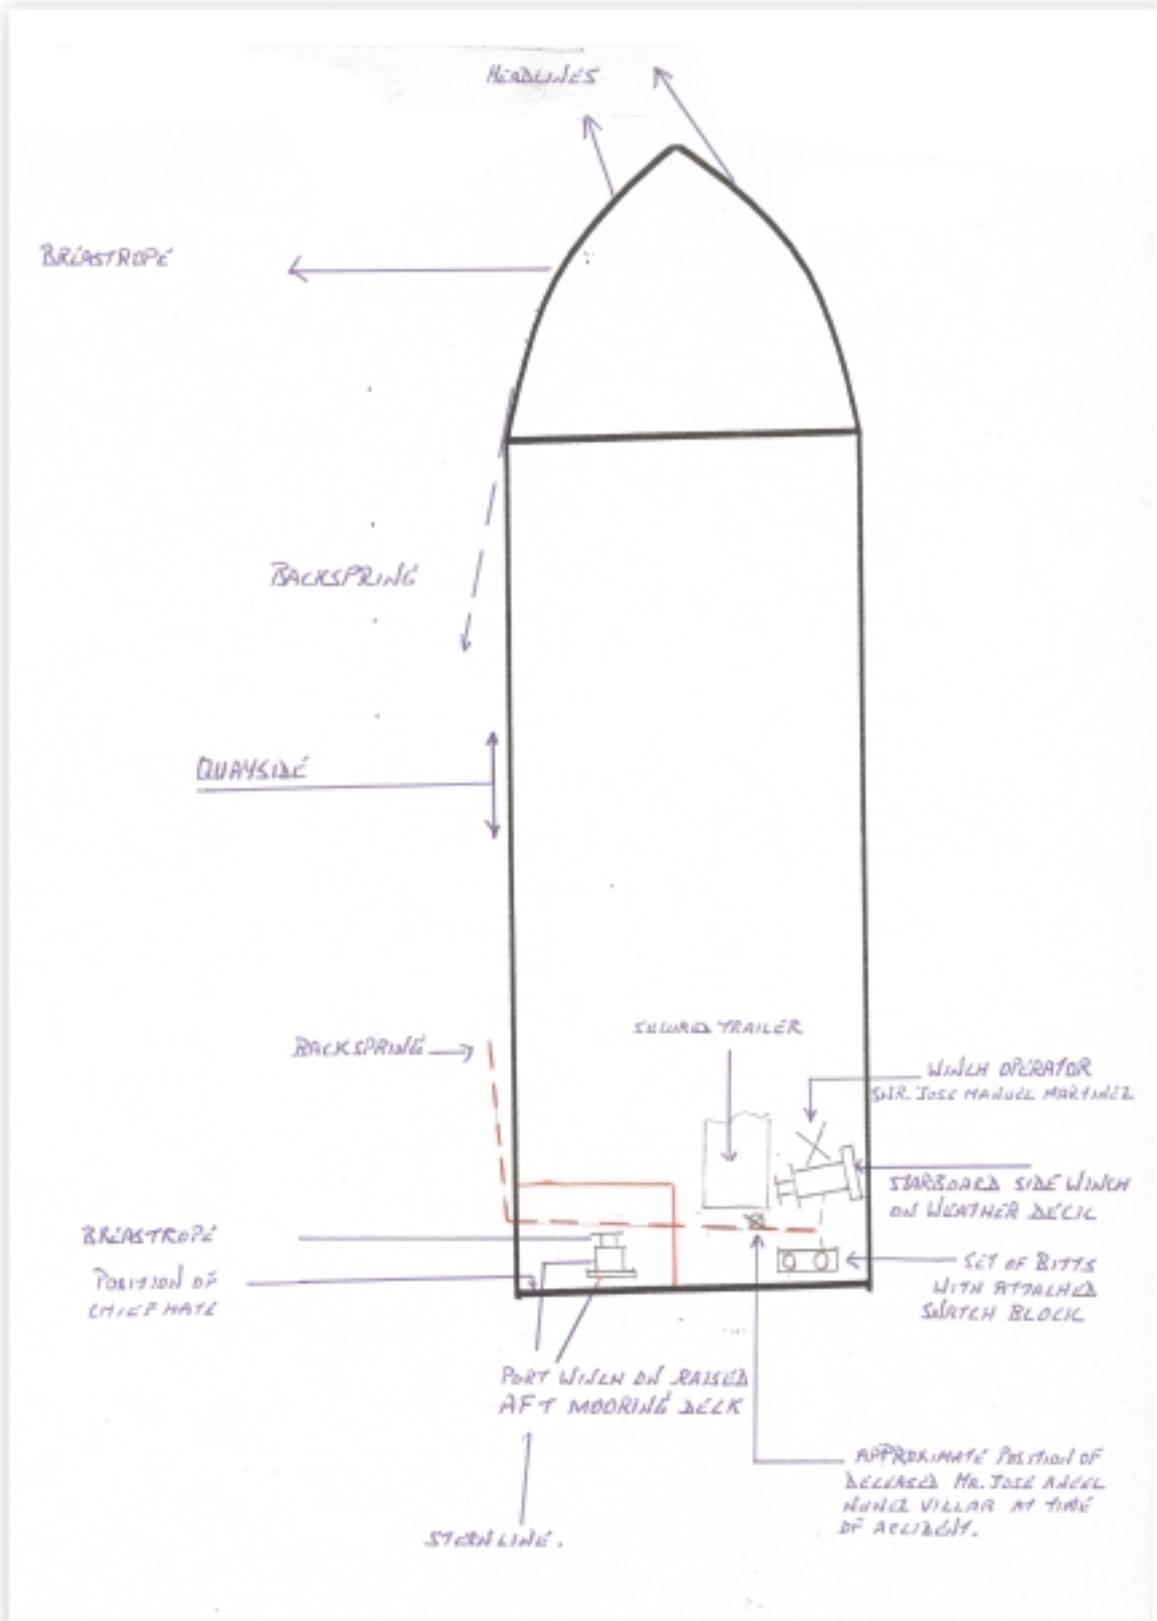
Appendix 9.3

- (i) The snatch block was connected to an unapproved weak link instead of implementing the stated agreed safe procedure. (See Appendices 9.13 and 9.15).
- (ii) The line of sight between personnel on the raised mooring deck and the starboard mooring winch operator was obscured by a cargo trailer;
- (iii) The supervision on the aft mooring operation was at an inappropriate level for this out of the ordinary mooring operation.
- (iv) Communication was difficult because of serious language difficulties and the noise from the mooring winches in the vicinity of the operation.
- (v) The deceased entered the danger zone of a dynamically loaded mooring line set up at an acute angle;

Sketch of the aft deck mooring arrangement at the time of the accident.

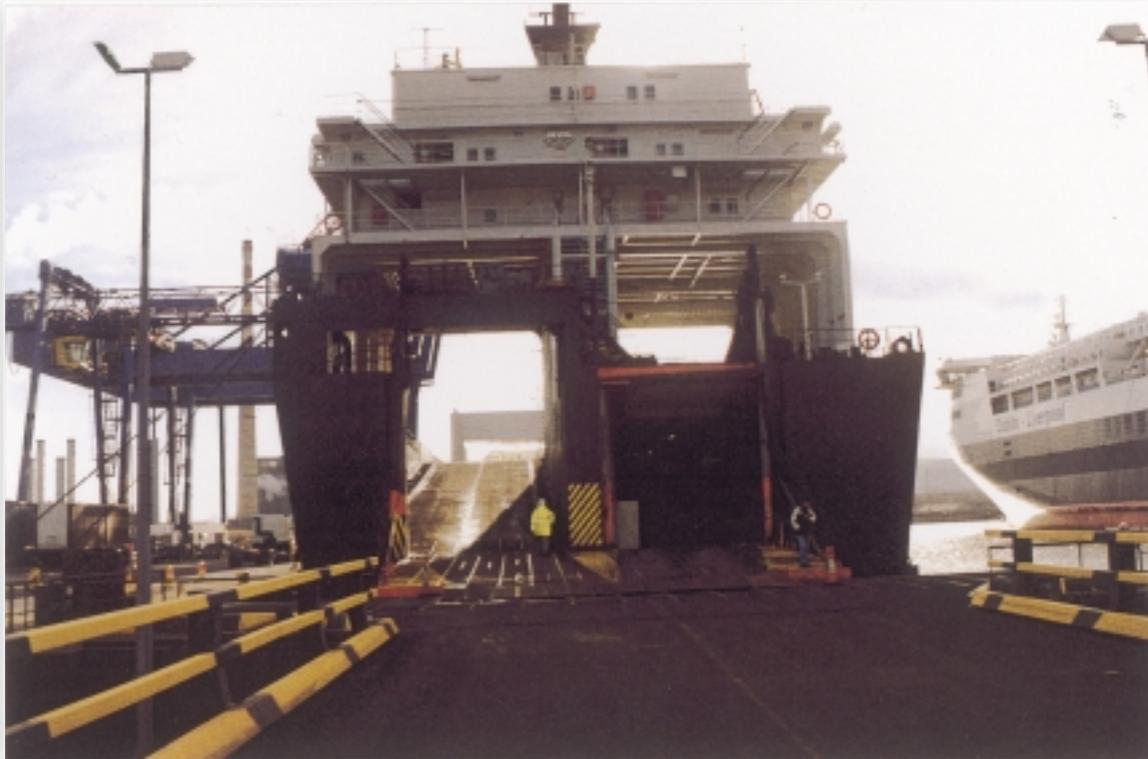
Appendix 9.6

Photograph showing the view from the head of the linkspan looking onto the stern of "Merchant Bravery"

A view from the head of the linkspan looking onto the stern of "Merchant Bravery". The raised aft mooring deck can be seen over the port stern opening leading up to the weather deck. Personnel can be observed walking on the ship's ramp/door that is resting in position on the linkspan.

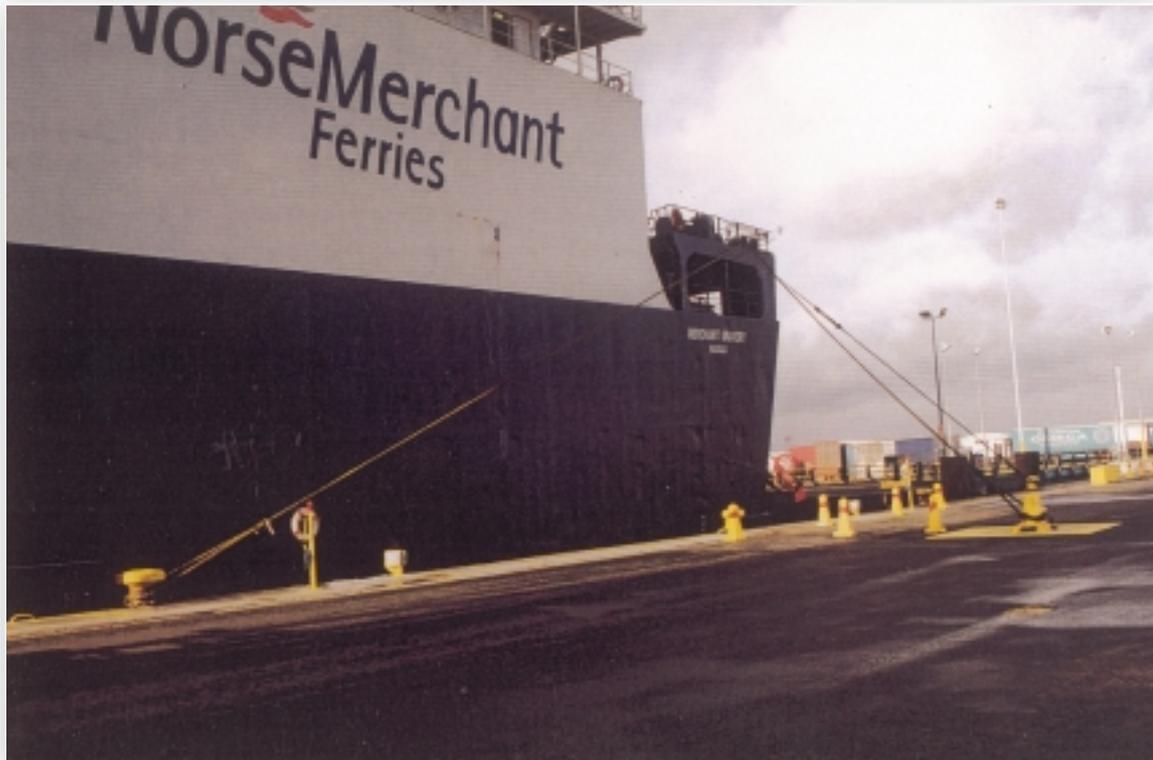
Appendix 9.7

Photograph showing the backspring leading forward and the breast and stern lines secure.

"Merchant Bravery" secured port side to Berth 53. Seen in the photograph is the backspring leading forward and the breast and stern lines secure onto shore bollards.

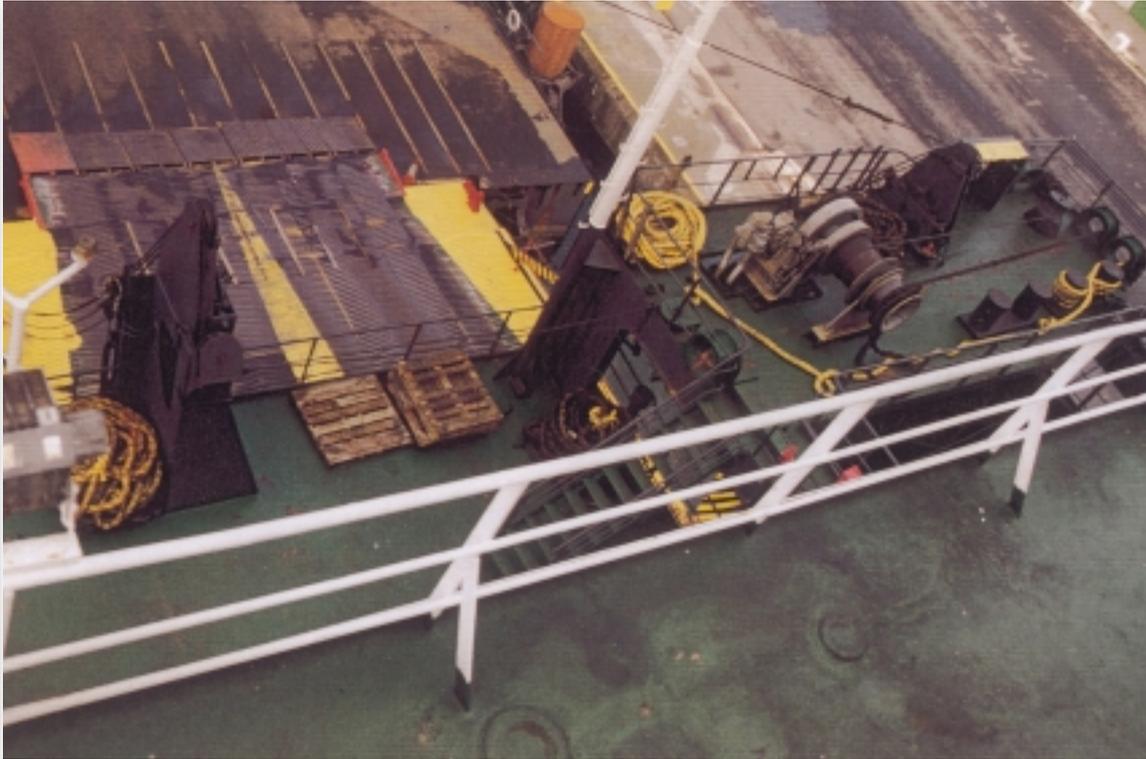
Appendix 9.8

Photograph looking down on the aft mooring area.

Looking down on the aft mooring area. On the right side of the photo is the control for the stern ramp/door. In front of the controls is the set of bitts that the backspring multiplait rope is turned up under normal mooring. To the left of the bitts is the port side mooring winch, which has the breast rope leading from the winch warp end and out through a Panama lead. The stern line is leading off the main drum of the winch. To the left of centre can be seen the stern ramp/door resting in position of the linkspan.

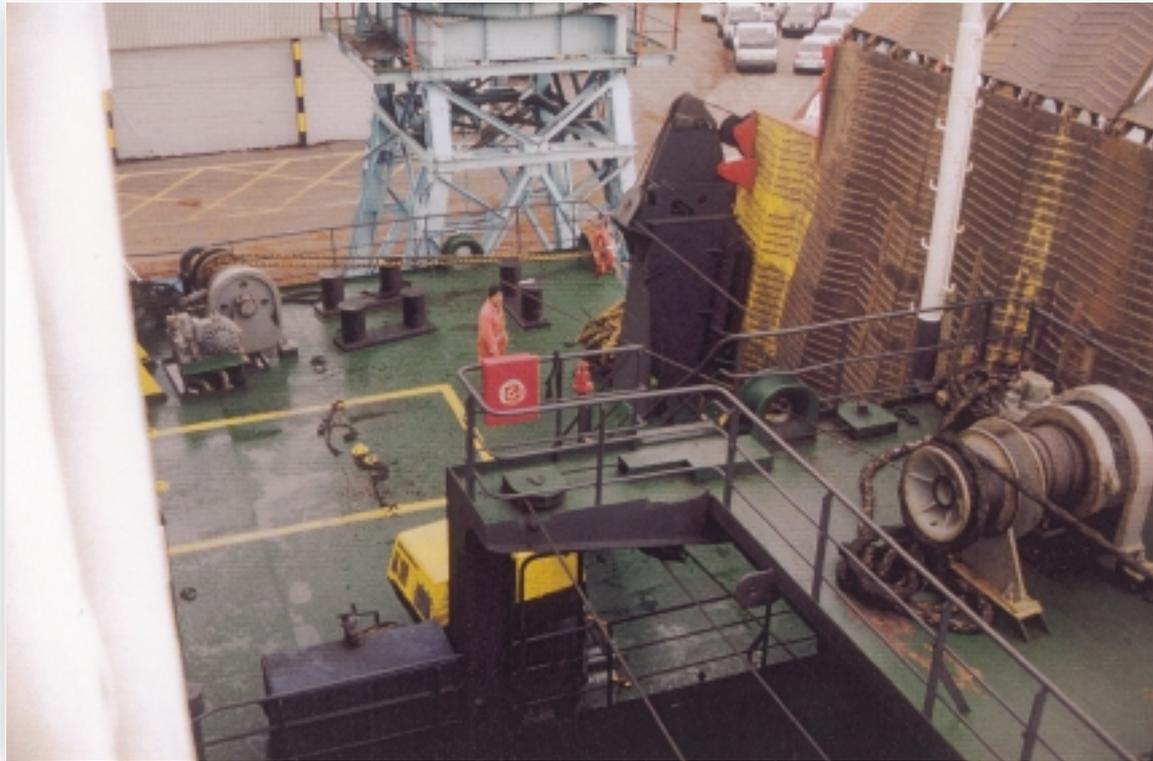
Appendix 9.9

Photograph showing the port winch.

This photograph shows the port winch to the right of the photo. The stern ramp/ door is in the raised position. The ladder down to the weather deck can be seen in the centre of the photograph. The deceased descended this ladder to pass instructions to the starboard side winch operator. The starboard winch can be seen to the left of the photograph. At the time of the incident a trailer was positioned in the marked off area just forward of the aft marking. The person seen standing on deck is in the approximate position where the deceased was standing on deck is the set of mooring bitts used as a lead for the back spring.

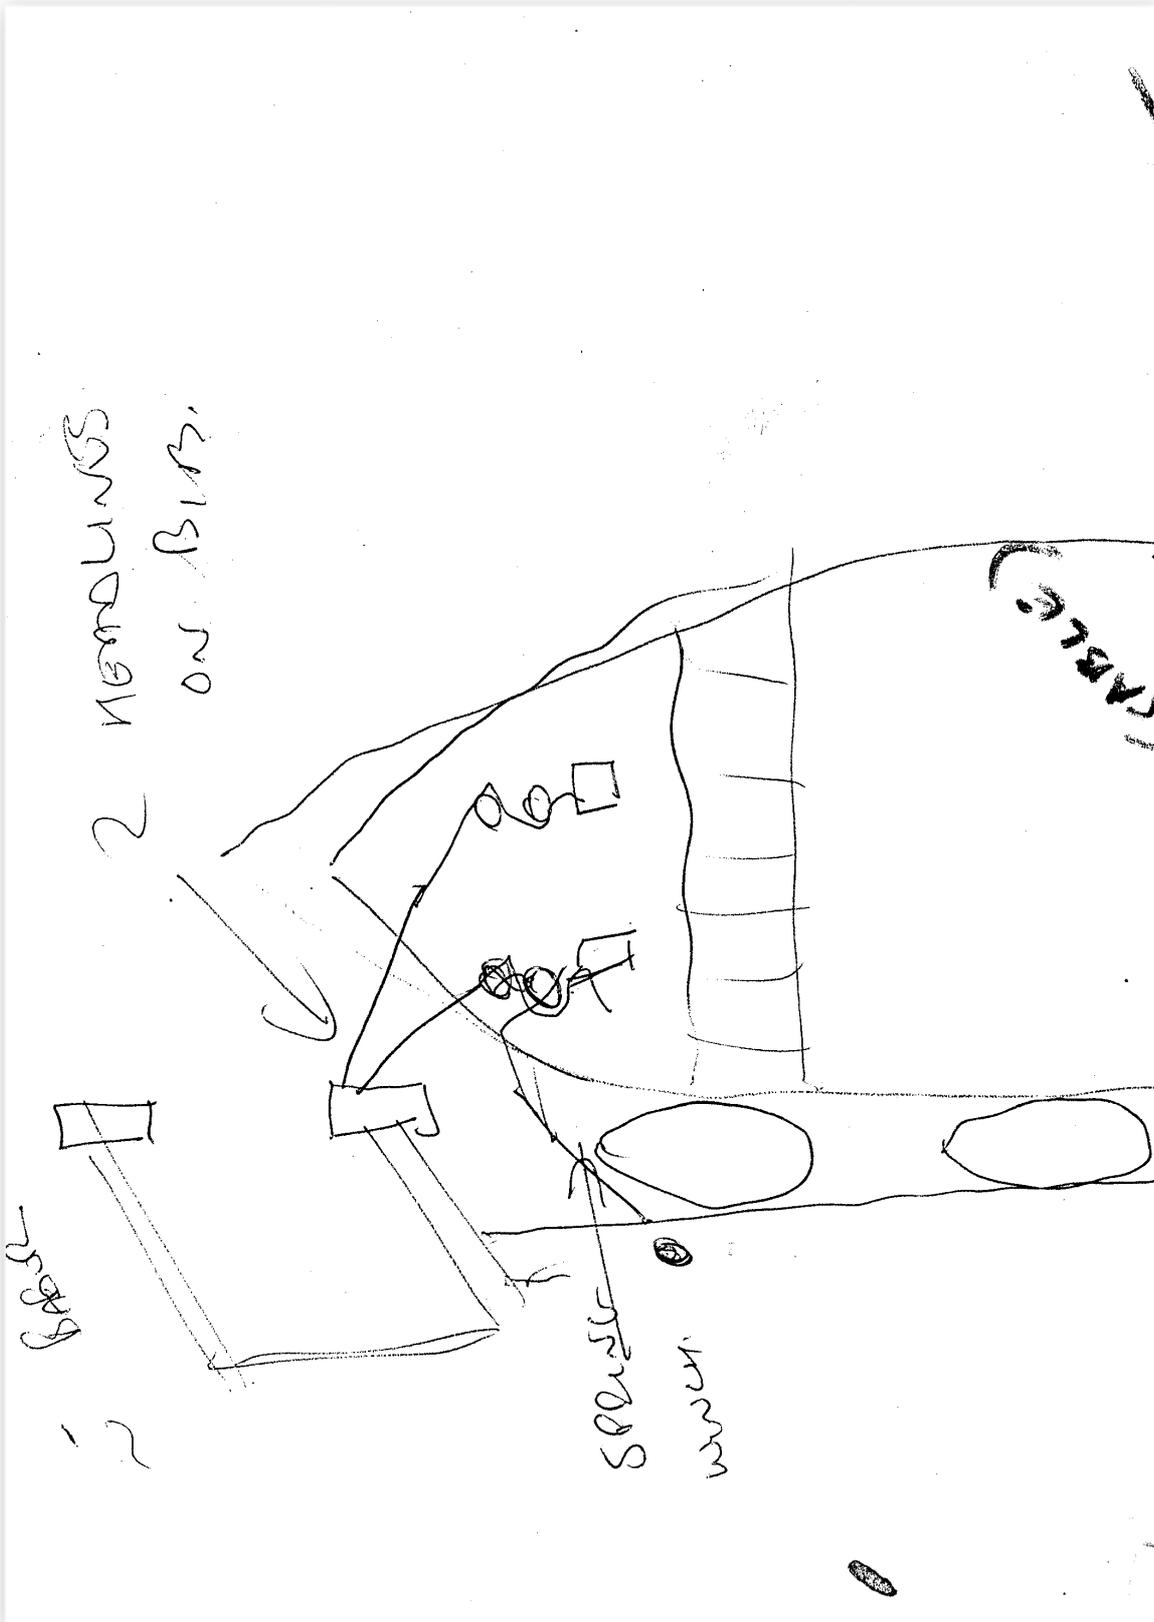
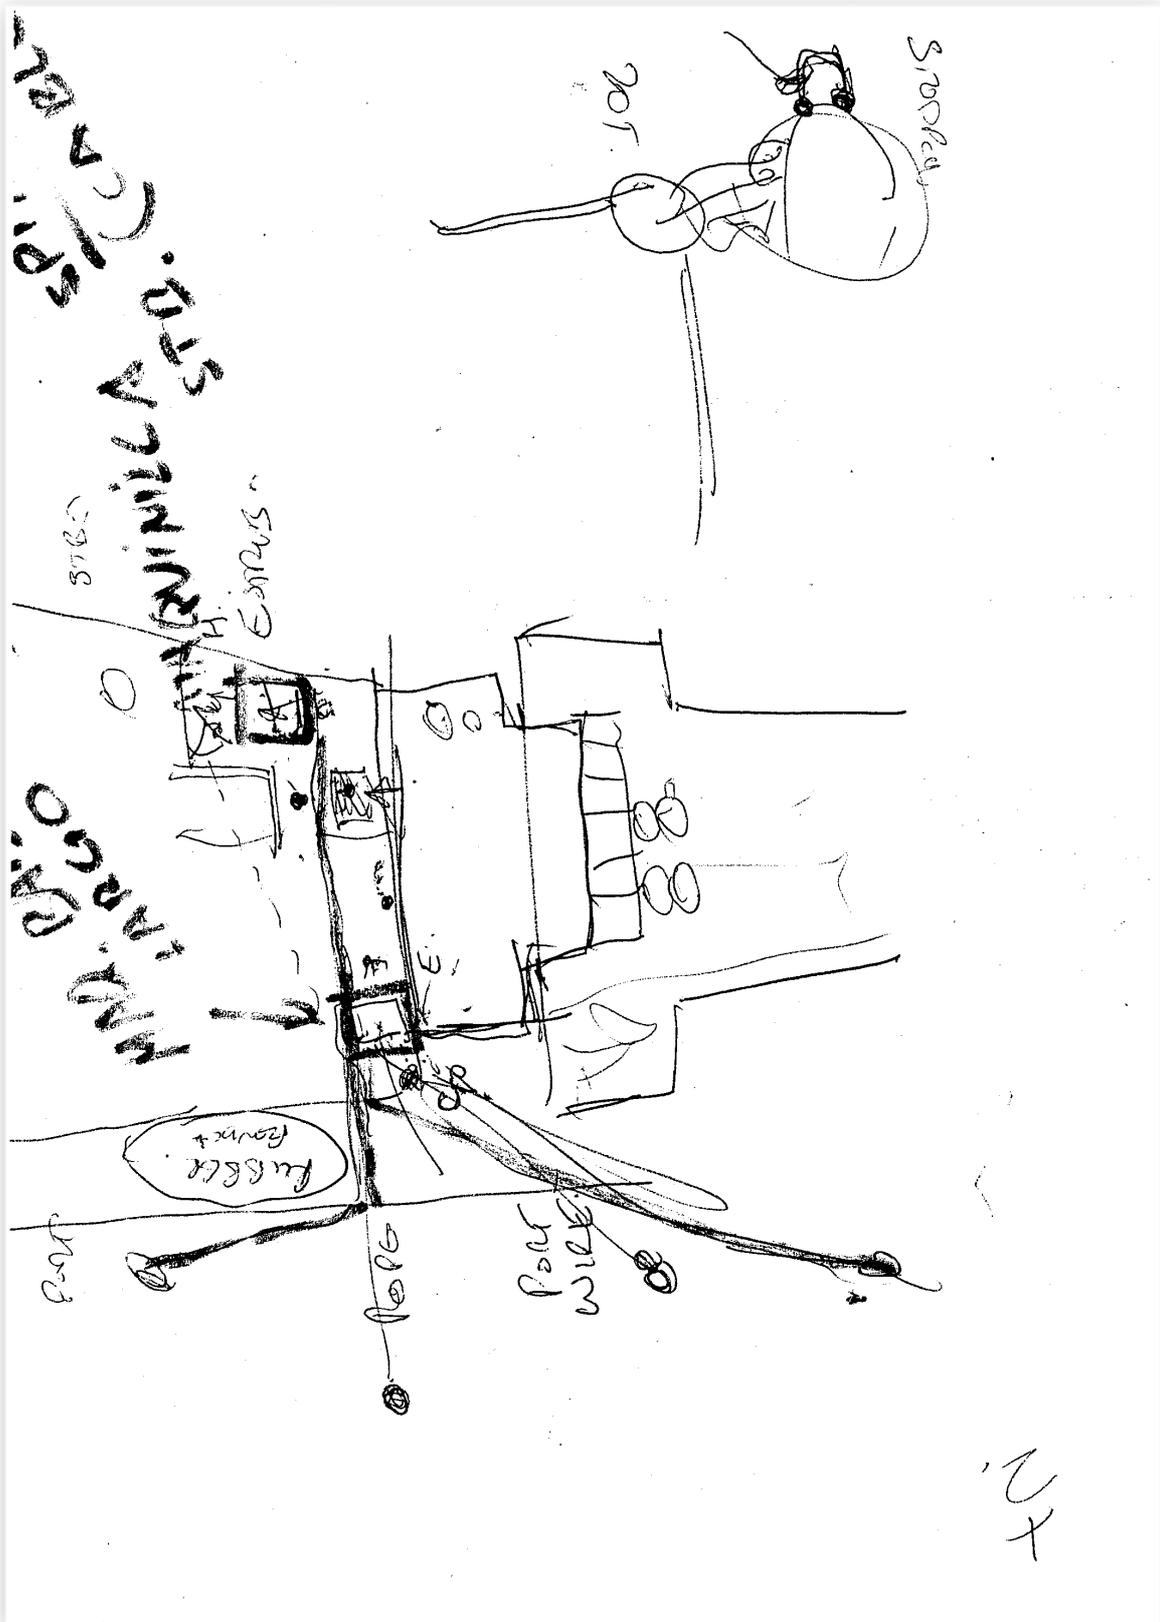
Appendix 9.12

- (vi) At approximately 13.00 hours on Saturday afternoon 25th January the Chief Mate en route to Dublin briefed the available mooring crew for arrival berthing at Dublin. The rating that operated the starboard winch on berthing was off duty and not present. A rough sketch of the proposed arrangements was made with the Bosun acting as an interpreter to the Spanish ratings for the English speaking Chief Mate. (The stated proposal was as shown in Appendix 9.12).

Sketch used during the crew briefing early afternoon 26/01/ 2003.

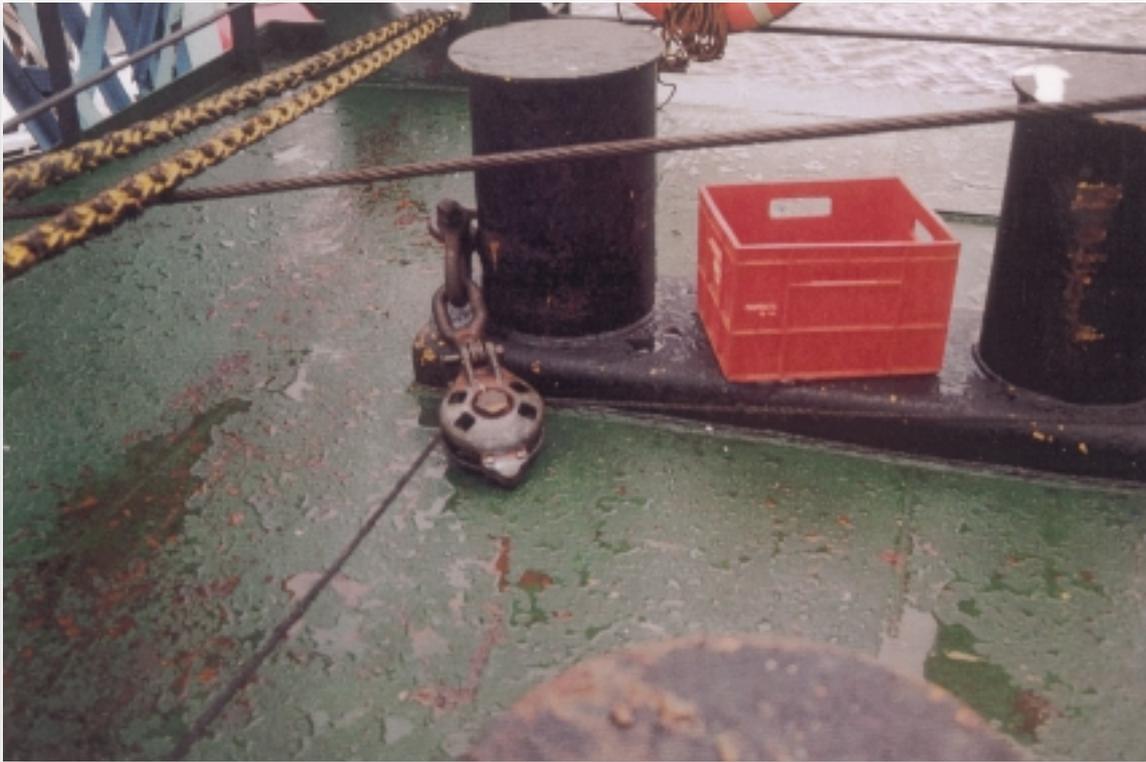
Appendix 9.13

- (vii) During the briefing session the Chief Mate, Bosun and the A.B seamen went down to the deck to look at the proposed arrangement. The Chief Mate stated that he connected, for simulation purposes, the snatch block with a shackle directly to the "U" connection. (See Appendix 9.13).

Photograph showing method used to connect the snatch block to the mooring bits.

The actual method used to connect the snatch block to the mooring bits.

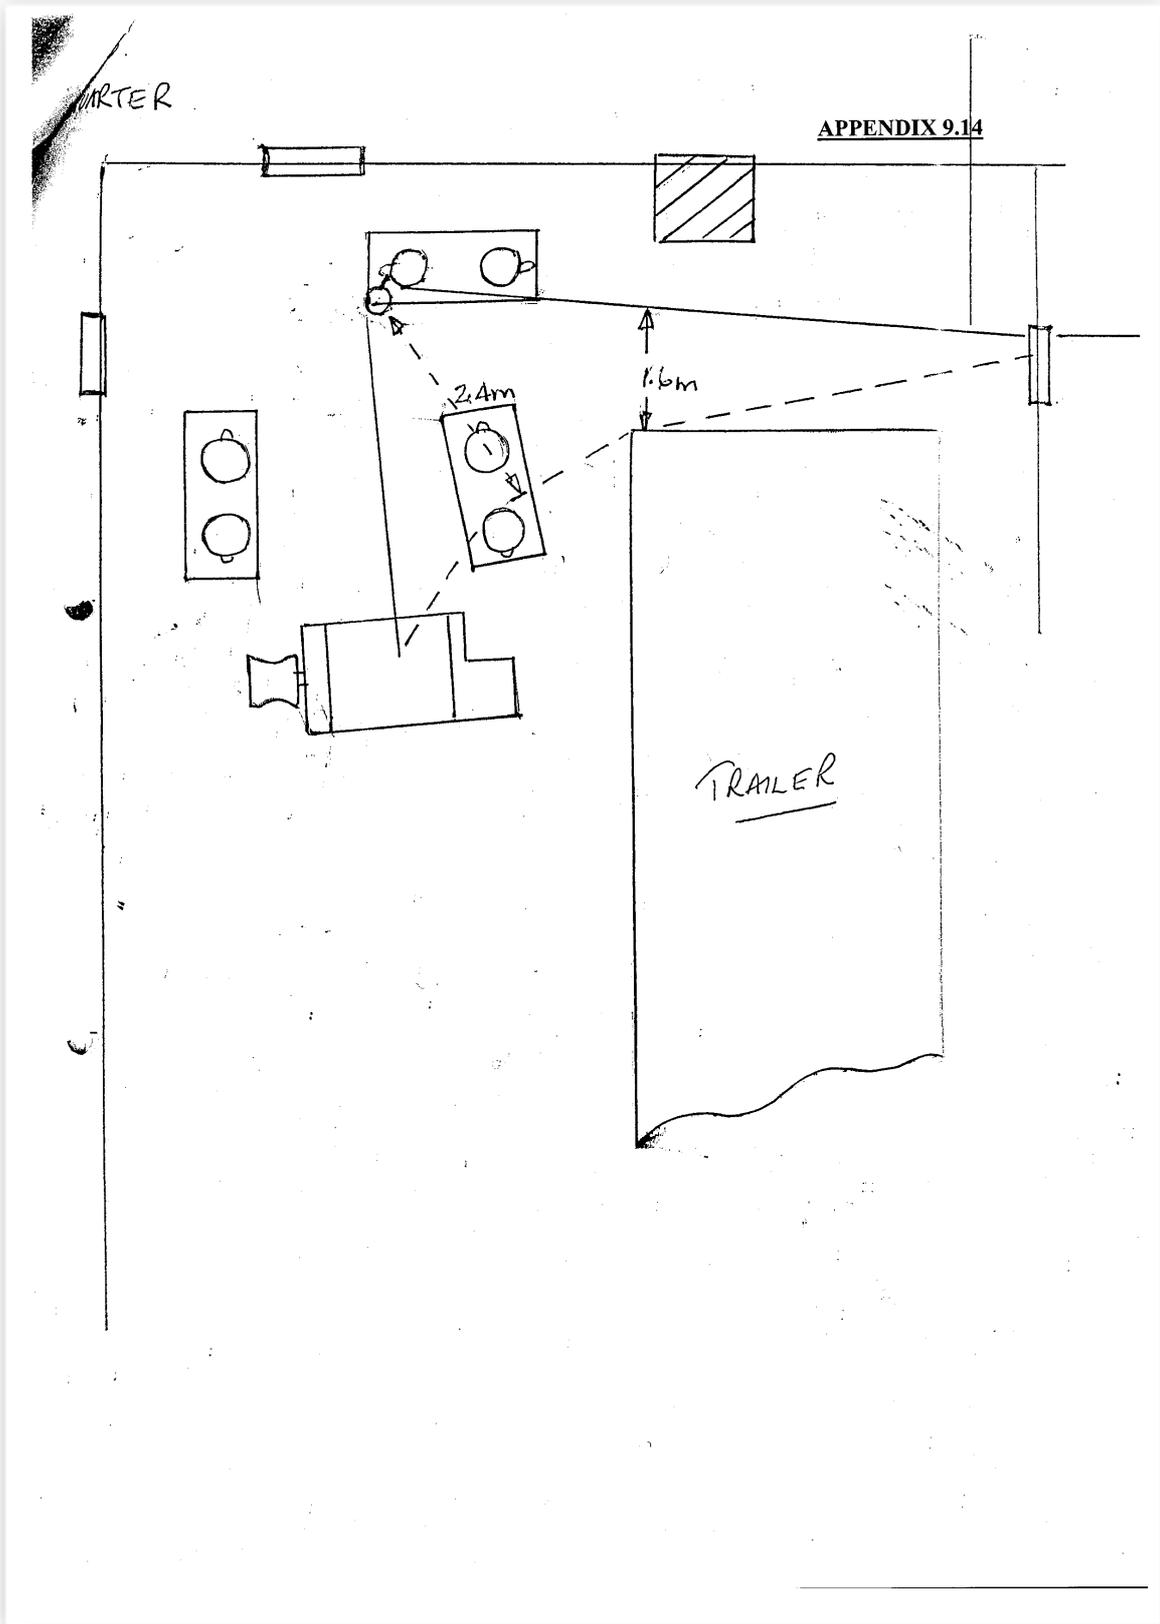
Appendix 9.14

- (iii) Snr. Jose Angel Nunez Villar (deceased) A.B. seaman 4 had been working on the raised mooring platform but at the time of the accident had descended the steel ladder to the weather deck in order to relay instruction to the starboard mooring winch operator. (See Appendix 9.14).

Sketch made by master of the incident area.

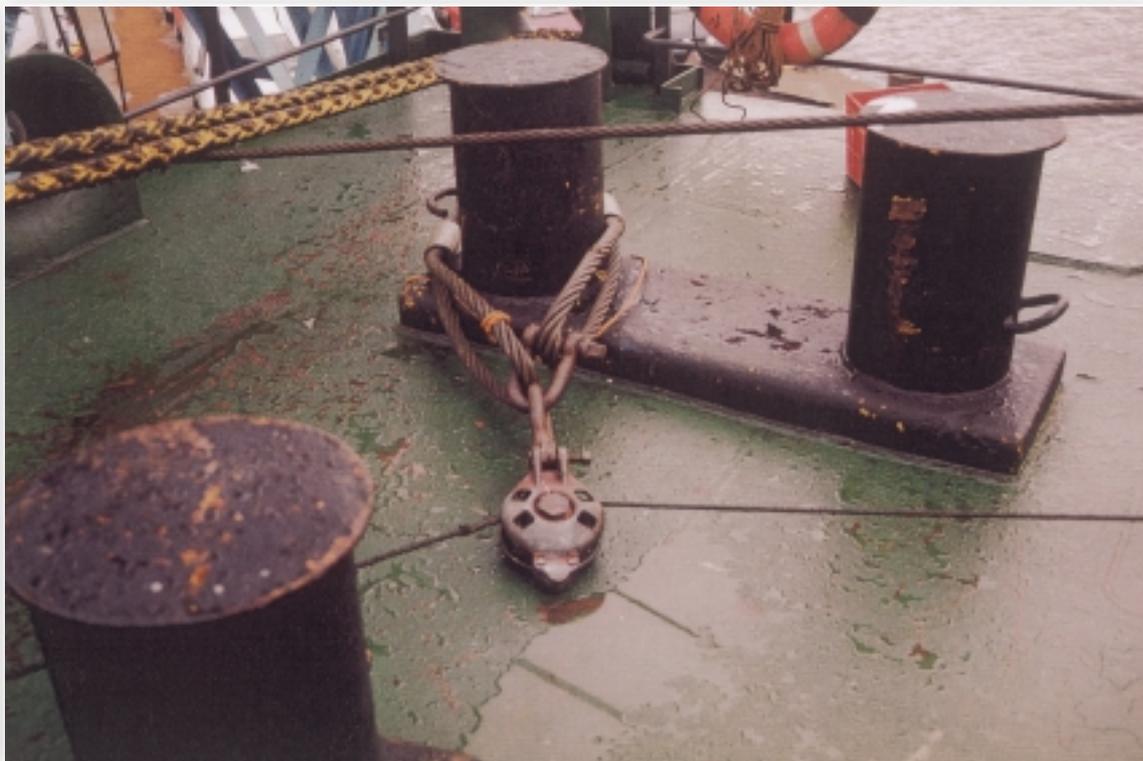
Appendix 9.15

Photograph showing the method that had been stated during the briefing session.

The method that had been stated as proposed during the briefing session early afternoon on Saturday 26th January 2003 to connect the snatch block and heavy-duty wire stop around the cylindrical post.

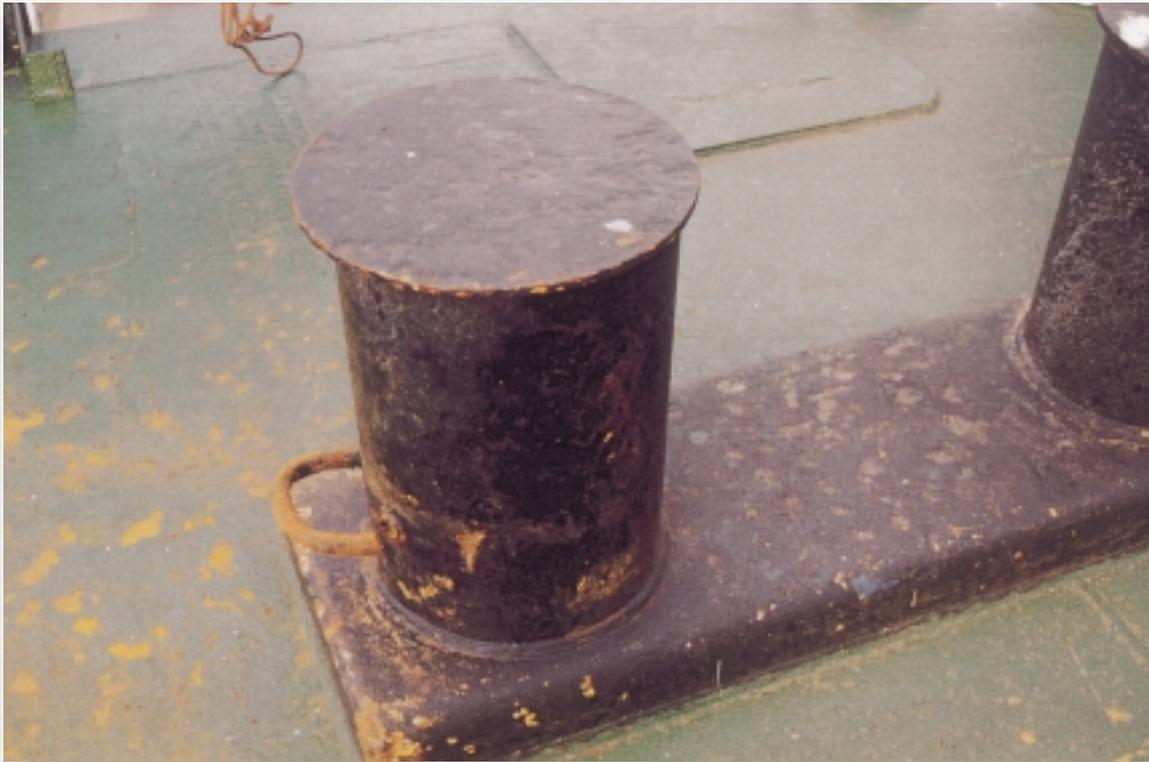
Appendix 9.16

- (i) The snatch block was connected to an unapproved "U" connection on the mooring bitt (See Appendices 9.16 & 9.17). When dynamic tension was put on the mooring line the weld in the "U" ring failed (See Appendix 9.17) causing the immediate release of the rope, which struck Snr. Jose Nunez.

Photograph showing the set of bitts.

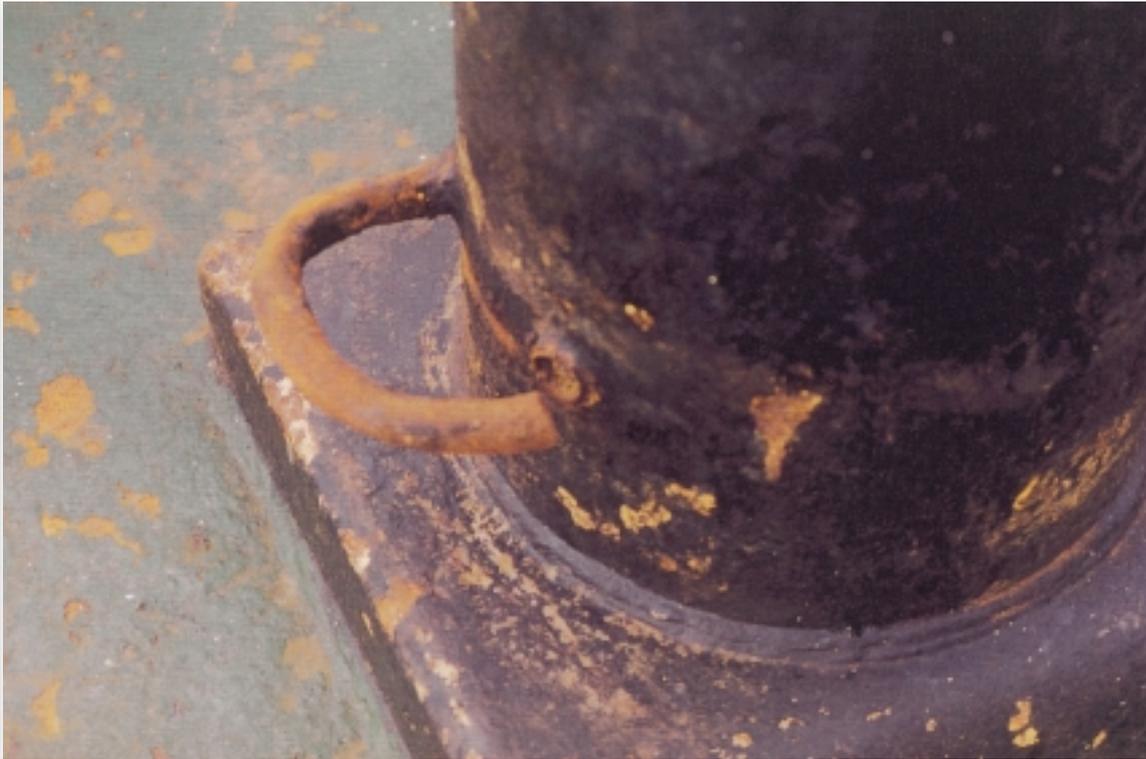
Appendix 9.17

- (iii) The "U" bolt connection was not an approved or certified piece of anchoring or lifting equipment.
- (iv) No lifting appliance certificates were available for the heavy wire strop, the "D" shackle and snatch block.

Photograph showing close up of the failed "U" bolt.

- 7.1 The Code of Safe Working Practices for Merchant Seamen for ships should be followed at all times and a Marine Notice should issue in this regard.
- 7.2 The Company/Operator should ensure that there is effective communication in the English language on board ship. The policy and assessment requirement should be contained within the Company International Safety Management (ISM) Code.
