**REPORT INTO THE
DROWNING OF
MR MATTHEW ARMSTONG
FROM THE
M.V. "MOON RIVER"
ON THE 18th DECEMBER 2005.**

The Marine Casualty Investigation Board was established on the 25th March, 2003 under The Merchant Shipping (Investigation of Marine Casualties) Act 2000

Published by The Marine Casualty Investigation Board
5th January 2007

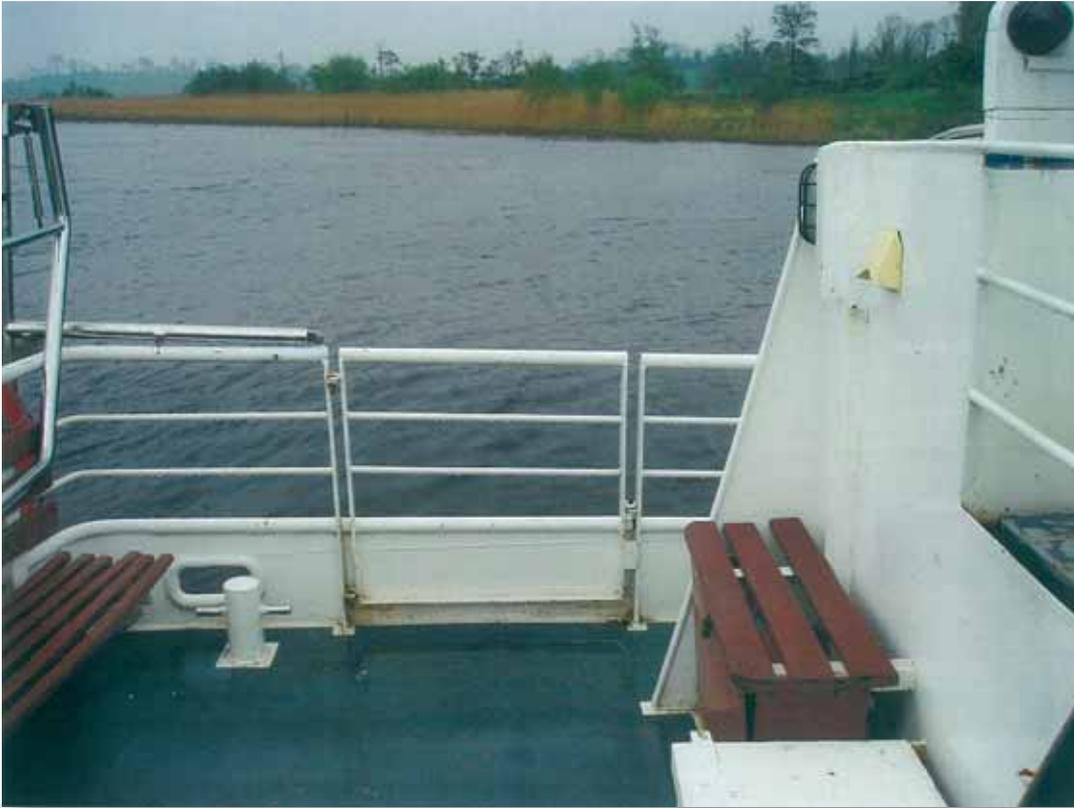
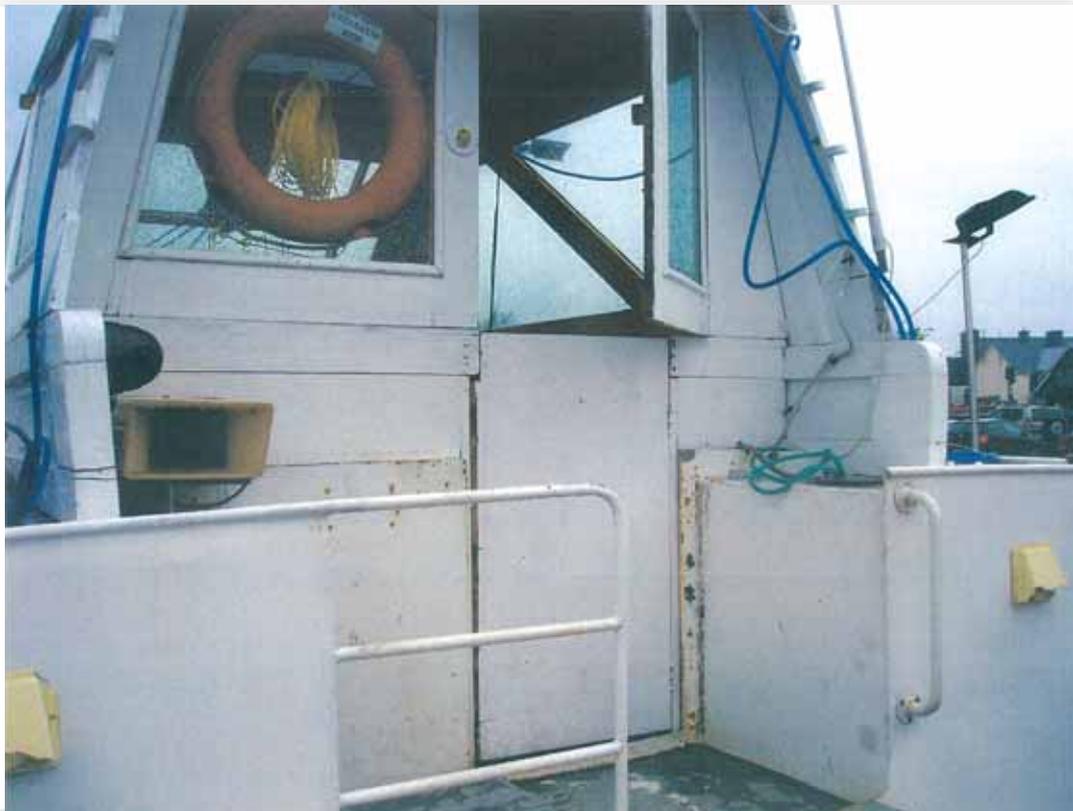
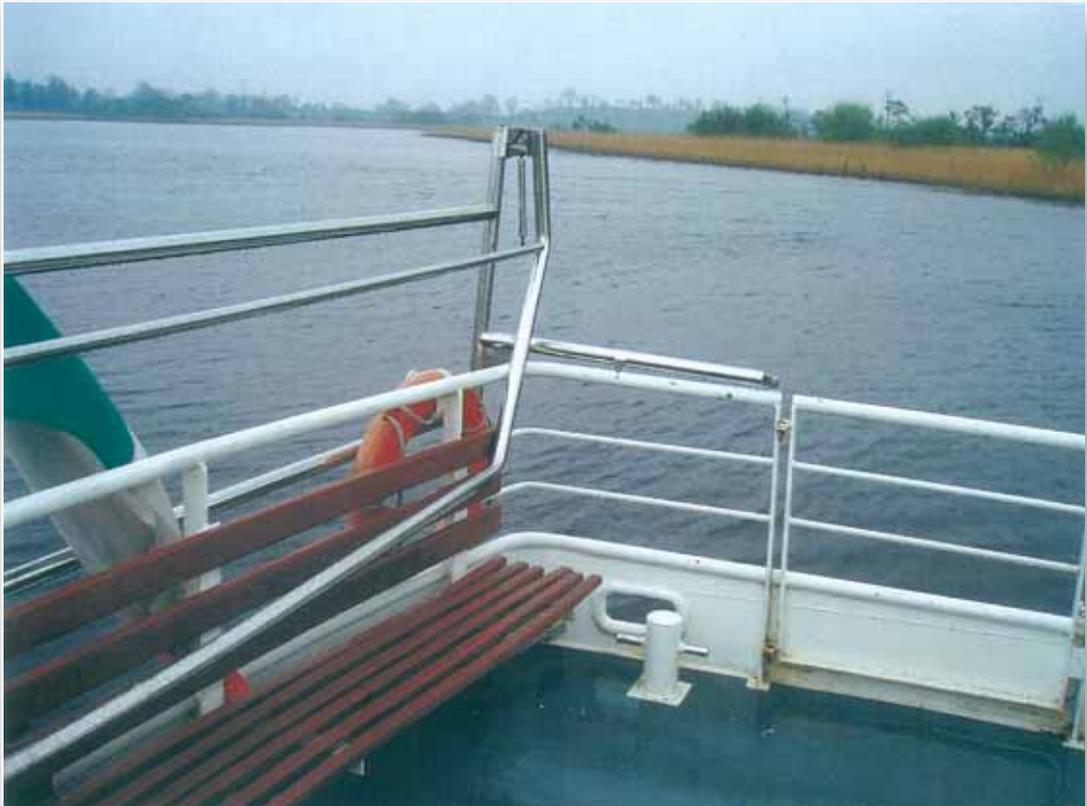
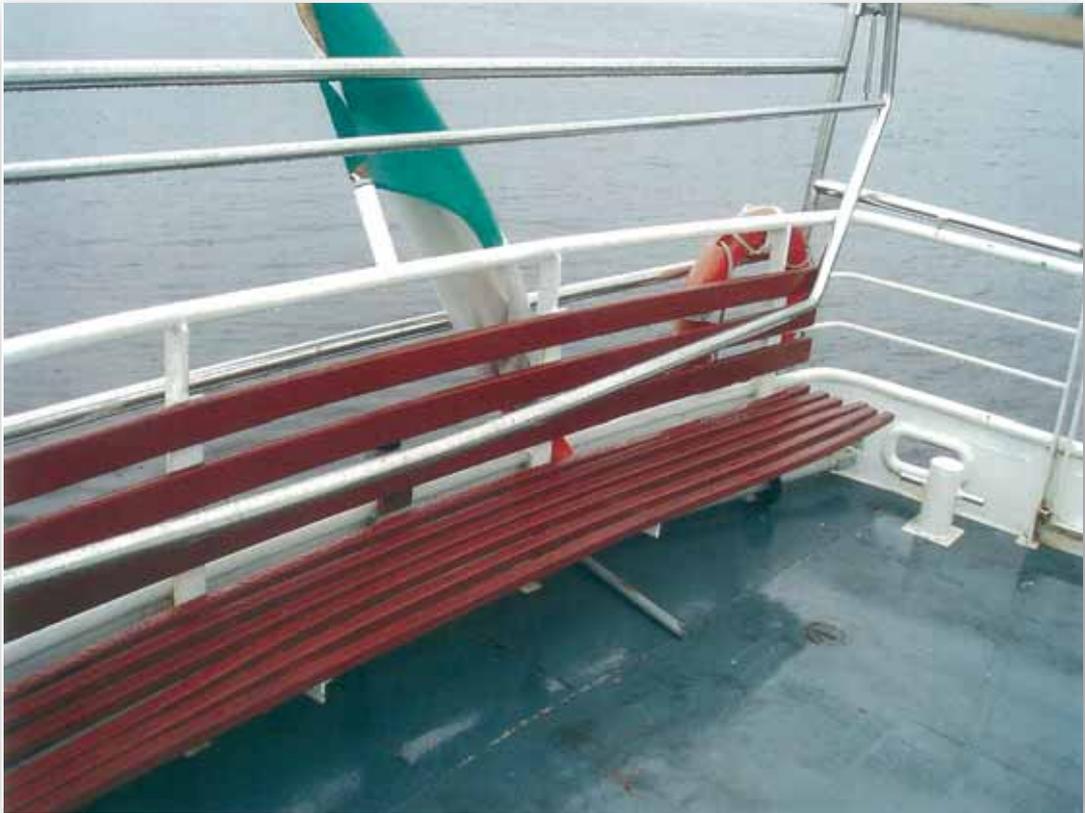
Appendix 8.1 Photographs

- 6.1 The incident was recorded on the vessel's CCTV system. The footage, which is held by the Gardai and reports to show the deceased taking off his shoes, say something to a friend, run for the port side rail at the after end of the vessel and jump overboard. The rail at this point is over one metre high. (See photographs at Appendix 8.1)
