**REPORT OF INVESTIGATION
INTO FATAL INCIDENT
AT MULRANNY, CO. MAYO
ON
22nd MAY 2010**

**REPORT No. MCIB/185
(No. 13 of 2010)**

Report MCIB/185 published by The Marine Casualty Investigation Board
12th November 2010.

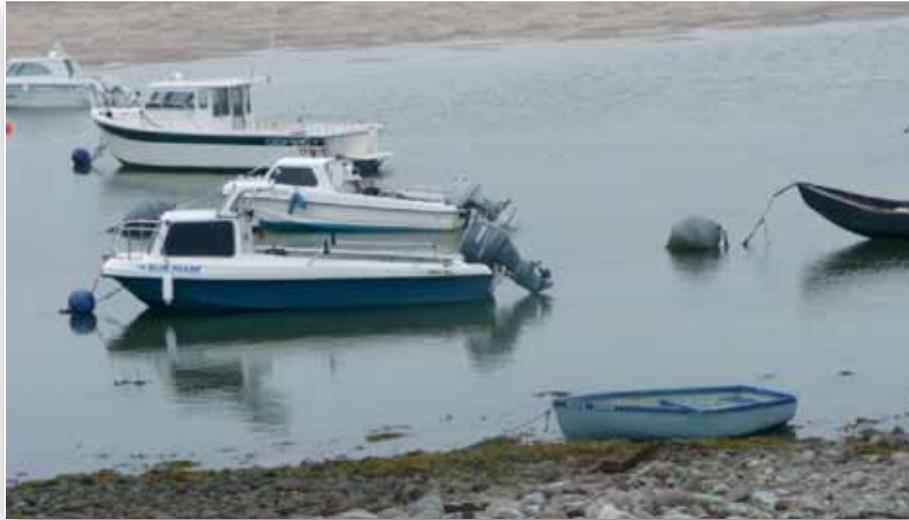
Mode of mooring the vessel was to secure the vessel to the eye on a single point mooring buoy, a rope passing from the boat through the eye on the buoy back to the boat. An arrangement somewhat similar to that used by Mr. Mulloy is shown in Photo 2.

Photo 2 - Typical mooring arrangements of boats at Mulranny.
(Further photos in Appendix 7.2)

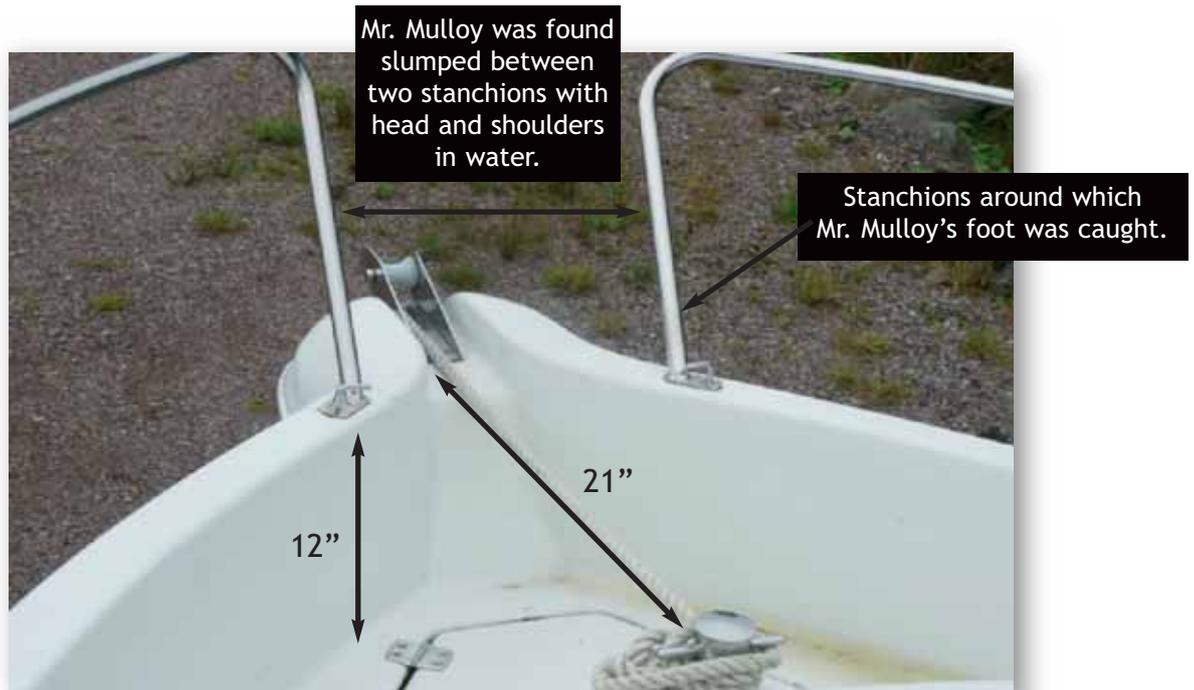
Photo 3 - Bow section of vessel.

- 4.7 Mr. Thomas Mulloy and Mr. Paul Grealis swam out to the boat, which was approximately 30 yards from the shore. Mr. Mulloy's head and shoulders were submerged in the water when they got to the boat which was lying in approximately six feet of water. Mr. Grealis got onboard the boat and found Mr. Mulloy's foot caught on the forward starboard stanchion of the boat. Mr. Mulloy's foot was freed and an attempt made to bring him onboard the boat, this was found not to be possible.

- 5.1 Mr. Martin Mulloy had been out fishing from Mulranny Pier. He had returned and was mooring his boat when his foot got caught in the bow stanchion and his head and upper body went in the water. He was unable to free himself and drowned.
- 5.2 Post Mortem concluded that the cause of death was drowning with a contributing factor of high blood alcohol level.
- 5.3 As there were no witnesses and no evidence to indicate what actually transpired it is not possible to reach a definite conclusion as to the cause of this incident.

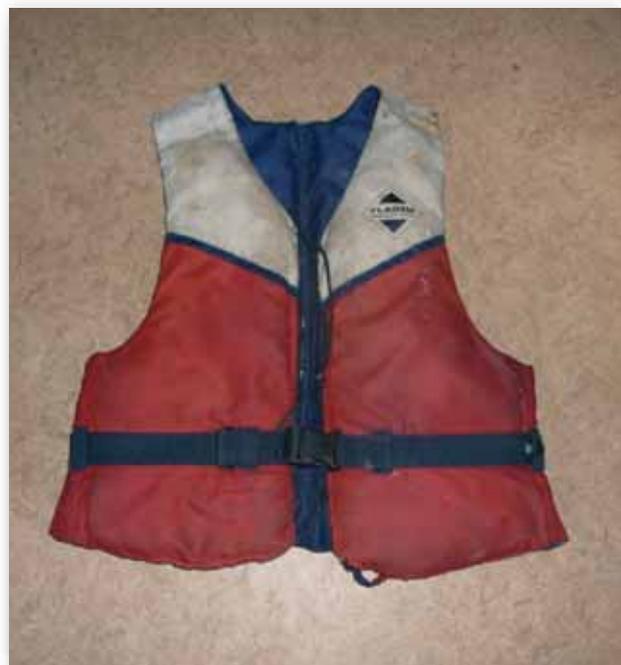
- 4.8 Mr. Thomas Mulloy and Mr. Grealis decided to swim into the shore with Mr. Mulloy who was wearing a lifejacket (PFD).
- 4.9 On arrival at the shore CPR was administered. Shortly after, Mr. Mulloy was carried up to the roadside and CPR continued to no avail. Mr. Mulloy was subsequently pronounced dead at the scene.
- 4.10 Mr. Mulloy's remains were removed from the pier and taken to Mayo General Hospital, Castlebar.
- 4.11 A post mortem examination was carried out on 23rd May 2010.
- 4.12 Mr. Mulloy's mobile phone was subsequently recovered from water in the vicinity of boat's mooring.

Photo 4 - Personal Floatation Device worn by Mr. Mulloy.

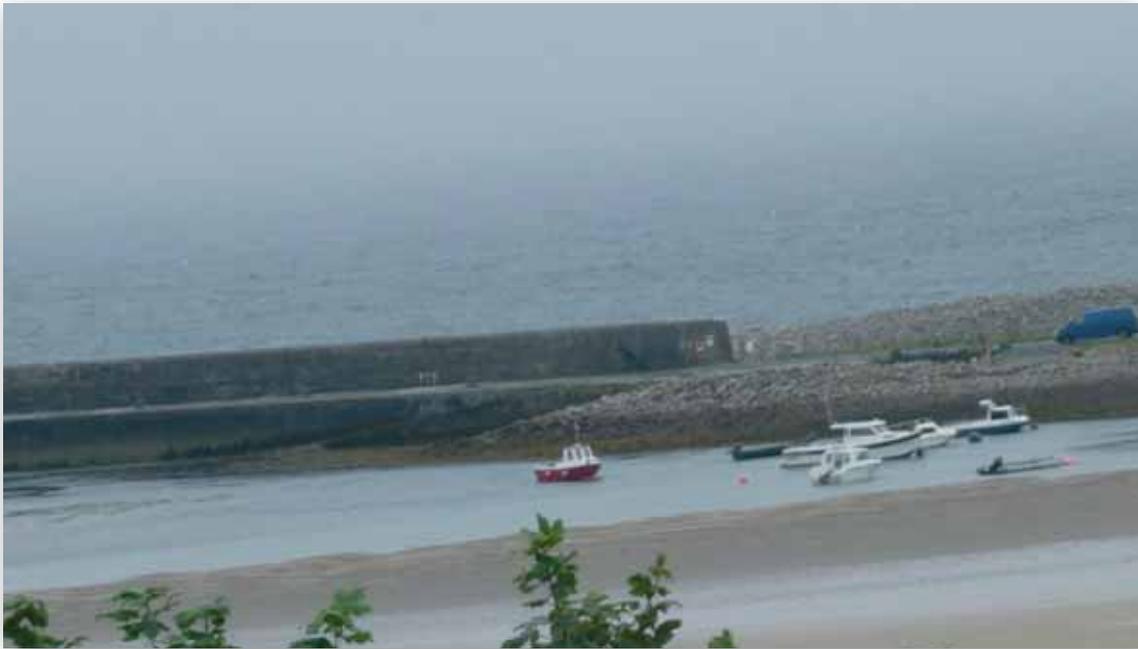
Boat mooring area and pier in Mulranny

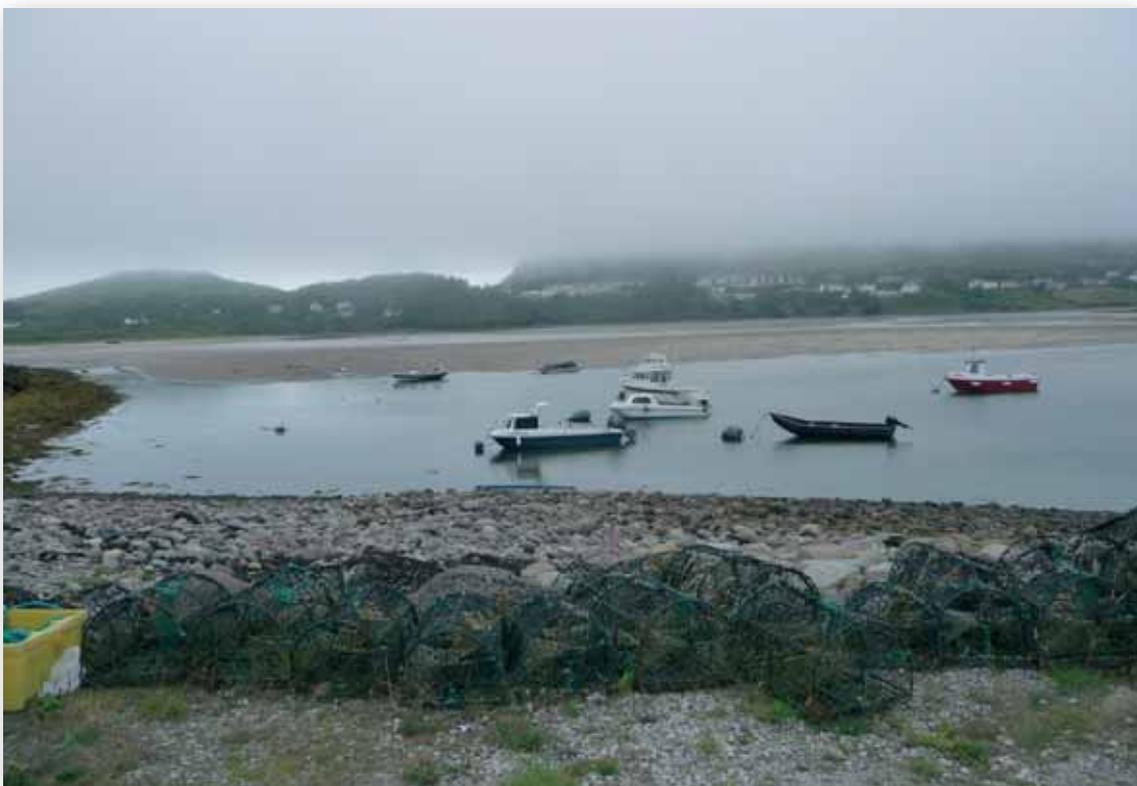
Foreshore area where the casualty was first brought ashore.
