REPORT OF THE  
INVESTIGATION INTO THE  
CAPSIZING OF THE  
“*NA BUACHAILLÍ*”  
ON  
18th FEBRUARY 2011.

REPORT No. MCIB/198  
(No.6 of 2012)

Report MCIB/198 published by The Marine Casualty Investigation Board  
Published 19th July 2012.

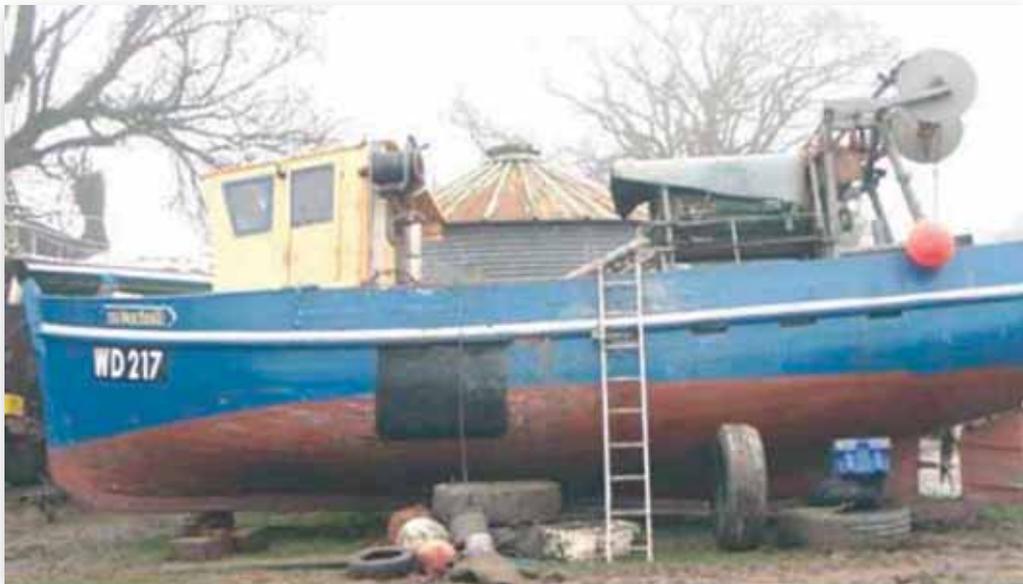
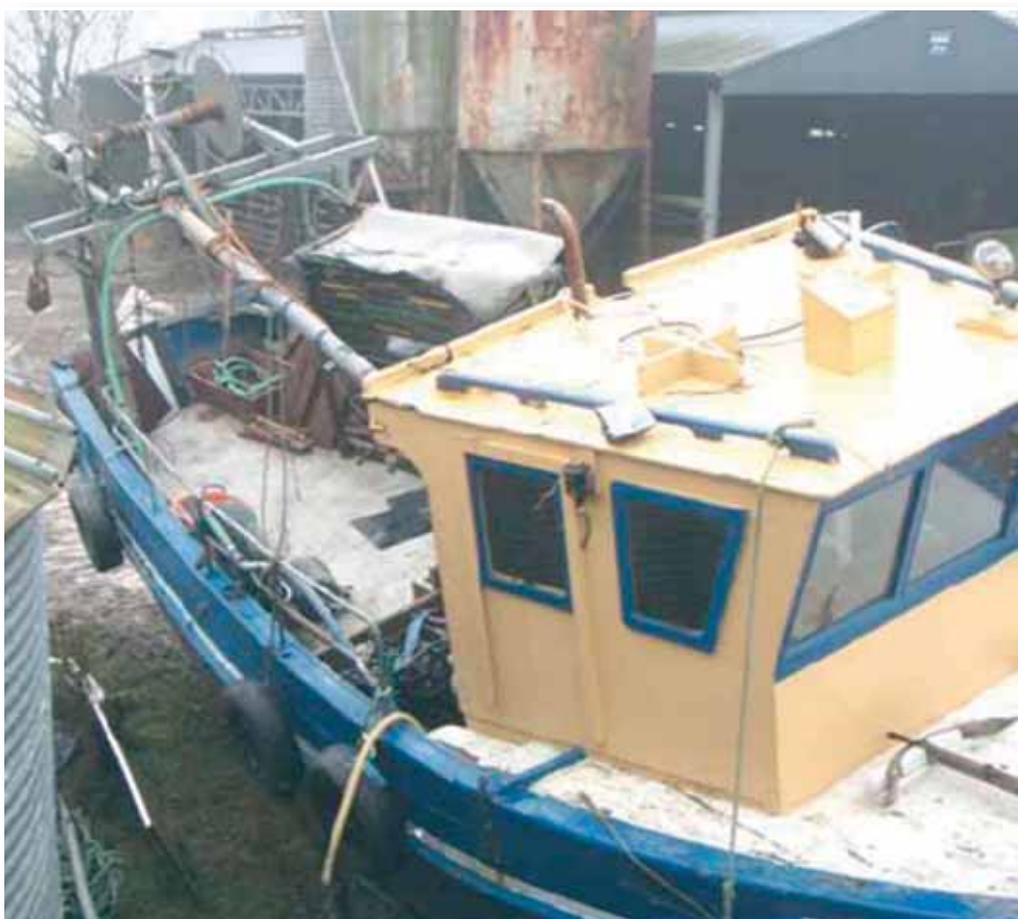
Photographs 1 and 2 taken by the MCIB on 25th February 2011 where the vessel was being stored after it had been raised, pumped-out and brought ashore after the sinking.

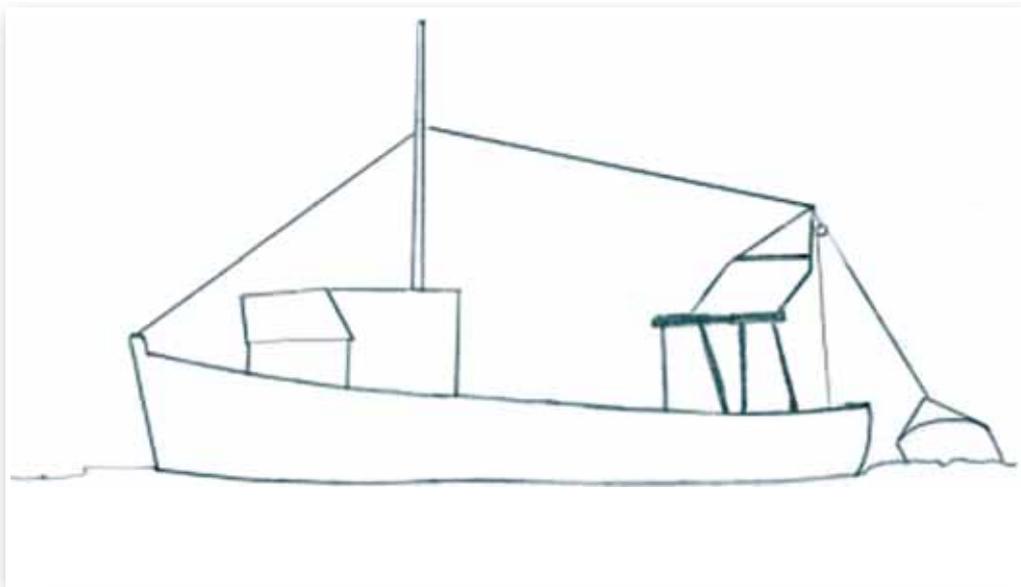
Fig 1

- 2.4 Mr. McNamara recounted that the floating equilibrium of the vessel was slightly to Starboard. This suited the operation of the vessel as the net hauler was located on the Port side and the increased lift on the port side was of assistance when operating the net hauler.
- 2.5 After the vessel was surveyed in 2009, Mr. McNamara occasionally fitted a mussel washer/sorter unit on the port side deck, forward of the gantry, when dredging for shell fish. This item was in use on the vessel at the time of the incident and can be seen in Photographs 1 and 2. The mussel washer/sorter was mounted on the Port side of the vessel and Mr. McNamara estimates that it weighed approximately 250-kgs but that this weight on the vessel was off-set by the fact that the fishing net had been removed and was not on-board at the time of the incident.

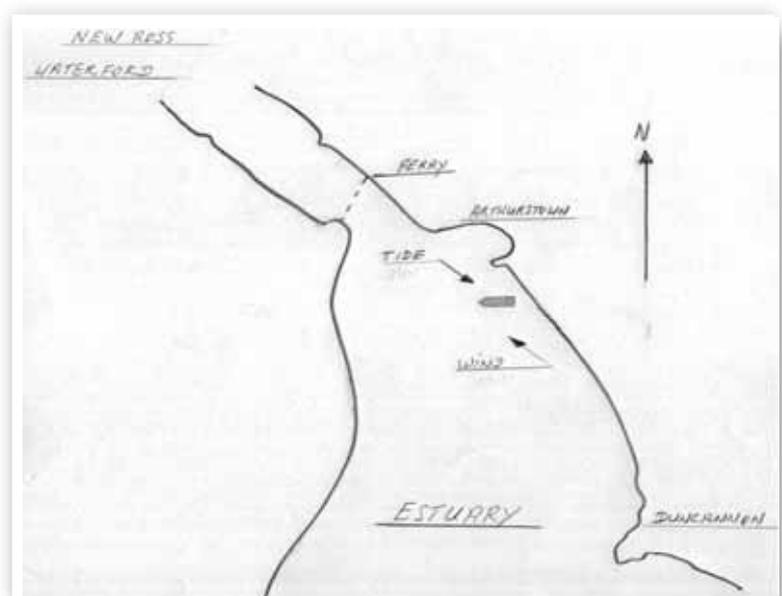
Fig 2

- 4.4 The position was  $52^{\circ} 11' N$   $006^{\circ} 56' W$  approximately 0.5 NM North of Duncannon. Please see (Fig. 2). This is a sketch of the estuary showing the approximate position of the vessel and the tidal/wind directions.
