**REPORT OF INVESTIGATION
INTO THE GROUNDING OF
MV "PANTANAL"
AT
CASHLA BAY, ROSSAVEAL
ON
31st MARCH 2011**

**REPORT No. MCIB/199
(No.2 of 2012)**

Report MCIB/199 published by The Marine Casualty Investigation Board.
Published 24th February 2012.

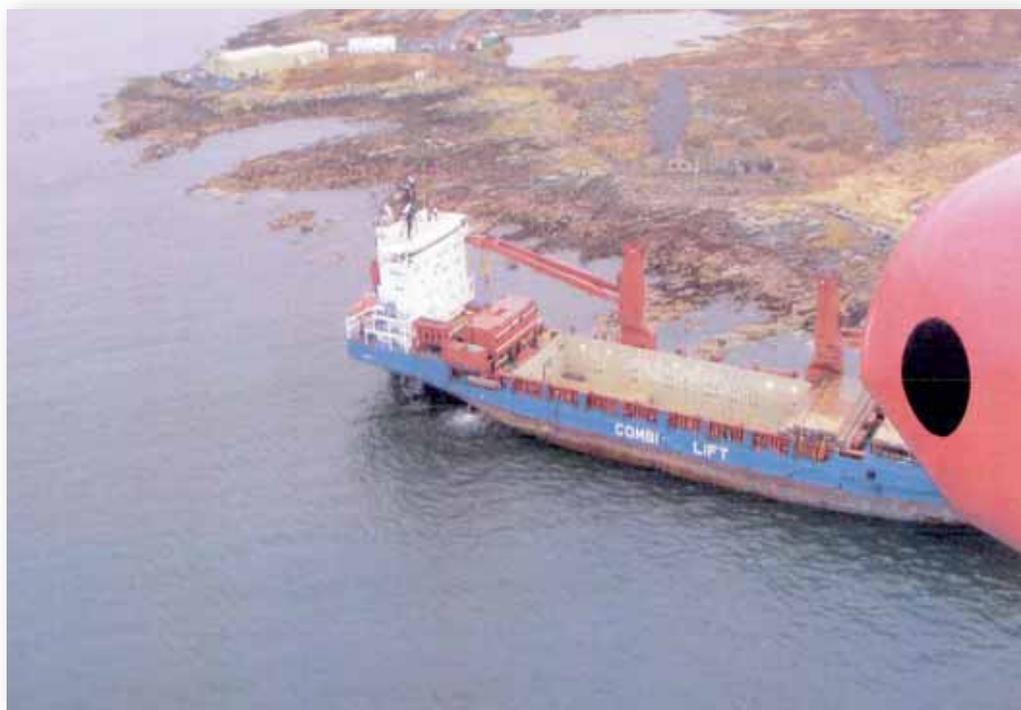
- 1.1 On 31st March 2011 at approx. 04.35 hrs. the vessel, which was anchored in Cashla Bay, began to drag anchor. At 04.55 hrs. the vessel took the ground on the North Eastern part of the Bay, in position 53° 15.7'N 009° 34.05'W. No lives were lost, however, the vessel was extensively damaged.

Photograph of "Pantanal" aground courtesy of Irish Coast Guard.

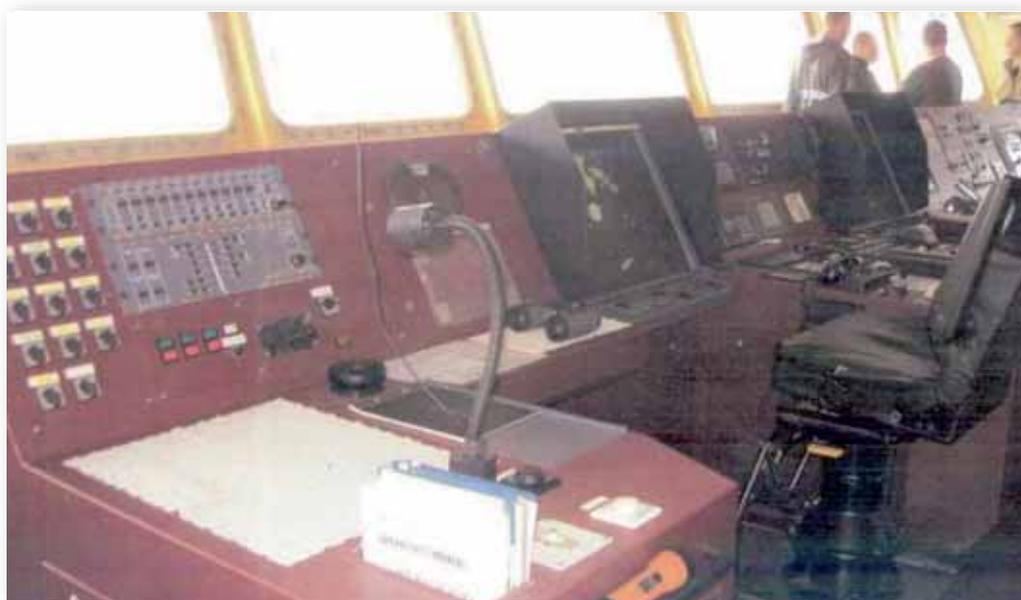
(a) Wheelhouse from port to starboard.

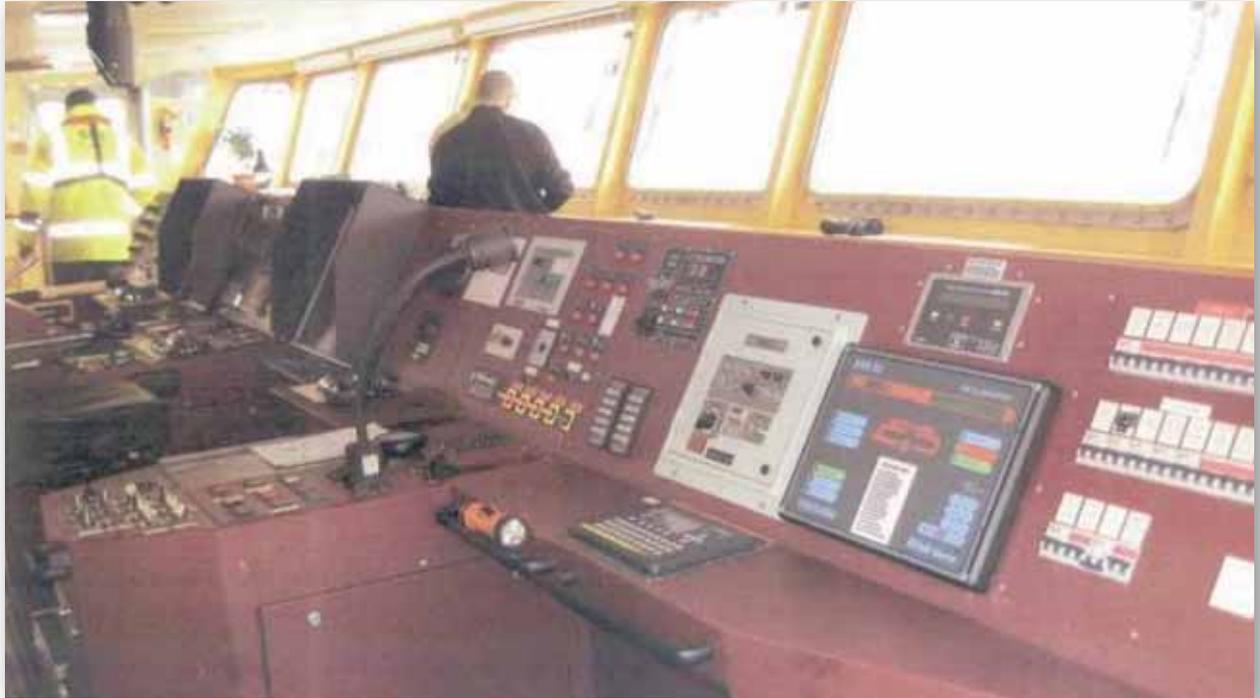
(b) Wheelhouse from starboard to port.

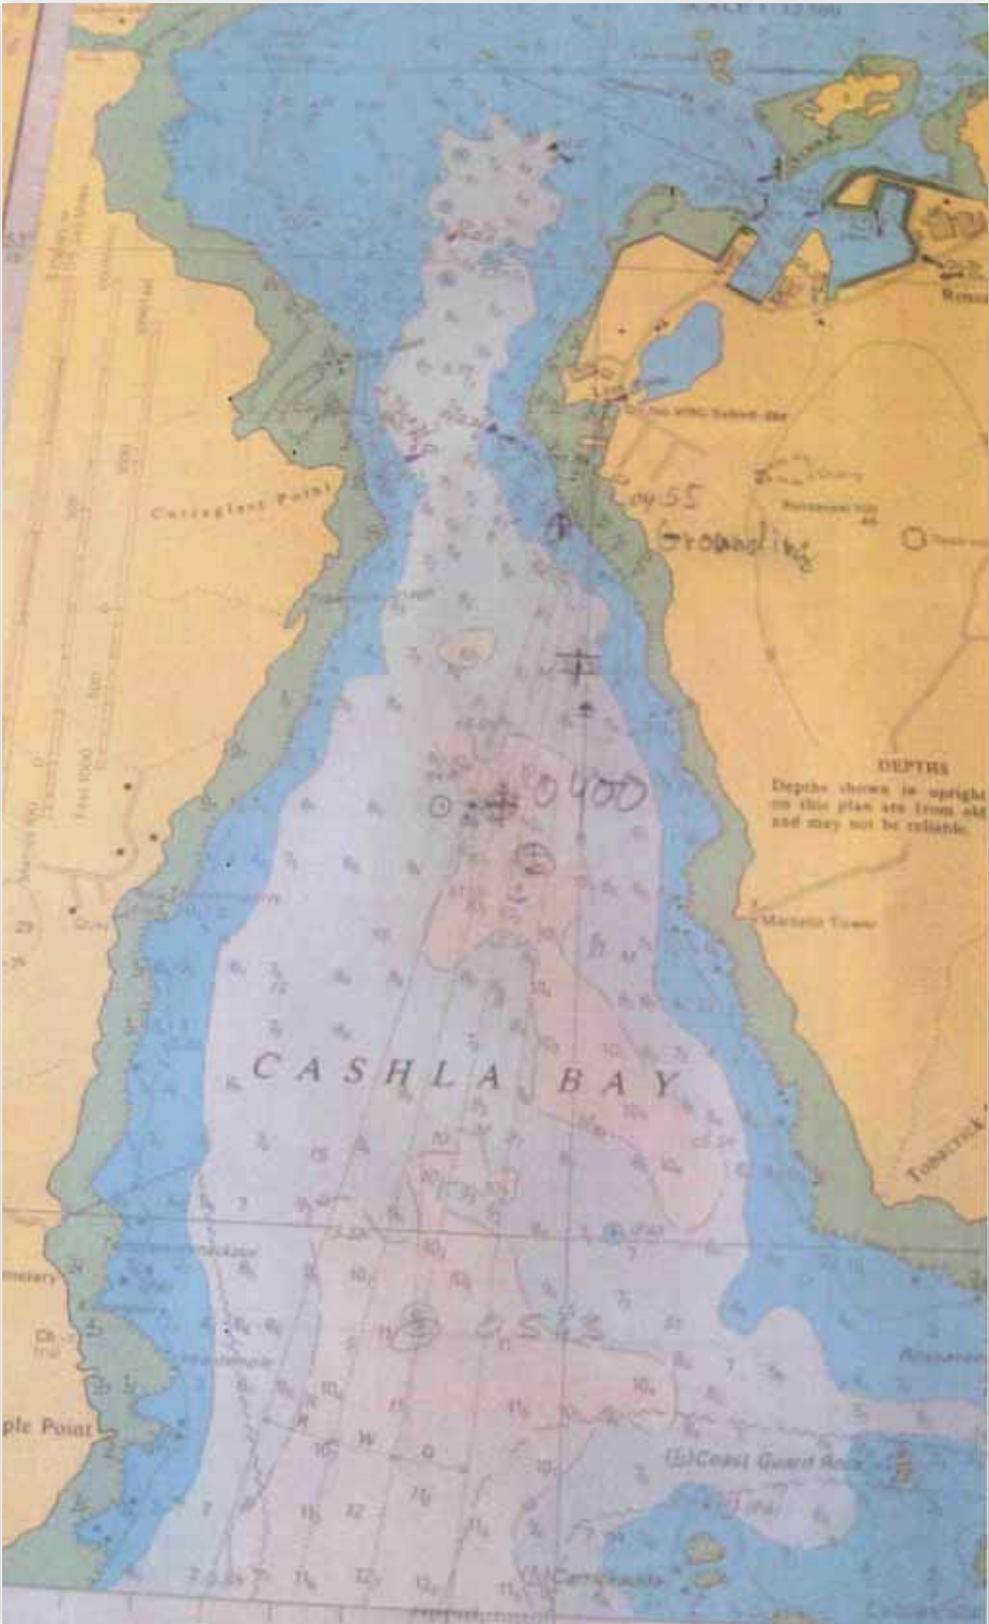
Appendix 8.3 Photograph of chart on board vessel.

- 5.10 The British Admiralty chart was examined. The chart in use was BA 2096 with an inset for Cashla Bay. The chart was "new" in appearance and the last correction entered was No. 6499 of 2009. The last position marked on the chart was for 04.00 hrs. It was noted that the distance from the shore was 3 cables or 0.3 nautical miles. The charted depth of water was 10.5 metres.
