**REPORT INTO THE SINKING OF  
THE IRISH REGISTERED  
FISHING VESSEL “PAULA”  
ON 24TH JANUARY 2005**

The Marine Casualty Investigation Board was established on the 25<sup>th</sup> March, 2003 under The Merchant Shipping (Investigation of Marine Casualties) Act 2000

Published by The Marine Casualty Investigation Board  
26th February 2007

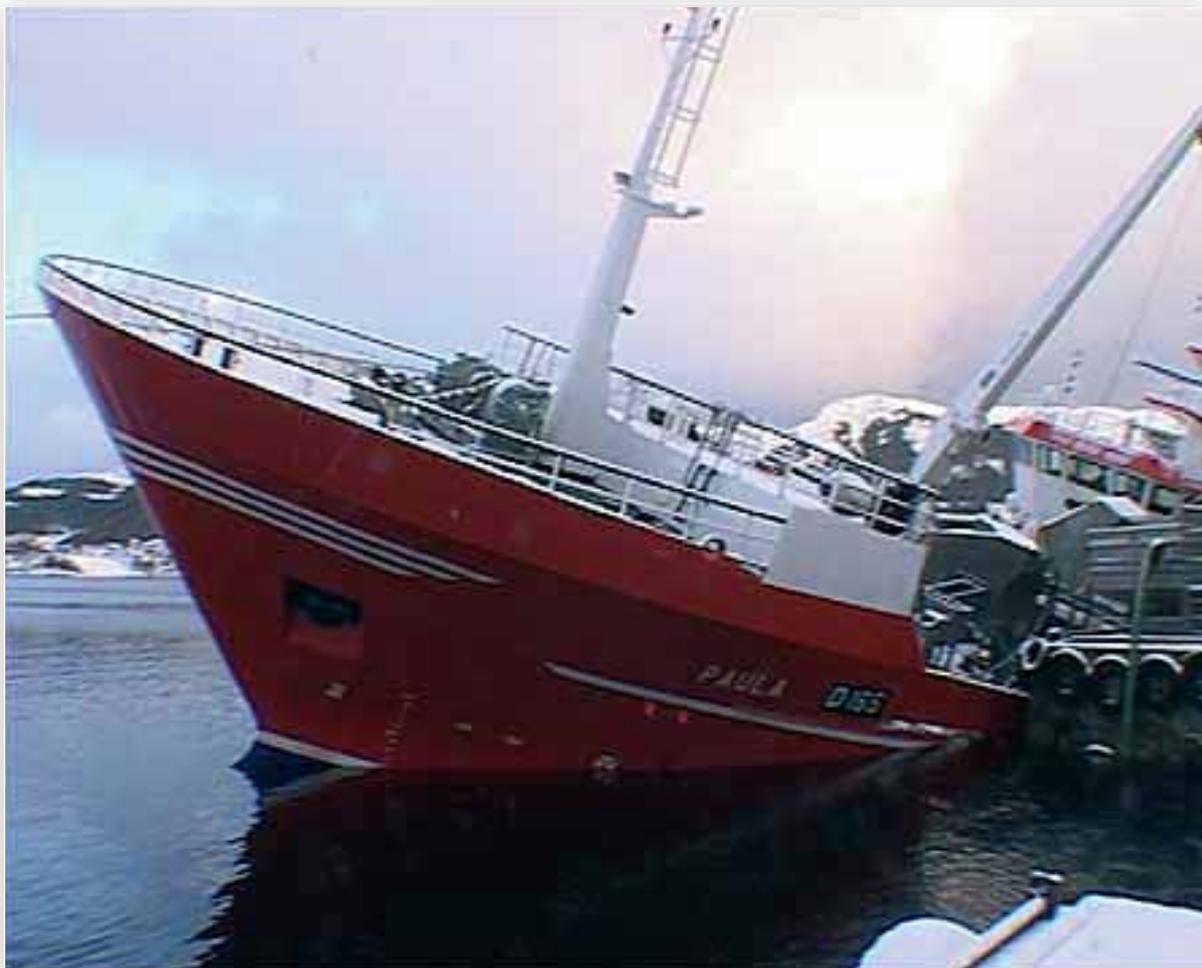
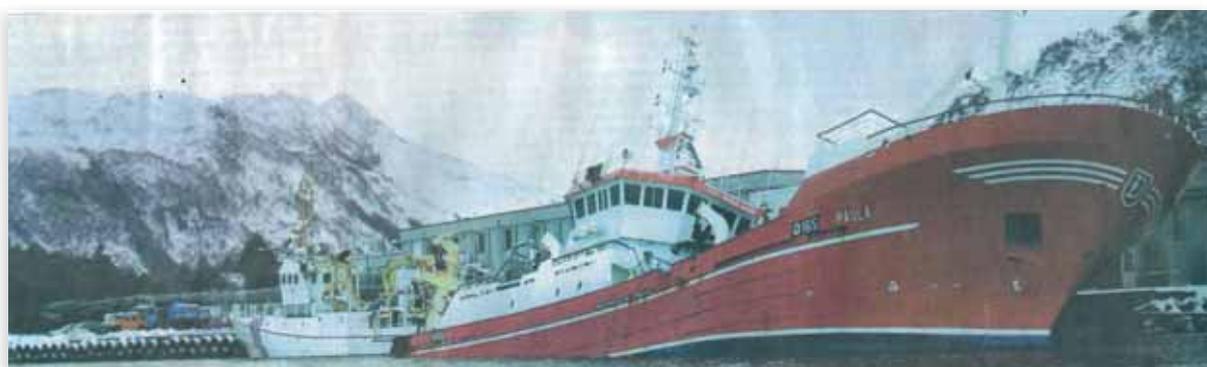
Appendix 8.1 Photographs of “Paula” partly submerged

- 5.6.1 The timing of events are somewhat unclear but in little over 30 minutes from the flooding starting the “Paula” was abandoned. The vessel eventually settled in a partially submerged condition, the aft part of the “Paula” being completely submerged and the vessel was listed over to port

and lay against the quay wall. Diagrams in appendix 8.6.5 and 8.6.7 and photographs in appendix 8.1 show the final condition of the “Paula”. Diagrams in appendix 8.6.1 to 8.6.7 show the progress of the flooding and the affect of the flooding in various spaces.

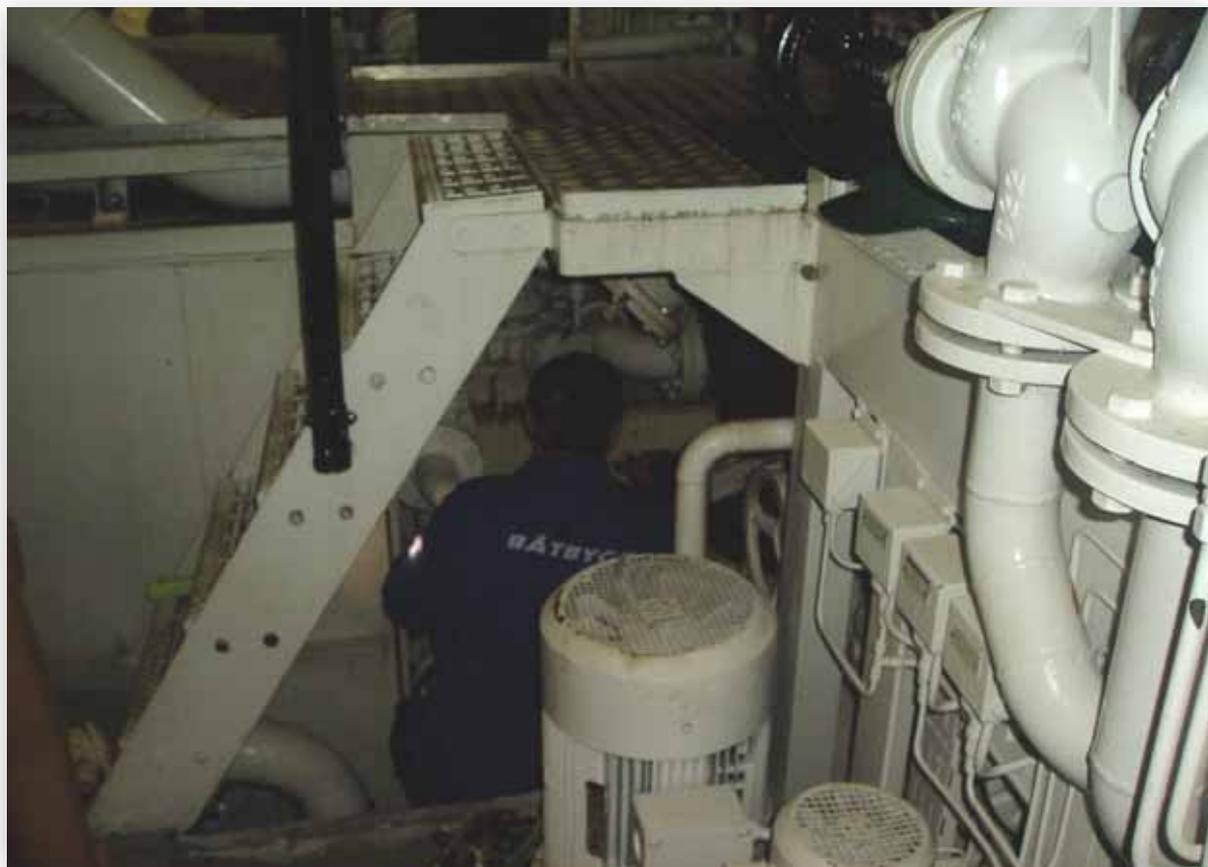
### Appendix 8.4.1 Photograph of general area of port valve chest

- 5.4.3 A third group assisted the chief engineer in donning his sub aqua gear and assisting him in the engine room.
- 5.5 The chief engineer entered the engine room where the water level had now risen to above the main engine. He dived down to the port side sea strainer housing but was unable to get close enough to move the housing lid from the port outboard valve where it lay and operate the port outboard ship side valve. This was due to the confined space where the valve and strainer housing are located. (See photograph at appendix 8.4.1).

- 5.12 The divers were unable to access the area adjacent to the port sea water suction strainer and had to remove the steps shown in photograph appendix 8.4.1 the salvage diver reported that the suction strainer cover was lying onto the butterfly valve outboard of the port main seawater suction strainer and was 3 turns open.

- 6.5.3 Access to the area was restricted in terms of space; the salvage divers had to remove the stair to get into this area in order to close the valve and replace the strainer cover. With near freezing seawater entering at considerable pressure this task would have been virtually impossible for ship’s crew. See photograph, appendix 8.4.1.

- 7.1 The accessibility of shipside valves be reviewed regularly, to ensure that they are easily operated at all times but especially during a flooding situation.
- 7.2 The bilge pumping capacity for Fishing vessel machinery spaces should be reviewed regularly to ensure there is adequate capacity, especially in cases where large capacity seawater piping is fitted.
- 7.3 Where possible the seawater supply for RSW systems should be taken from a separate source than that used for machinery space seawater requirements.
- 7.4 Appropriate Marine Notices should issue regarding the above.

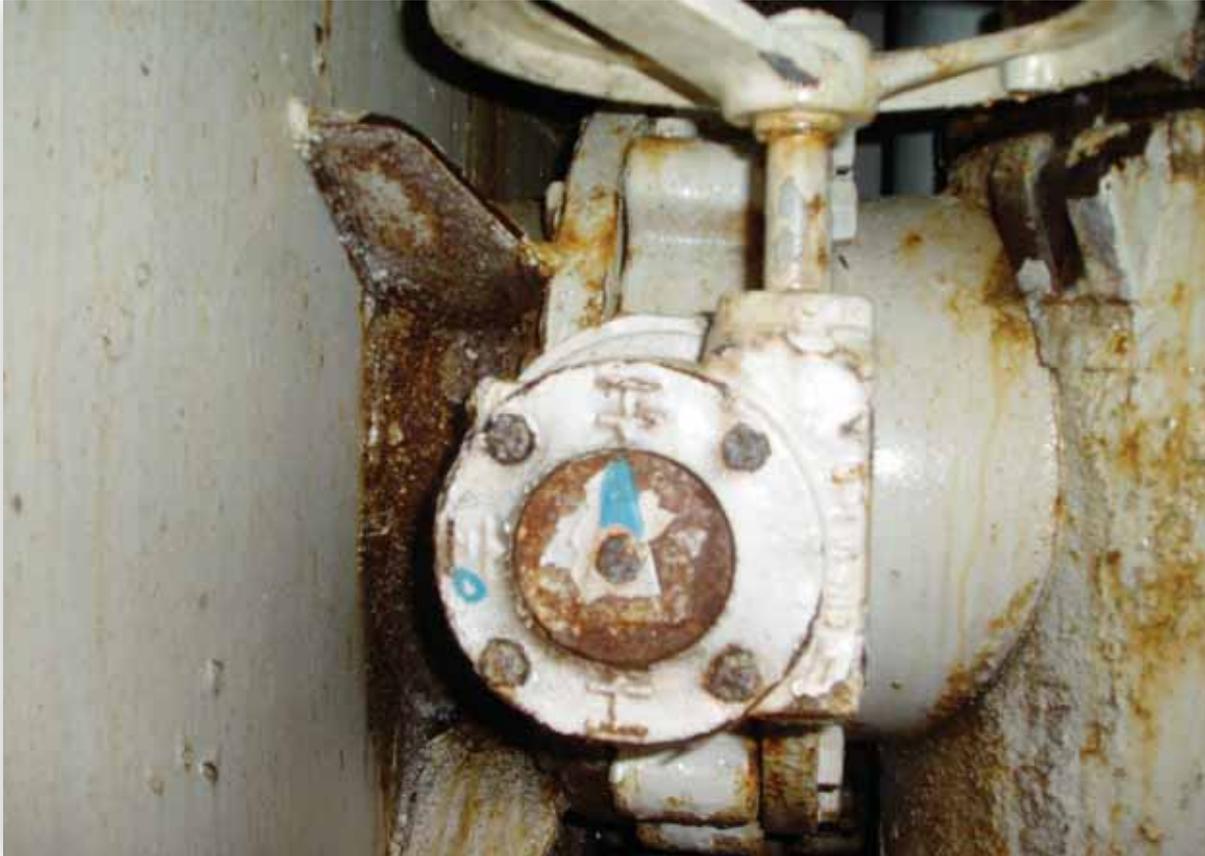
Appendix 8.4.2 Photograph of valve position indicator

- 6.5.2 The position indicator itself was difficult to read as shown in photograph, appendix 8.4.2. The indicator having been marked in blue marker by ships staff to assist in checking its position. The position indicator reading was subsequently checked against the actual valve position and found to be accurate.

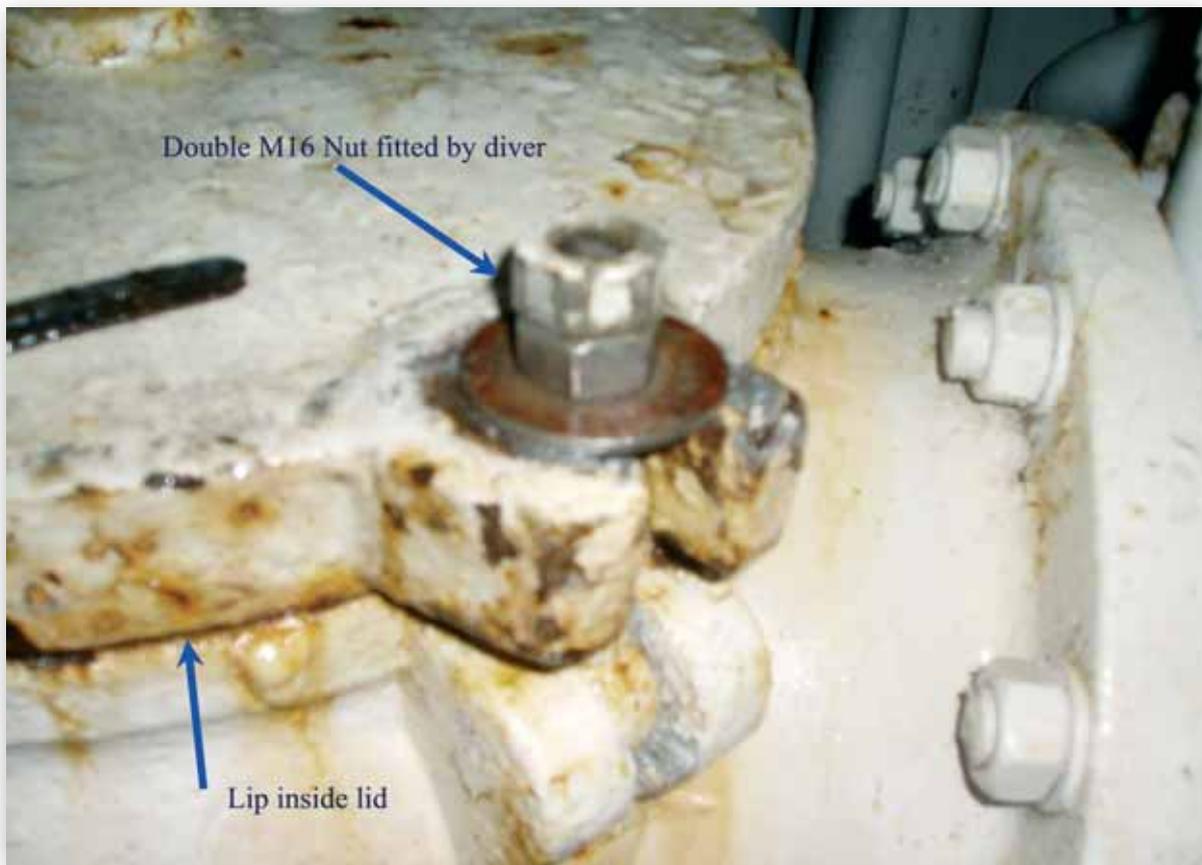
Appendix 8.5.2 Photograph of suction strainer nuts

- 6.6.2 Given that the strainer body cover had a reasonable lip it is unclear how much the cover could be raised as there is little room to 'back off' the securing nuts see photograph appendix 8.5.2.

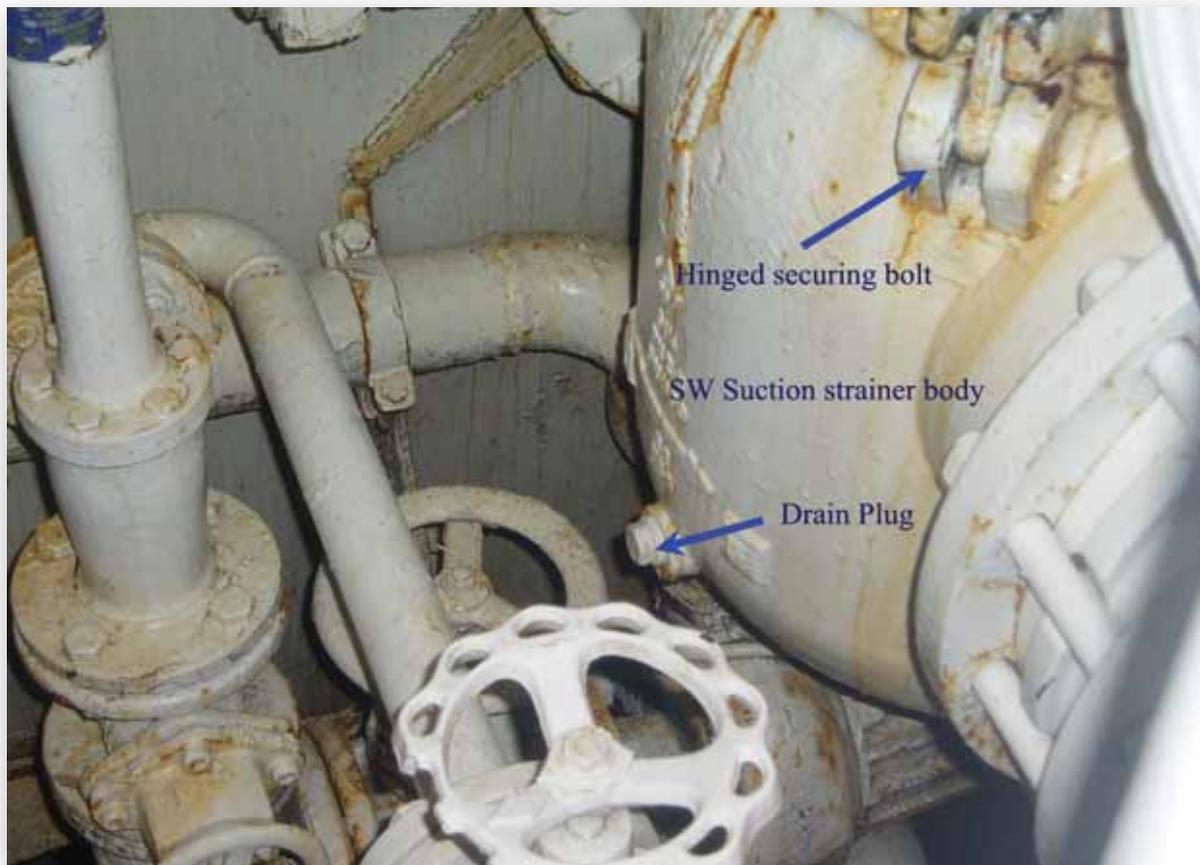
Appendix 8.5.3 Photograph of suction strainer body drain

- 6.6 Another significant contributory factor was the fact that in spite of the seawater strainer housing being fitted with a drain plug at the bottom of the housing this was not slackened back or removed to check for pressure inside the housing before the cover was removed. Inspection of this plug indicated they had not been removed for some time and the ships engineering staff stated it had not been part of the normal procedure removing the strainer from its housing to do so. See photograph at appendix 8.5.3.

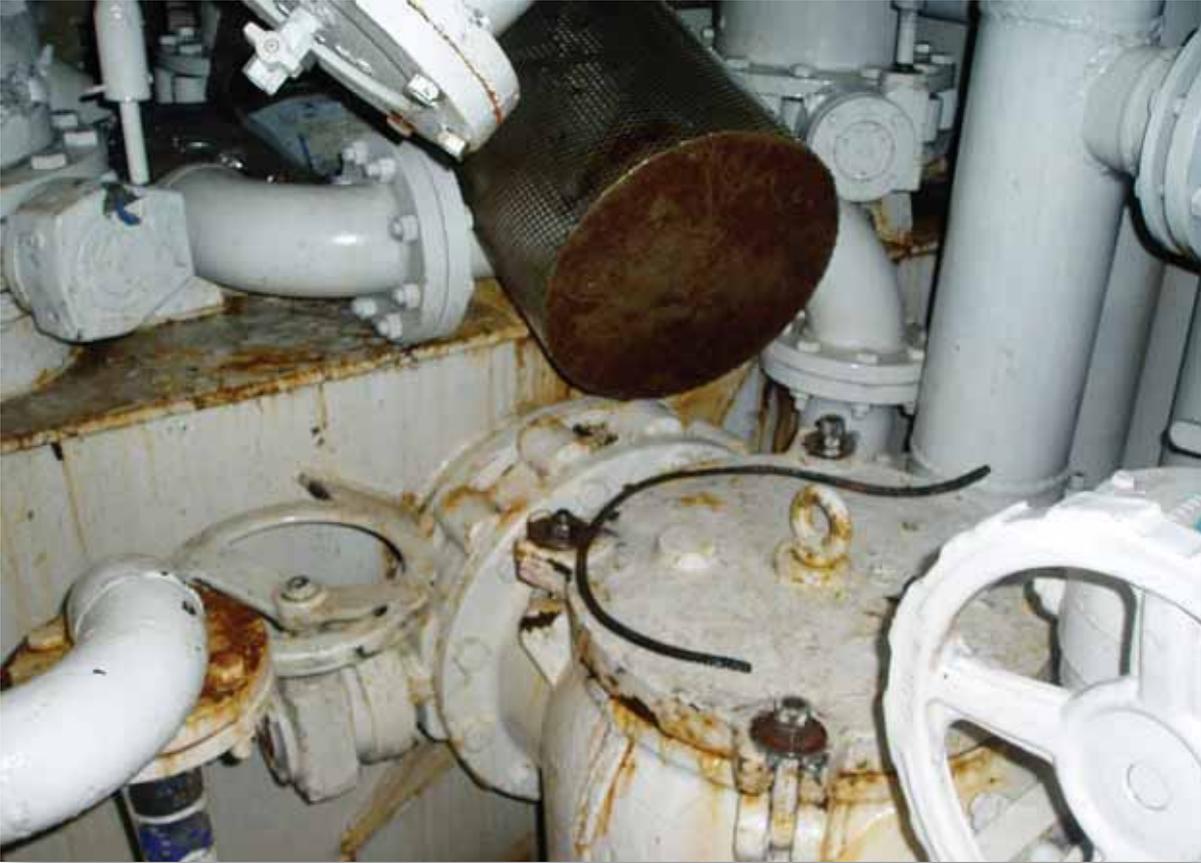
Appendix 8.5.4 Photograph of suction strainer body

- 6.5.1 The engineer operating the valve-operating wheel was unable to see the position indicator fitted to the side of the valve-operating gearbox from the position where he operated the valve. See photograph appendix 8.5.4.

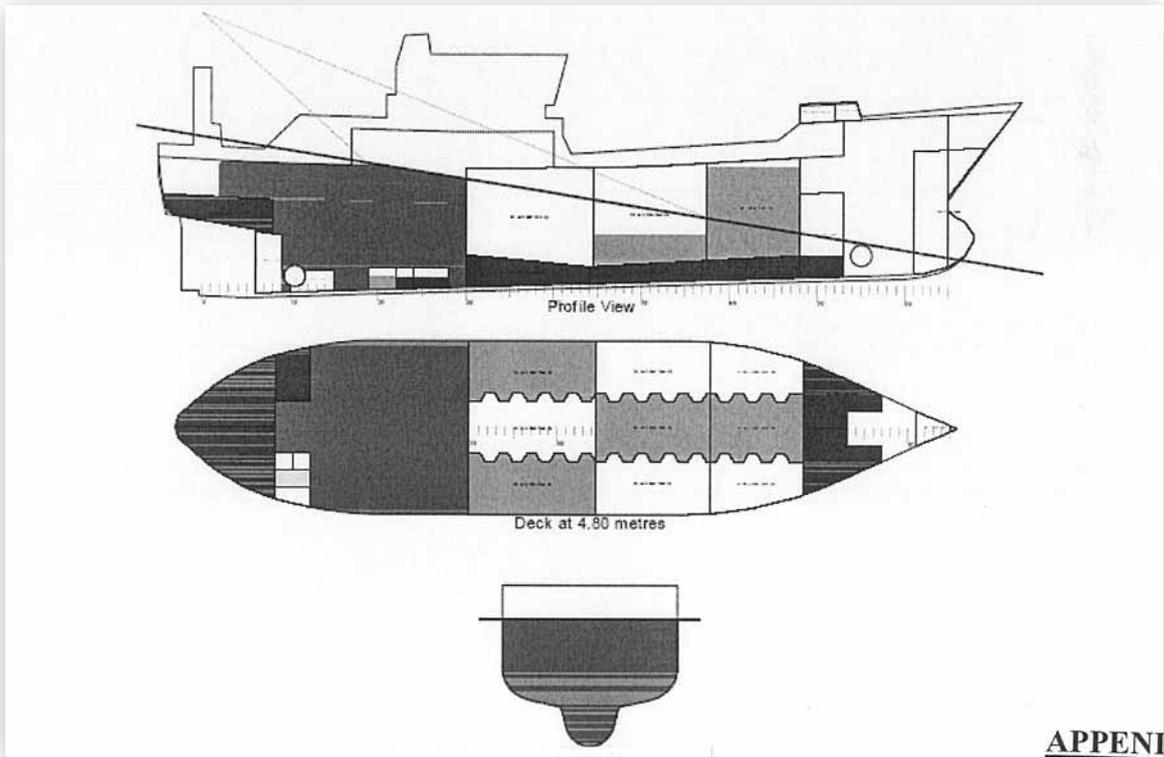
### Appendix 8.6.5 Diagram of grounding in condition 8.6.4

- 6.11 The combined capacity of all the bilge and ballast pumps fitted to the "Paula" were insufficient to deal with the inflow of water.
- 6.12 The effect of the portside RSW passage door being open as shown in appendix 8.6.6 and 8.6.7 did not change the outcome of this incident as the "Paula" would have grounded by flooding of the engine room, RSW room and accommodation alone as shown in appendix 8.6.5.

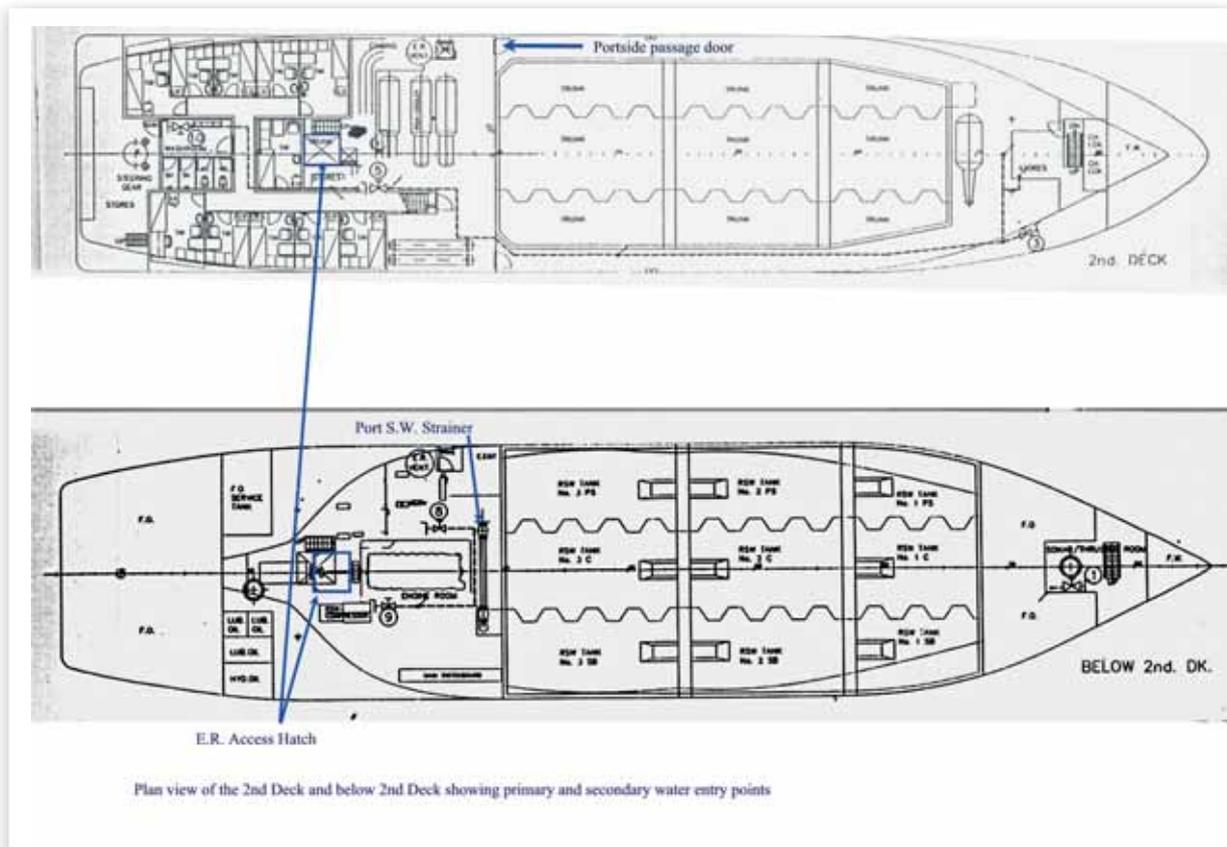
Appendix 8.7 Diagram showing water entry points

- 5.4 The crew split into three groups:
  - 5.4.1 One group moved through the ship and shut watertight doors and started the emergency power supply. As they made their way from the forward side of the ship down the port side passage beside the RSW tanks, water had begun to flow up the passage way and they were unable to shut the door (See the diagram in appendix 8.7).

- 5.4.2 A second group of crewmembers started to open the aft hatch marked on the plan (shown in appendix 8.7). The purpose of this was to allow pumps to be lowered into the engine room. As the hatch could only be opened internally this was done before the rising water level made the task impossible.
