**REPORT INTO THE LOSS OF  
THE MFV "POD SANT YANN"  
ON THE 26TH APRIL 2005**

**The Marine Casualty Investigation Board was established on the 25<sup>th</sup> March, 2003 under The Merchant Shipping (Investigation of Marine Casualties) Act 2000**

Published by The Marine Casualty Investigation Board  
21st October 2005

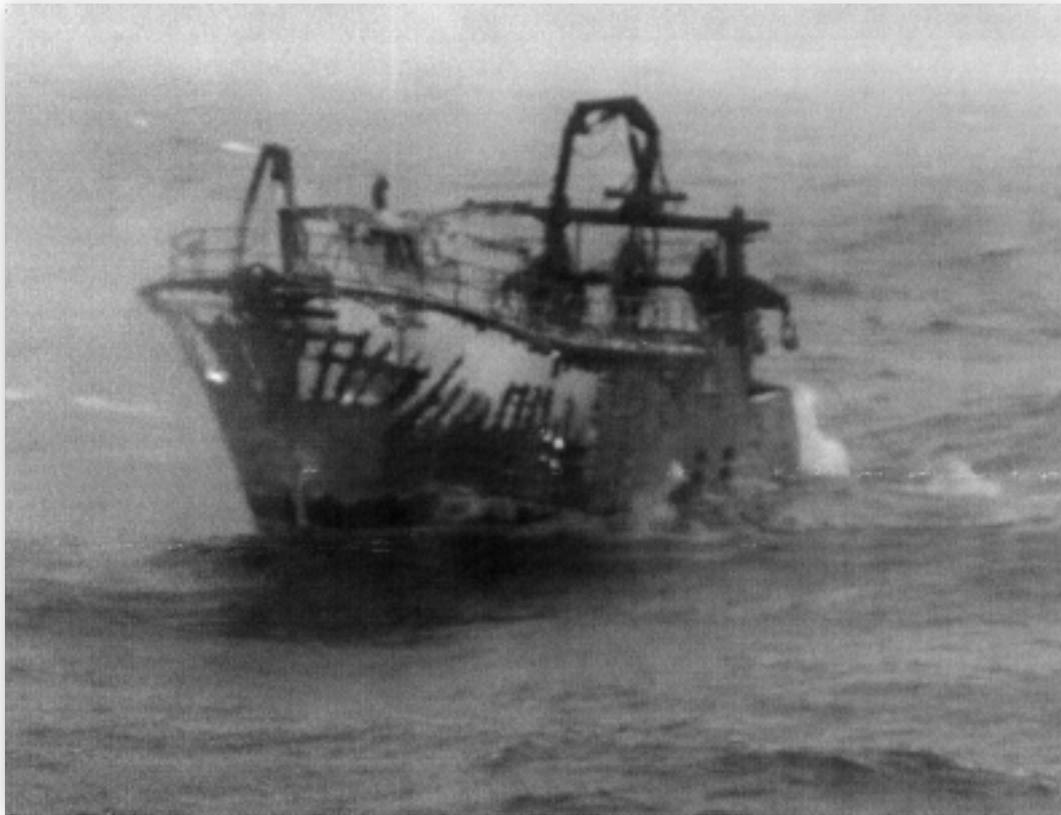
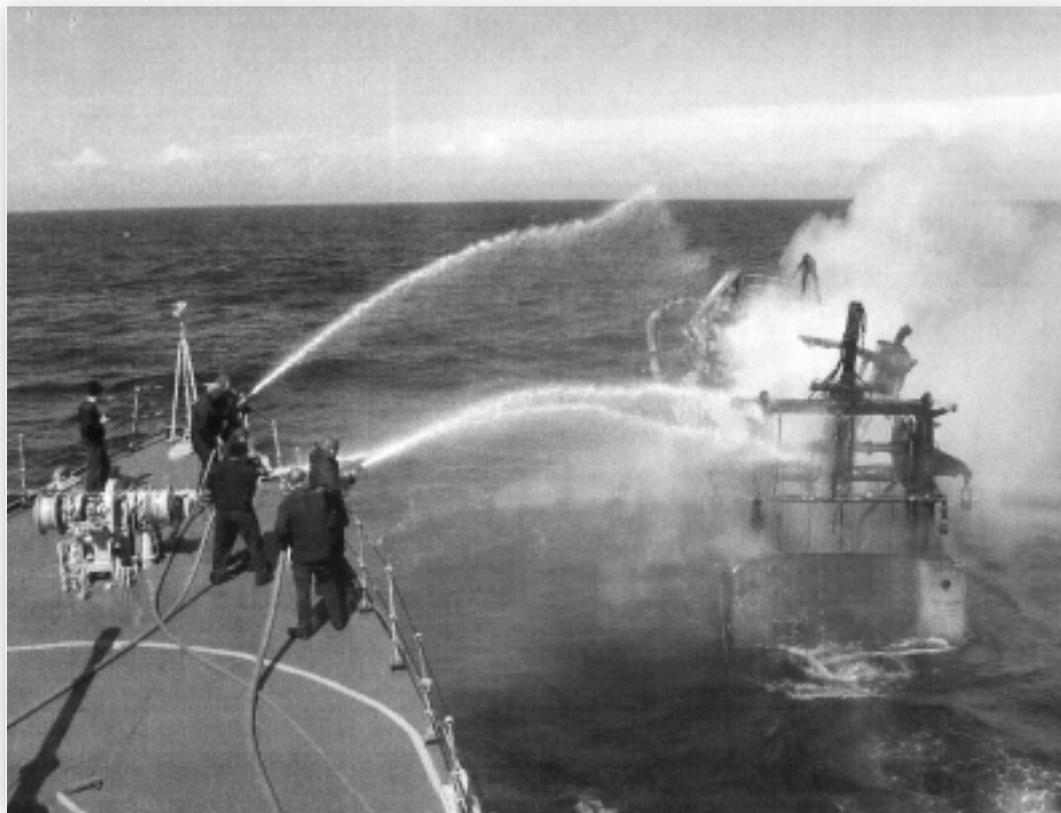
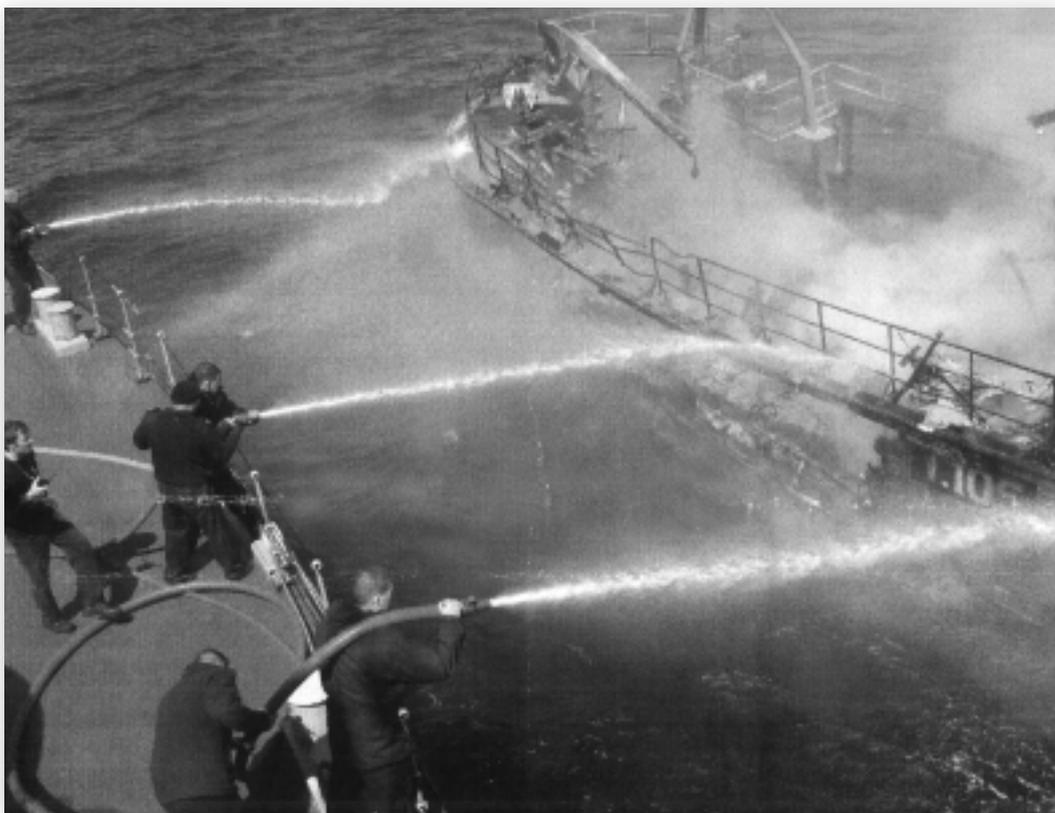
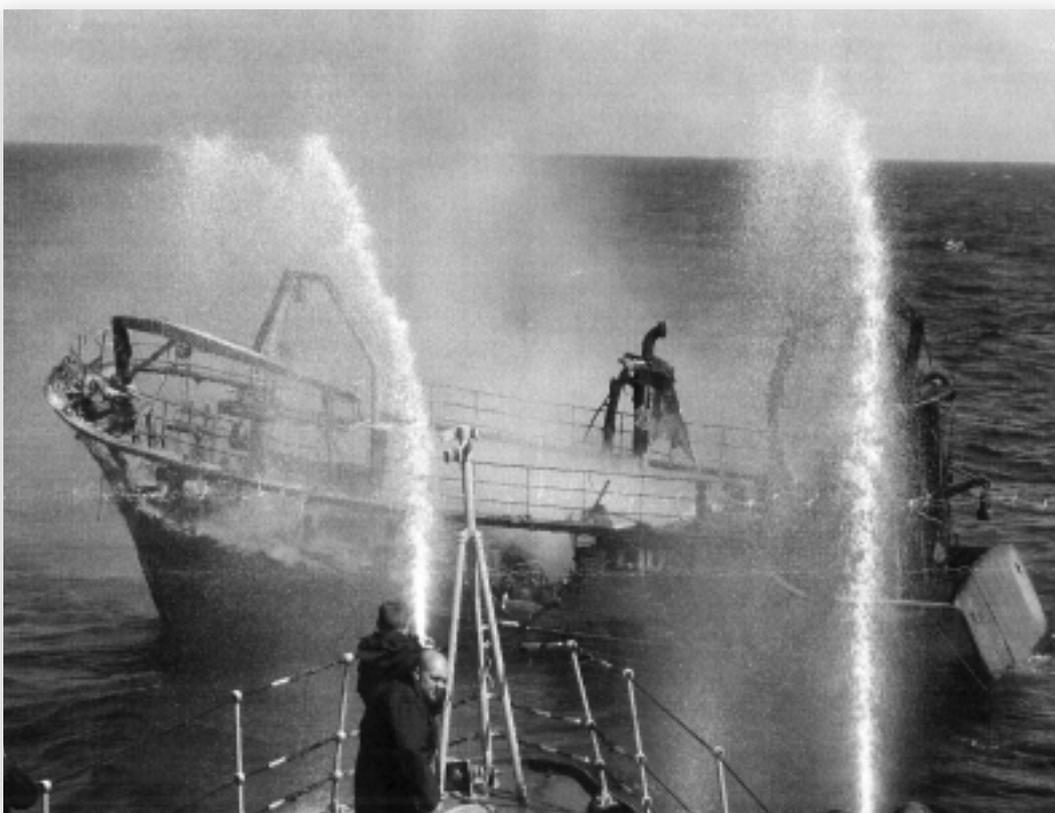
# APPENDIX 8.1

- 5.9 The vessel remained afloat still burning and eventually sank at 17.45 hours in position 51 11.4N 008 40.5W in water depth 102 Metres.
- 5.10 There were no injuries reported in connection with this incident.

- 6.1 The vessel burned out and sank and therefore the cause of fire cannot be determined.
- 6.2 Attempts by the Skipper to use the fire fighting appliances did not include the use of the CO2 Fixed Fire Fighting Installation. If this system was working and had been used the fire might have been extinguished.
- 6.3 The fire went out of control rapidly necessitating the evacuation of the Skipper and Crew. This took place without difficulty, aided by the reasonable weather conditions.
- 6.4 There have been no reports to date of any oil pollution and therefore it can be assumed that the oils on board the vessel remain contained in the vessels storage tanks and drums. It can also be assumed that at some time in the future the oil will eventually leak into the sea.

- 8.1 Photographs of "Pod Sant Yann" on fire and being extinguished by LE "Ciara"  
(Photographs courtesy of Naval Operations Command)

- 7.1 It is recommended that the Skipper or the person responsible for using the Fixed Fire Fighting Installation should be fully familiar with its correct operation in the event of an engine room fire.
- 7.2 It is recommended that Fire Fighting Appliances including the Fixed Fire Fighting Installation be maintained by a competent servicing agent at a period not exceeding two years.
