**REPORT OF INVESTIGATION  
INTO FATAL INCIDENT  
ON LOUGH CORRIB  
NEAR ANNAGHDOWN,  
CO GALWAY  
ON  
19th MARCH 2012**

**REPORT No. MCIB/213  
(No.14 of 2012)**

Report MCIB/213 published by The Marine Casualty Investigation Board  
Printed 10th December 2012.

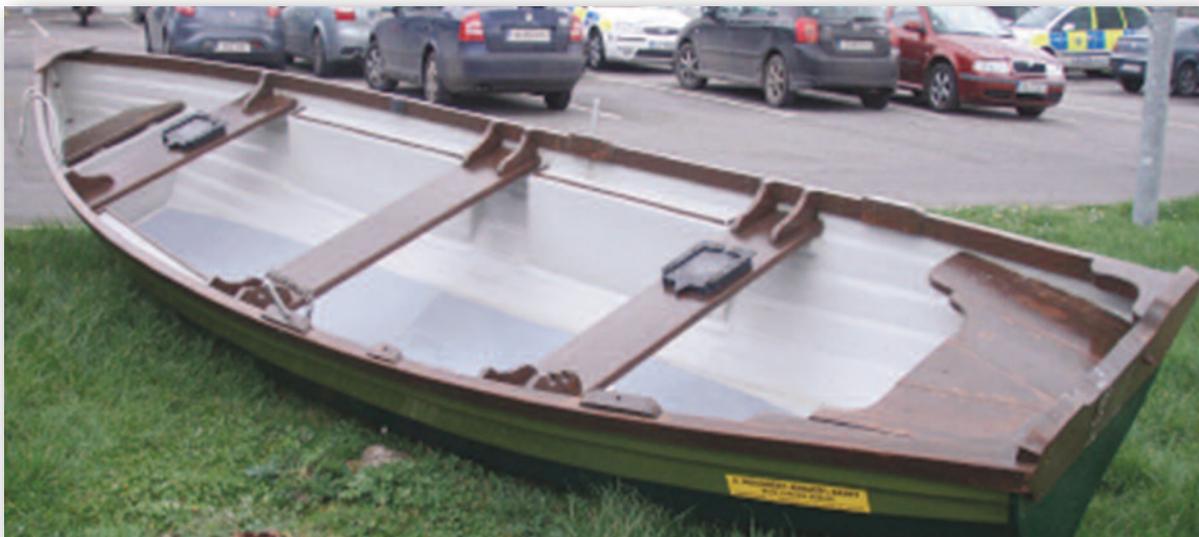
- 4.1.2 In addition to wooden transverse thwarts most of the boats have revolving seats mounted on the thwarts - these seats can be removed. The boat in use had two such seats one on the forward thwart and on the second from aft thwart. These seats were both slightly offset to starboard and did not have a locking mechanism and are always free to revolve.

Photo 1: The boat - note two mounts for revolving seats.

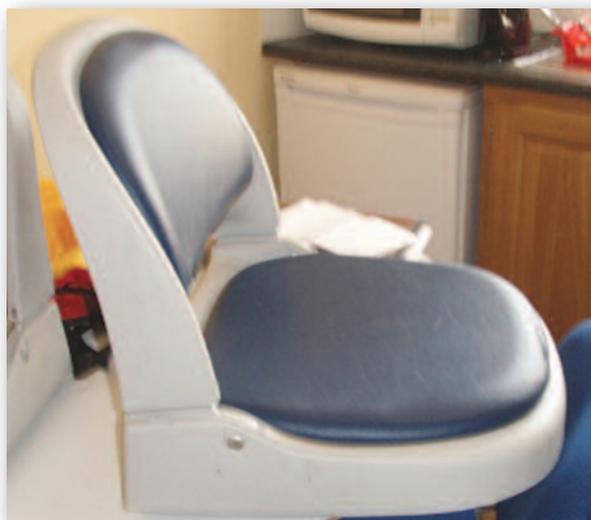
- 4.3 Weight distribution and boat handling will have an effect on a boats performance whatever the category. The swivel seat that Mr Coyle was sitting in was on the forward thwart and mounted slightly to starboard - see Appendix 7.2 (Photos 1 & 2). Whilst it may not have had a detrimental effect on stability whilst fishing when the boat was under way other factors would come into play.

- 4.3.1 The position in the bow, the narrowest part of the boat would not be the best place to sit when the boat heels.
  - 4.3.2 The seat was offset to starboard which was the direction the boat heeled.

- 4.3.3 The momentum of the person sitting in the seat would rotate them sideways in the direction of heel, in this case to starboard.
  - 4.3.4 The net result was that the person in the swivel seat was situated above and close to the starboard gunwale on an unstable platform so when the boat heeled he was easily thrown into the water.

Photo 2: Revolving seat.

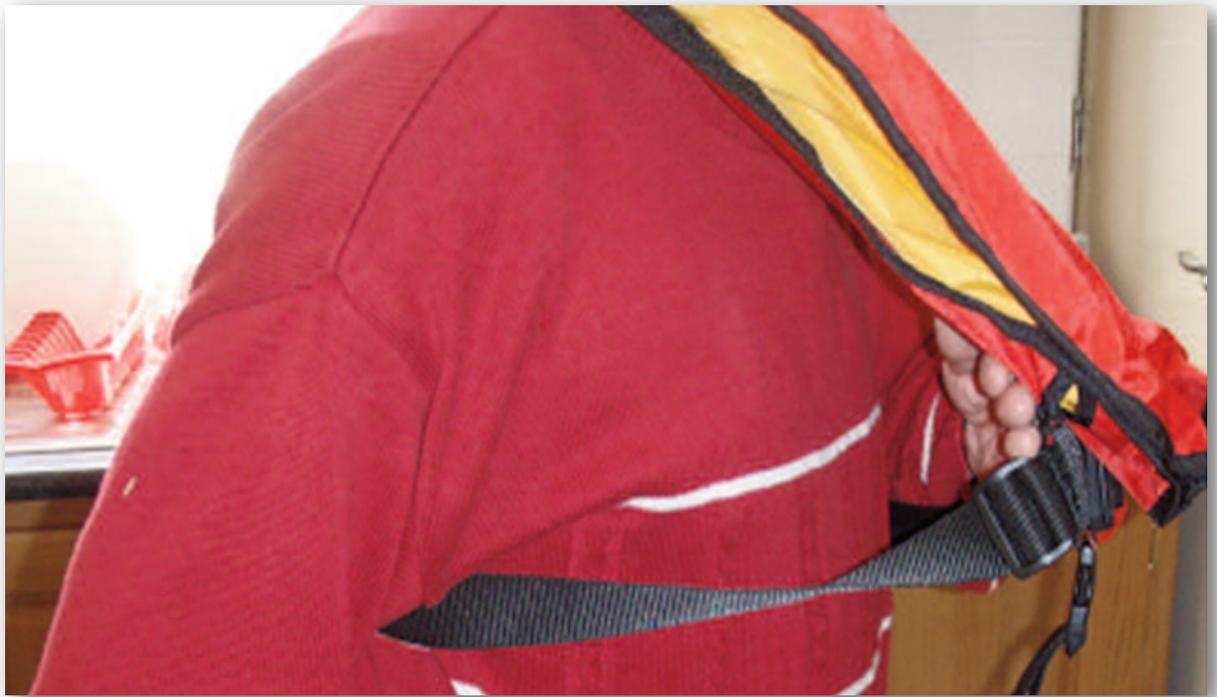
- 4.6 Inspection of the life jackets found them both in good condition, and they both inflated correctly during the incident. Mr Coyle's had no crotch strap and the crotch strap on Mr Ruane's was not secured when it was recovered. As Mr Ruane's lifejacket came off after immersion, therefore it is not unreasonable to assume that it was not fastened between his legs when he was thrown into the water.

- 4.7 The waist straps on both jackets, when inspected subsequently, appeared not to have been adjusted and were expanded to full extent. On Mr Coyle's this was a circumference of 132cm (52 inches) and on Mr Ruane's 137cm (54 inches). Mr Coyle's chest measurement was about 118cm (44 inches) and Mr Ruane's was similar. This would leave about a 25cm (10 inches) slackness of the waist strap in relation to the chest. Appendix 7.2 (see Photo 3). The buoyancy of the jacket would pull the waist strap up over the chest, even with the extra clothing the men were wearing. The wearing of a lifejacket or PFD is mandatory for occupants of vessels of less than 7 meters LOA, the legislation does not cover the correct or incorrect wearing of such a lifejacket or PFD.

Photo 3: Mr Ruane's Lifejacket - note lack of adjustment of waist strap.
