**REPORT OF THE
INVESTIGATION INTO THE
SINKING OF THE
IRISH FISHING VESSEL
"RISING SUN" IN THE VICINITY
OF THE SALTEE ISLANDS,
CO. WEXFORD,
ON 29th NOVEMBER 2005**

Published by The Marine Casualty Investigation Board
28th May 2007

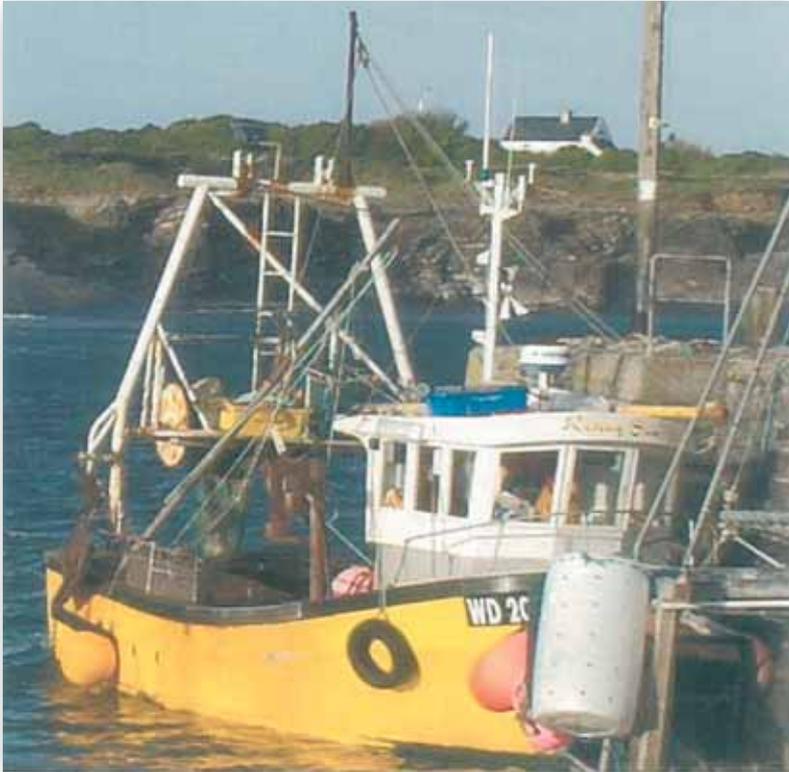
APPENDIX 9.1

The vessel was photographed during the days immediately prior to the incident, see Appendix 9.1. There is a winch fitted on the watertight working deck aft of the wheelhouse and a gantry fitted over the stern. A further net drum is fitted on a platform on this gantry. A pot hauler is fitted on the starboard side behind the wheelhouse.

At some time after the above survey, Mr. Colfer had extra equipment installed and which included a net drum installed on the aft gantry of the vessel. This was in connection with the vessels intended future dual use as a trawler and potter. The addition of this and other relatively heavy pieces of machinery high up on the vessel had a serious negative affect on the stability of the vessel. Although the vessel operated for a considerable period of time without mishap with this machinery fitted, there were other contributory factors affecting the stability of the vessel on 29th November 2005.

In the days immediately prior to the incident, the "Rising Sun" had been involved in trawling operations in the Waterford area and was therefore carrying nets and associated trawl gear, doors etc. onboard during these fishing trips. On the day of the tragedy the vessel departed Duncannon with all of the trawl gear still onboard, including the net on the drum on the aft gantry. There were also some boxes containing lengths of chain carried onboard in elevated positions.

Appendix 9.1 Photograph of Rising Sun before incident. Notnet drum, booms and other trawl equipment fitted.

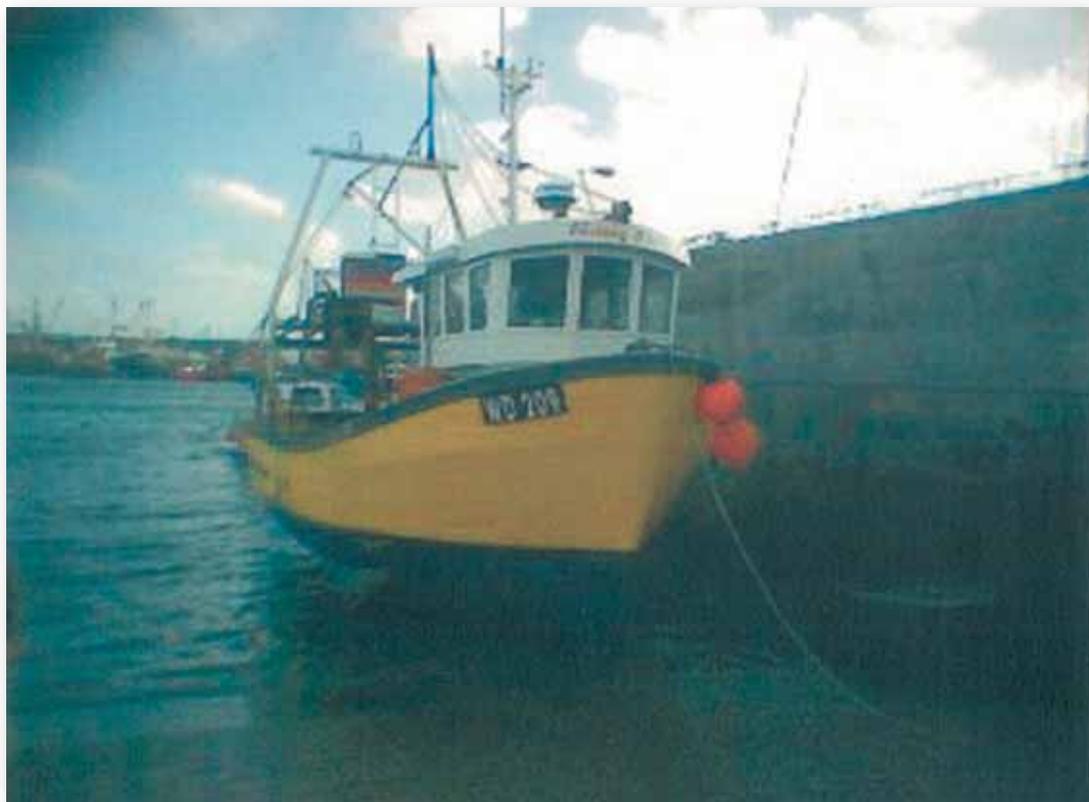
period" time. From this information a reasonably accurate picture of the stability characteristics of a vessel can be ascertained. Although the "Rising Sun" passed the criteria for the test, the results showed that it was only a marginal pass. The attending surveyor recalled informing Mr. Colfer that it was not good practice to store fish boxes up high on the gantry. At this time the vessel was rigged for potting operations only and there was no net drum fitted on the platform of the aft gantry. See appendix 9.4.

Appendix 9.4 View of the vessel in 2004 before addition of Net Drum on aft gantry and other trawling equipment.

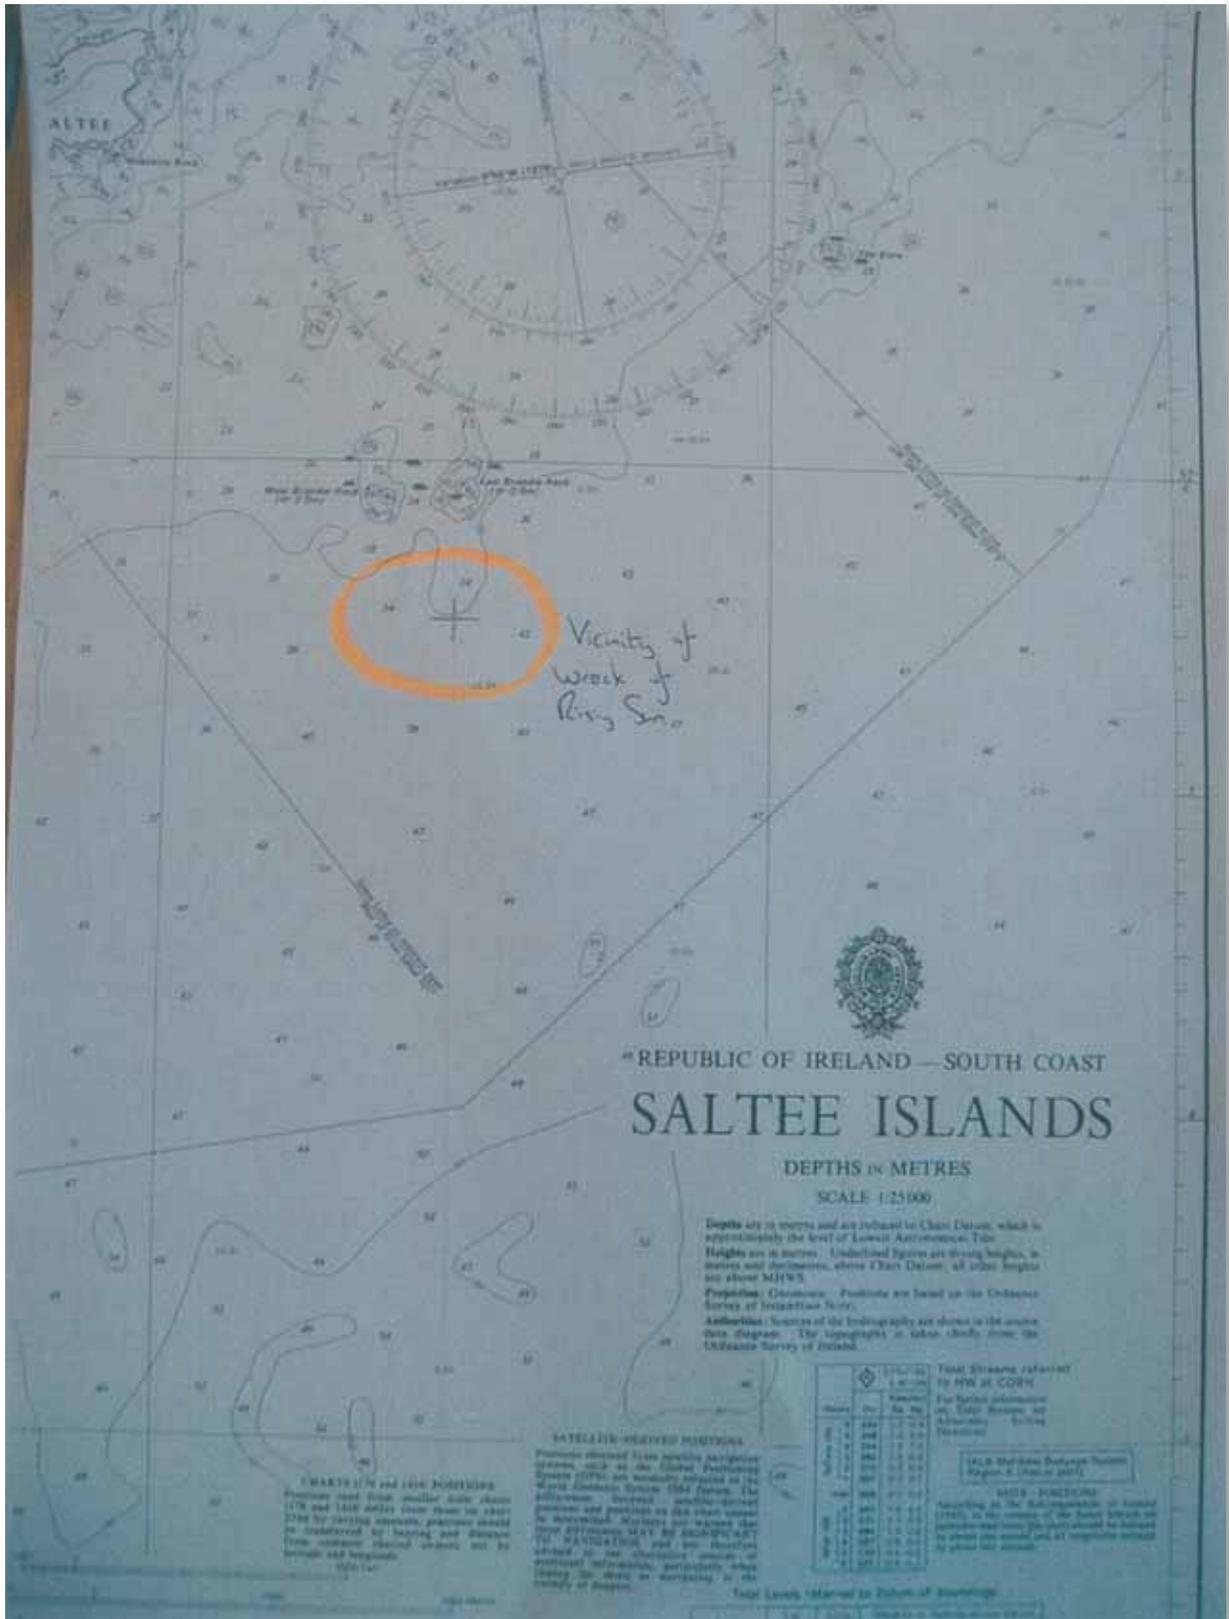
Appendix 9.7 Chart Extract showing the position of the wreck

- 5.4 The search for the missing skipper, Pat Colfer continued through the night and for several days thereafter, but the skipper was not found. The position of the wreck in the vicinity of 52° 05.5 N 006° 34.56 W was signalled by the appearance of a slick and debris on the morning of the 30th November and was confirmed by the Naval Service Diving Unit later that day. (see Fig 9.7)
