**INVESTIGATION INTO AN
INCIDENT ONBOARD THE FV
"RÓISE CATRÍONA" OFF THE
COAST OF CORK, RESULTING
IN THE DEATH OF A
CREWMAN,
ON THE 8th MAY 2008.**

REPORT No. MCIB/159

Report MCIB/159 published by The Marine Casualty Investigation Board
28th September 2009

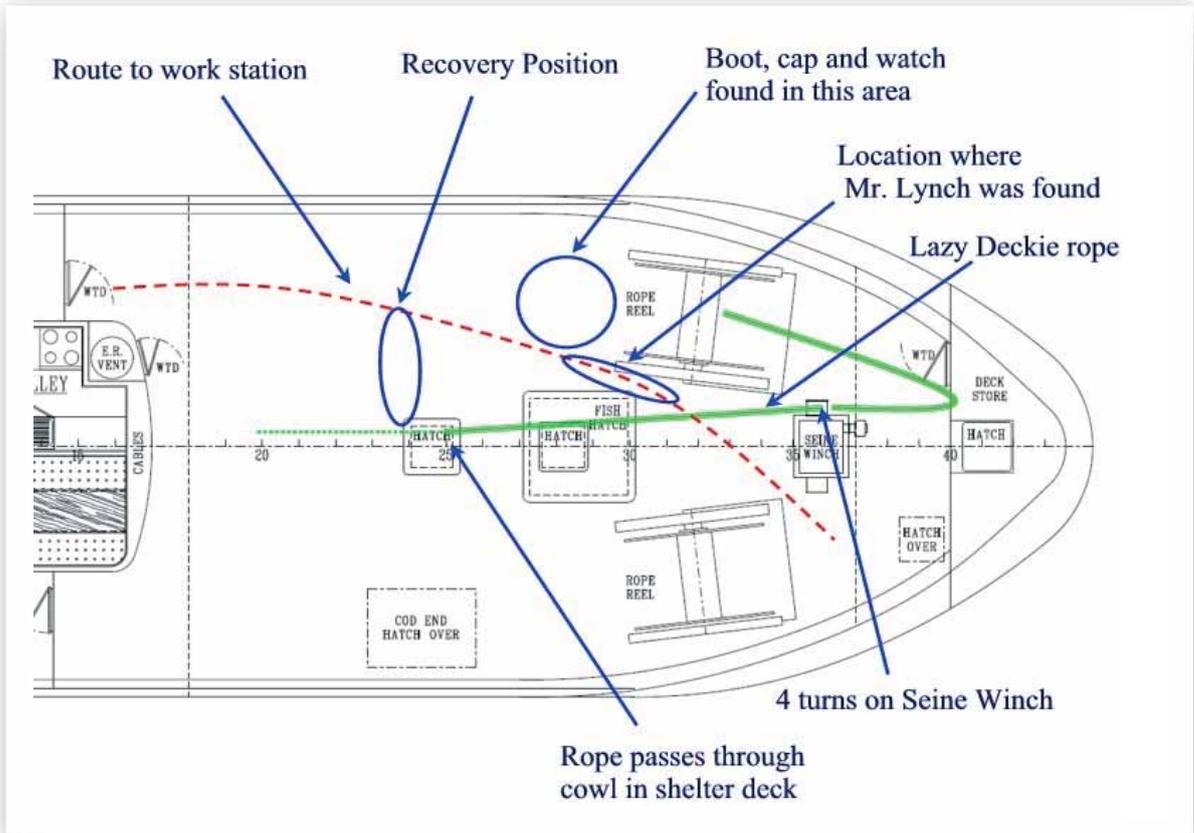
Appendix 8.3 The path most likely to have been taken by Mr. Lynch.

- 3.4 The gear on the port side was shot first, Mr. Lynch then proceeded into the shelter deck to connect up the gear on the starboard side. The path most likely to have been taken by Mr. Lynch is shown in the diagram in Appendix 8.3.

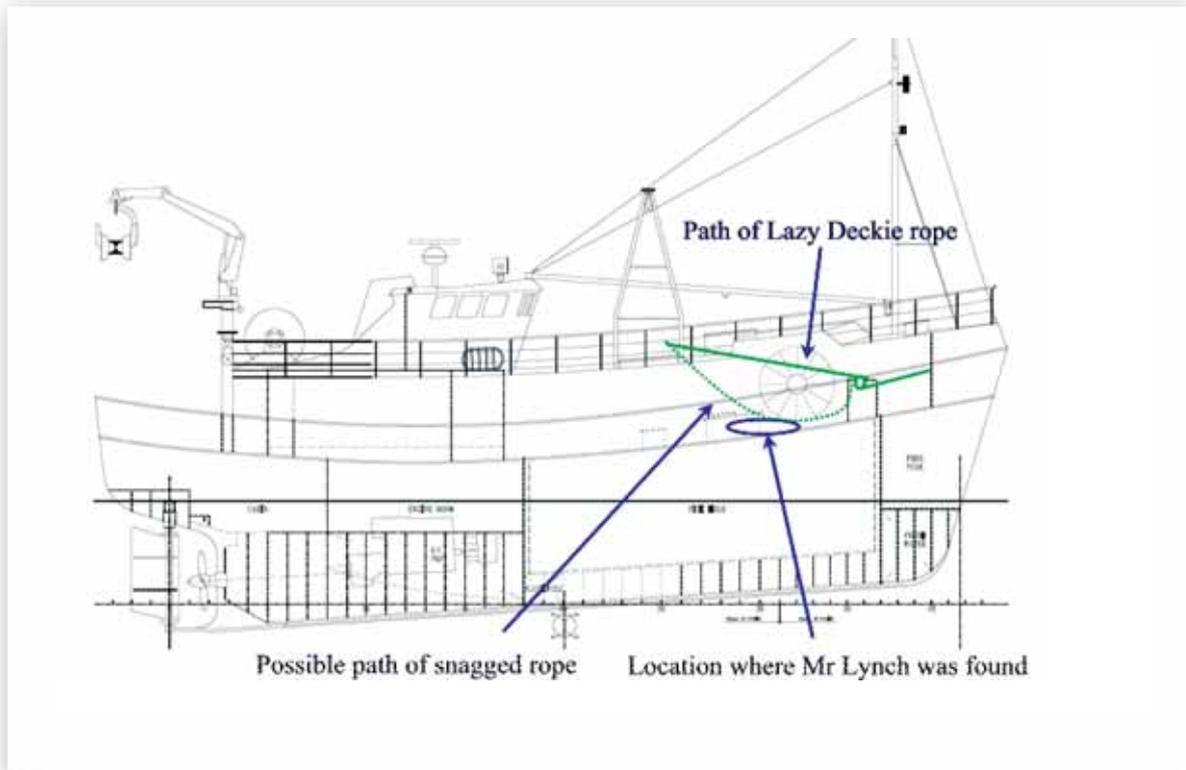
Appendix 8.4 Shelter Deck Space.

- 6.5 Given the area where Mr. Lynch was found, consideration has been given to the possibility that the lazy deckie rope, which was leading from the capstan out the cowl in the top of the shelter deck, became snagged on the fish hold hatch. The rope may have either freed itself as Mr. Lynch came past it on his way to the starboard workstation or Mr. Lynch may have attempted to clear the rope.

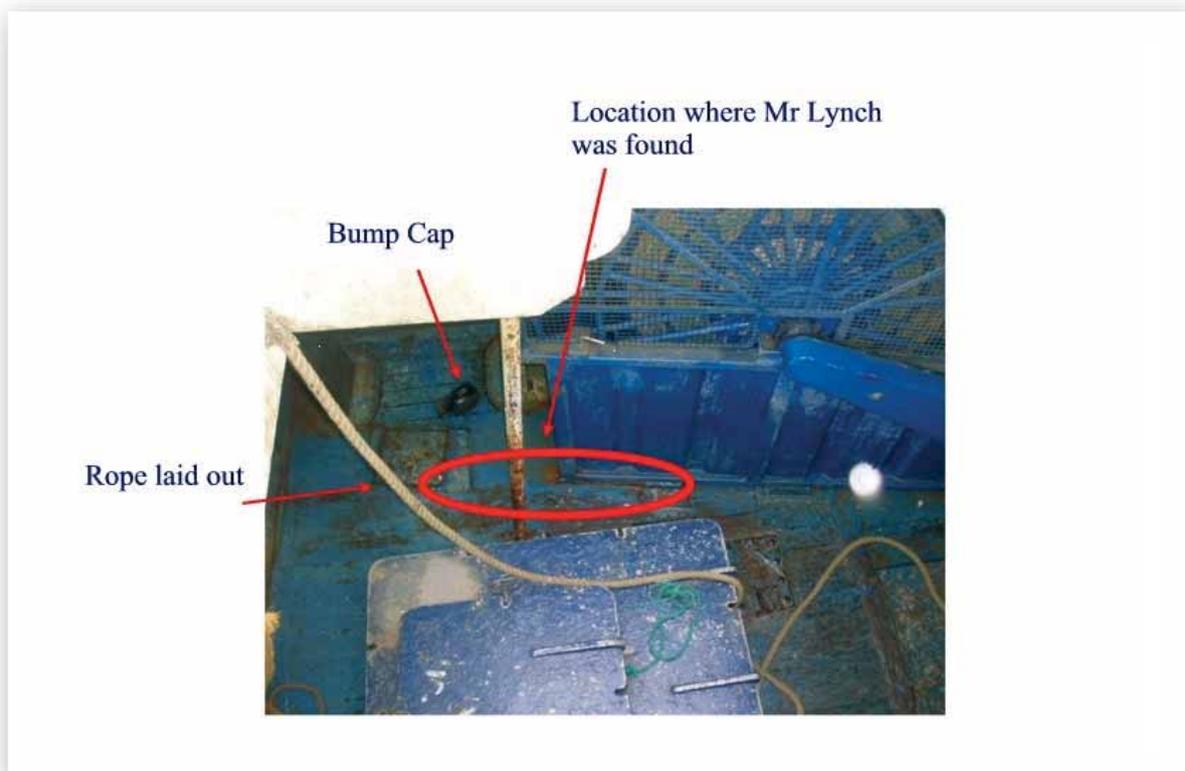
Appendix 8.5 Location where Mr. Lynch was found.

- 5.7 Crewmembers showed the location where Mr. Lynch was found. Adjacent to the area was a wristwatch (with broken strap) a right shoe and a bump cap (light duty head protection). There were items associated with first aid treatment in the area adjacent to the recovery position.

- 6.3 The location where Mr. Lynch was discovered, between the port reel and the supporting stanchion has very little clearance for a man of Mr. Lynch's height and build. It is considered probable that he was standing at, or very close to this location at the time of the accident.

- 6.6 The injury may have been caused by the direct impact of the rope as it sprung into its normal leading direction or by Mr. Lynch kicking the rope and the resultant spring in the rope as it came free caused Mr. Lynch to be thrown forcefully backward and striking his head against the port rope reel frame.
