**REPORT OF THE
INVESTIGATION INTO THE
GROUNDING OF THE MALTA
REGISTERED CAR CARRIER
"SEA HAMEX" AT ROSSLARE
EUROPORT, CO. WEXFORD ON
28TH JANUARY 2003.**

The Marine Casualty Investigation Board was established on the 23rd, May 2002 under The Merchant Shipping (Investigation of Marine Casualties) Act 2000

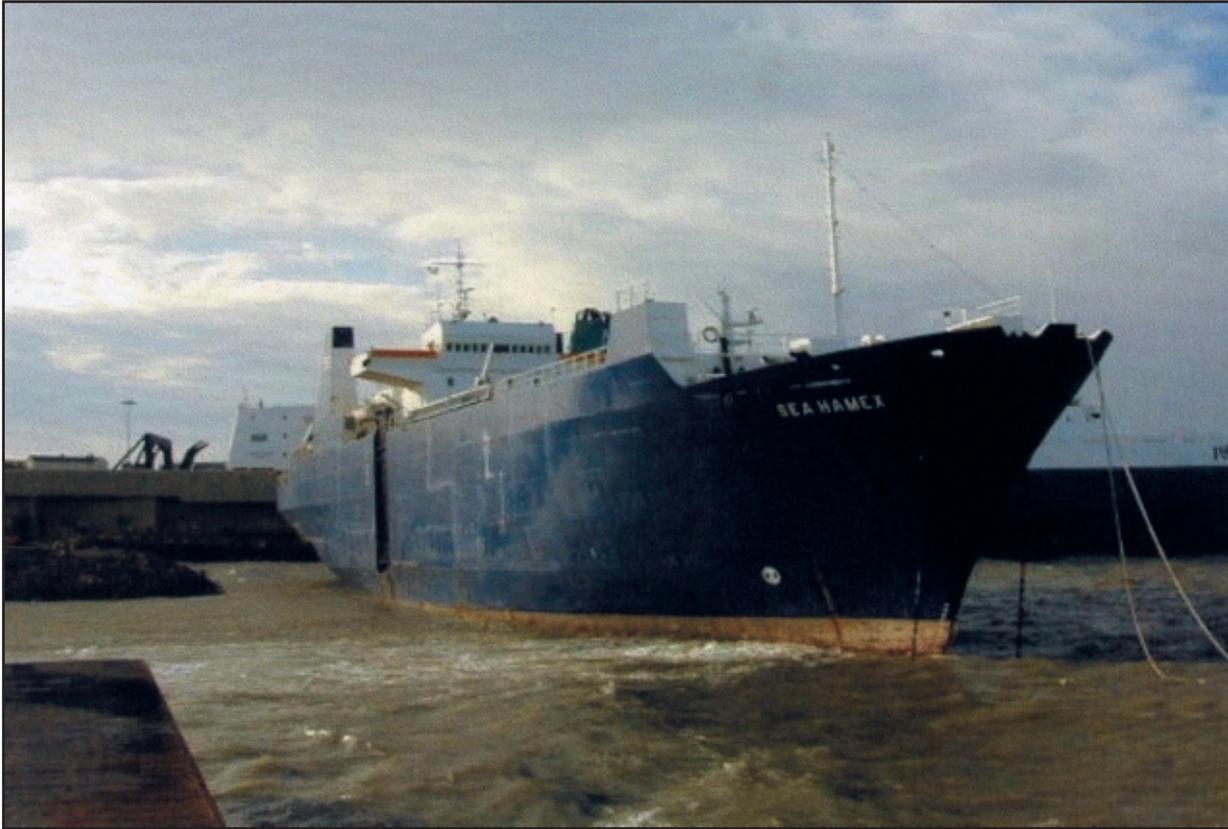
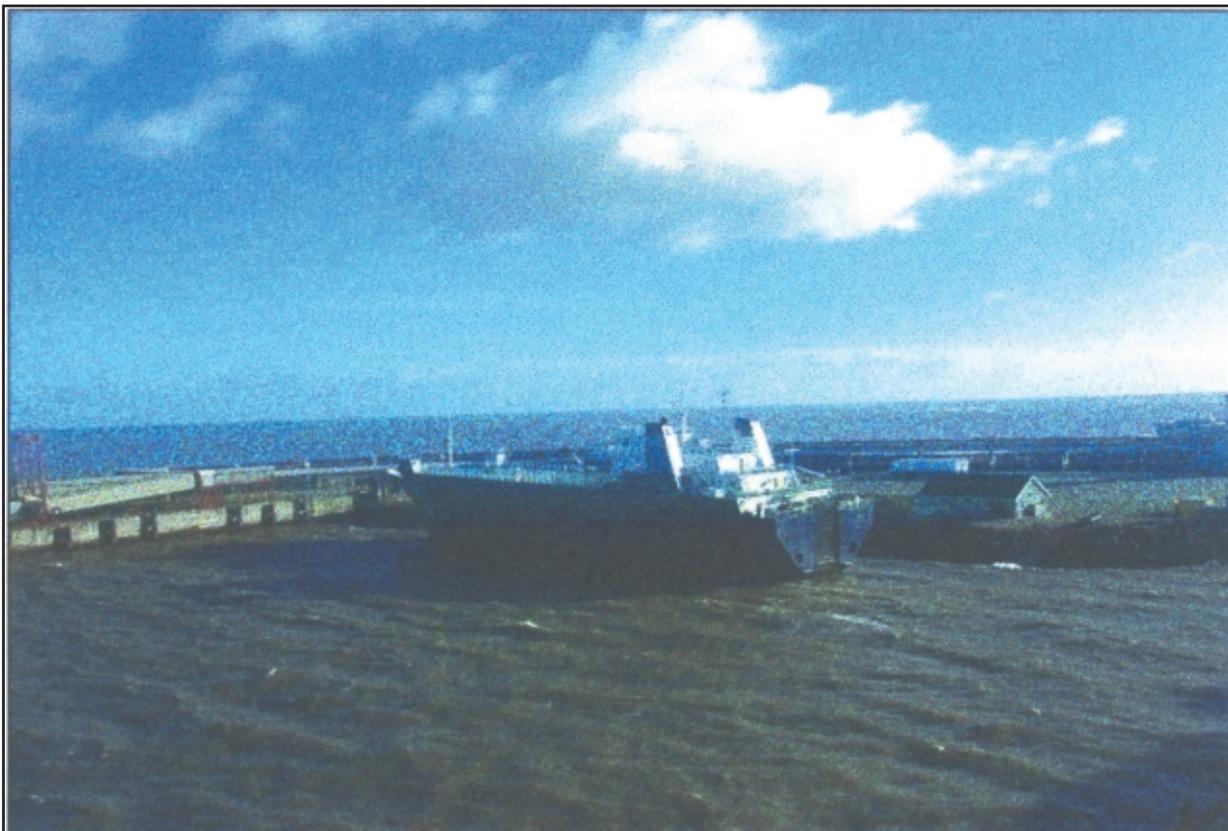
9.4 Photographs showing the "Sea Hamex" aground in Rosslare Europort.

- 4.2 After clearing the "European Diplomat" on Berth 2, the Master of the "Sea Hamex" did drop the anchors. This was intended to stop the drift of the bow. It would appear that the first anchor was dropped before the vessel grounded and the second anchor was dropped around the time of grounding. The position of grounding at 1112 hours is indicated on the Rosslare Europort chart extract. The vessel grounded on the starboard quarter. The photographs in Appendix 9.4 show the vessel aground.
