**REPORT OF THE
INVESTIGATION INTO THE LOSS
OF THE "SEA SWALLOW"
ON 27TH JULY 2001.**

The Marine Casualty Investigation Board was established on the 5th, June 2002 under The Merchant Shipping (Investigation of Marine Casualties) Act 2000

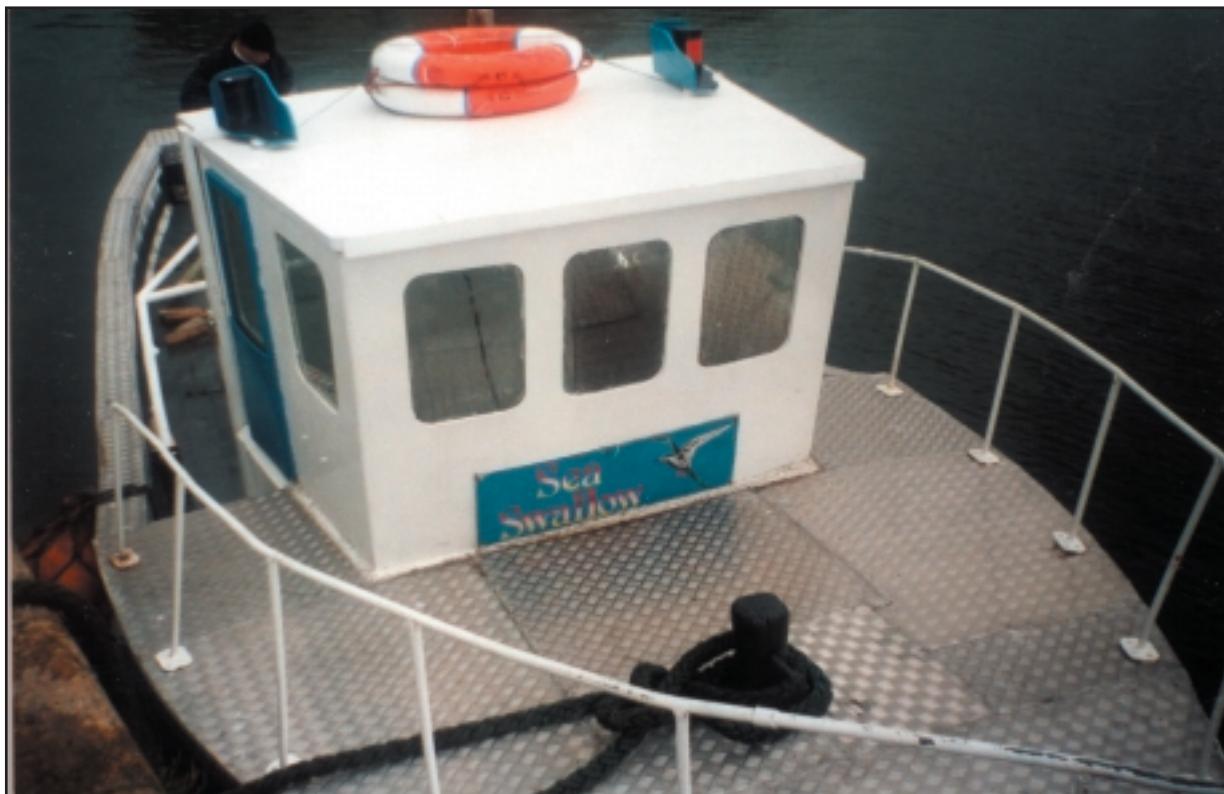
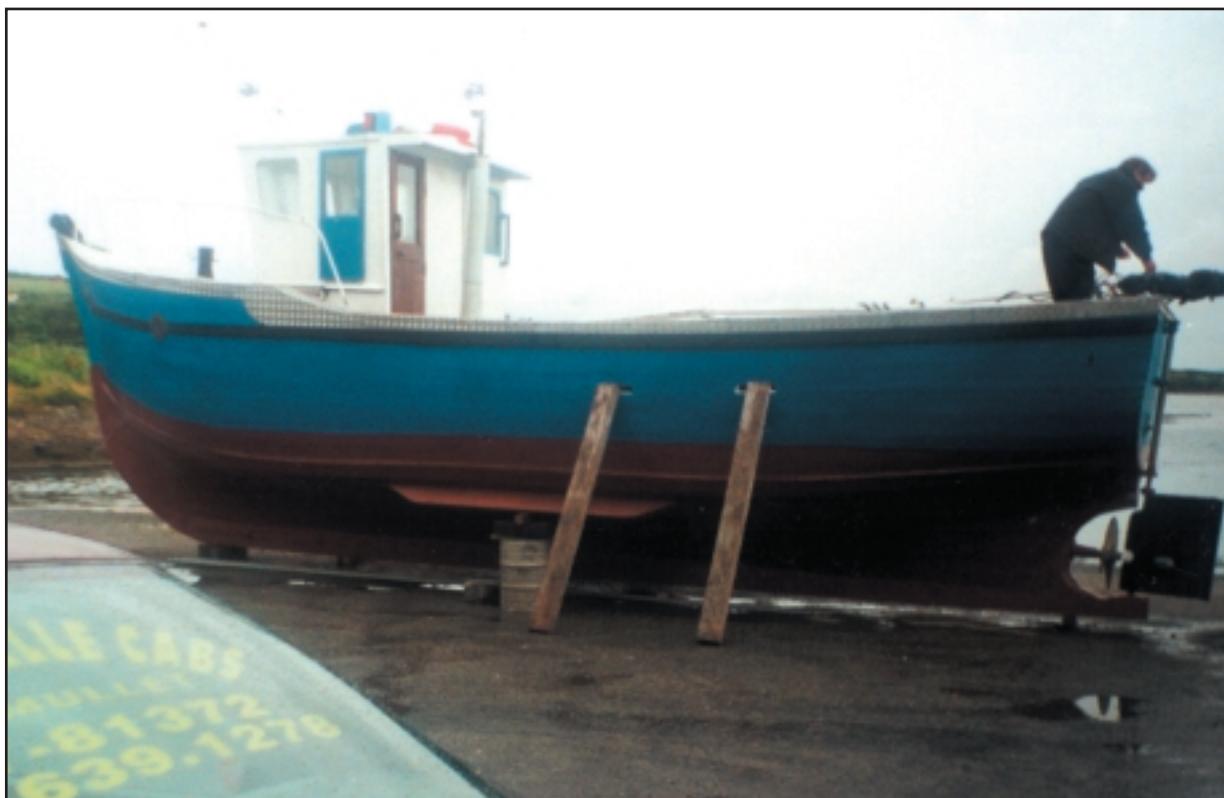
8.1 Photographs of the "Sea Swallow"

Photographs of the "Sea Swallow" in the weeks immediately prior to the casualty are shown in the appendix 8.1.
