**REPORT OF THE
INVESTIGATION INTO
THE DROWNING INCIDENT
AT SHEEP HAVEN BAY,
CO. DONEGAL
ON 3RD MAY, 2004.**

The Marine Casualty Investigation Board was established on the 25th March, 2003 under The Merchant Shipping (Investigation of Marine Casualties) Act 2000

Published by The Marine Casualty Investigation Board
18th April 2005

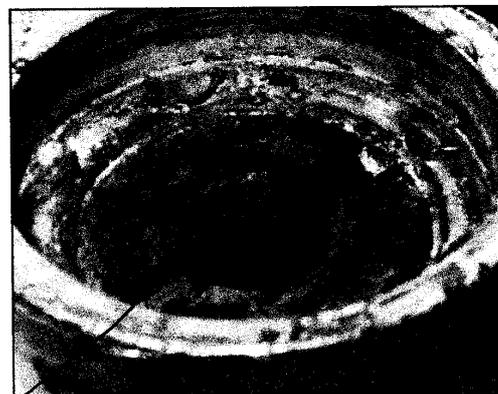
Photograph 04

Example of bushing flush with hub.
