**REPORT OF THE
INVESTIGATION INTO THE
GROUNDING OF THE BARGE
"SKERCHI" AT BRAY HARBOUR,
CO. WICKLOW ON
03 APRIL 2000.**

The Marine Casualty Investigation Board was established on the 5th, June 2002 under The Merchant Shipping (Investigation of Marine Casualties) Act 2000

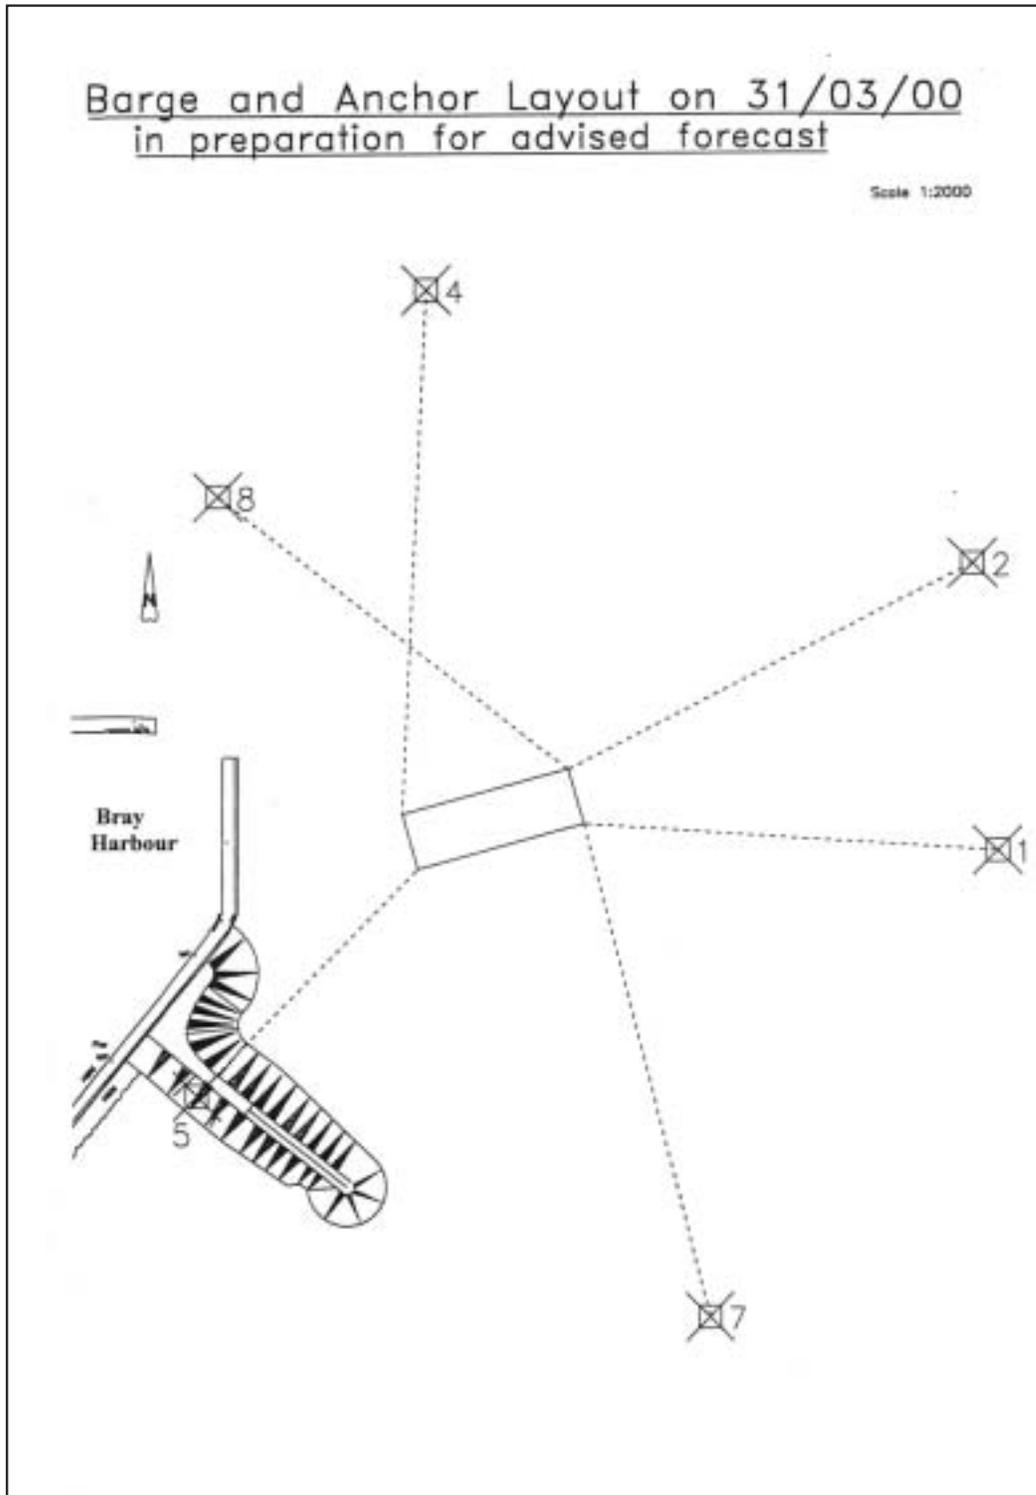
8.4. Barge and anchor layout on 31 March 2000 in preparation for advised forecast.

- 3.2 On Friday 31st March 2000, the Barge Master Mr Ari de Bilde stated that there were no gales in the 5 day forecast. See Appendix 3.
- 3.3 The Barge Master considered normal mooring of the barge to be sufficient for the weekend. The barge was secured 100 metres off shore with the anchor layout as given in Appendix 4. Anchors 1 and 2 were chain stoppered off to take the strain off the winches.

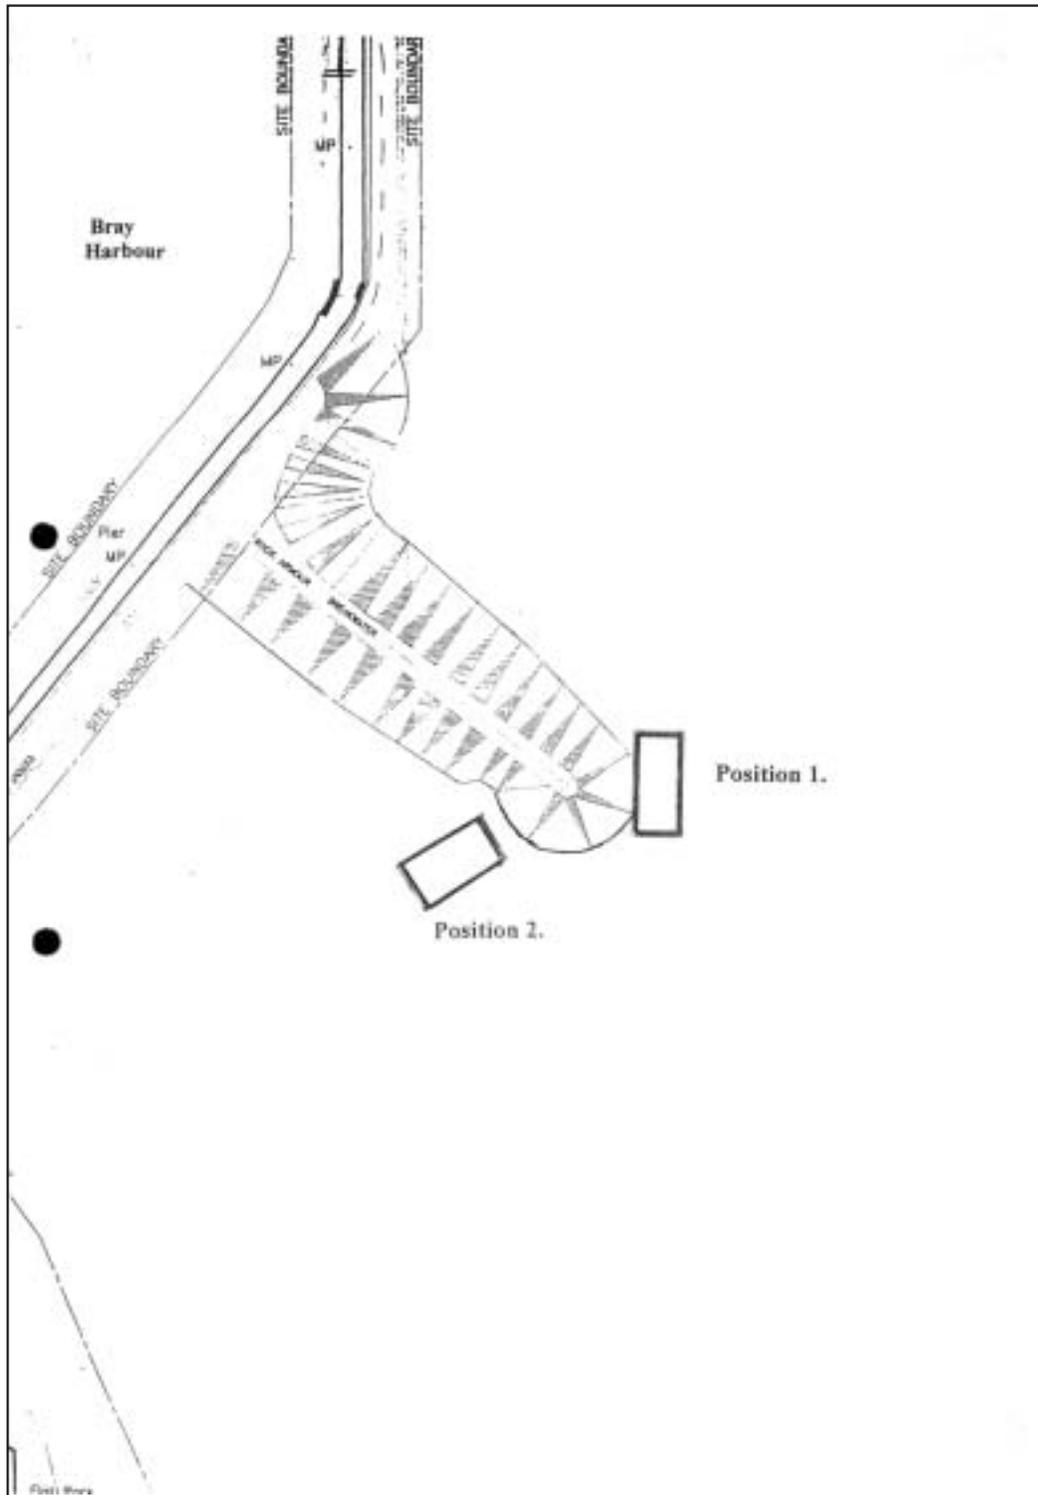
8.5. Different barge positions during 03 April 2000.

Early on the 03 April 2000, the barge grounded on the end of the rock armour breakwater attached to the seaward side of the South Pier. The barge finally came to a rest position on the beach side of the rock armour.

- 4.1 At 0630 hours on Monday 3rd April 2000, when an Ascon employee arrived on site to inspect the barge, he observed that it had moved from its anchored position. The Barge Master and various Ascon personnel were contacted. When these arrived on site, shortly after 0900 hours, they found the barge in Position 1 as shown in Appendix 5.

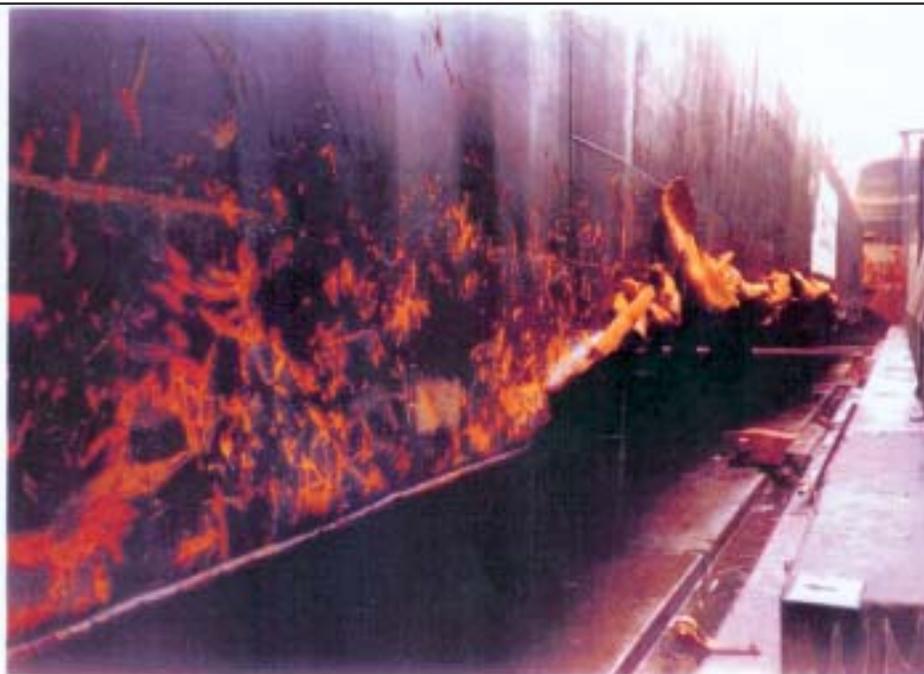
PHOTOGRAPH NO. 1 SIDE SHELL

- 5.5 The barge "Skерchi" was secured ashore to prevent unwanted movement to sea and ashore watch maintained by Ascon personnel.
- 5.6 The "Skерchi" was refloated by the tug "Vanguard" on the 5th April 2000 at about 1030 hours and was towed to Dublin Port. There was extensive hull damage to the barge as shown by the photographs in Appendix 6. Repairs to the barge were carried out in Dublin.

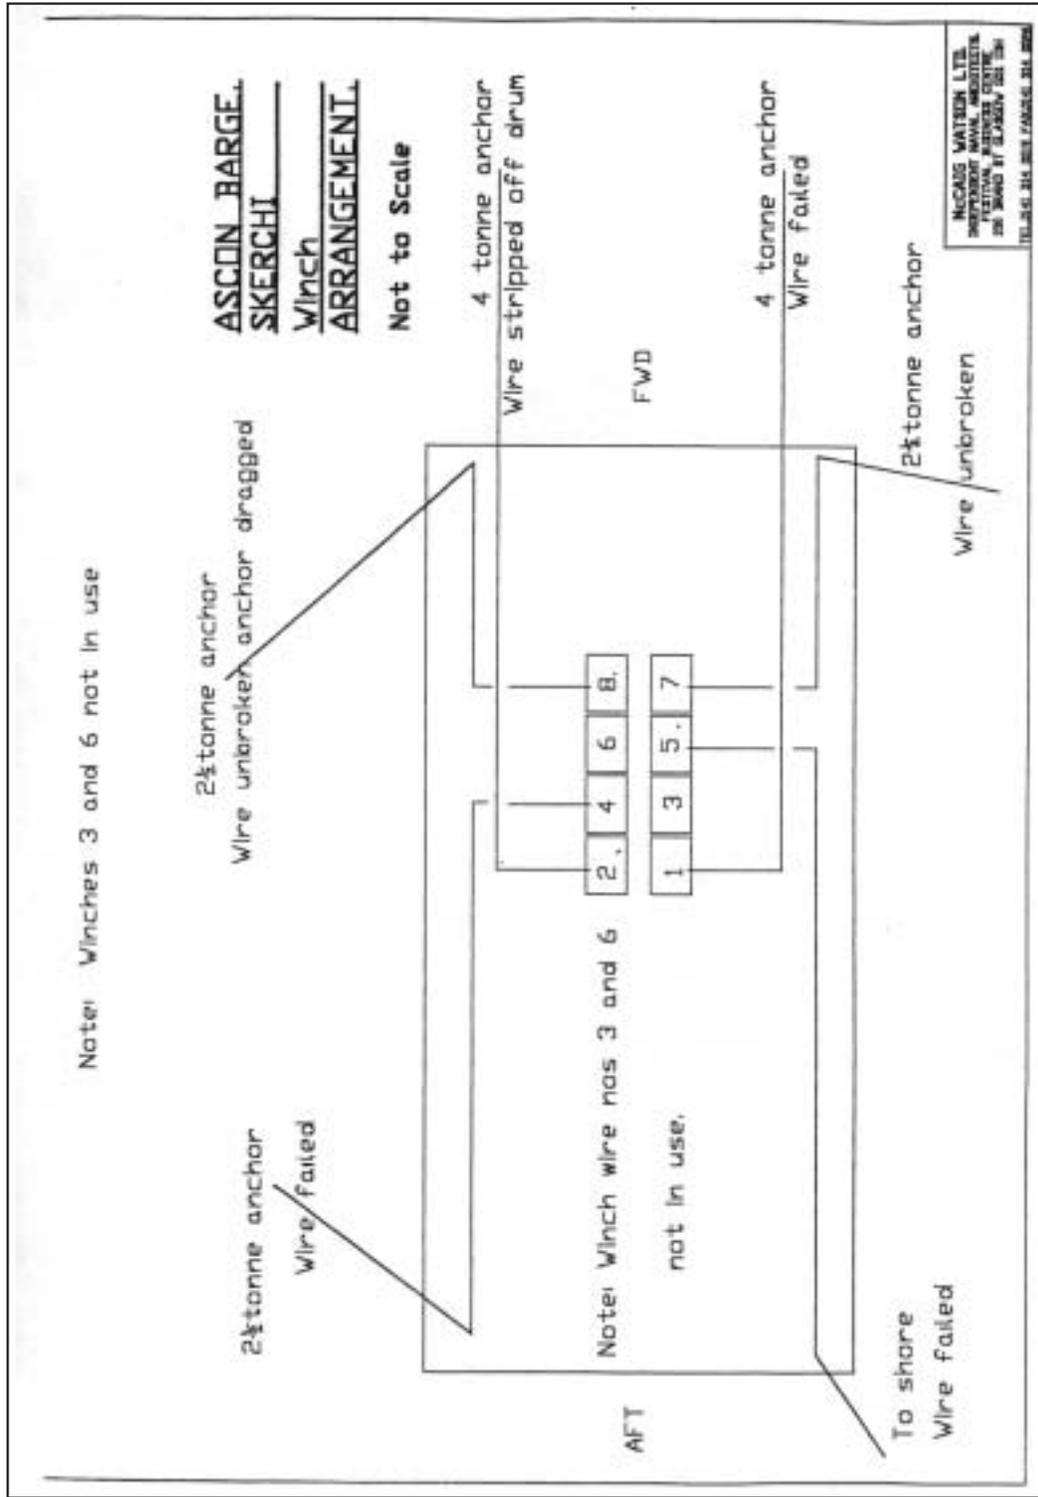
8.7. Sketch showing the anchor wire situation after the grounding.

- 6.1 After the grounding it was found that anchor wires 1,4 and 5 had broken, No 2 wire had pulled off the drum, No 7 and 8 wires were unbroken and Numbers 3 and 6 were not used. During the refloating No 7 anchor was recovered and No 8 wire was cut. A sketch shown the anchor wire situation after the grounding is given at Appendix 6.

- The ropes from winches 1 and 4 had fractured under tensile overload, the presence of shear fractures in each case being an indication that the failures most likely occurred where the ropes were bearing heavily against some other object such as a fairlead.

- The fracture of the core in the rope from winch 1 is an indication that the rope had possibly been subjected to shock loading.
 - The rope from winch 5 had suffered from severe crushing damage, which had greatly influenced the failure. It had been observed during the site visit that deep rope impressions were present in at least one of the fairleads. If this rope had been around such a fairlead, it may well account for the damage to the rope under severe load conditions.

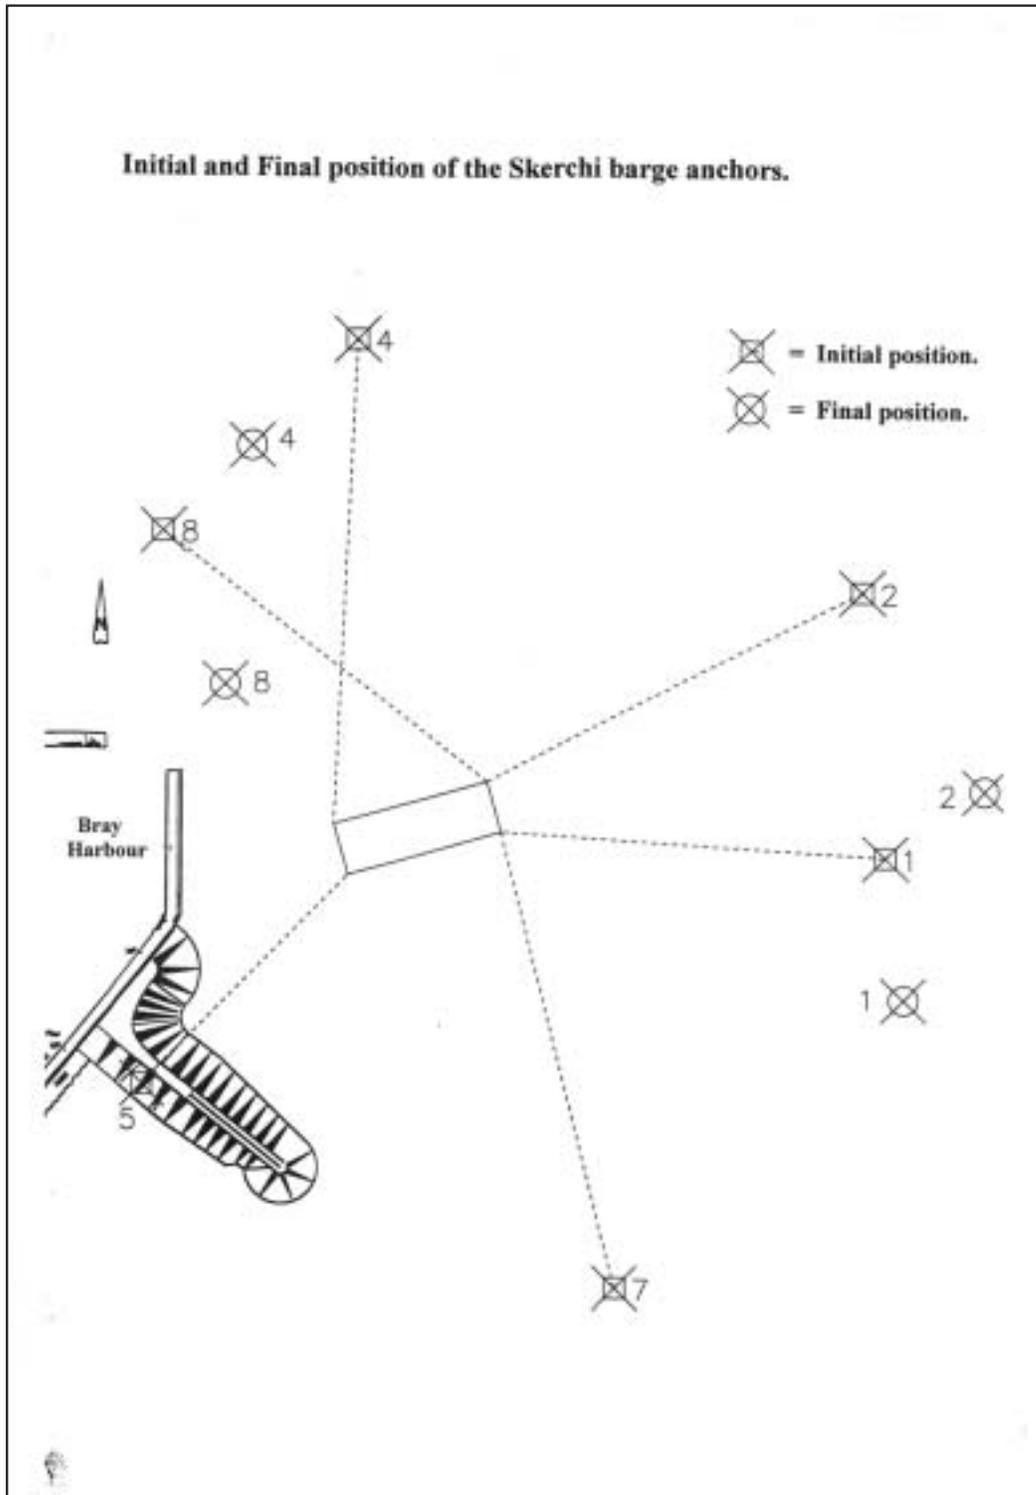
8.8. Diagram showing the initial and final positions of the anchors.

- 6.2 Anchors Nos. 1, 2, 4 and 8 were recovered from the seabed and their positions were noted. The initial and final positions of the anchors are given in Appendix 8. The anchors were found to have been dragged in a general Southerly direction.
