**REPORT OF THE
INVESTIGATION INTO
THE FIRE ONBOARD
THE "SPAILPIN FANACH"
NEAR SKELLIGS ISLAND ON
28TH SEPTEMBER 2004.**

Published by The Marine Casualty Investigation Board
31st January 2006

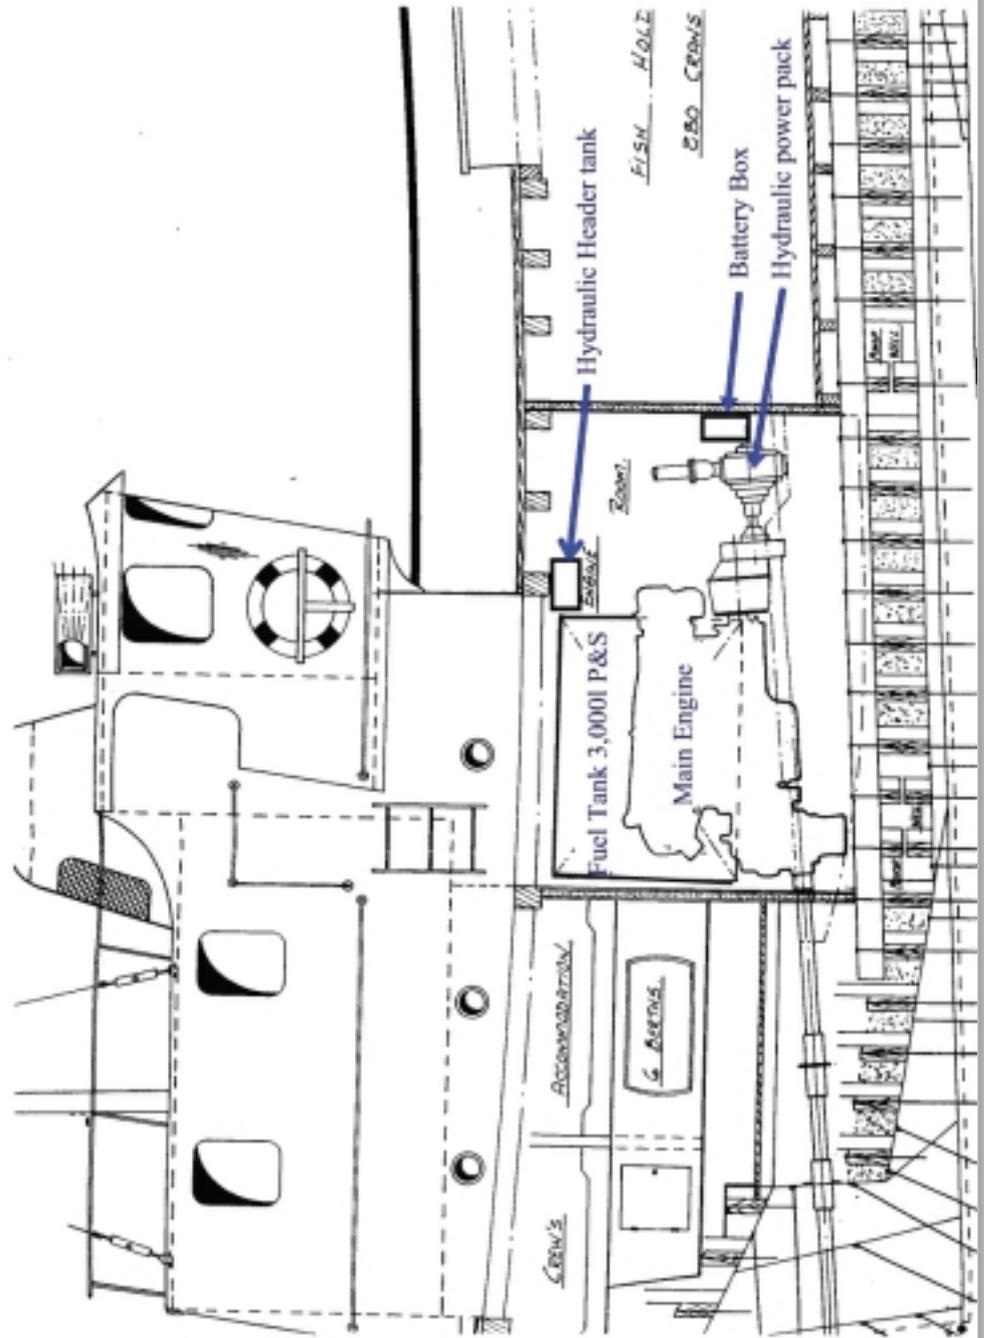
Appendix 8.6

- 6.2 The cause of the sinking was due to major ingress of seawater into the vessel through hull planking that had been burned during the fire.
- 6.3 The Skipper felt the fire was in the region of the battery box in the engine room, since the auxiliary engine (Battery Start) started while the crew were in the Liferaft it seems that the batteries were not the initial cause of the fire. Other crewmembers reported the smoke and smell as being that of burning hydraulic oil.

- 6.4 The description of the fire from accounts from the crew indicates that a hydraulic oil tank and at least one fuel tank were feeding the fire from the early stages. The absence of any significant oil slick or sheen on the water from video footage from R115 indicates that all Diesel and Lubricating oil onboard the vessel (estimated at around 2,000 litres) was consumed in the fire.

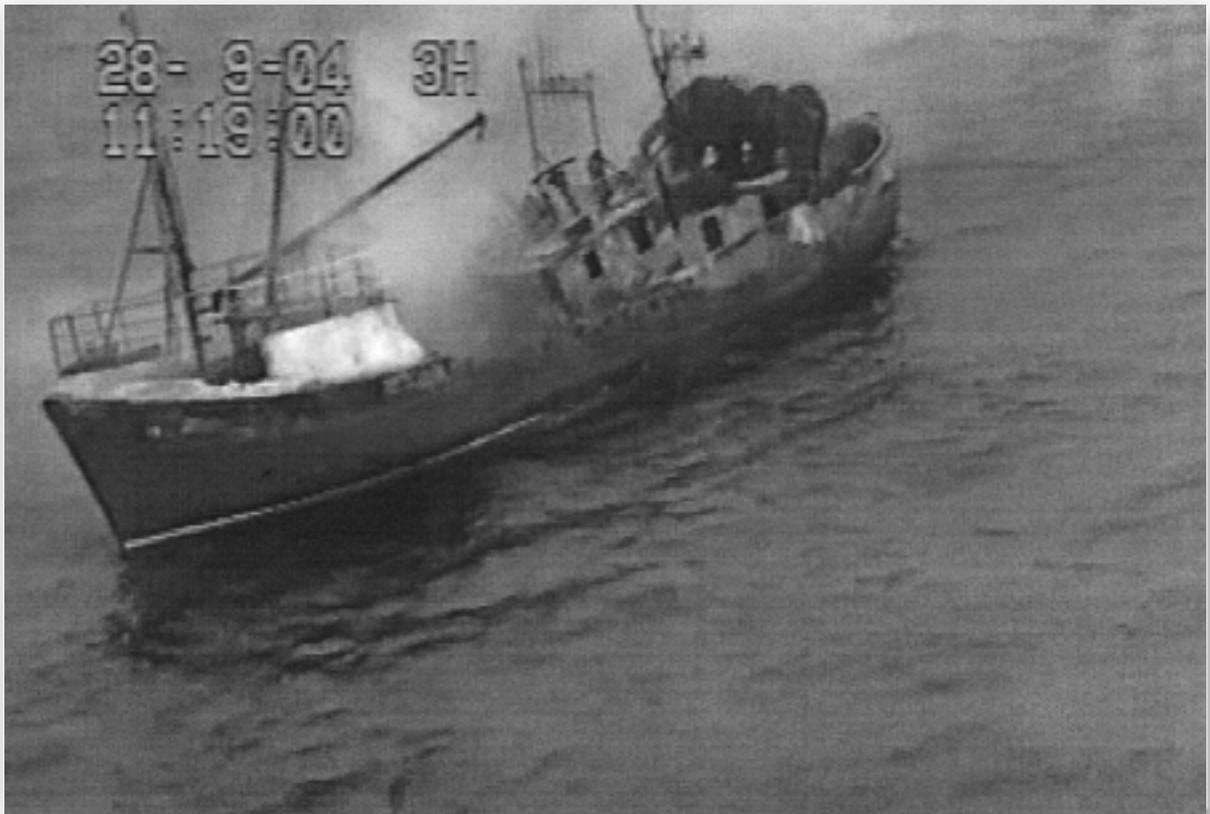
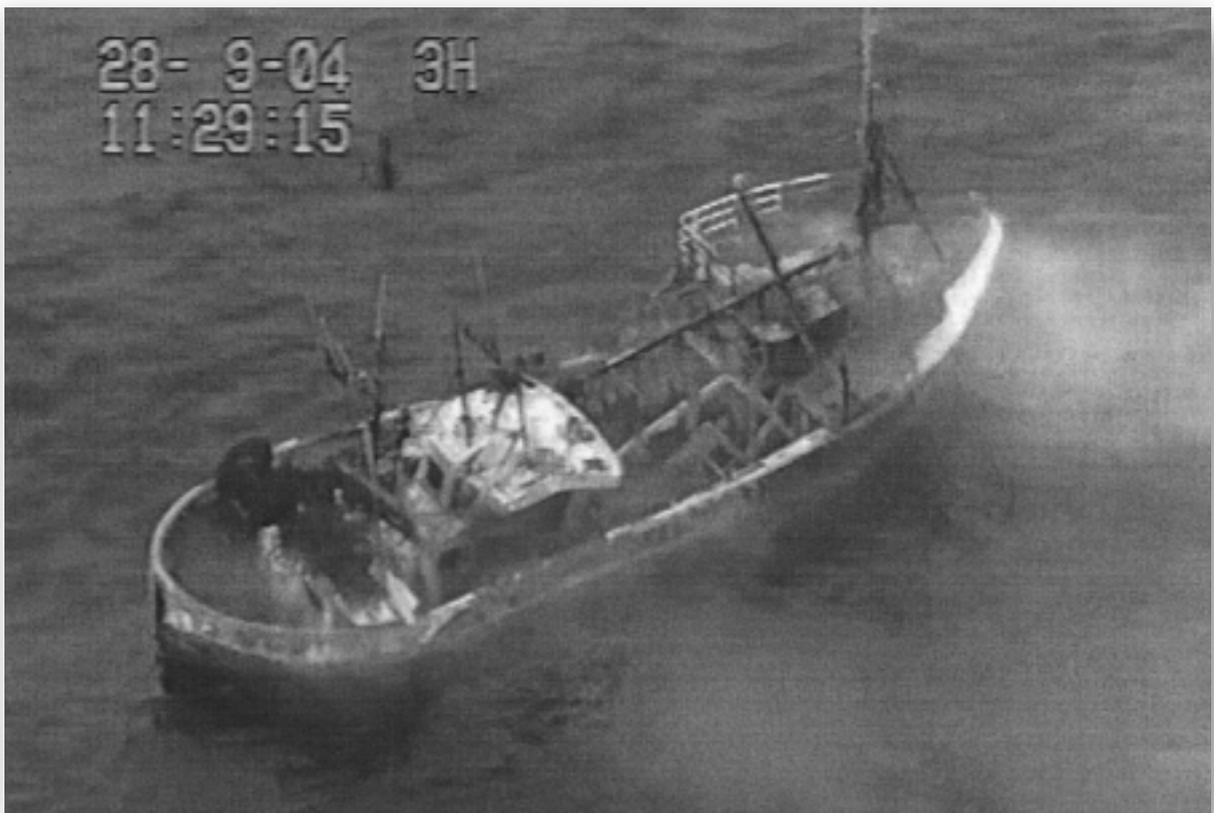
Appendix 8.8

- 5.5 Video footage shot from R115 shows the vessel wallowing heavily low in the water, the fire had almost totally consumed the internals of the vessel, the steel wheel house had distorted and buckled forward from the heat of the fire. Large sections of the aluminium whale back have been burned out. A substantial number of planks in the hull had burned through allowing water to enter the hull. (See Appendices 8.8 for video stills showing the damaged vessel).

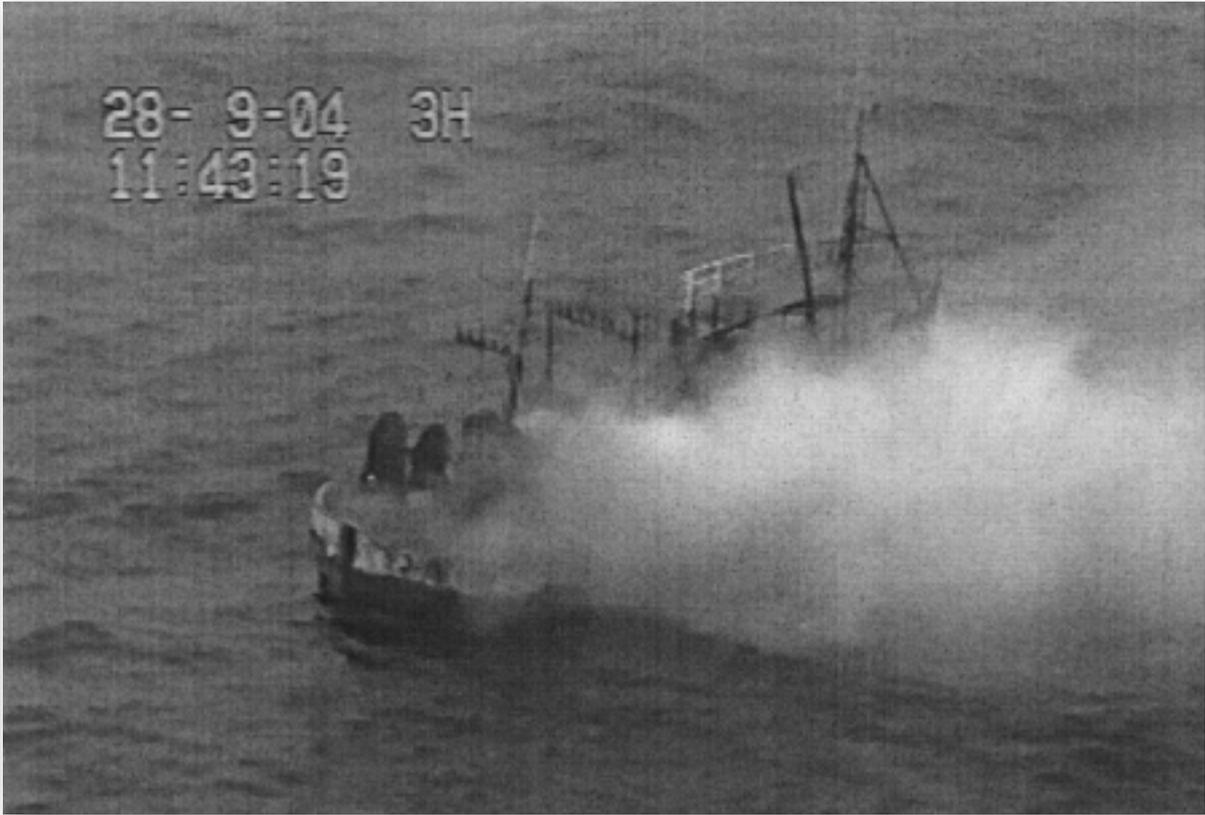
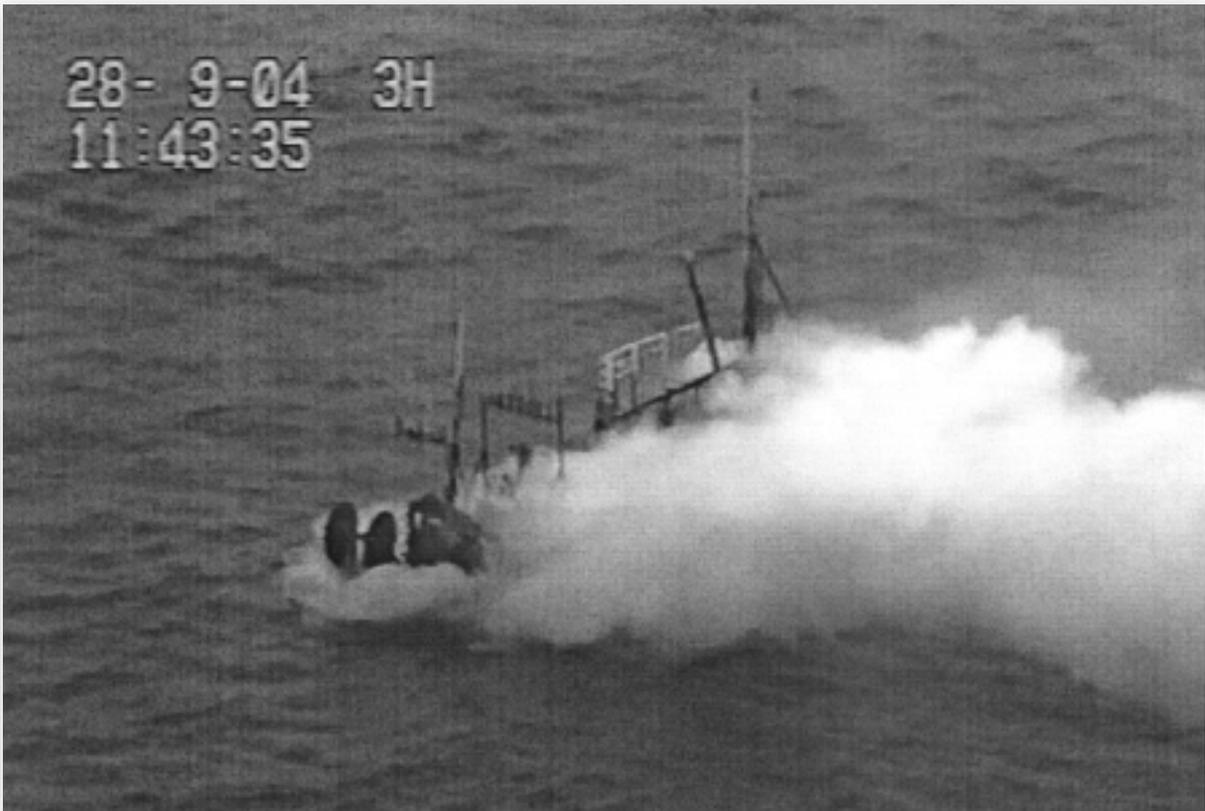
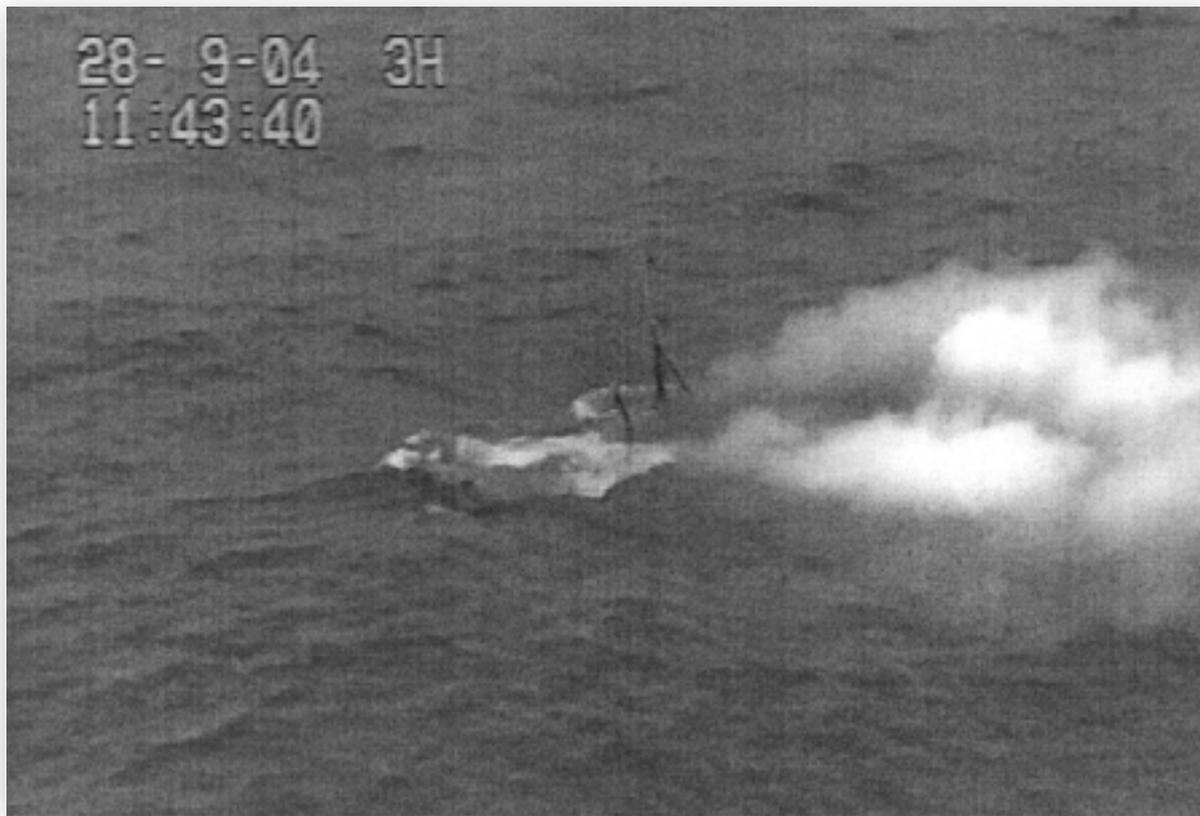
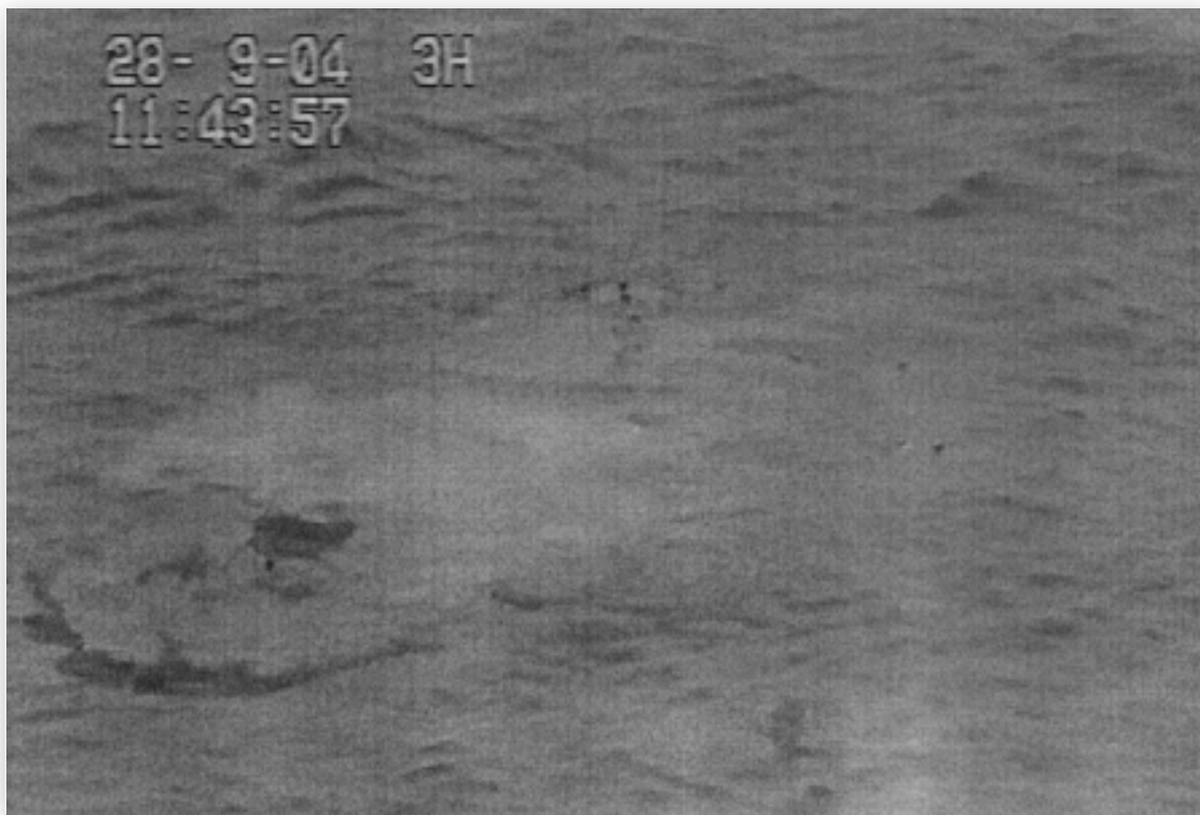
- 5.6 At 11.43 hours a large cloud of steam is seen to come from the vessel caused by a large inflow of cold seawater, the vessel sinks within a minute of this event. A small amount of bilge oil and burnt gas cylinders are floating on the surface, pollution is minimal. (See Appendix 8.9 video stills taken from R115 show the vessel sinking).
