**REPORT INTO THE FATAL
INCIDENT ON BOARD THE
ANTIGUAN AND BARBUDAN
REGISTERED VESSEL
THE MSC "SUFFOLK"
DURING BERTHING OPERATIONS
AT DUBLIN PORT
ON 5TH MARCH, 2003.**

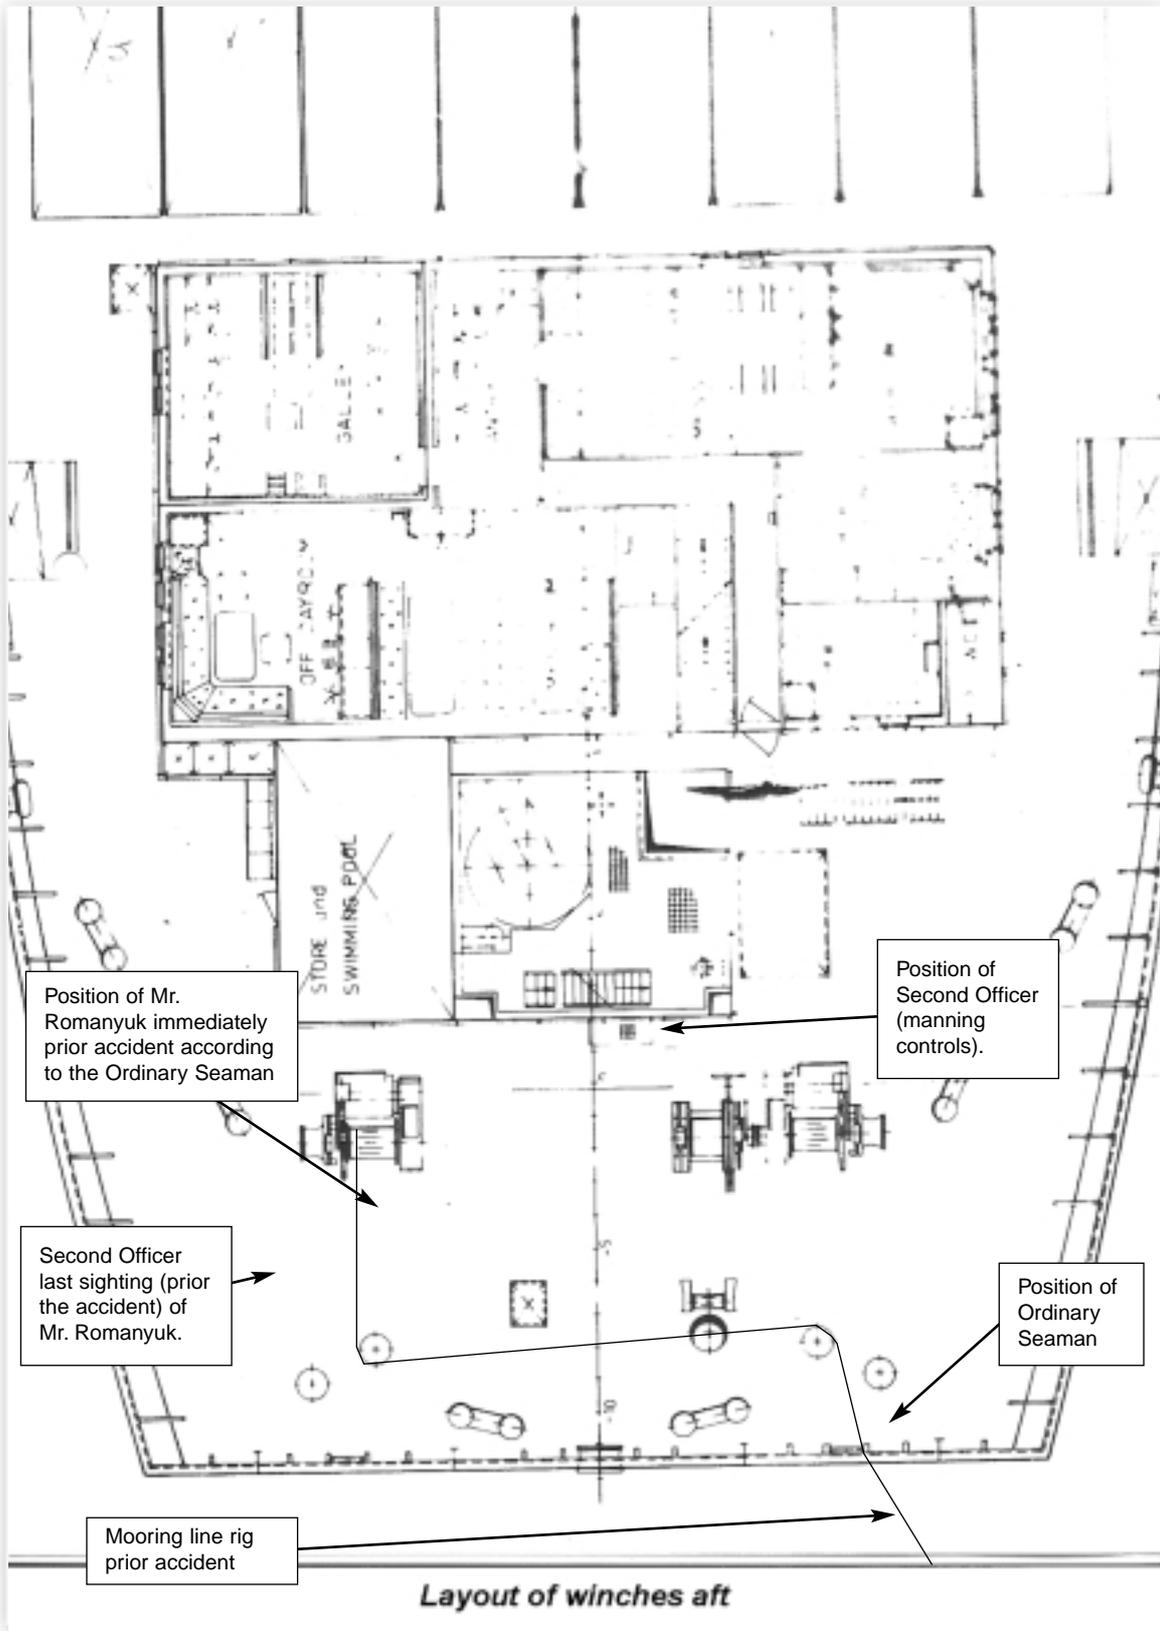
Appendix 8.1

- 6.8 The mooring arrangement on the aft deck of the MSC "Suffolk" is designed so that the mooring ropes feed onto the mooring winch drums from the underside, the roller leads are at a height above the deck which make it impractical to lead the ropes over the top of the mooring drums.

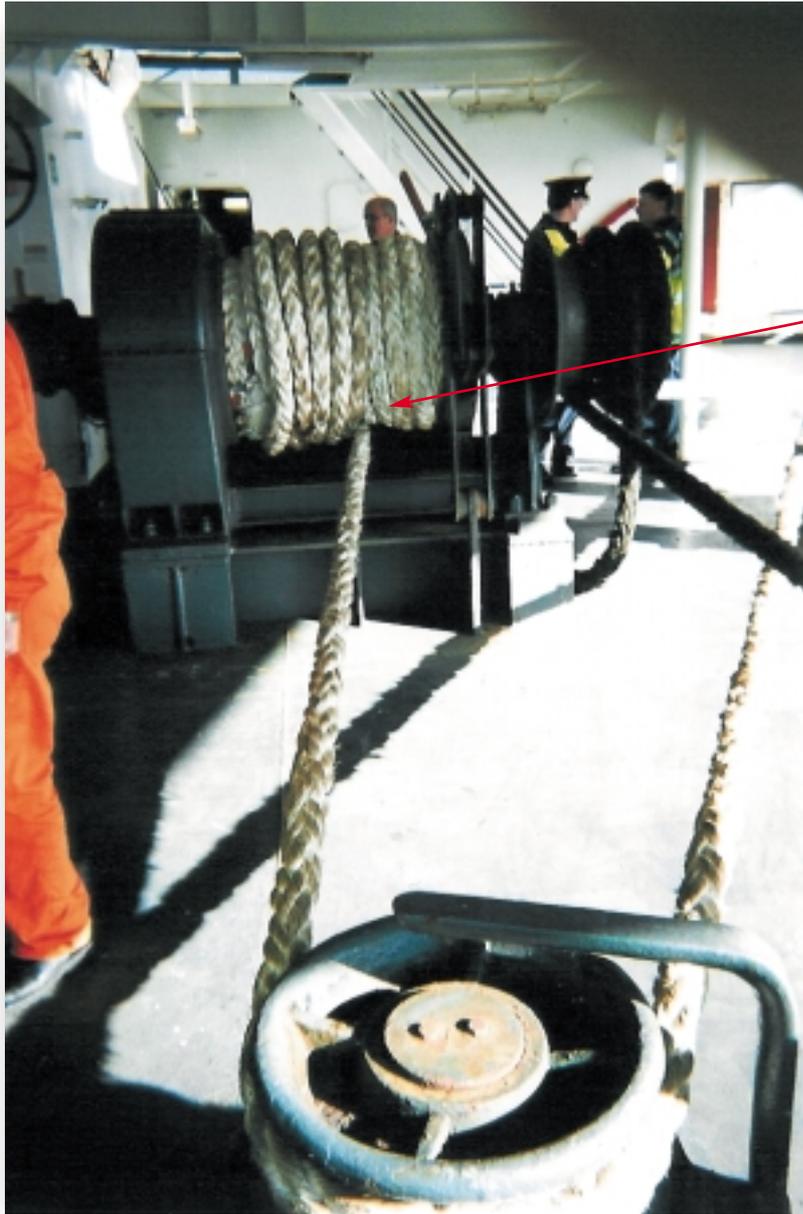
Appendix 8.2

- 6.9 On the MSC "Suffolk" there is no guard or protection to prevent a person from being dragged underneath a mooring winch.
- 6.10 There were 14 crew on board the MSC "Suffolk" on arrival at Dublin. In addition to the deck crew there were three oilers. In the normal course of events the oilers were not utilized for mooring operations. The Minimum Safe Manning Certificate issued by the Flag State indicates that a minimum of fourteen crew are required to man this vessel. A footnote indicating special requirements clearly states that the grades and personnel listed (on the Minimum Safe Manning Document) reflect the minimum number of persons necessary for the safety of navigation and operation.

The starboard aft mooring winch was used to deploy the aft spring line. Note how the mooring rope leads from the underside of the drum.
