**REPORT OF INVESTIGATION INTO
THE SINKING OF THE
MFV "TIT BONHOMME",
NEAR GLANDORE HARBOUR,
WEST CORK
ON
15th JANUARY 2012**

**REPORT No. MCIB/210
(No.5 of 2013)**

Report MCIB/210 published by The Marine Casualty Investigation Board
Printed 27th March 2013.

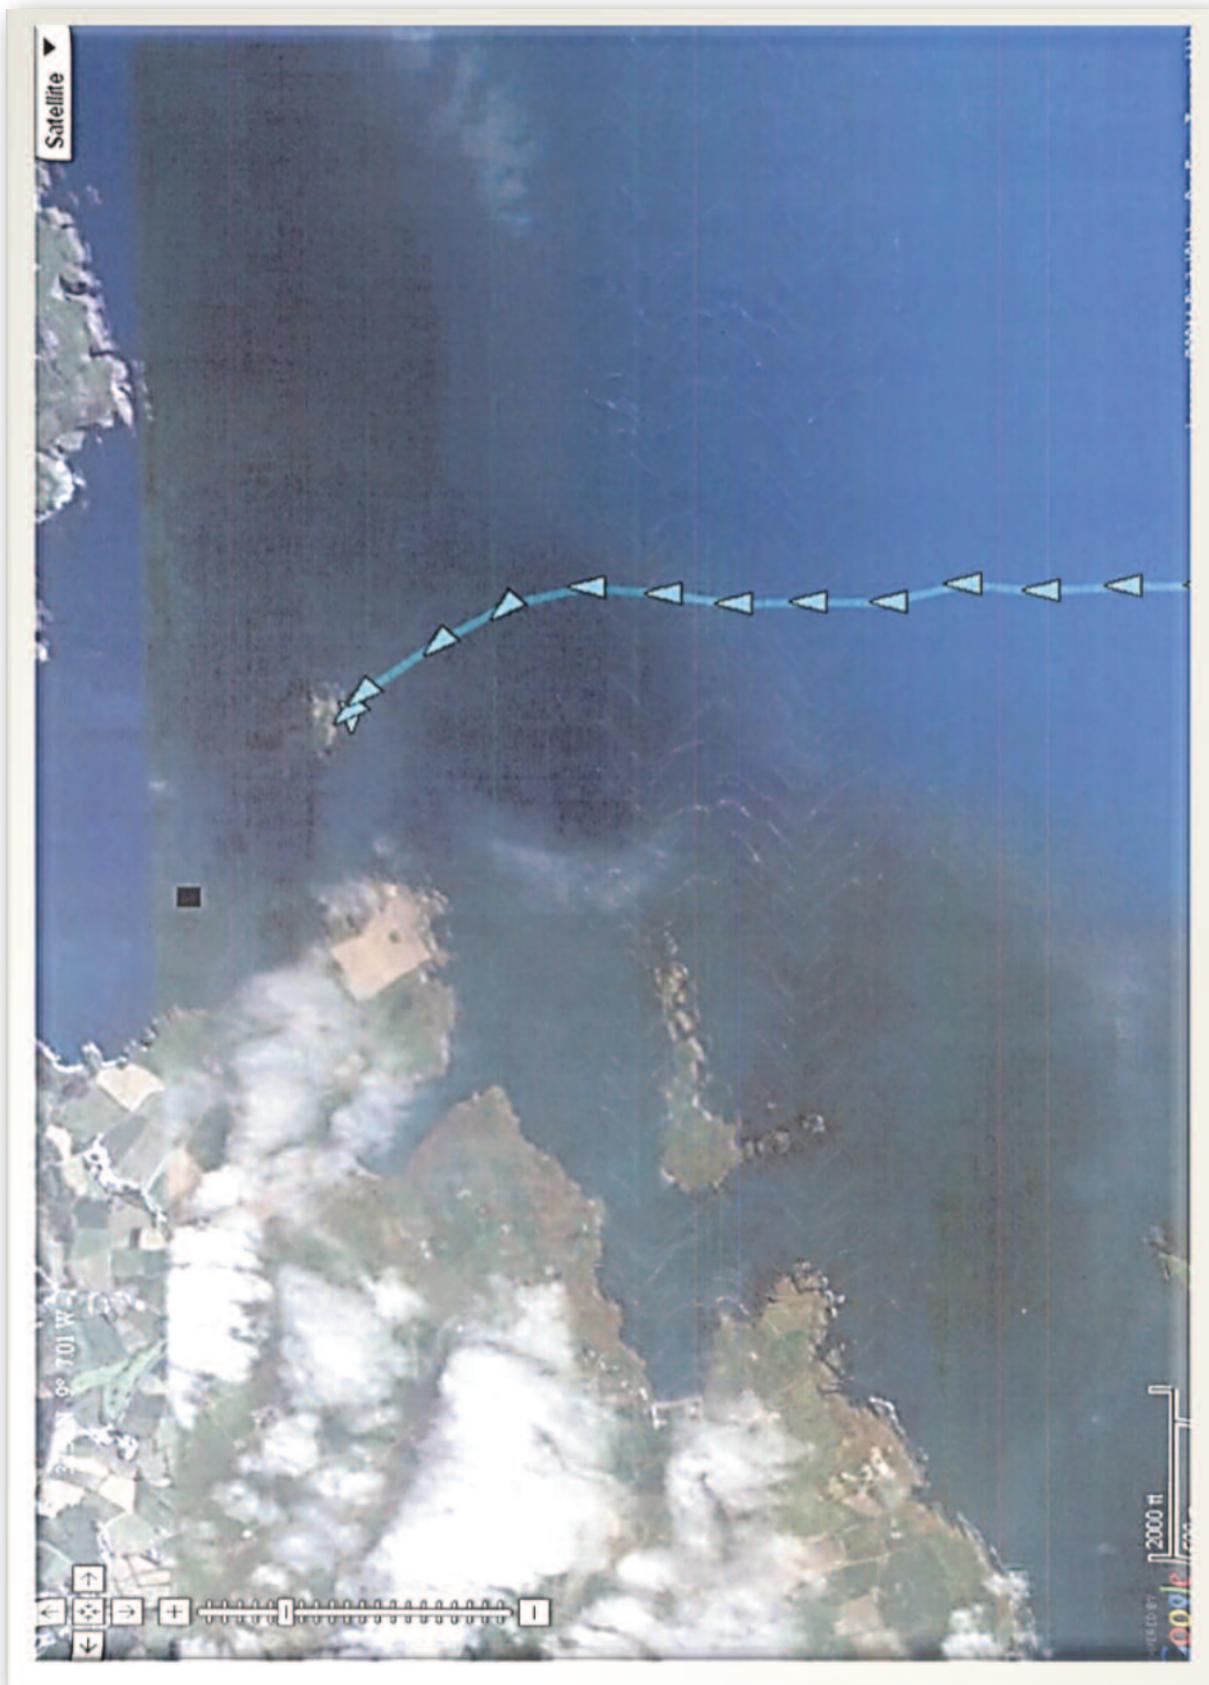
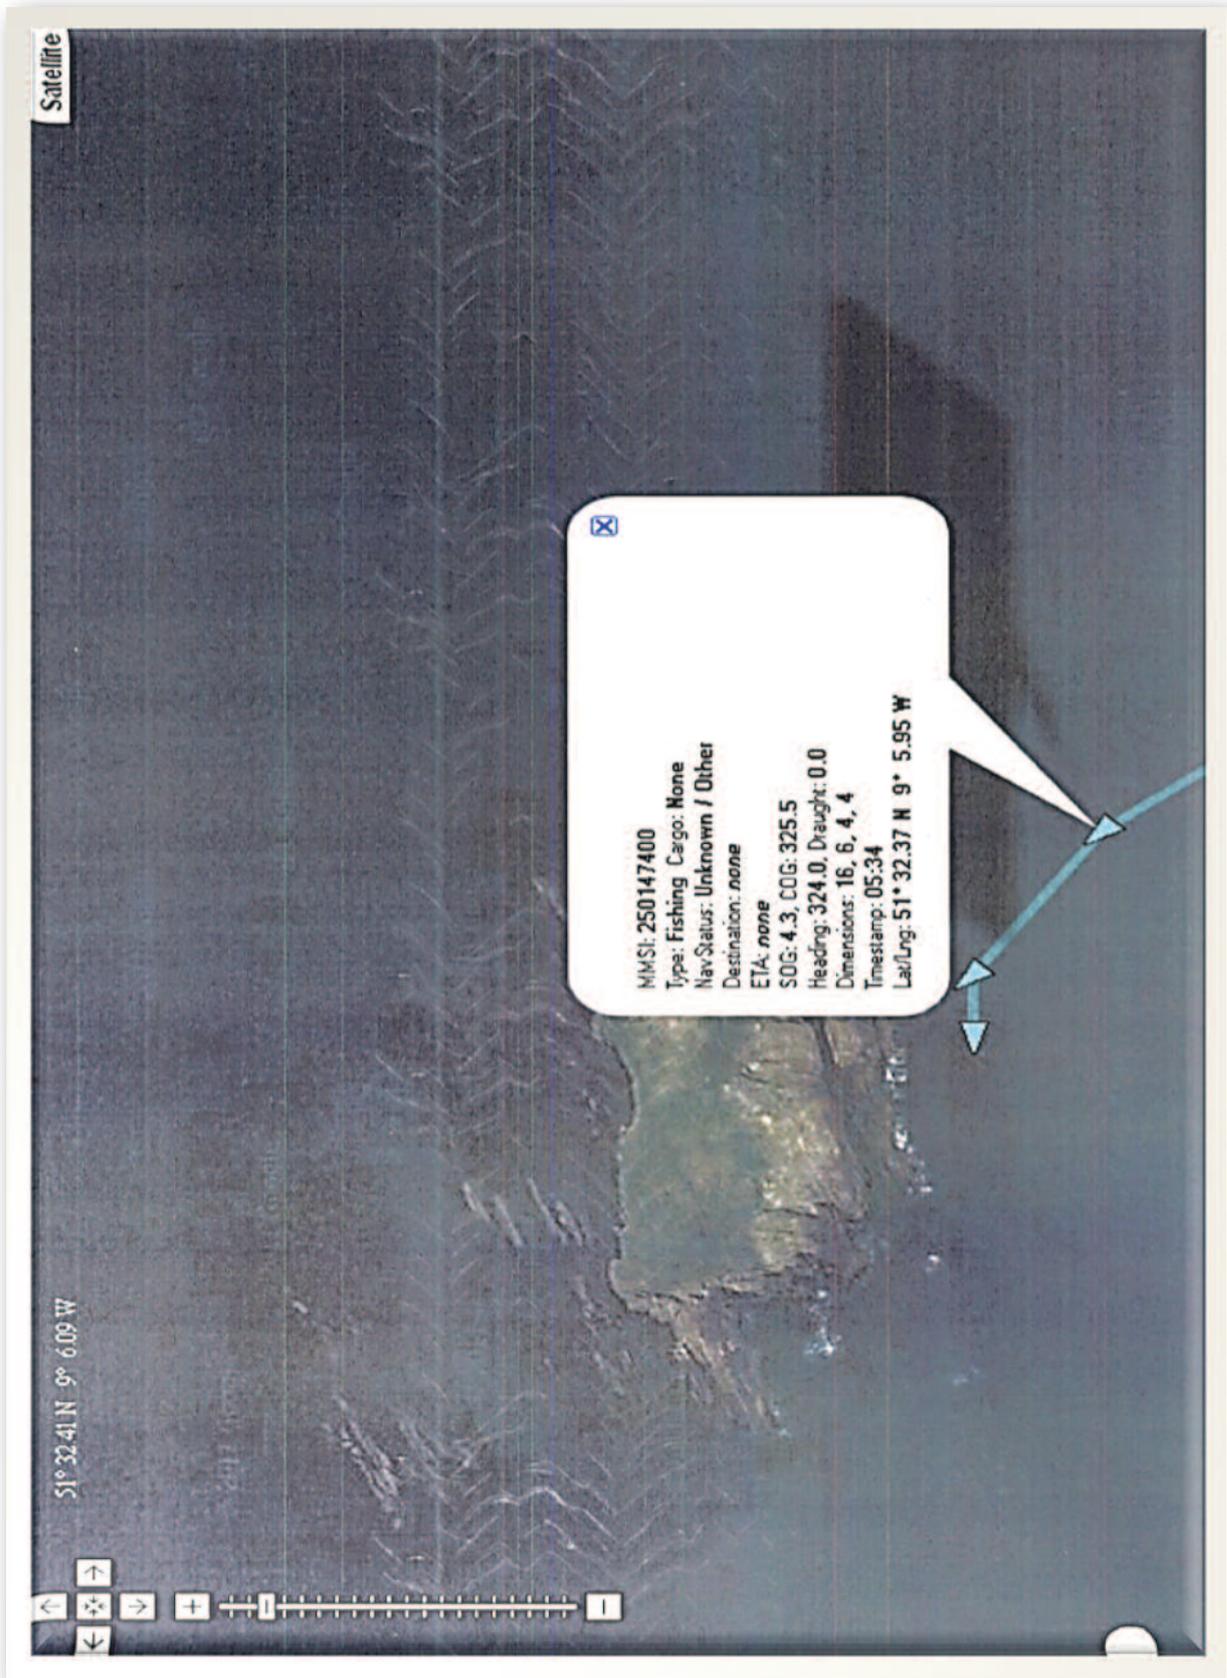
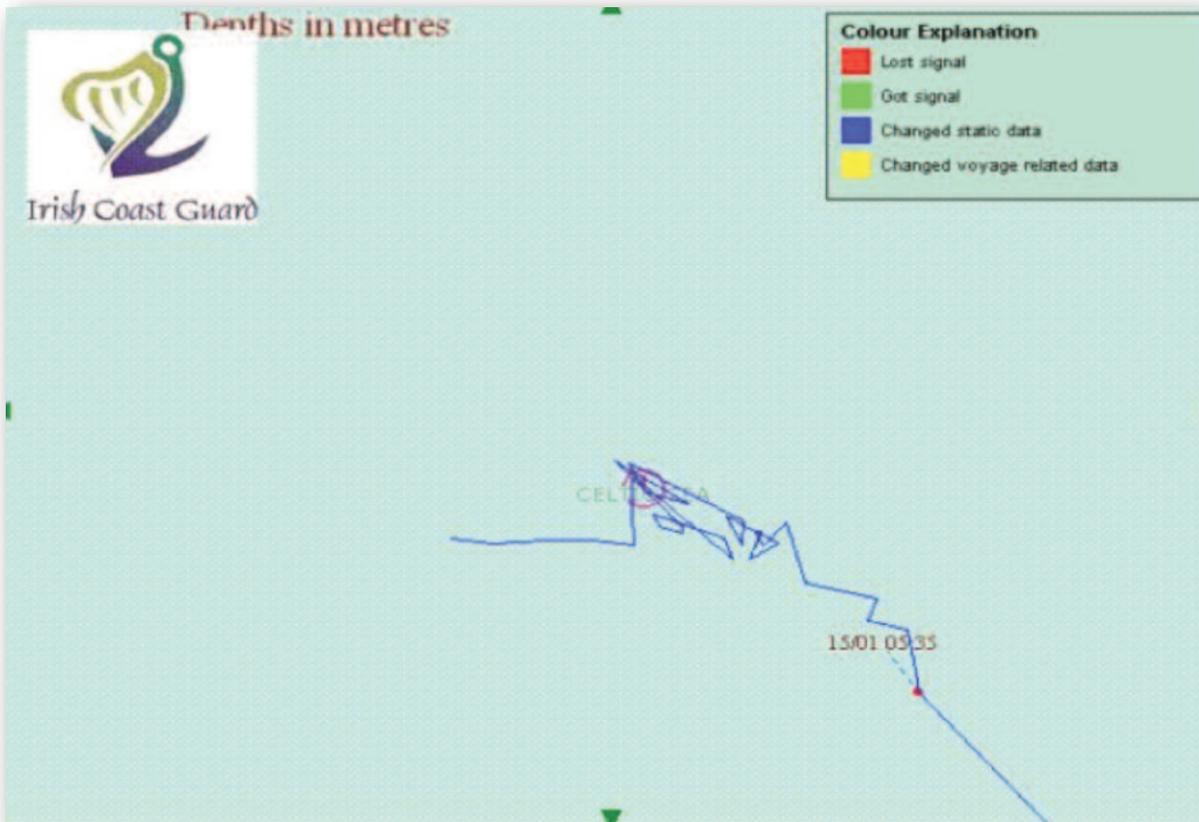
Appendix 7.9 AIS Track of Vessel Grounding.

Note: At 05:43hrs the last signal was received from the vessel and her position was recorded as: 51° 32.89'N 009° 07.16'W.
- 4.2.6 The vessel was fitted with an auto pilot Navitron NT 920. The record indicates that the vessel was operating on auto-pilot up to the point of stranding. When recovered, the unit was noted with an indicated heading of 110-112°.

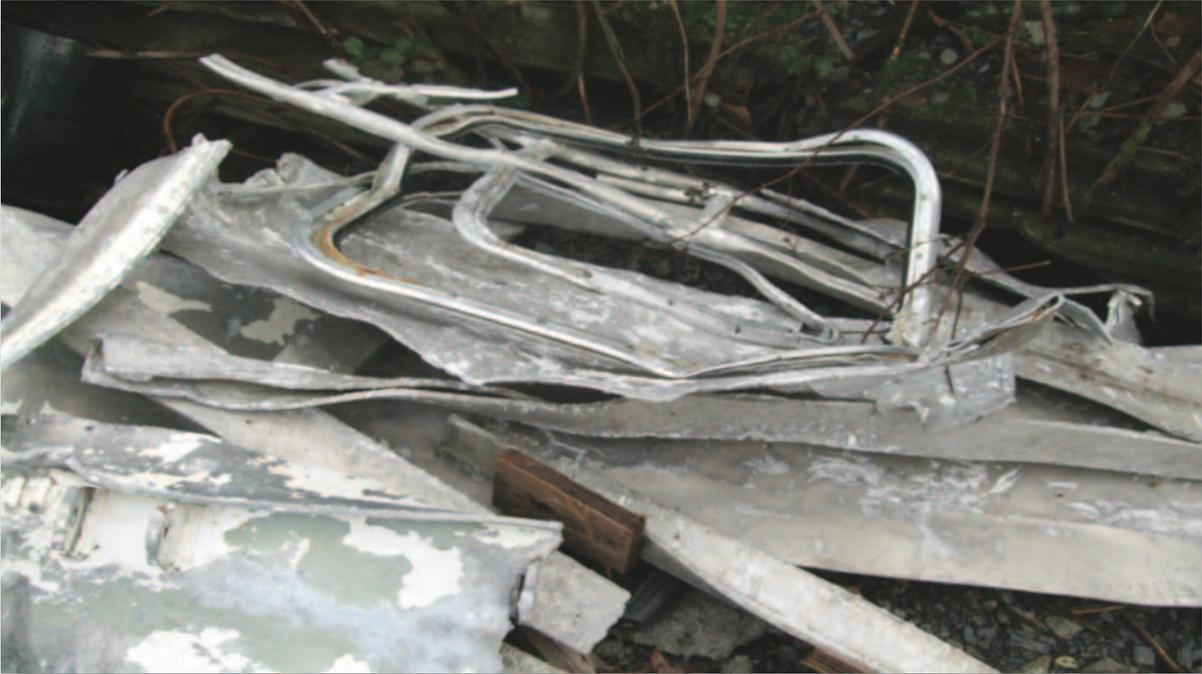
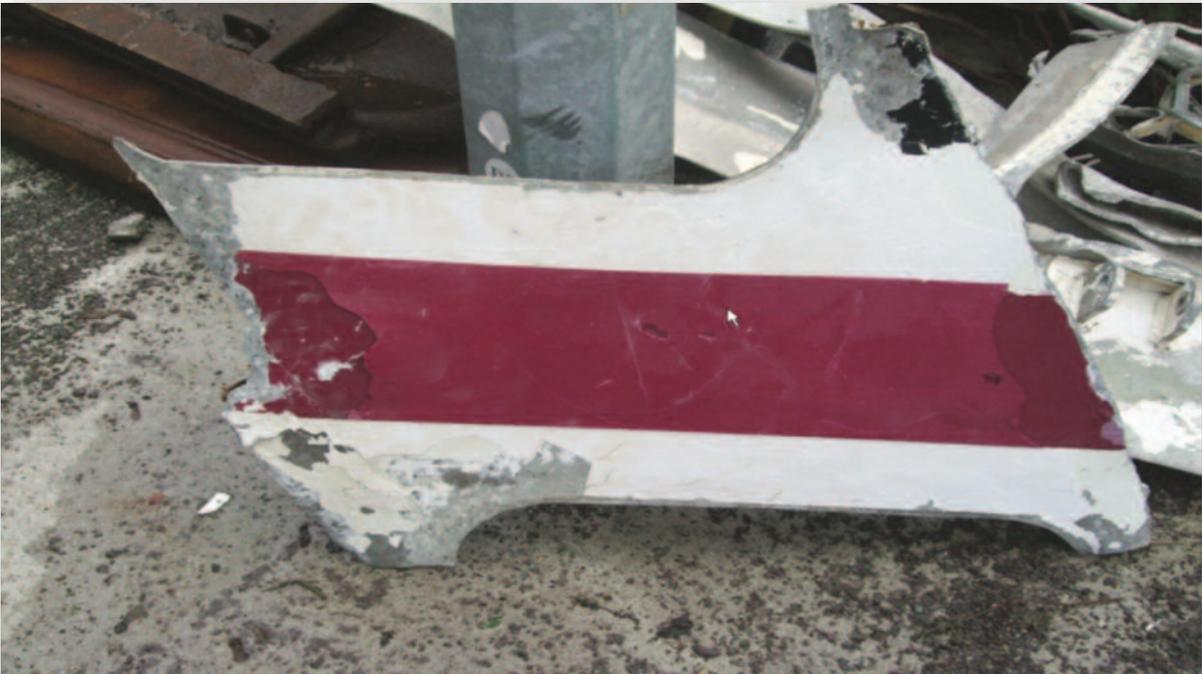
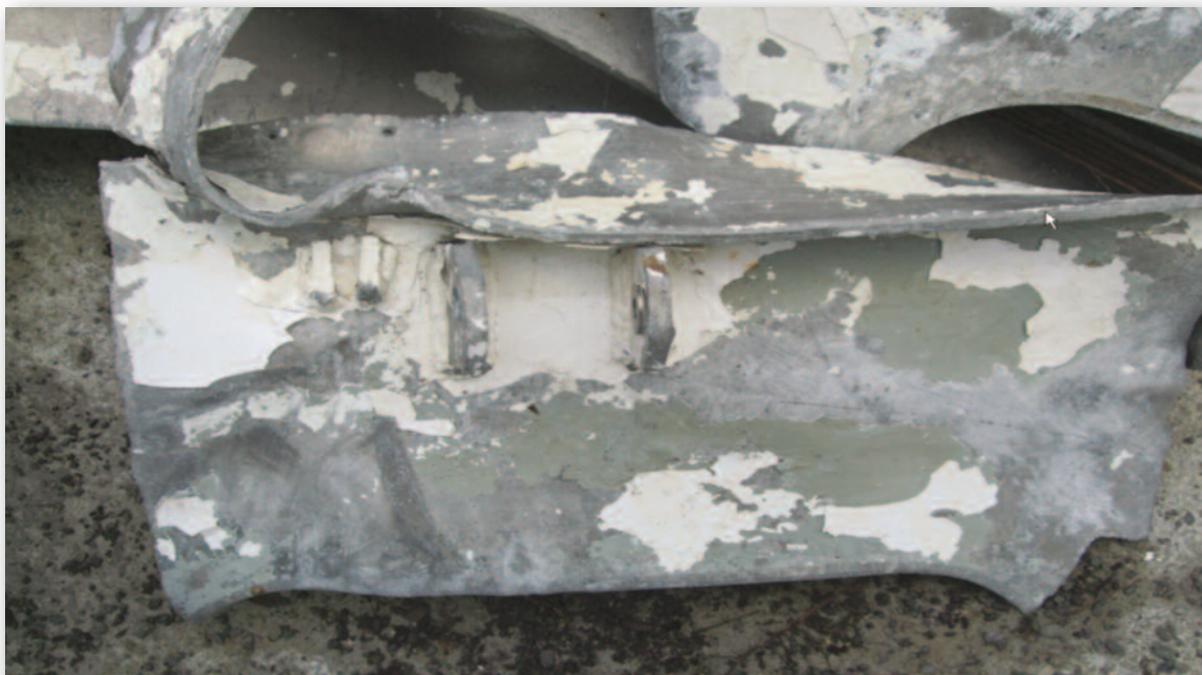
Appendix 7.11 Remains of aluminium wheelhouse recovered.

4.2.8 The Auto-Pilot Unit had sustained physical damage in the incident.
