**REPORT OF INVESTIGATION  
INTO GROUNDING AND  
SUBSEQUENT FOUNDERING  
OF EMERALD STAR LINE  
CAPRICE 8  
ON 9th OCTOBER 2009**

**REPORT No. MCIB/178  
(No. 7 of 2010)**

Report MCIB/178 published by The Marine Casualty Investigation Board  
30th June 2010

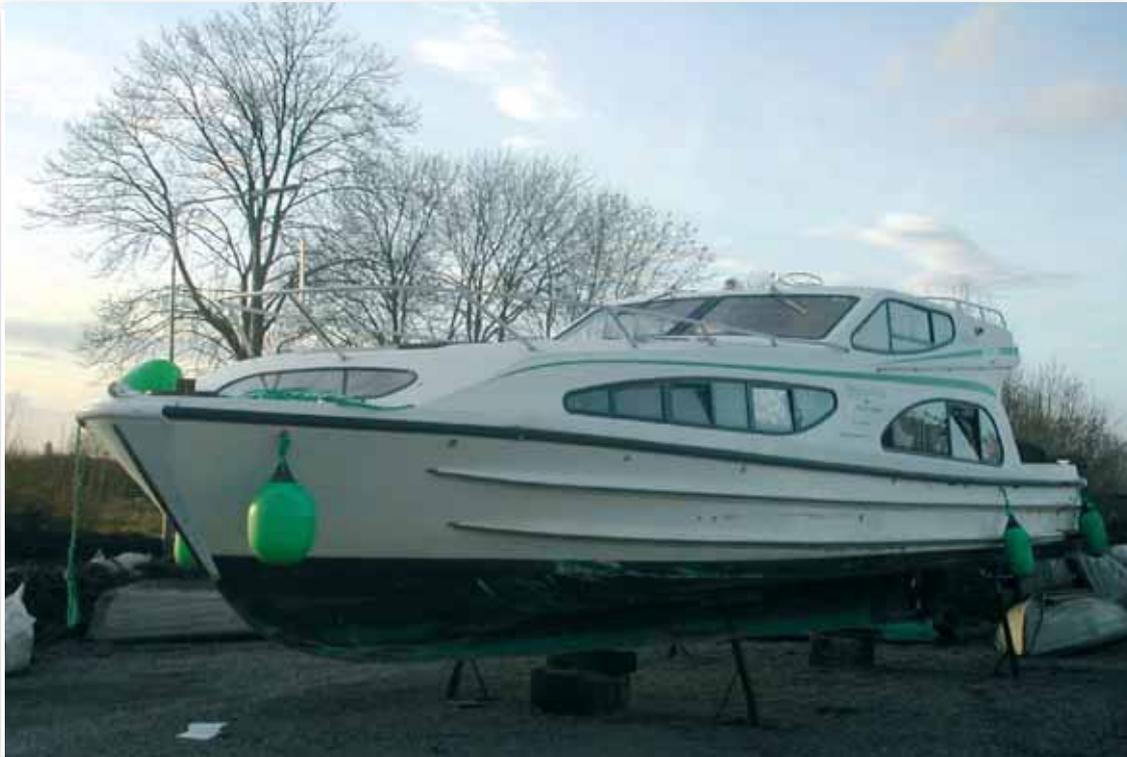
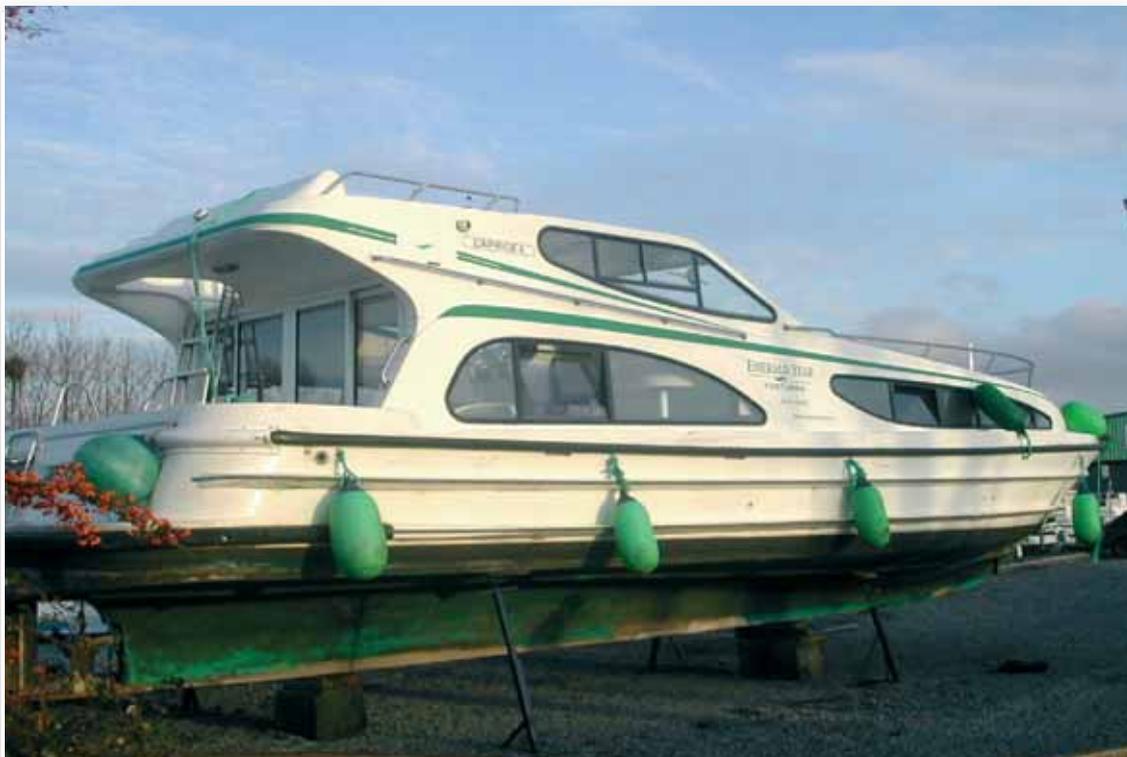
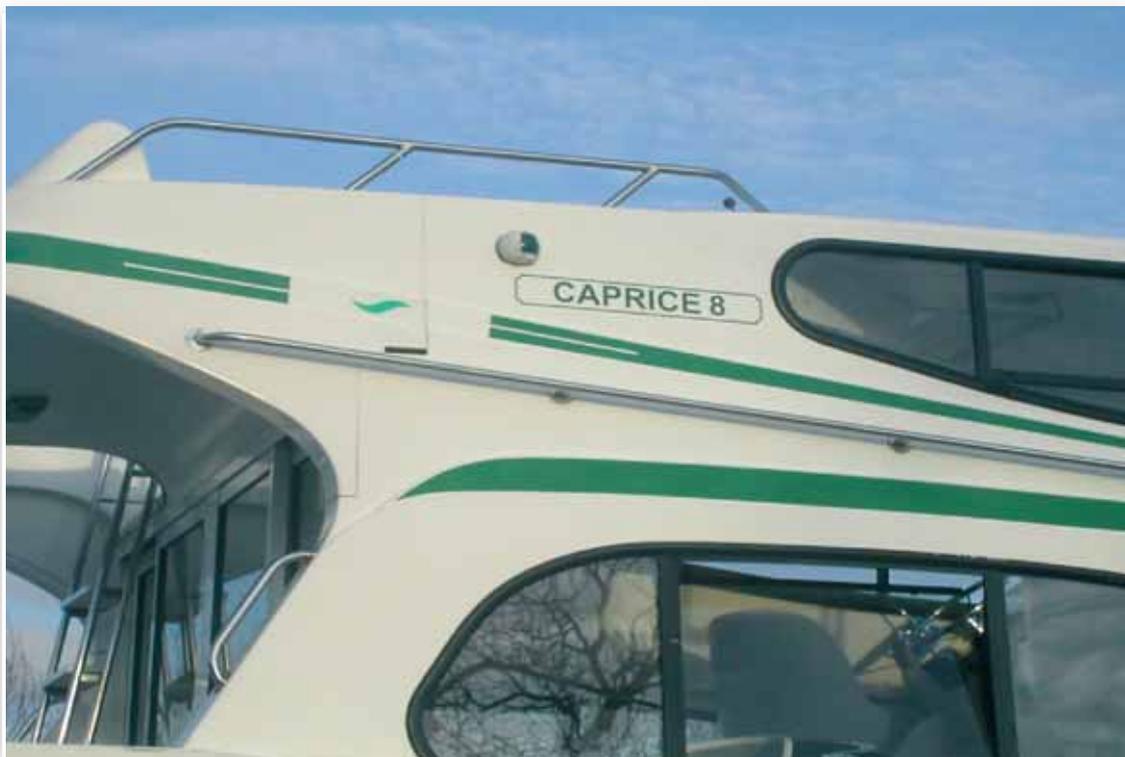
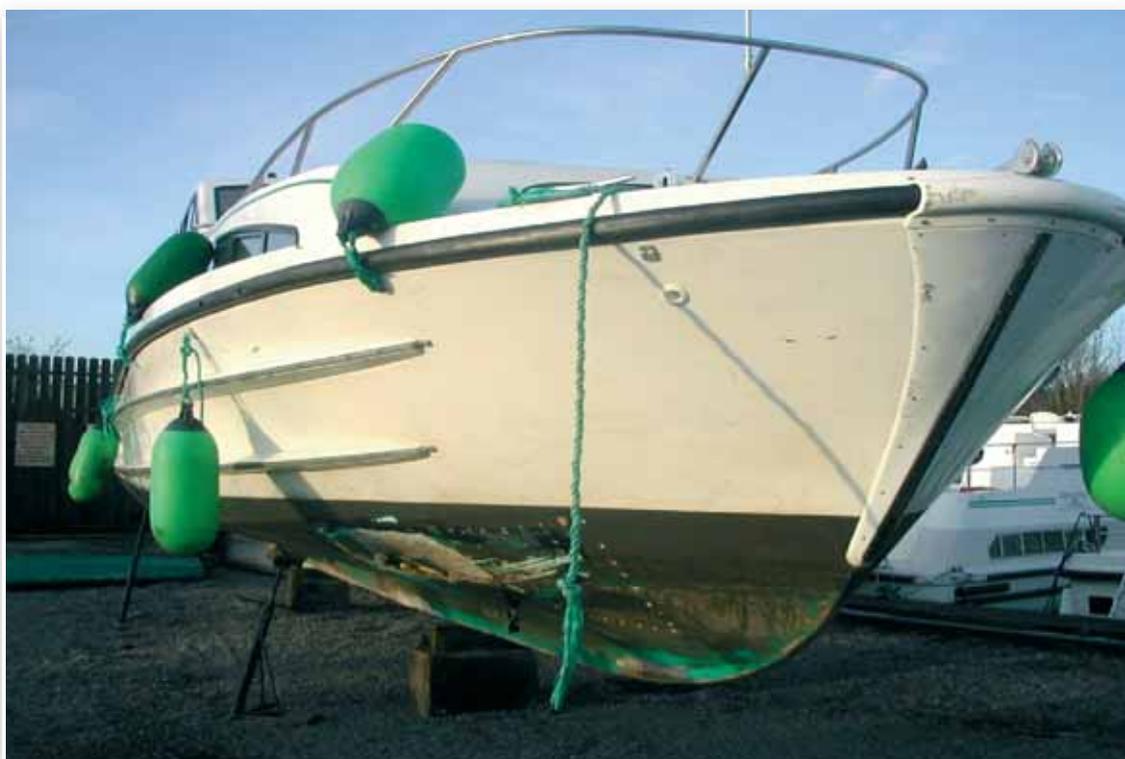
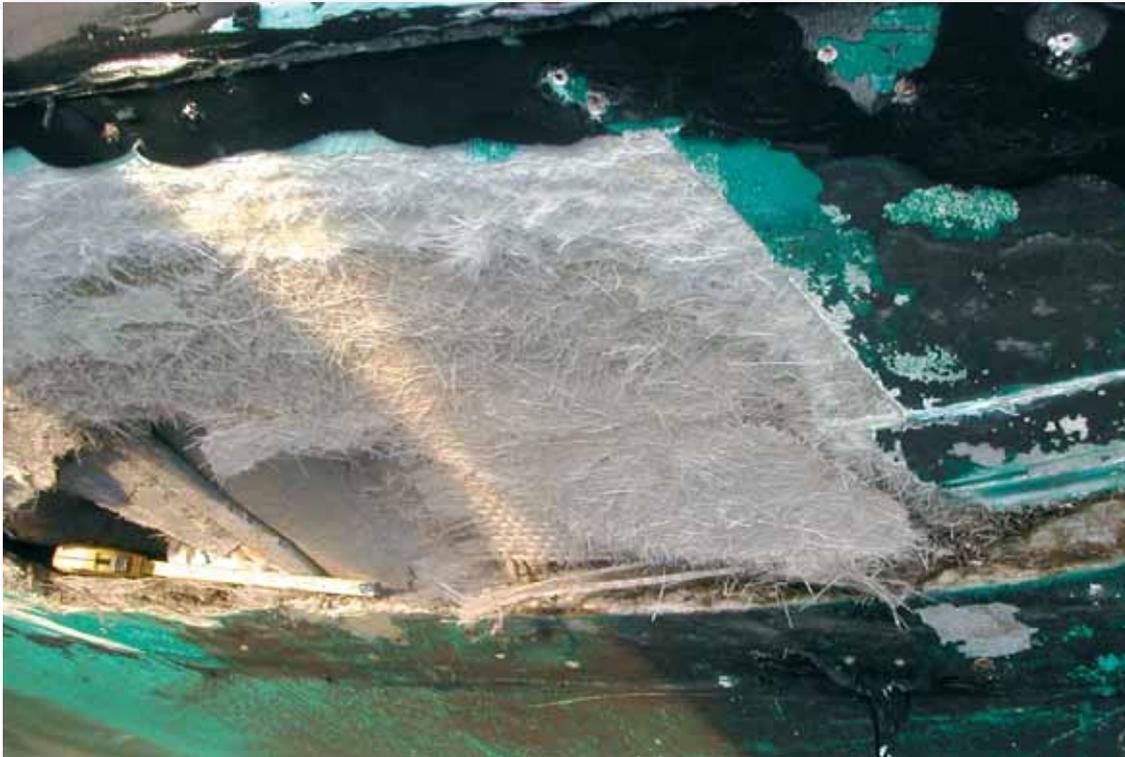
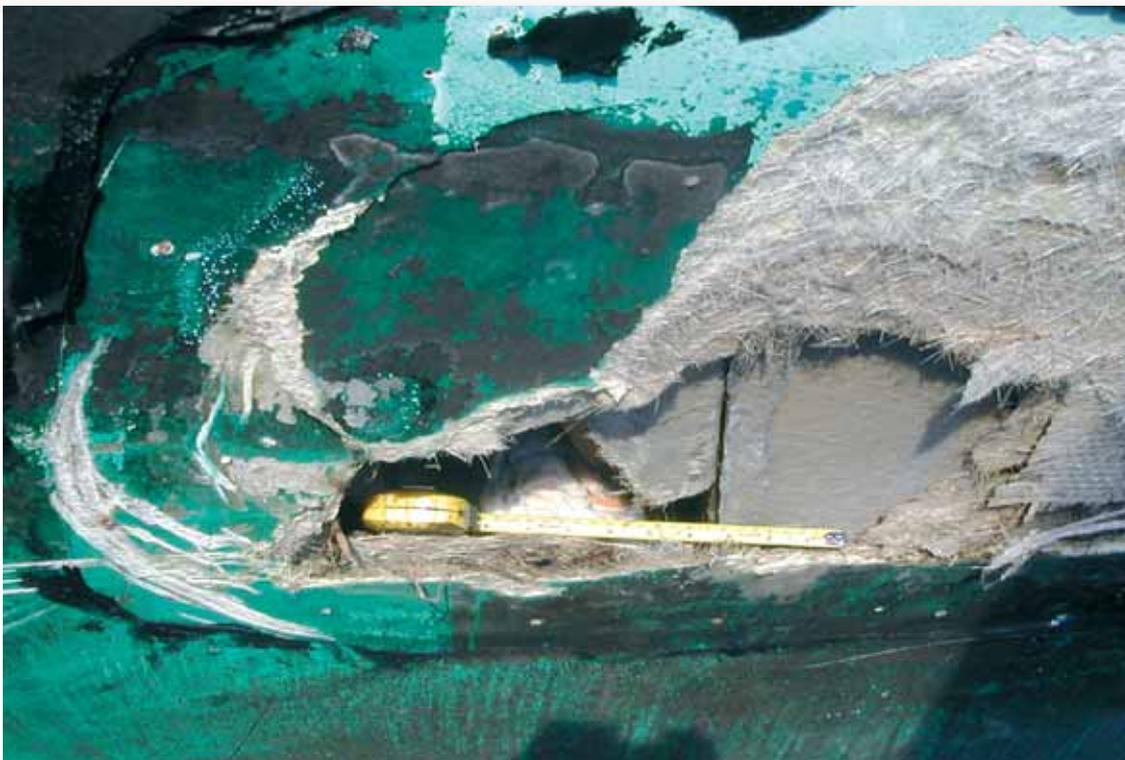
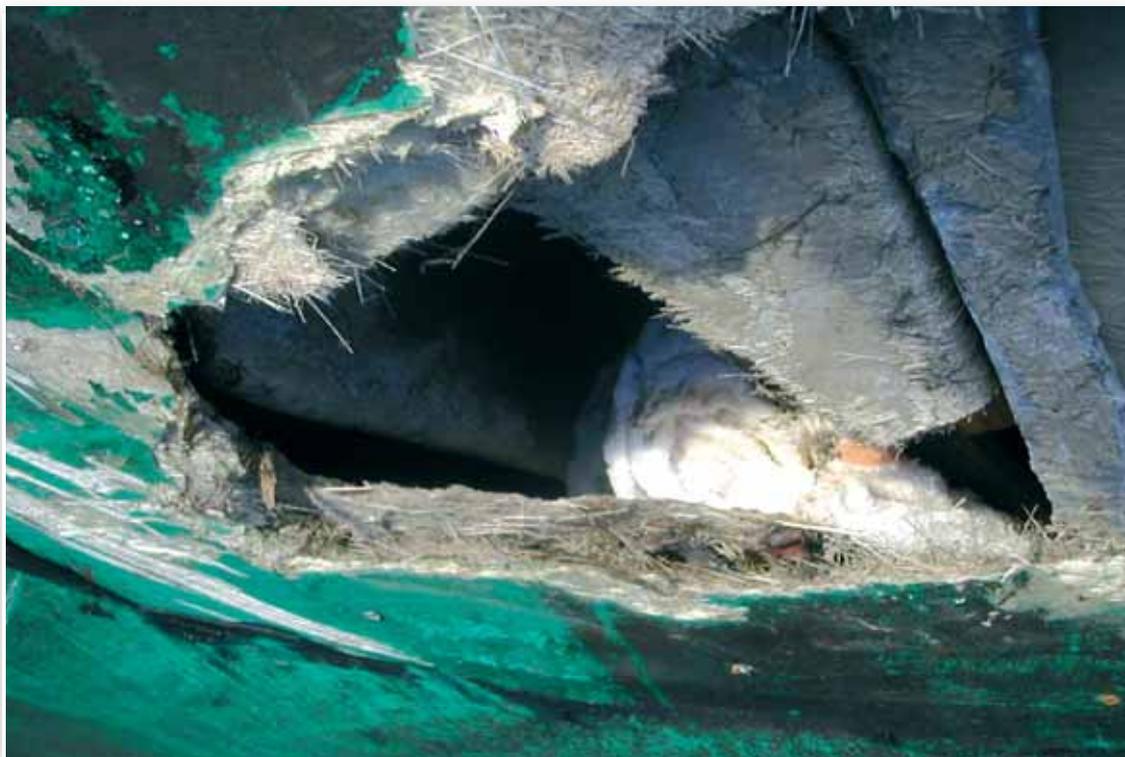
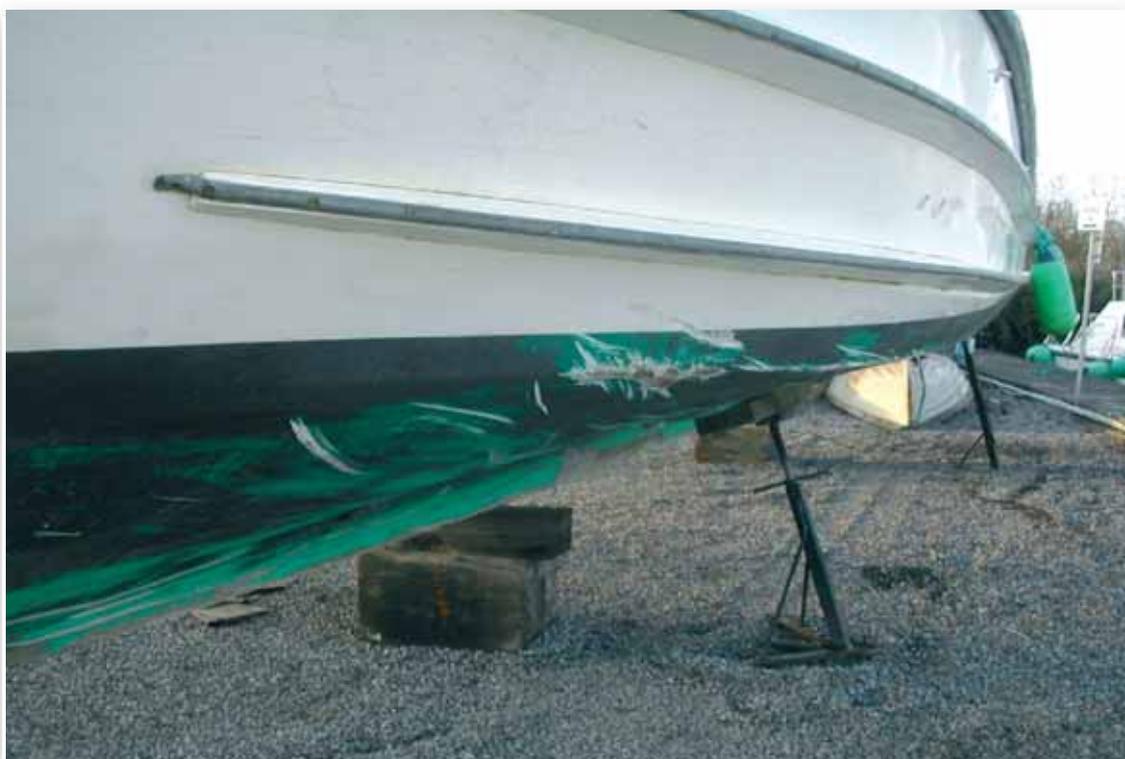
### Appendix 9.1 Photographs of the vessel.

The vessel was inspected ashore at the Emerald Star Line base in Portumna. Significant damage was noted to the for'd starboard section of the hull consisting of a large hole approximately 0.5m x 0.5m with further cracking of the hull extending forward for a further 0.75m located approximately 0.85m from the bottom of the skeg to the lower edge of the hole, 0.2m from the waterline to the upper edge of the hole and 1.6m from the bow to the leading edge of the crack. It was further noted that the glass fibre exposed by the damage shows very poor wet out and adhesion of resin in the laminate (photos, see appendix 9.1). Further damage was noted on the port side of the vessel just below the waterline, approximately 1.5m from the bow (photos, see appendix 9.1). The damage found was consistent with the grounding. It is not known whether the ultimate foundering of the vessel contributed to the damage or if it was all caused by the initial grounding.
