**REPORT INTO THE
FATAL INCIDENT ON BOARD
'MFV ENDURANCE'
APPROXIMATELY
200 NAUTICAL MILES OFF
SOUTH WEST COAST
ON
8th NOVEMBER 2016.**

**REPORT NO. MCIB/267
(No.2 OF 2018)**

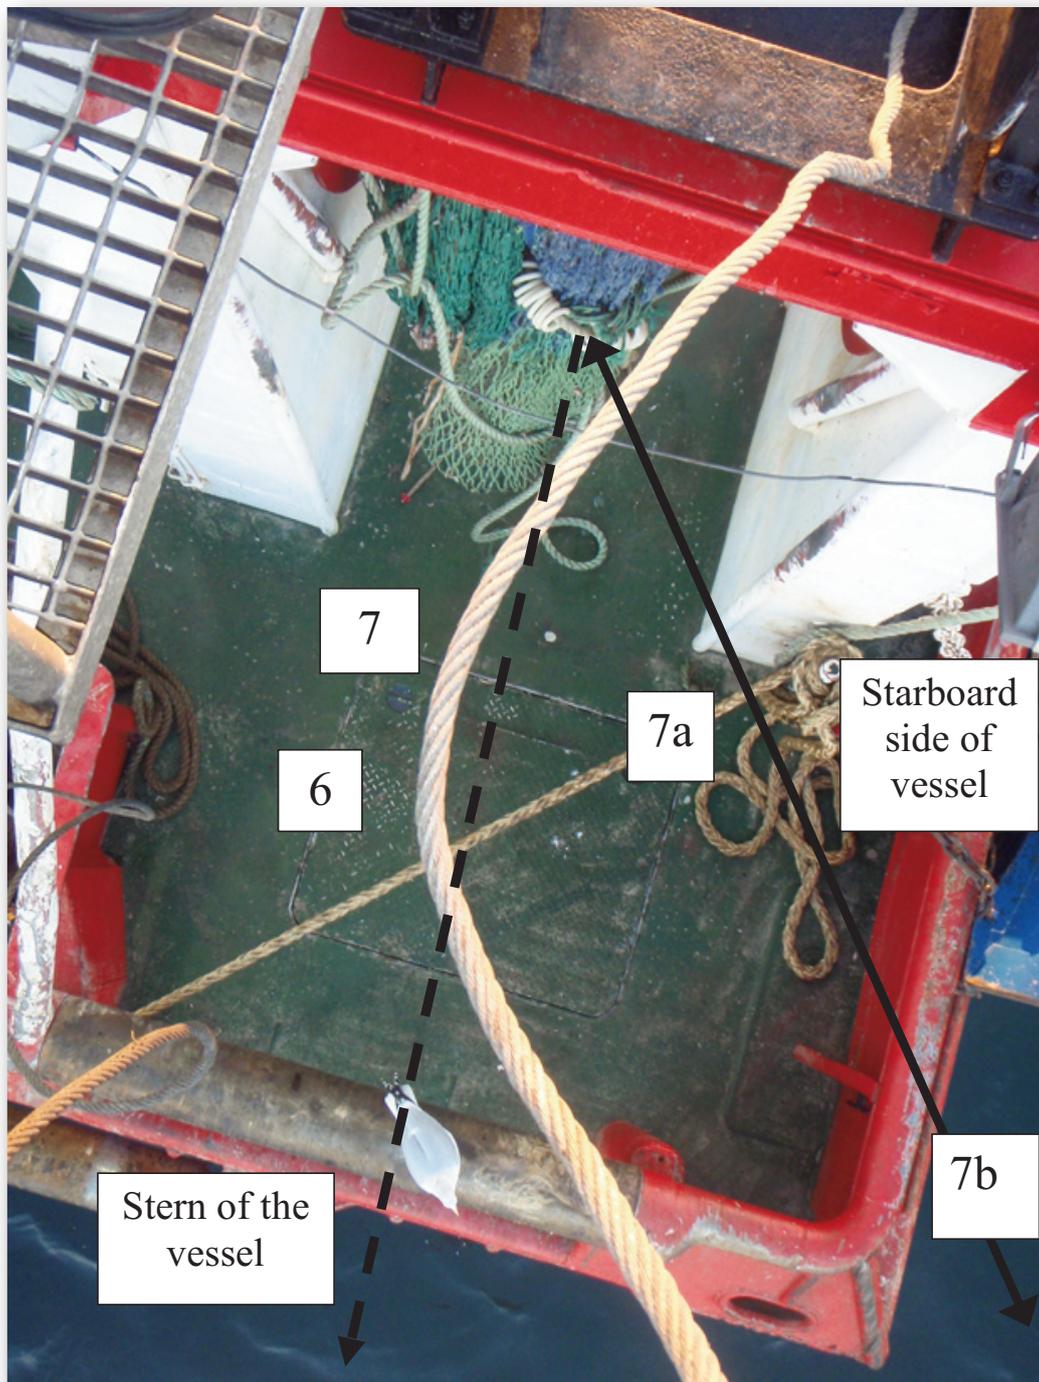
Crewmember No. 6: Working with the starboard net on the upper deck aft on the starboard side adjacent to Crewmember 7 (see Appendix 7.1 Photograph No. 3).

Crewmember No. 7: Working with the starboard net on the upper deck aft on (The Casualty) the starboard side adjacent to Crewmember 6.(see Appendix 7.1 Photograph No. 3).

- 3.9. The attention of Crewmember No. 6 was diverted momentarily. When his attention was re-focussed, Crewmember No. 7 had gone underneath the net through the gap between the net drum and the deck. Crewmember No. 7 was in approximately position 7a indicated in Appendix 7.1 Photograph No. 3 at this time.

- 3.10. Co-incident with this, the net was swept sideways by the motion of the sea and the vessel towards the starboard quarter which pushed Crewmember No. 7 with it (see Appendix 7.1 Photograph No. 3 motion of net indicated by the blue lines).

- 4.6. It is not possible to determine how Crewmember No. 7 came to be in the position underneath the net through the gap between the net drum and the deck, as indicated at 7a in Appendix 7.1 Photograph No. 3. The position puts Crewmember No. 7 in a danger zone between the net and the starboard rail. The only available shelter being forward between the starboard base for the gantry and the starboard rail.

Photograph No. 3: View from gantry/gilson winch looking down on the upper deck starboard aft quarter.

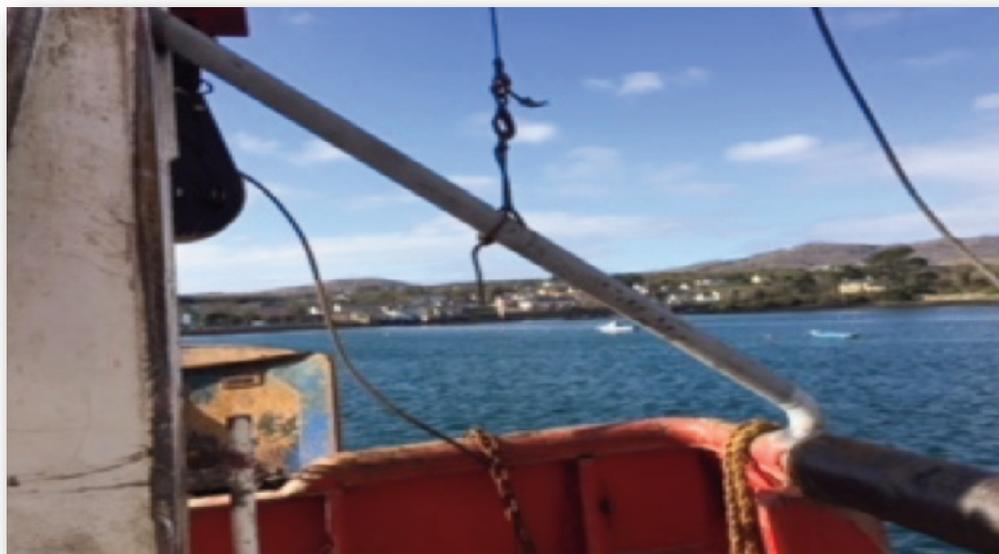
Photograph No. 4: Protection bars fitted.

- 4.11. Remedial works have been carried out to prevent a recurrence of such an incident. Protection bars were fitted to the stern of the vessel, stone traps to fishing nets and a new camera console with more camera angles for hauling and shooting nets (see Appendix 7.1 Photograph Nos.4 & 5).

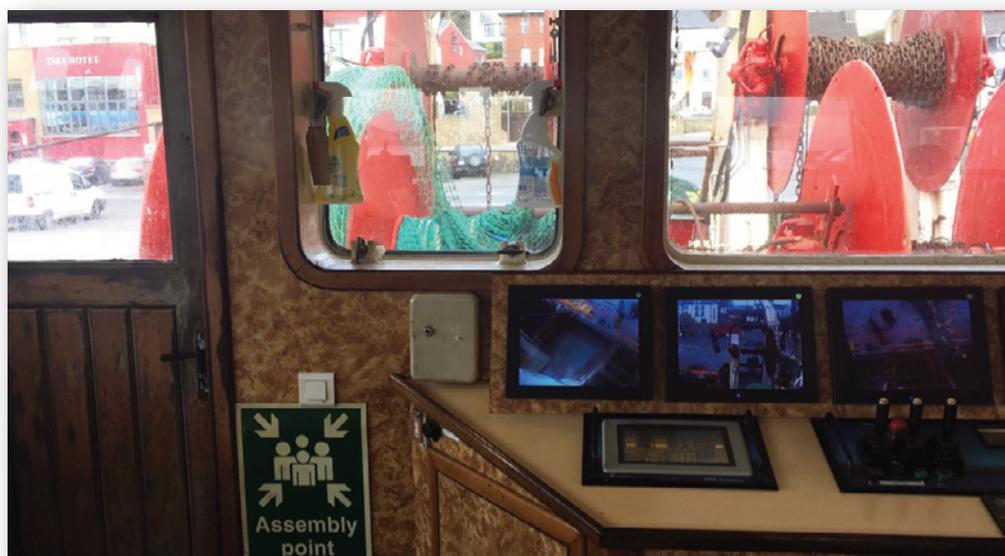
Photograph No. 5: Camera console.
