**REPORT OF THE INVESTIGATION
INTO
A FATAL INCIDENT AT
CASTLETOWNBERE
ON
17th AUGUST 2012**

**REPORT NO. MCIB/225
(No.2 OF 2014)**

Report MCIB/225 published by The Marine Casualty Investigation Board.
Printed 28th July 2014.

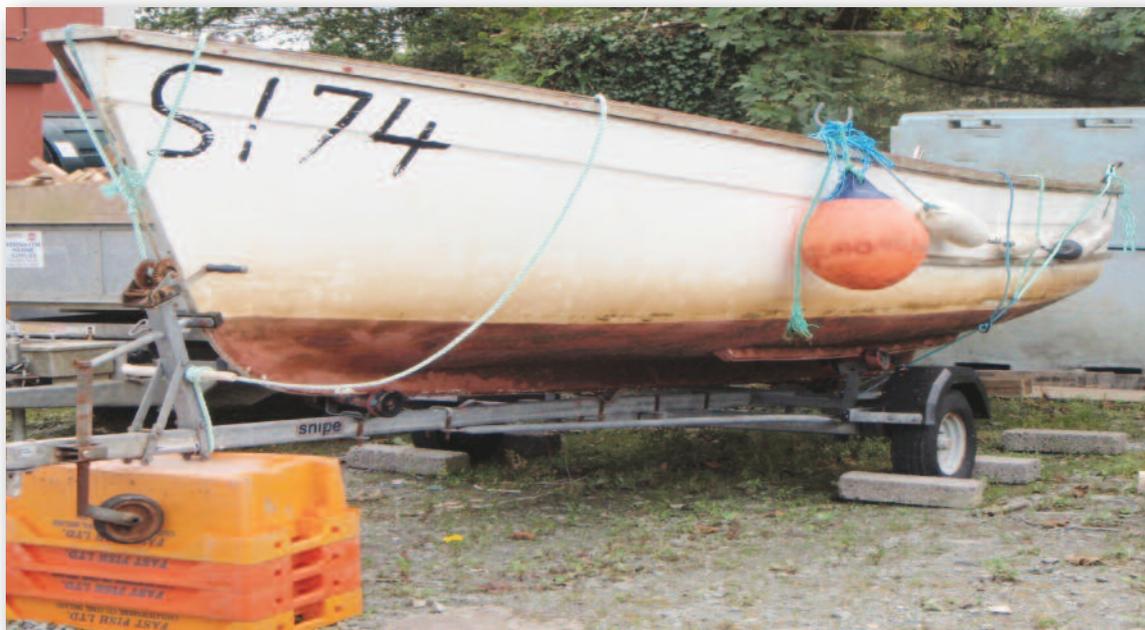
Photo P8281497. Photograph of the Vessel on Trailer

The boat was in good condition overall with no damage to the hull or fittings. The marking painted on the bow of the boat (S174) related to the registration of a previous boat owned by the Casualty, namely the Cliona. The Cliona was decommissioned but was not taken off the register of sea fishing boats. The current boat that was involved in the incident was used for recreational use only. It was not registered and should not have had the marking (S174) displayed on it.

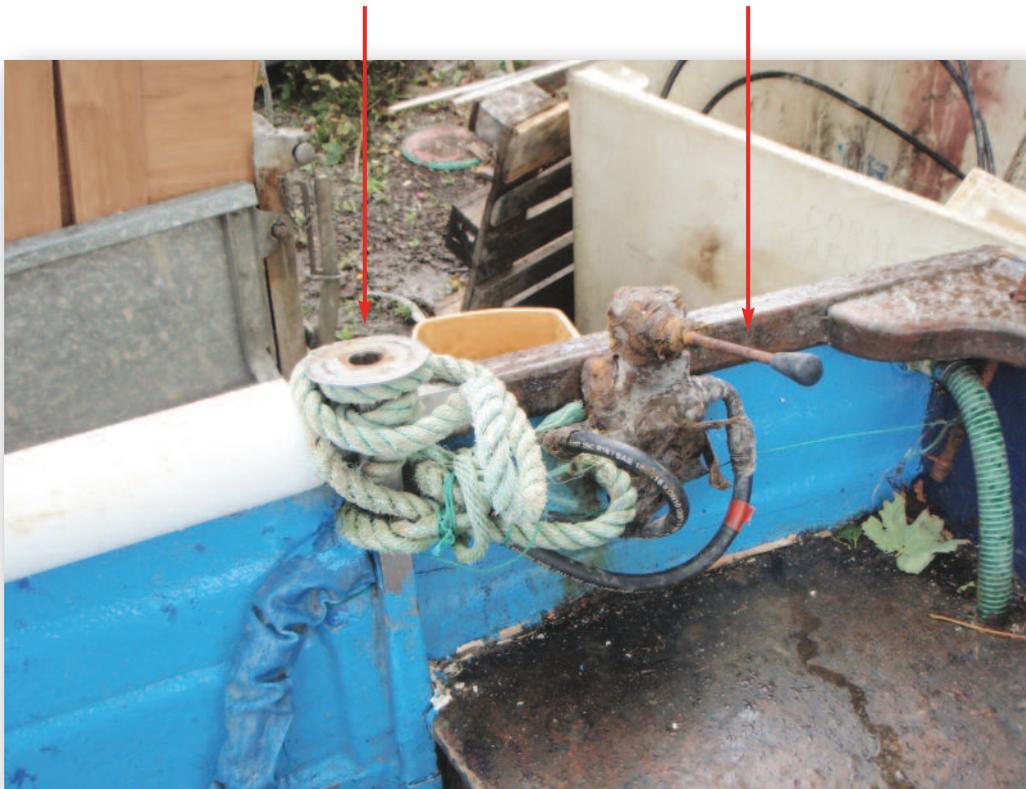
Appendix 7.4 Photo of Pot Hauler fitted into its mounting bracket.

The hydraulically powered pot hauler winch was fitted on the starboard side stern quarter. See Appendix 7.4 photograph showing the pot hauler fitted into its mounting bracket. The donkey engine for the hydraulic pot hauler was located forward in the boat.

- 4.3 The fitting of the pot hauler on the starboard stern quarter was evidently the Casualty's preference. However, it is considered that this is the least stable location on the boat for the pot hauler. The recommended position for a pot hauler on a small boat is approximately 1/3 of the overall boat length aft of the bow. In the course of the incident, if the stern/starboard quarter of the boat was pulled-over it would have offered the least amount of resistance to the ingress of water and it also would have allowed the lobster pots and associated ropes stowed on board to cascade towards the stern adding to the instability.

- 4.4 As stated earlier, the control valve for the pot hauler was of a type that drives the pot hauler at a fixed speed and the operating lever does not return to the neutral position of its own volition when it is released. The fitting of a control lever or of a foot pedal control that requires continued positive action by the operator to maintain the desired speed and movement may have been a better option in this instance because such a system requires constant supervision.

Support bracket for the pot hauler.

Control lever for the pot hauler.

- 5.4 It is considered that the pot hauler should not have been fitted on the starboard stern quarter. If it had been fitted in a forward position the boat would have been more stable and it would have had a greater resistance to capsizing and inundation.

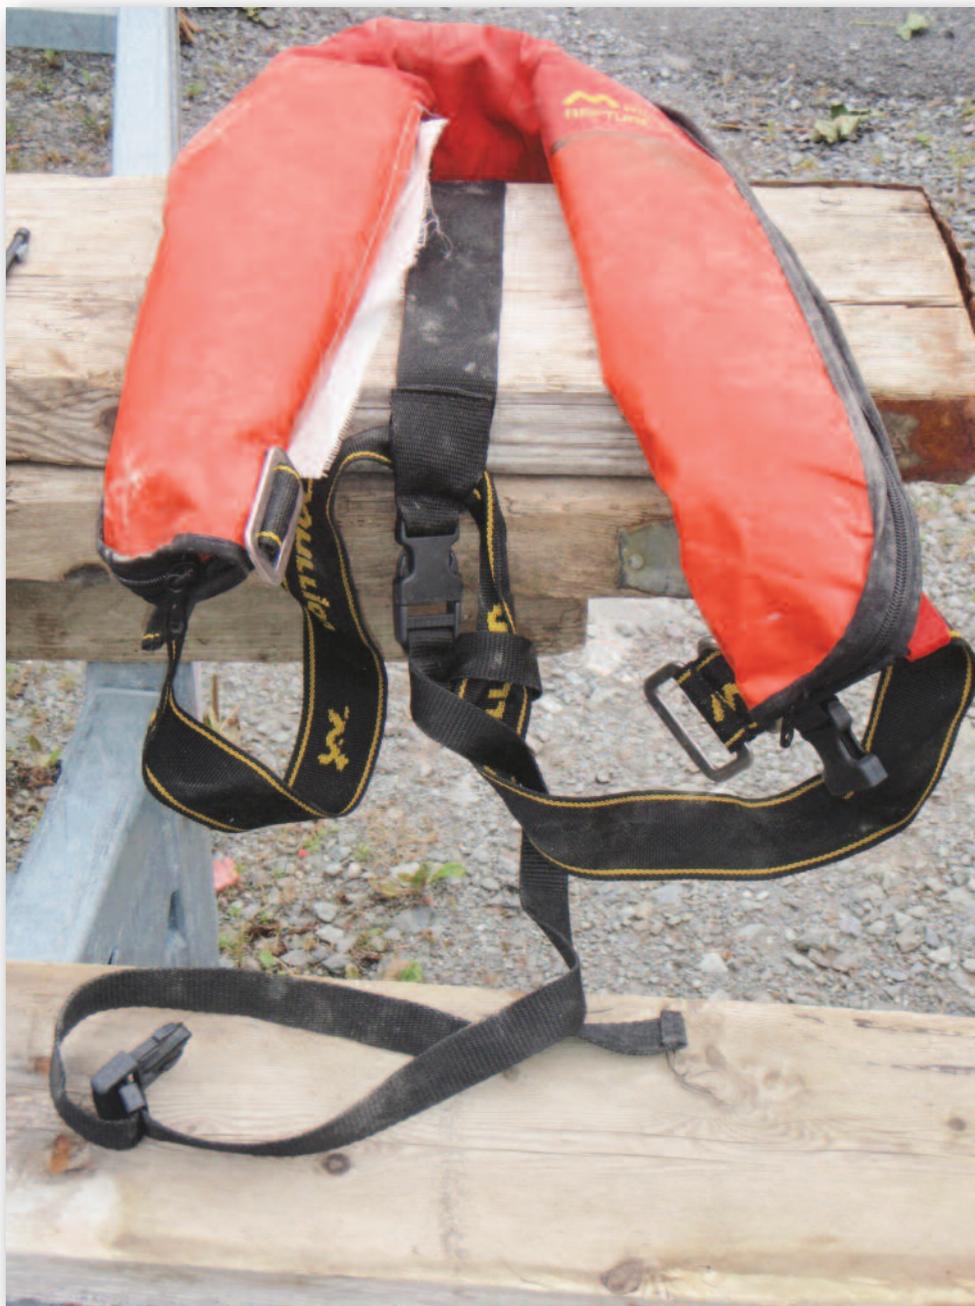
Photo P8281538.

In the course of the rescue an un-inflated Personal Floatation Device (PFD), was found floating in the water adjacent to the boat. The PFD was visually examined on 24th August 2012 and the details were recorded but it was not opened out or examined in any detail at that time.

- 4.7 The Investigation has not been able to establish the history of the PFD in respect of servicing and maintenance. When the incident happened and the PFD was immersed in the water it did not inflate because the gas cylinder charge had been activated at some time prior to the incident and was exhausted.

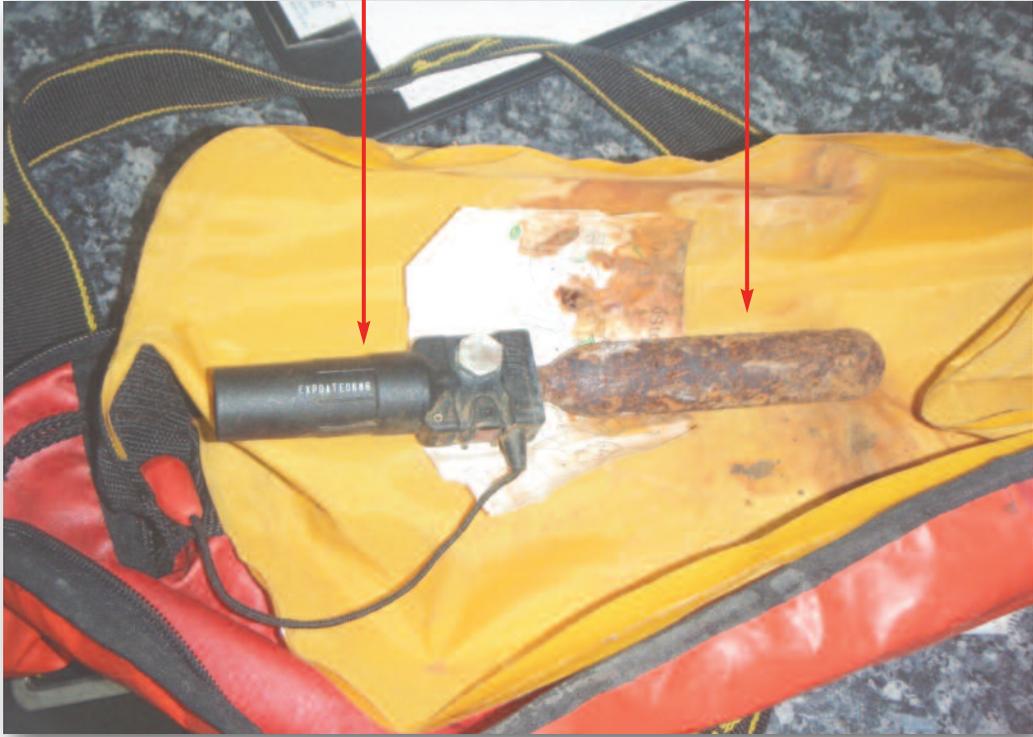
The PFD was unfolded and the details such as make, type and serial number as stated earlier were confirmed. Please see Appendix 7.6 photo taken on 12th February 2013 after the PFD was unfolded and shows the cartridge, body and gas cylinder.

- The fabric service record tab on the jacket was ripped away at the stitching and any records that may have existed had been obliterated for some time. The green plastic activation indicators on the cartridge and the pull cord mechanism were missing.
- The cartridge was found to have operated and was expended.
- The gas cylinder was found to have been operated.
- The seal had been punctured by the knife in the pin mechanism.
- The gas cylinder was heavily corroded externally.
- The corrosion was encrusted into and had stained the fabric of the bladder where the latter folded around the cylinder.
- The bladder was intact and not punctured.

The bladder was inflated using compressed air. It inflated and maintained pressure. A new gas cylinder was fitted and the bladder was inflated manually, it inflated and maintained pressure. A new gas cylinder and a new cartridge were fitted to the jacket and it was immersed in water, it inflated and maintained pressure. The corroded gas cylinder that was removed from the jacket was pressure tested to 10-bar for a period of about 15 minutes and immersed in water. During that time no leakage or deformation was observed and the conclusion is that the external corrosion had not perforated the wall of the cylinder and allowed the gas to seep out over time.

The original cartridge serial number was 30077086 and it had an expiry date of 11/06. The actual cartridge fitted was number 30042094 and had an expiry date of 06/06. This expiry date predates the one that was fitted when the PFD was manufactured. The usual expiry for cartridges is three years.

It was not possible to read the serial number on the gas cylinder due to degree of corrosion on the external surfaces. Thus it was not possible to determine if the gas cylinder fitted to the PFD at the time of the incident was the original or if it had been changed.

Cartridge.

Gas cylinder.

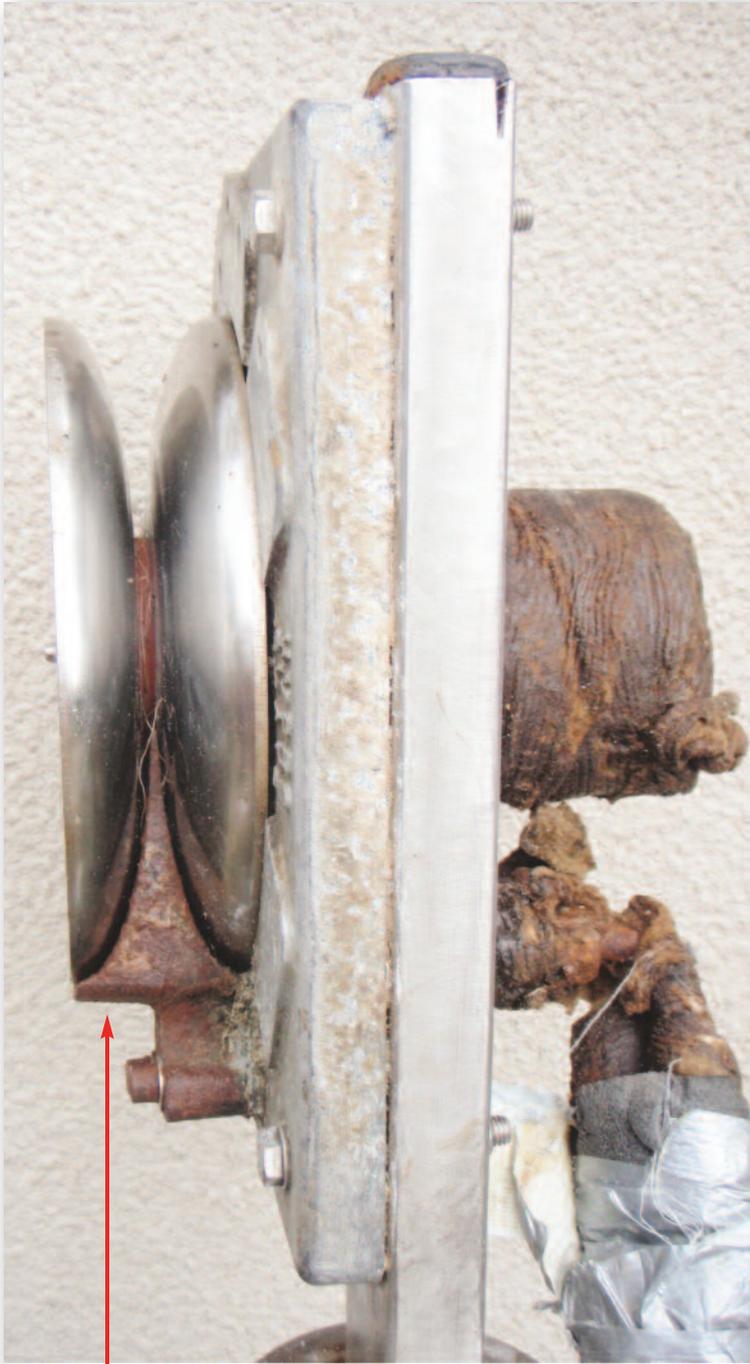
Appendix 7.7 Pot Hauler Knife.

- 4.5 The knife of the pot hauler can be set in four different positions on the frame of the pot hauler. Please see Appendix 7.7 photograph of the knife. In the photograph it can be seen that the knife is fixed in the last position, thus as a rope is hauled-in and it travels over the sheave it goes to the 5 o'clock position before it meets the knife. It may have been better if the knife had been fitted in the 4 o'clock position so as to reduce the tendency of the rope to embed itself on the sheave but there is nothing to link this to the incident.

Pot hauler knife
