**REPORT OF THE INVESTIGATION
INTO
THE FATAL INCIDENT ABOARD
“FV LIBERTY”
ON
14th FEBRUARY 2013**

**REPORT NO. MCIB/230
(No.4 OF 2014)**

Report MCIB/230 published by The Marine Casualty Investigation Board.
Printed 10th November 2014.

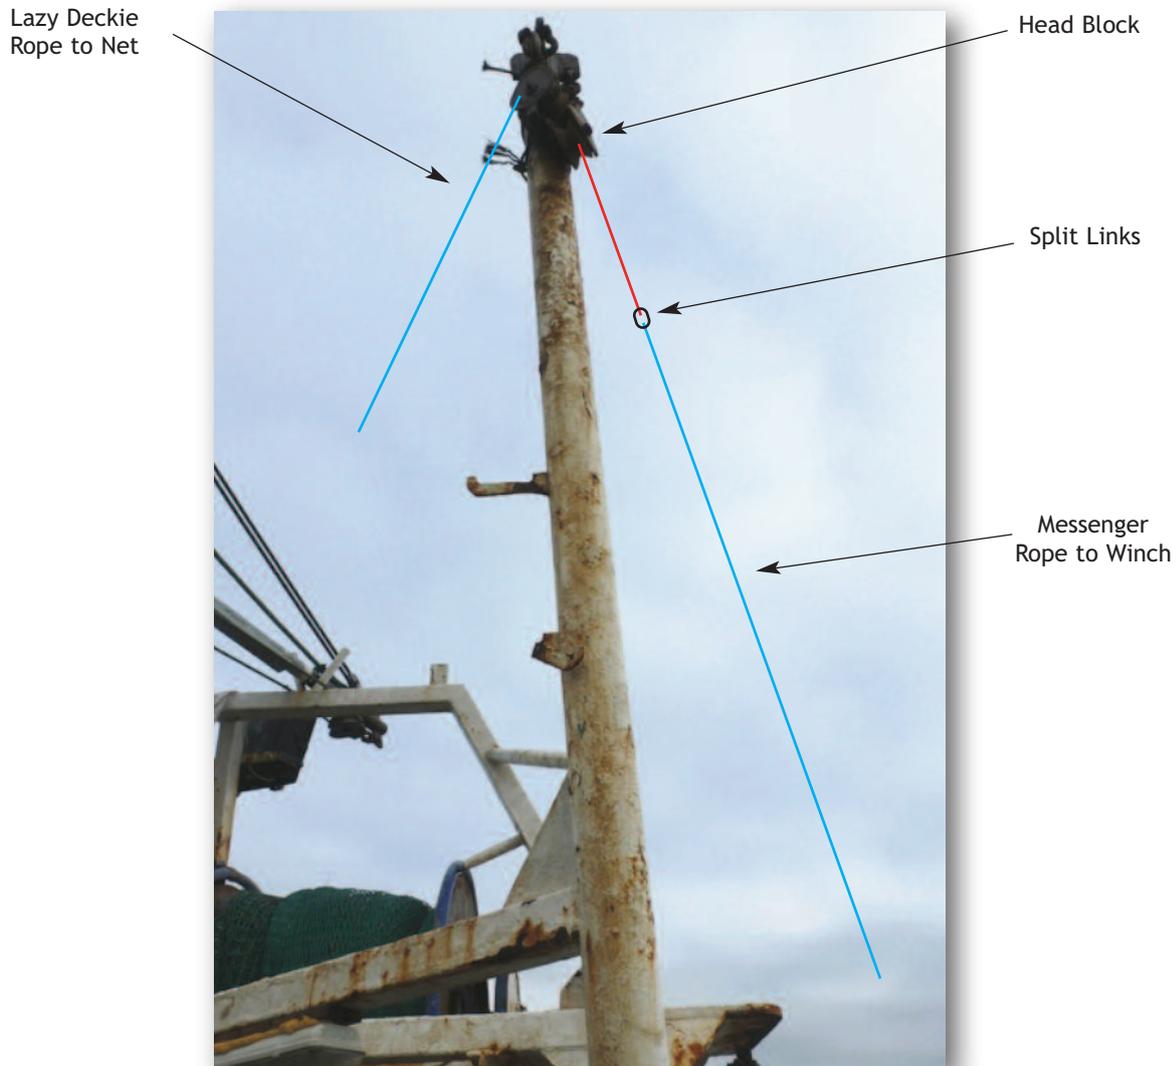
The lifting equipment on the vessel consisted primarily of the following elements; a trawl winch, cod end derrick, head block on derrick, lead sheaves from base of cod end derrick to winch, the messenger rope, lazy deckie (also known as a splitter rope or bag rope) and connection (split links) between lazy deckie and messenger rope. (See Photographs Nos. 2, 3 & 4).

Photograph No. 2: Arrangements of Ropes and Components on Cod End Derrick

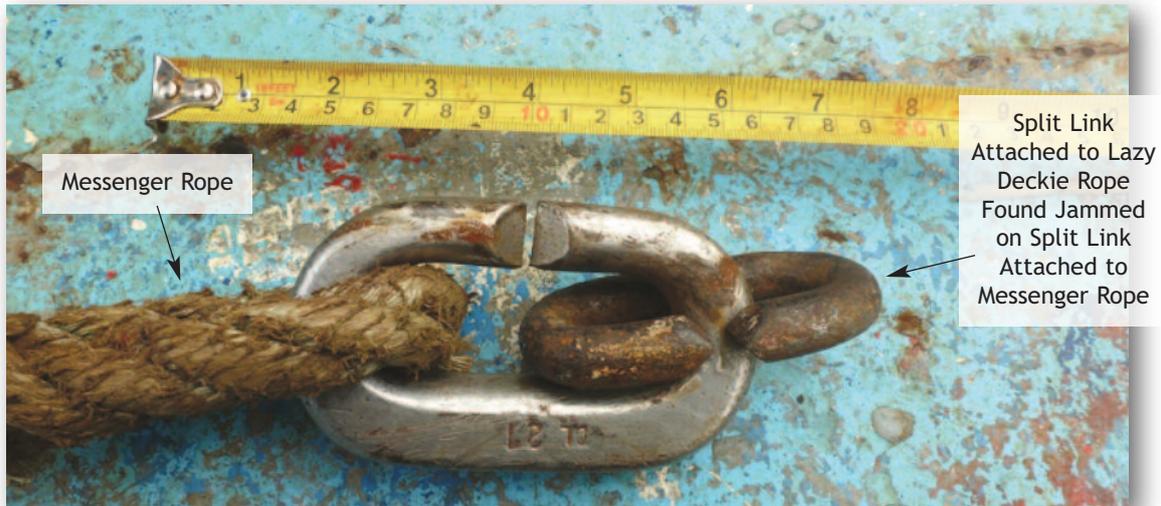
The split links connection consisted of a Boss DL 21 Split Link attached to the messenger rope and an unmatched split link that would have been attached to the lazy deckie rope. The Boss DL 21 Split Link had a rated load safe working load of 1.4 tonnes. There were no identification marks on the unmatched split link. (See Photograph No. 3).

The messenger rope was spliced into a Boss DL 21 Split Link. The lazy deckie rope was stated to have been spliced into the unidentified split link (See Photograph No. 3).

Photograph No. 3: Close-up of Split Links

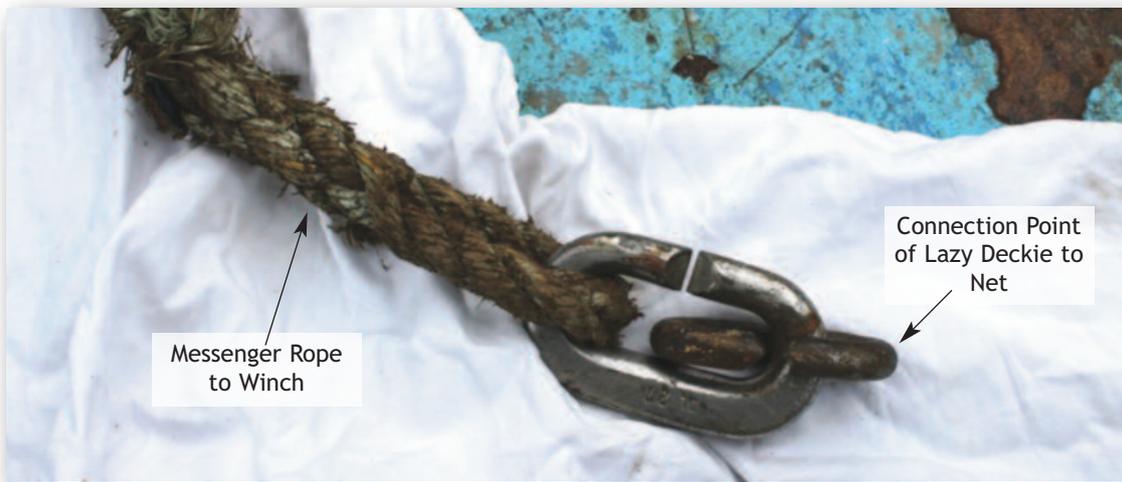
Photograph No. 4: Split Links

The main items in the vessel's lifting equipment, namely winch, sheaves, split links, blocks and derrick were noted to be in a poor condition. (See Photographs Nos. 4, 5, 6, 7) and (Photographs Nos. 9, 10, 11 & 12 in Appendix 7.3).

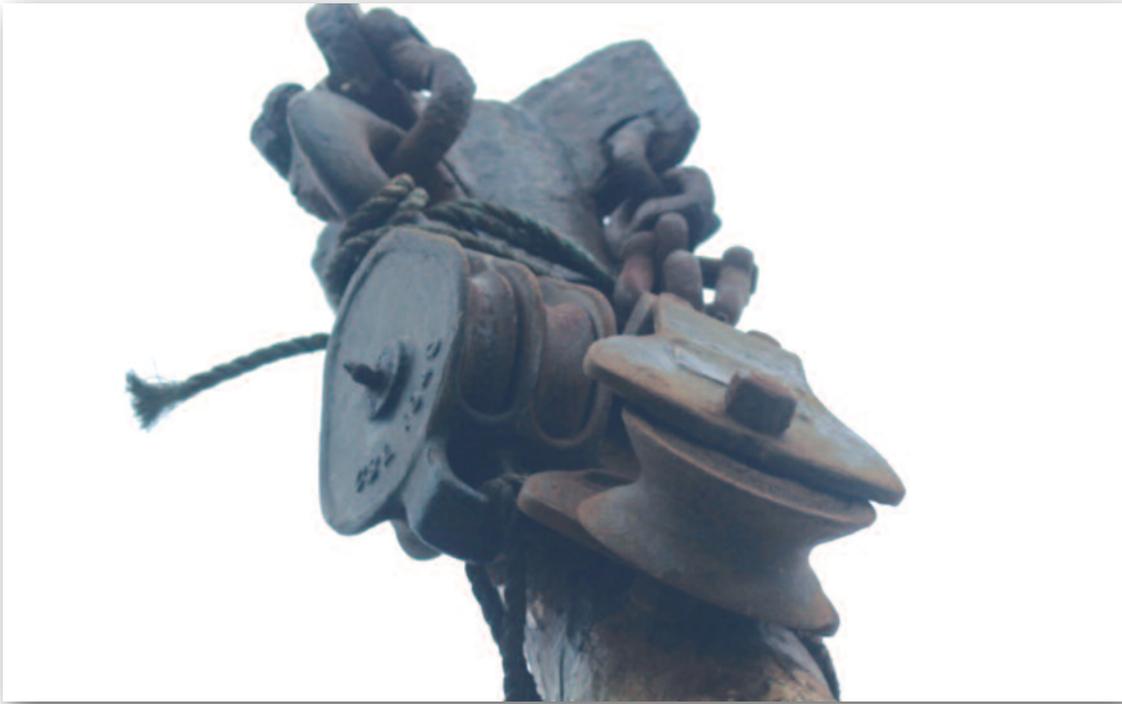
The main components of the lifting equipment were found generally to be in a poor condition with excessive wear apparent. On the head of the lifting derrick two sets of blocks were secured; the block used for the lazy deckie messenger rope was found to be in a badly worn condition. (See Photographs Nos. 5, 6 & 7) and (Photographs Nos. 9, 10, 11 & 12 in Appendix 7.3).

The positioning of the pair of blocks would be prone to jamming ropes passing through one of the blocks.

Photograph No. 5: Arrangement of Blocks on Derrick Head

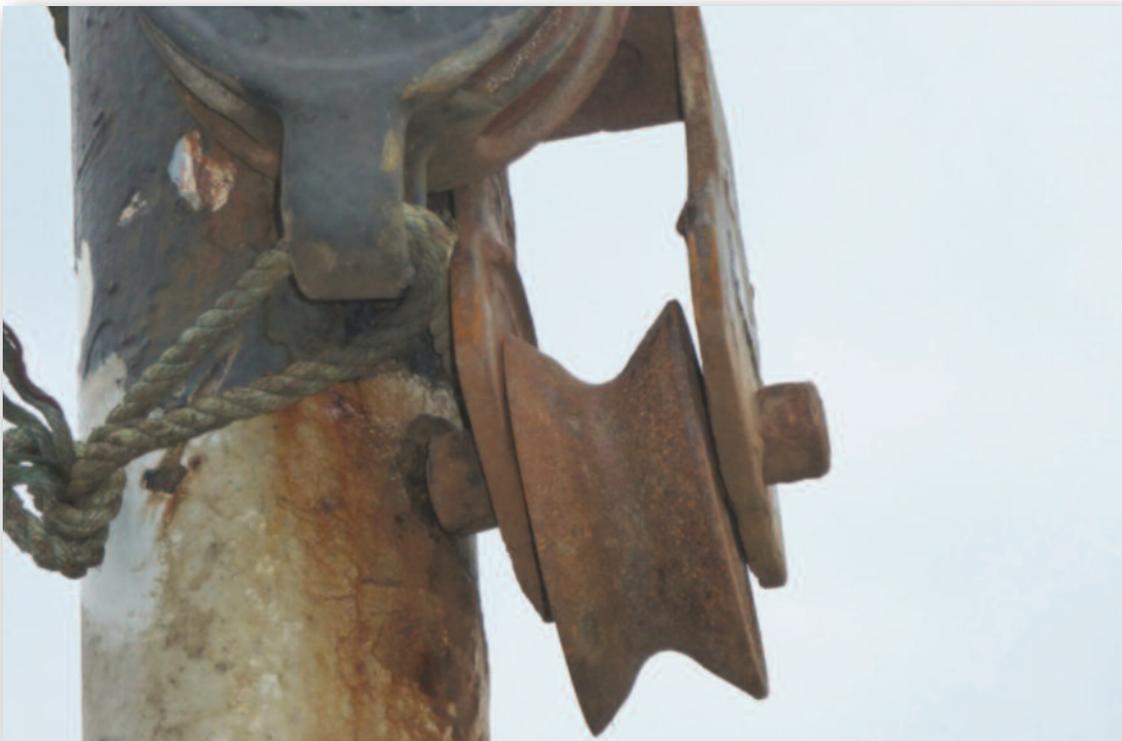
Photograph No. 6: Block at Derrick Head that Lazy Deckie, Split Links & Messenger Rope Passed Over

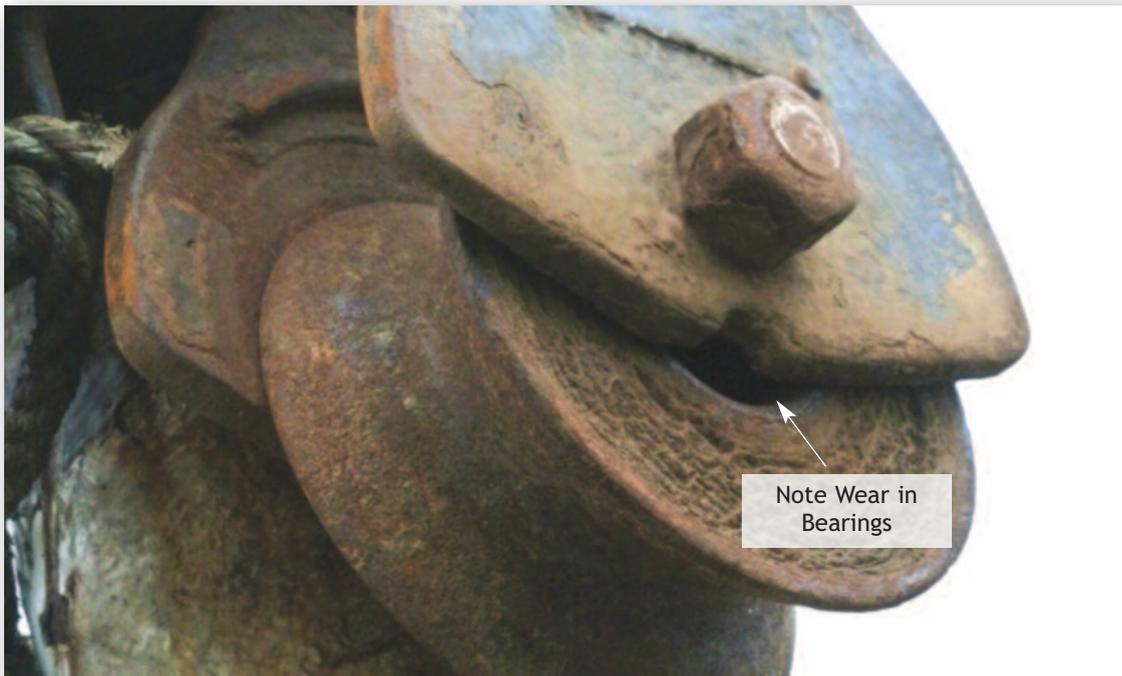
Photograph No. 7: Close-up of Head Block

- 5.4 It is known that the split links used for the joining of the lazy deckie to the messenger rope were not compatible and prone to jamming and that the head block used for the lazy deckie messenger ropes were in a poor condition.

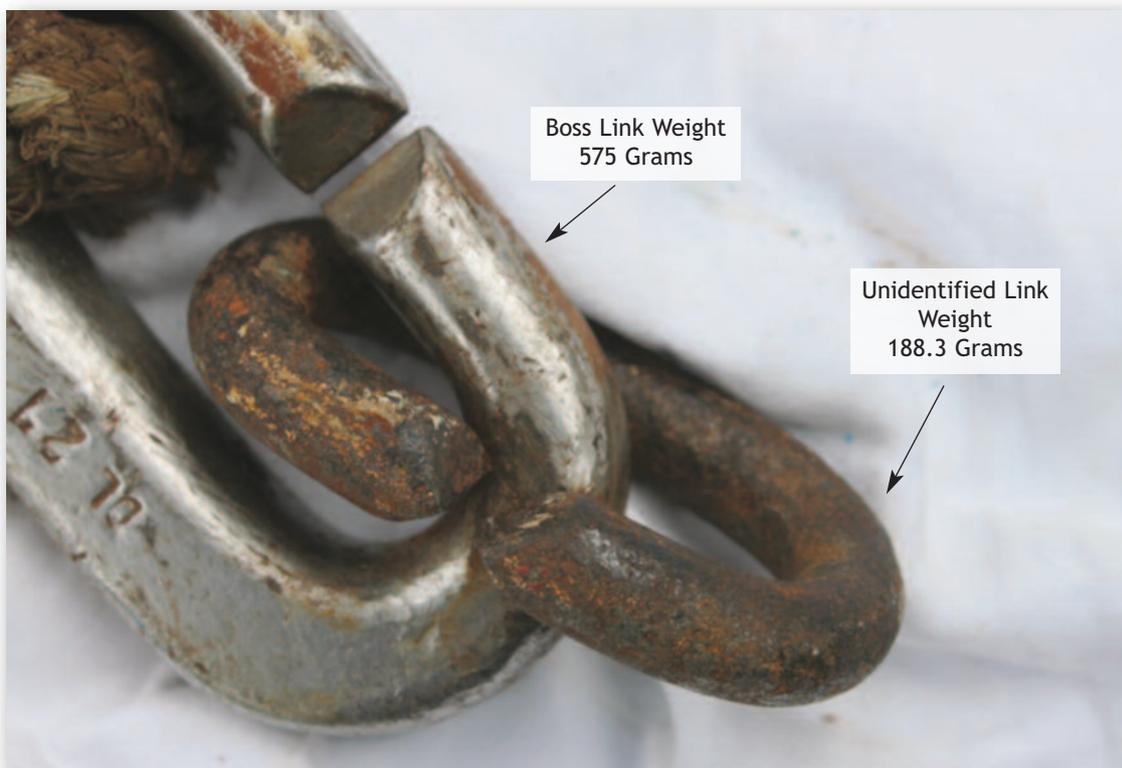
The two split links were of different sizes and on initial inspection they were found to be jammed together and thus would not be able to move freely through blocks and over sheaves (See Photograph No. 8).

Photograph No. 8: Jammed Split Links

If the rope or split links got jammed in the derrick block, the winch could have put forces on the rope or splices that they were unable to withstand. Alternatively, the lazy deckie rope could have been in a poor condition, resulting in its failure.

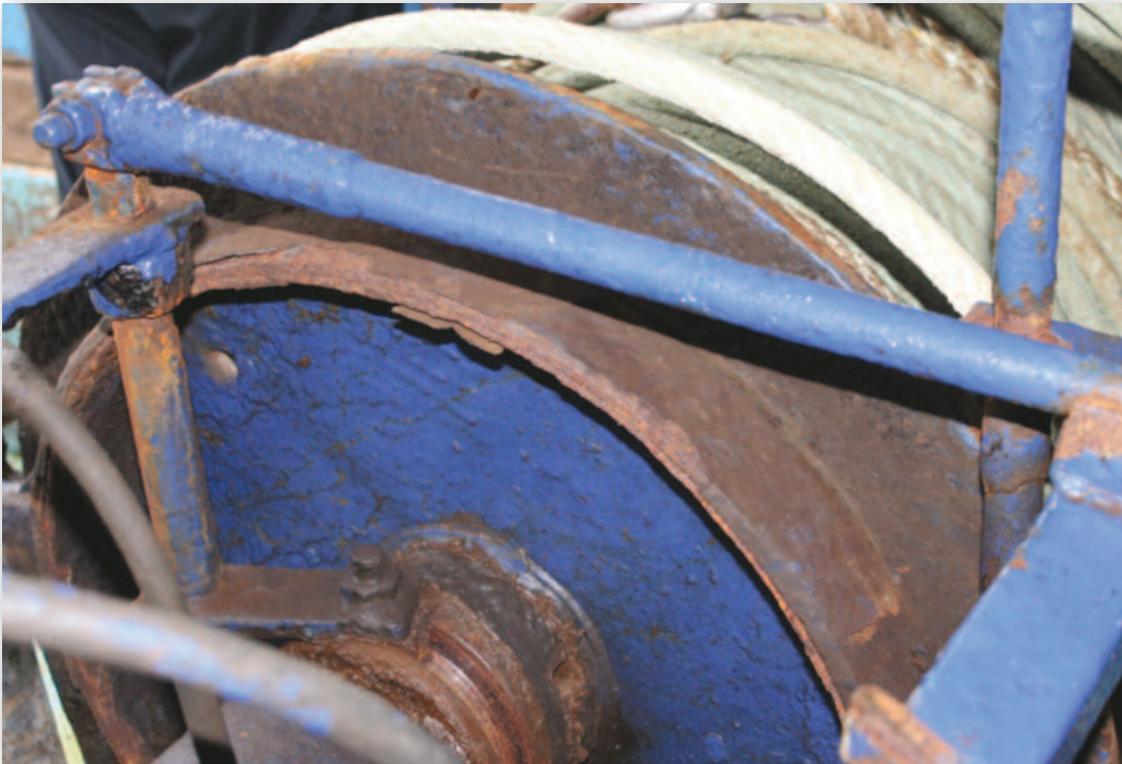
Photograph No. 9: Winch Break Band
Note Excessive Corrosion. The Winch was being used in the Lifting Operations

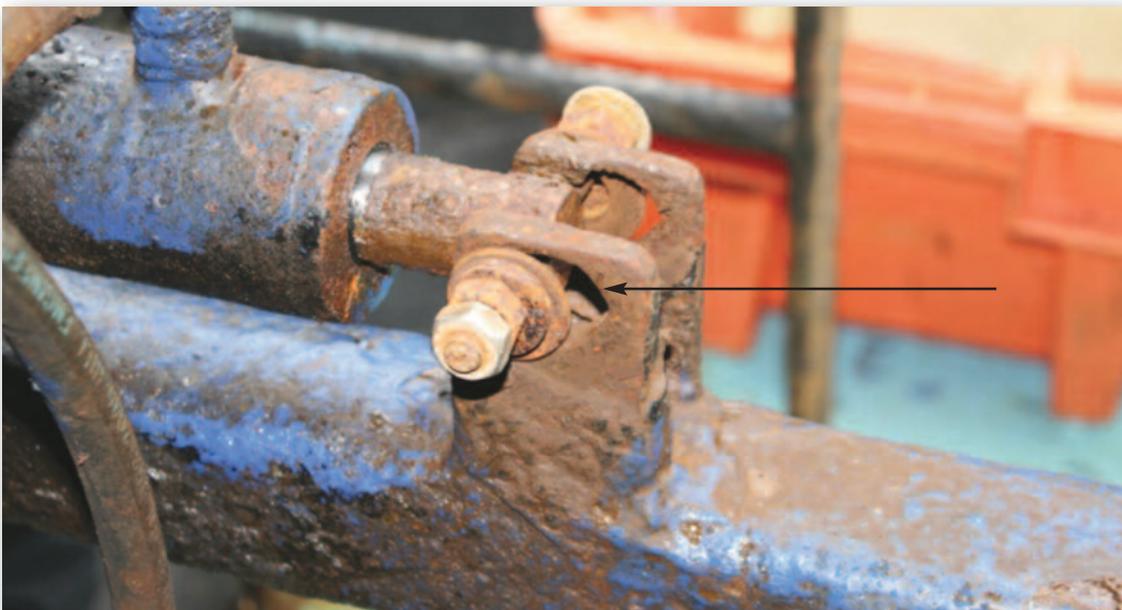
Photograph No. 10: Wear in Winch Guiding on Gear Securing Arrangement

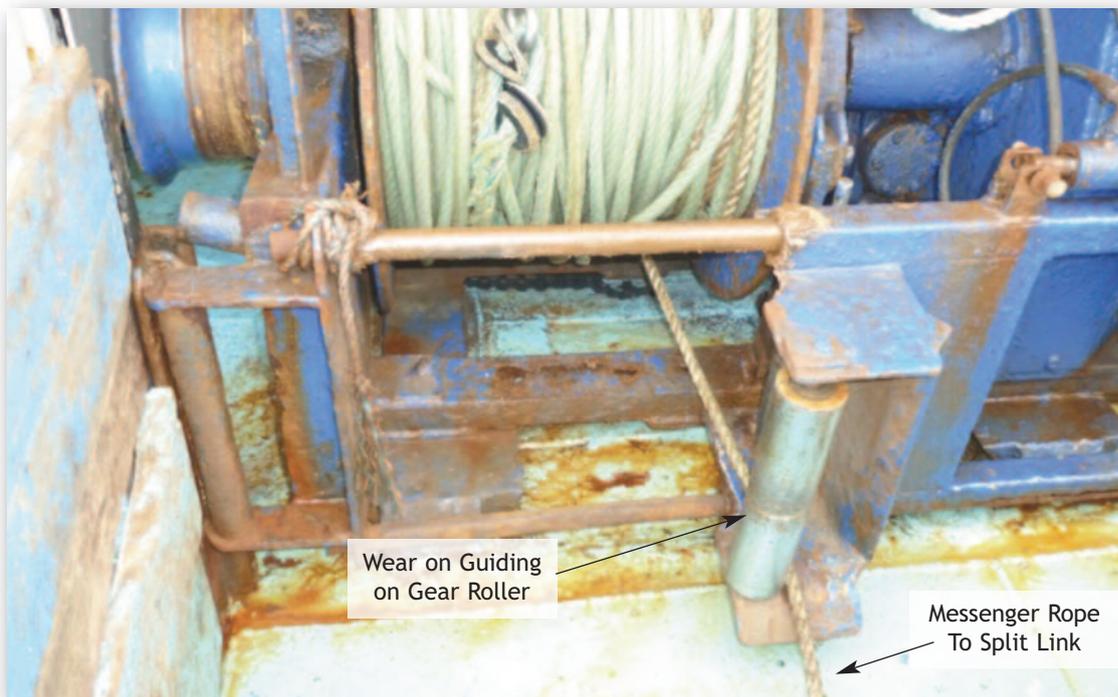
Photograph No. 11: Winch Guiding on Gear
Note Wear on Guiding on Gear Roller

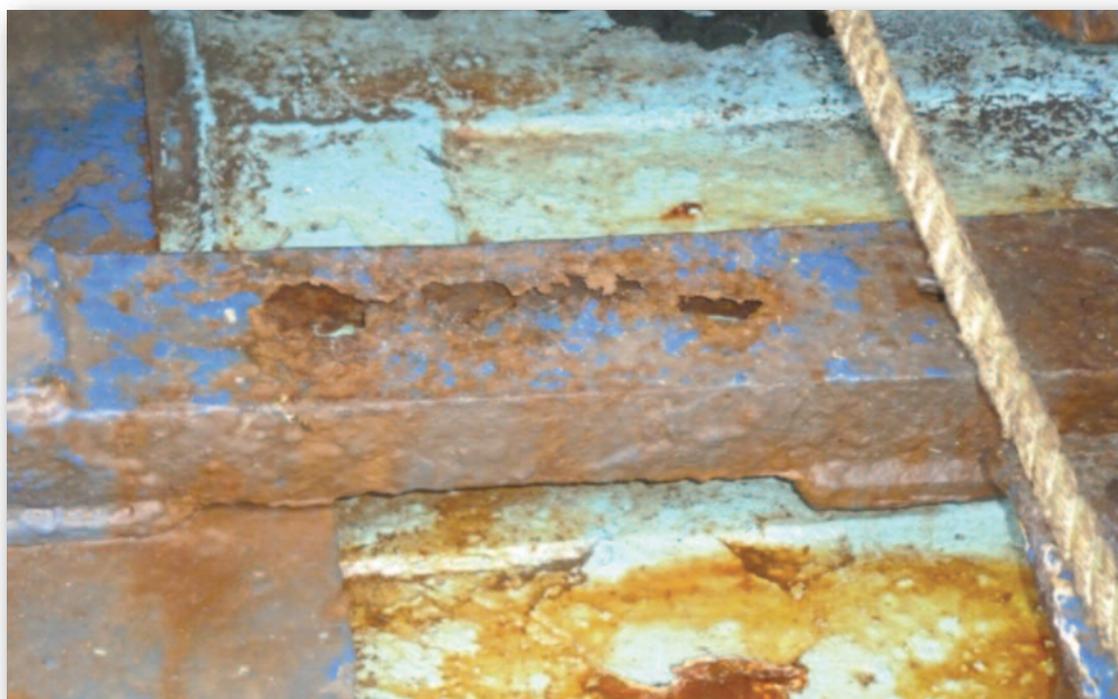
Photograph No. 12: Winch Corroded Foundations
