**REPORT OF THE INVESTIGATION
INTO
THE FATAL INCIDENT INVOLVING
THE “MFV LEONORA JACINTA”
NEAR SALTEE ISLANDS,
CO. WEXFORD
ON
25th NOVEMBER 2013**

**REPORT NO. MCIB/233
(No.3 OF 2014)**

Report MCIB/233 published by The Marine Casualty Investigation Board.
Printed 10th November 2014.

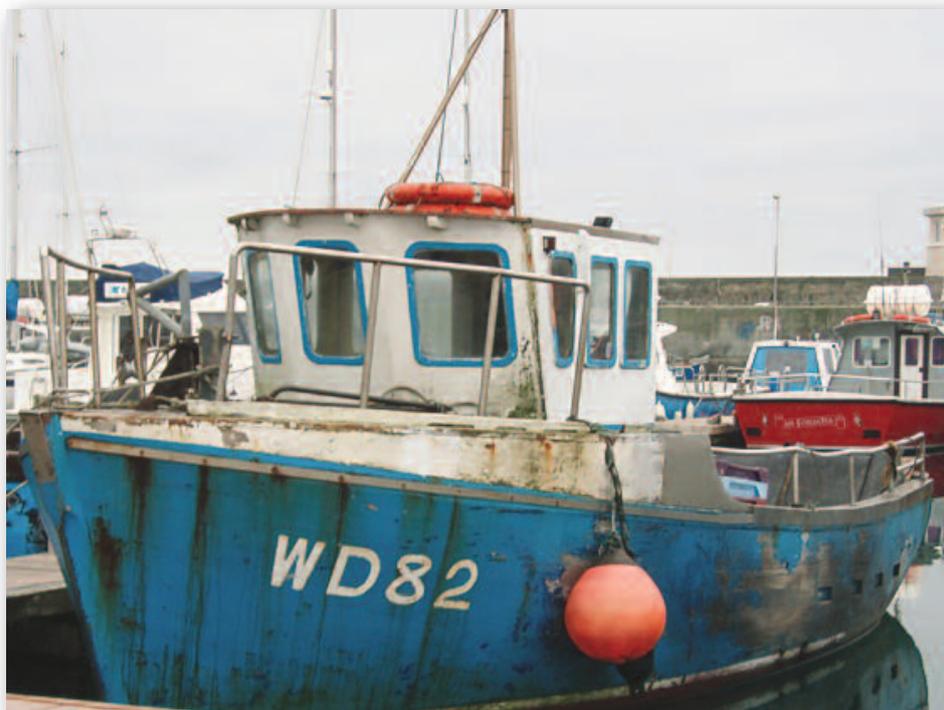
Name:	“MFV Leonora Jacinta”
Type:	Half decked wooden vessel.
Fishing No:	WD 82
LOA:	8.6 metres (m)
Breadth:	3.38 m
Depth:	1.25 m
Year:	1978
Construction:	Wood, pine carvel on oak frames.
Engine:	Ford inboard diesel.
Power:	38.8 kW

Photograph No. 1 - The “MFV Leonora Jacinta”

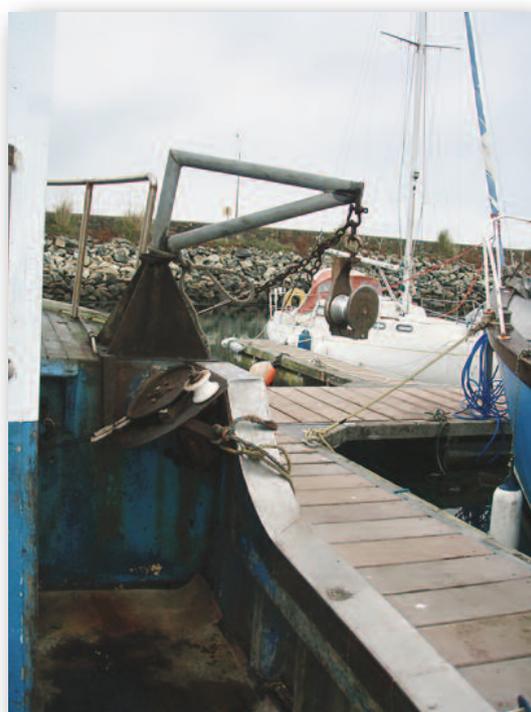
3.1.16 The pot hauler was on the starboard side just outside the wheelhouse door. The height of the gunwale at the pot hauler was 540mm. (See Appendix 7.1 Photograph No. 2).

- 4.2 The height of the gunwale is only just over half a metre at the pot hauler and consequently a person leaning out to cut pots off a line would not have much support from above their knees. The weather was calm with a slight swell, but it would be possible for the vessel to lurch and a person to lose their footing.

The height of the bulwarks and top rails on the "*MFV Leonora Jacinta*" were 950mm which complies with the code. There would be unreasonable interference with working the pot hauler so there were no rails at that point leaving only a bulwark of height 540 mm. This is a 41% reduction in the required height, which is quite significant but allowed because the code does not specify a minimum height.

- 5.1 It is considered likely that the owner of the “*MFV Leonora Jacinta*” fell overboard whilst cutting pots free from a fouled line.
- 5.2 It is not possible to determine the exact circumstances, which led to the owner falling overboard. The low height of the bulwark and absence of higher rails meant a person working at the pot hauler had little or no support.

Photograph No. 2 - The position of pot hauler, note low bulwark

- 6.1 That the Minister for Transport, Tourism and Sport should consider amending the “Code of Practice for Fishing Vessels under 15 m LOA” section 6.1.2 Bulwarks, Guard Rails and Hand Rails so that a minimum height of rail/bulwark is stipulated.
- 6.2 The Minister for Transport, Tourism and Sport should issue a Marine Notice reminding fishers of their obligation to wear a Personal Flotation Device (PFD) while on deck in accordance with S.I. No. 586/2001, as amended.

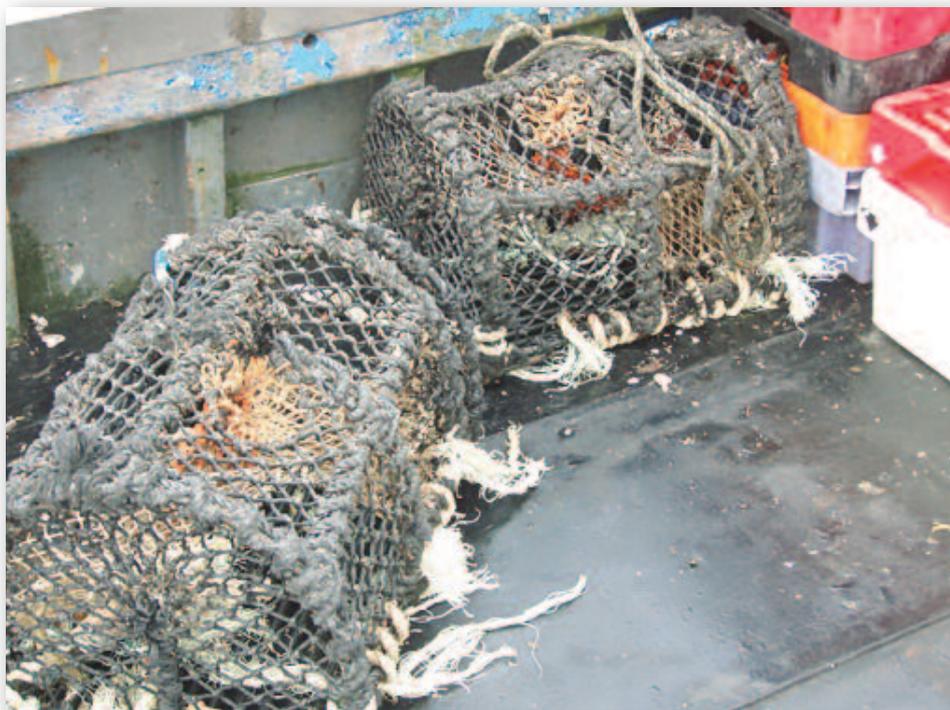
3.1.17 There were two pots on the aft deck, which showed signs of being recently cut from the line. (See Appendix 7.1 Photograph No. 3).

- 4.1 The intended operation to recover lost pots had begun as there were two pots cut away from the line on the deck of the vessel when it was found. In addition the engine was running to provide power for the hydraulic pot hauler.

Photograph No. 3 - Two pots cut off as found on vessel

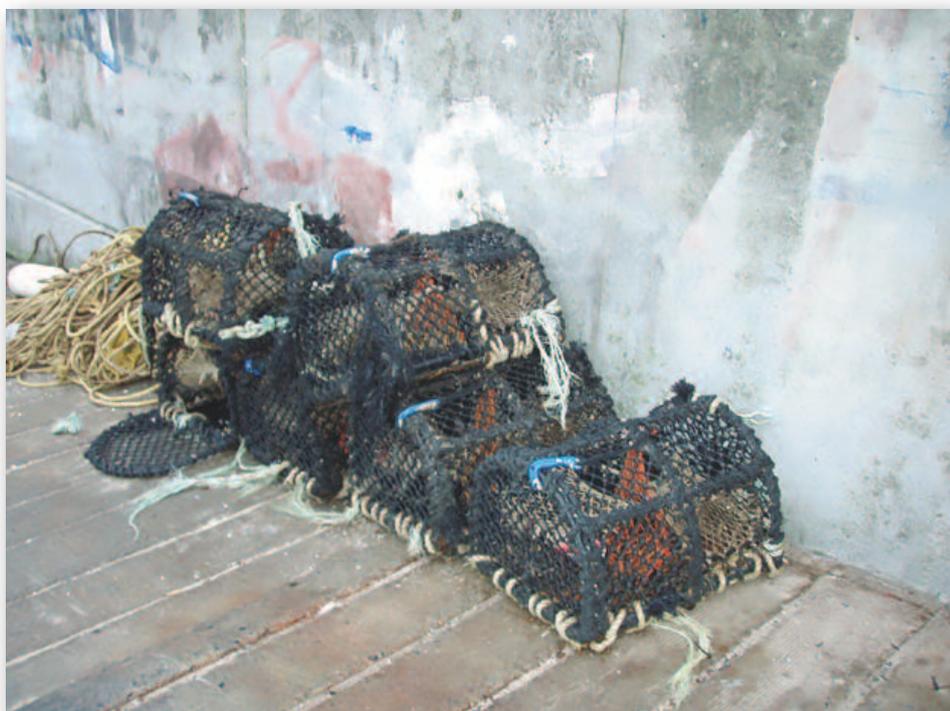
3.1.18 The line of pots was examined and parts of the line were observed to have clean ends indicating that the pots had been recently cut off. (See Appendix 7.1 Photograph No. 4).

Photograph No. 4 - Remainder of pots recovered from sea
