**REPORT OF THE INVESTIGATION
INTO THE SINKING OF
“MFV MOLLY’S QUEST”
ROSSLARE, CO. WEXFORD
ON
15th JULY 2014**

**REPORT NO. MCIB/239
(No.7 OF 2015)**

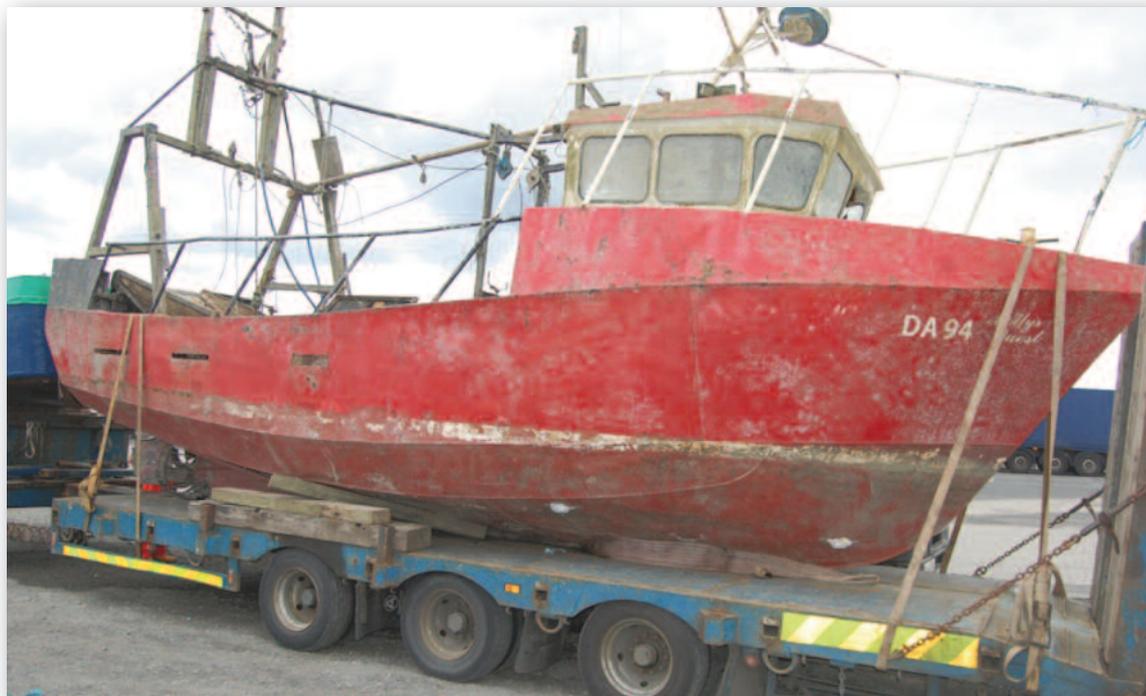
- 4.1 The vessel was recovered on 19th of August 2014 by a local salvage firm approximately 1.1 N.M. from the coast in approximately 4 m of water (See Appendix 7.2 Chart of incident area) and placed on the hard on the west pier of Rosslare Harbour (See Appendix 7.3 Photograph No. 1).

Photograph No. 1 - Vessel after recovery

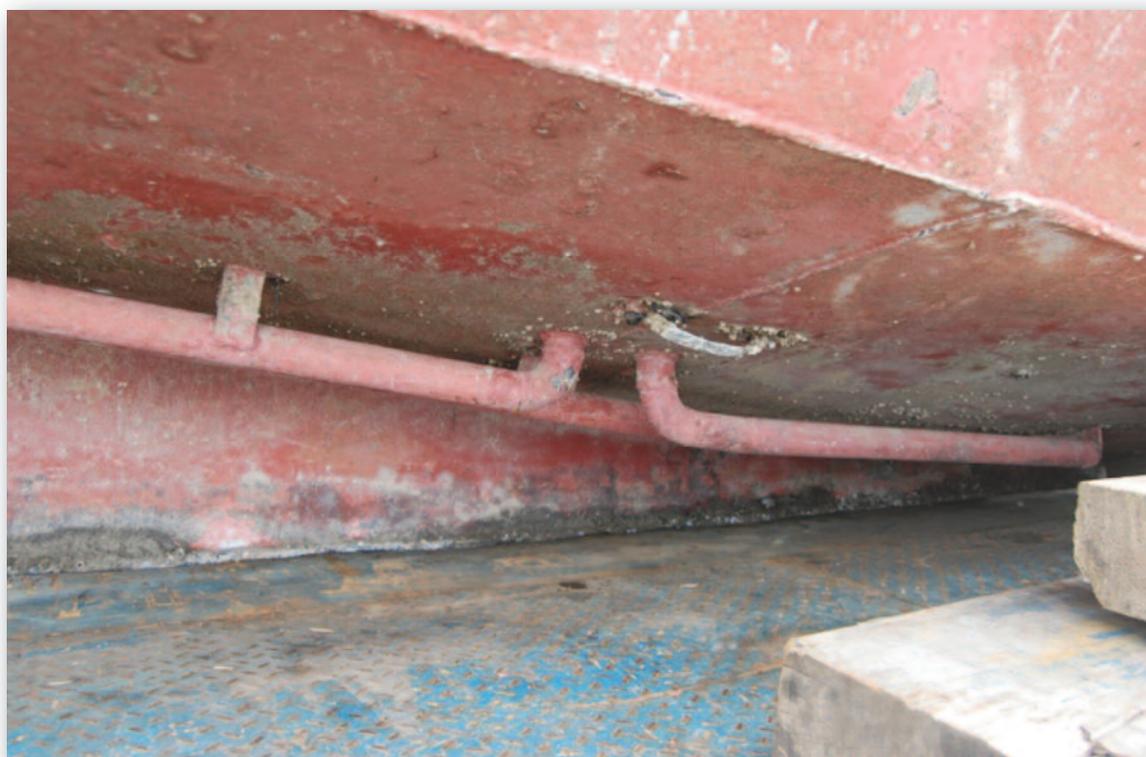
- 4.2 The hull was found to be generally in good condition, with no large impact marks or obvious signs of cracks in welds. The steel coatings inside and outside were in good condition (See Appendix 7.3 Photograph No. 2).

Photograph No. 2 - Vessel after recovery

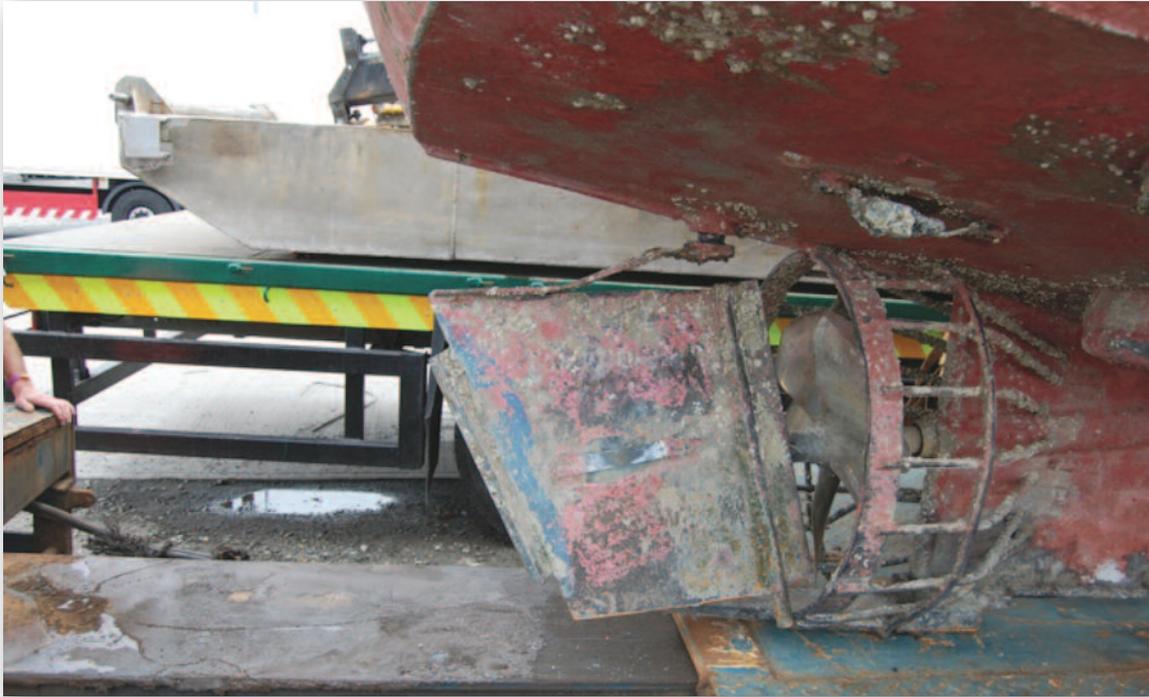
- 4.3 The rudder and propeller were both damaged, however the salvage company confirmed that this was done during the recovery processes (See Appendix 7.3 Photograph No. 3).

Photograph No. 3 - Showing damage to rudder and propeller

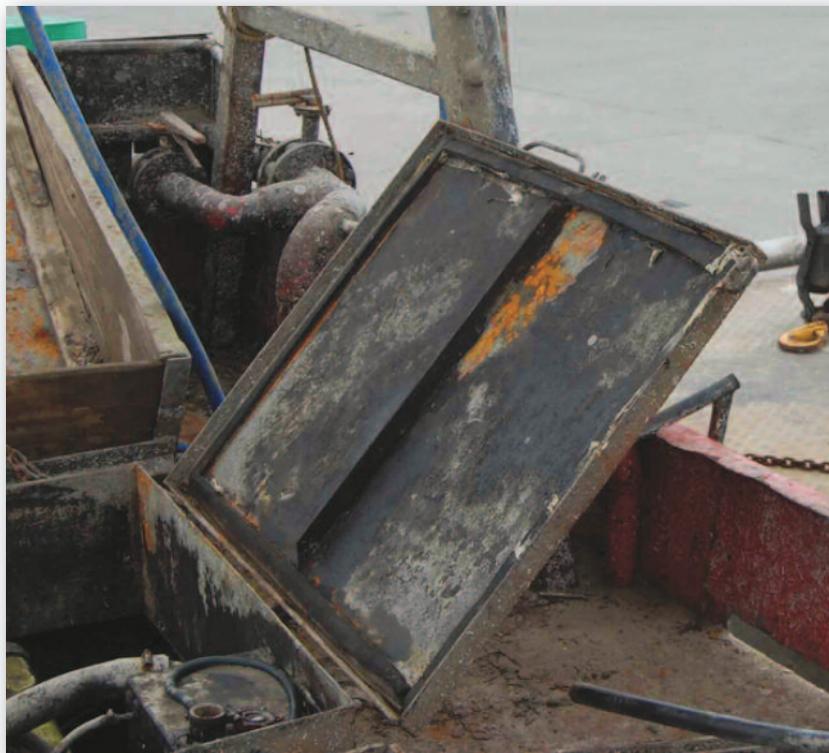
- 4.5 The vessel's two deck hatches were found to have good seals and good securing arrangements. However these securing arrangements were found to be undone on both hatch covers (See Appendix 7.3 Photograph No. 4).

Photograph No. 4 - Showing hatch cover

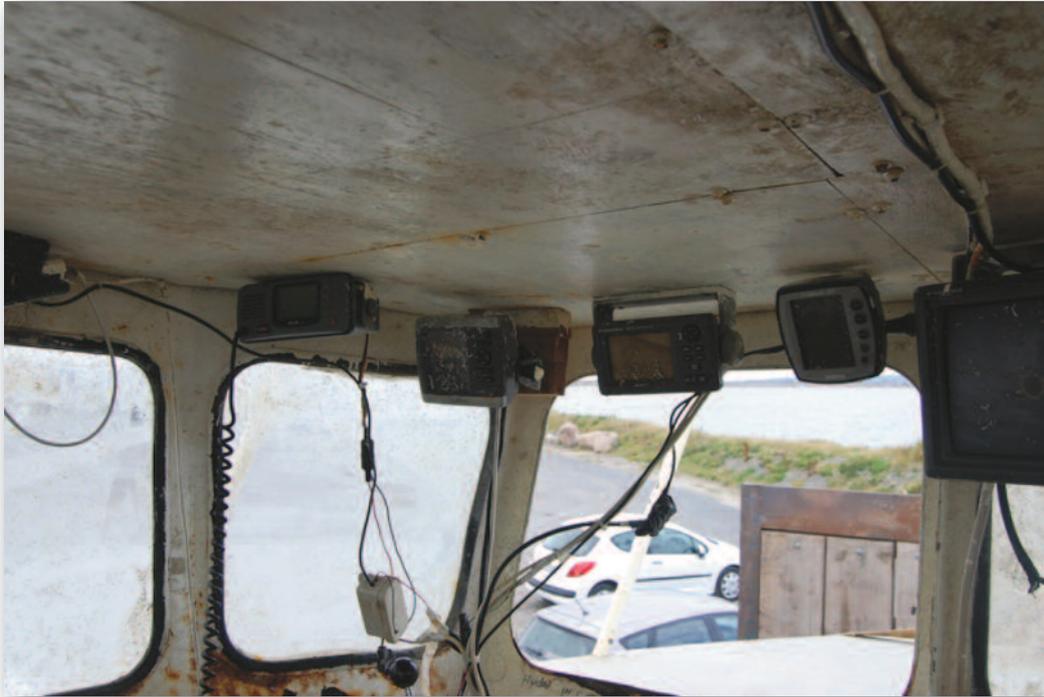
- 4.6 The wheelhouse door was no longer on the vessel, most probably lost during the period that the vessel remained on the seabed or during salvage.
- 4.7 The wheelhouse itself was found to be structurally sound, however, the equipment and console had all shifted, with much of it on the floor and in the forward compartment. The portside wheelhouse window was found in the wheelhouse space. The glass was unbroken, suggesting that it probably came out as a result of hydrostatic pressure rather than impact from waves (See Appendix 7.3 Photograph No. 5).

Photograph No. 5 - Showing wheelhouse with missing window

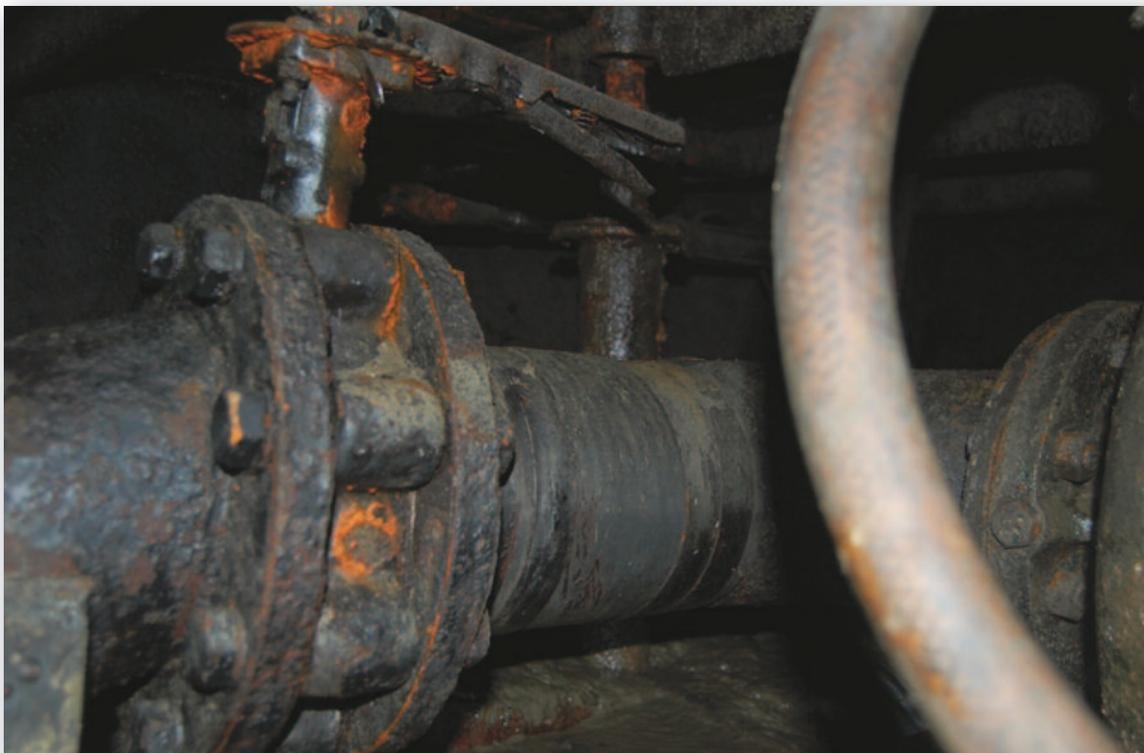
- 4.9 The engine seacocks and pump piping were found to be watertight with no sign of damage (See Appendix 7.3 Photograph No. 6).
- 4.10 The dredge gantry appeared to be at least three to four years old as there were several layers of paint on it (See Appendix 7.3 Photograph No. 7).

Photograph No. 6 - Showing Dredging cage water pump

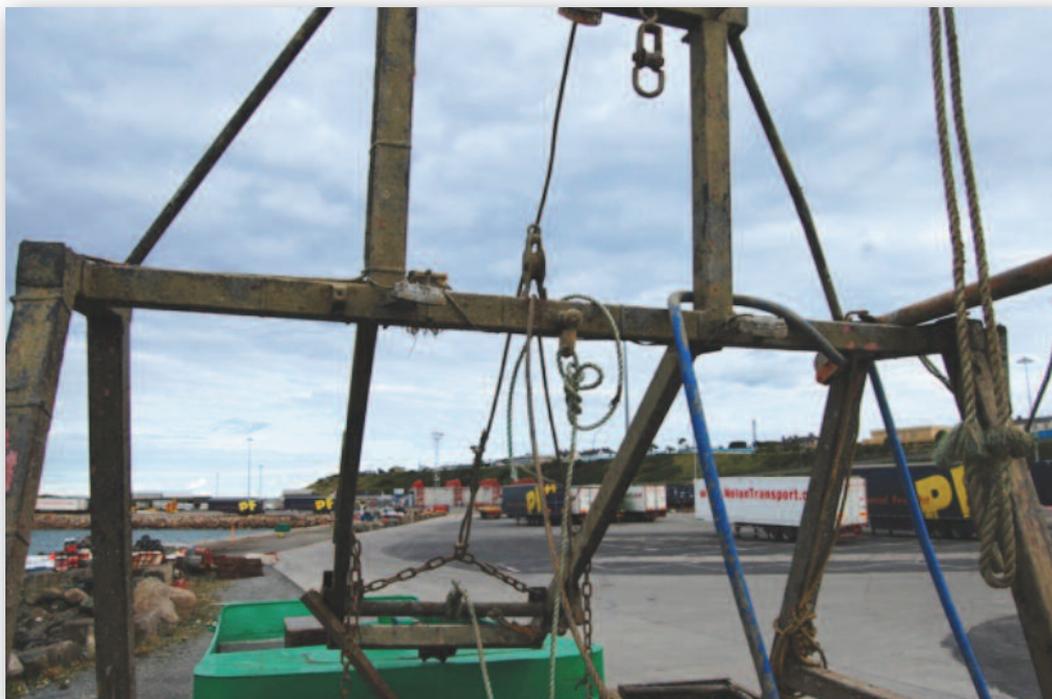
- 5.2 The vessel had been operated as a razor-dredging vessel for at least four years before the incident and had remained largely unmodified over that period. This is supported by the fact that the gantry had several seasons of paint applied to it, and that there were no signs of fresh welding other than a minor repair on the gantry cross beam.

Photograph No. 7 - Showing Gantry

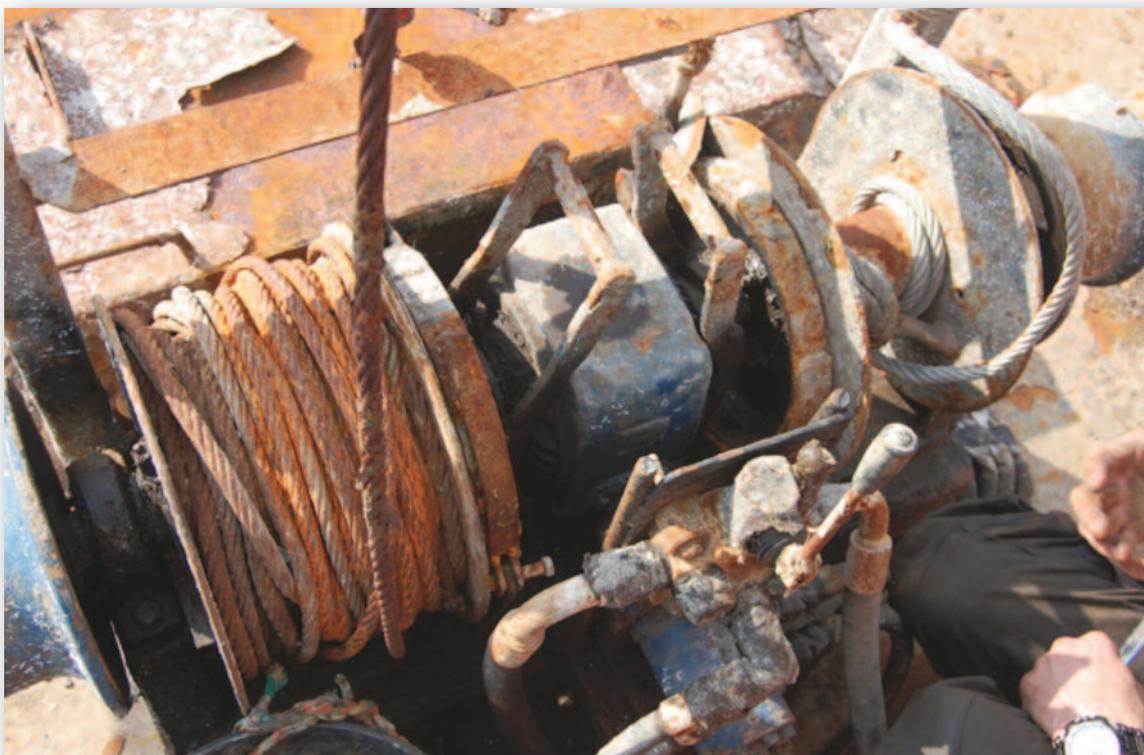
- 4.11 The lifting cables for the dredging cage were found wound up on the winch reels and the lifting cable had been disconnected from the cage (See Appendix 7.3 Photograph No. 8).

- 5.5 The dredging cage lifting cables were found rolled up on the winch, indicating that the dredging cage was above the surface at the time of the incident and therefore it could not have become fast on the seabed.

Photograph No. 8 - Showing the Dredging cage lifting winch with lifting line wound up
