**REPORT OF THE INVESTIGATION
INTO THE FATAL INCIDENT
INVOLVING
'MV CARA ROSE'
BROADHAVEN BAY,
CO. MAYO
ON
11th SEPTEMBER 2015**

**REPORT NO. MCIB/248
(No.5 OF 2016)**

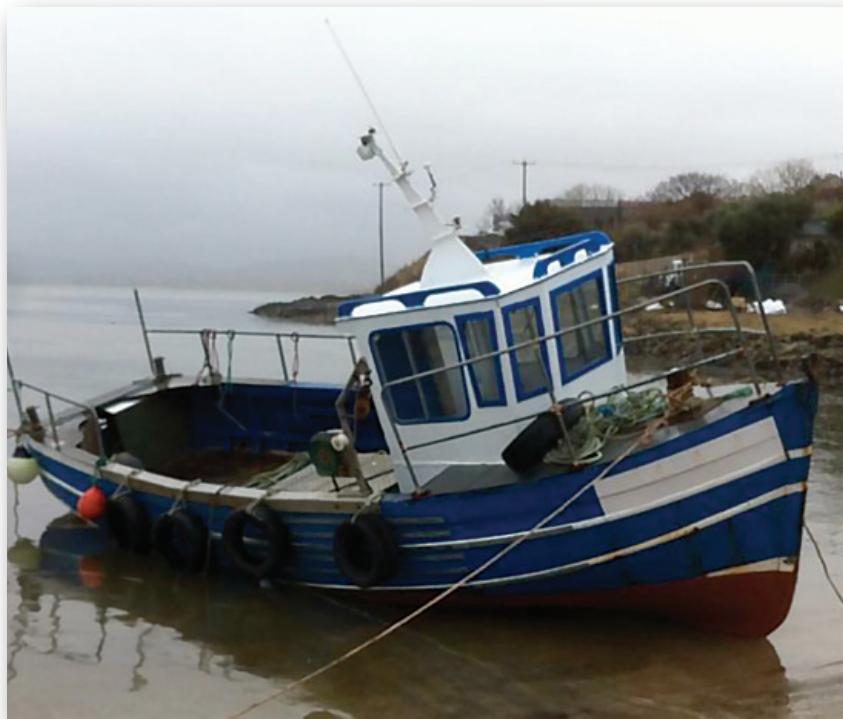
The hull of the vessel was of wooden carvel construction with a raked stem and transom stern. The frames were of oak and hull planking pine. The fore part was decked with plywood and there was a small plywood wheelhouse/cuddy forward. The vessel had a hydraulic pot hauler on the starboard side just outside the wheelhouse door. The hydraulic power was supplied by a pump driven from the main engine. The deck planking aft was not watertight and there were no freeing ports at deck level. There were steel side rails bolted to the top of the gunwales, except along the starboard side.

Photograph No. 1: 'MV Cara Rose'.

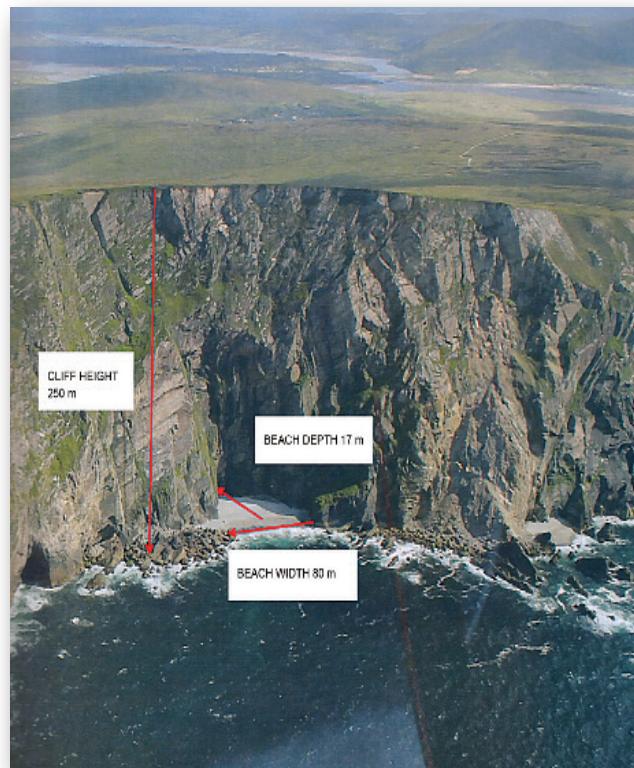
- 3.5 At 19.04 hrs Ballyglass Lifeboat sighted a vessel on the shore under the cliffs at approximate position 54°20.6’N 009°48.5’W. The vessel was bow on to a shingle beach under the cliffs at Benwee Head (See Appendix 7.1 photograph No. 2). The lifeboat sent an inflatable boat to the vessel and two crew boarded the vessel. They did not find anyone on-board. The navigation lights were on and VHF radio and navigating equipment were powered up. They identified the vessel as the ‘*MV Cara Rose*’. The lifeboat crew reported the vessel was damaged with some of the planking and gunwale on the starboard side missing. The water was surging inside the vessel. Due to freshening wind and sea the inflatable boat had to withdraw.

Photograph No. 2: Cliffs at Benwee head - showing beach where
'MV Cara Rose' came ashore.

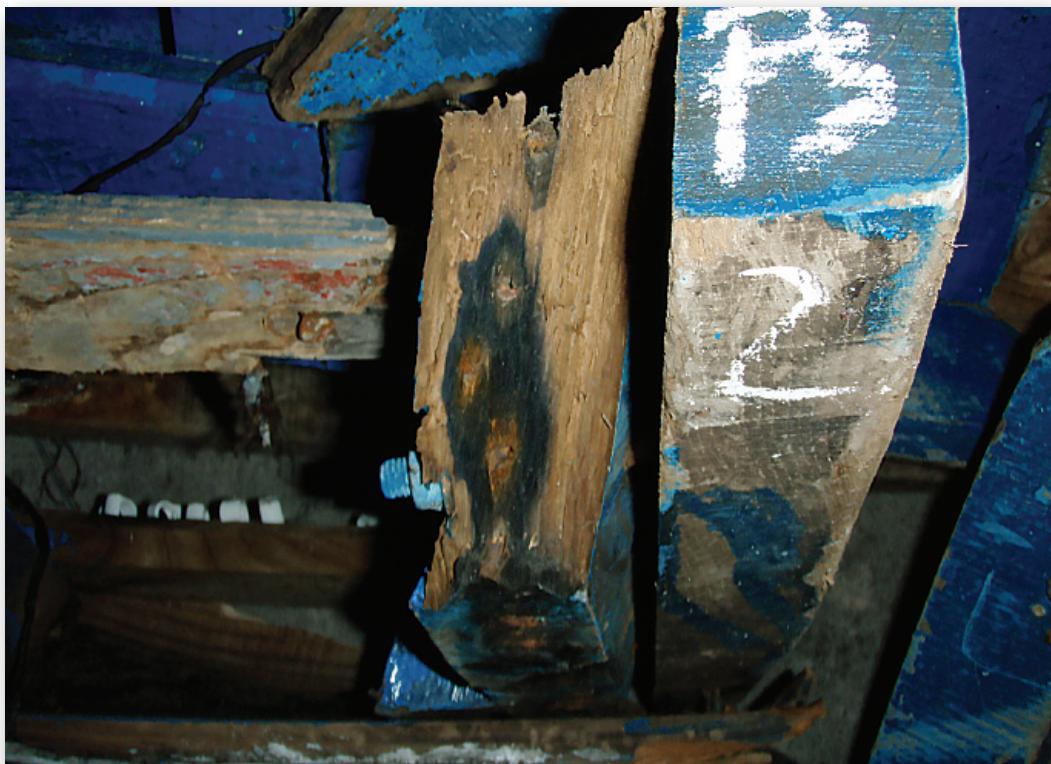
- 3.11 Examination of the woodwork recovered shows that there was no rot or decay in the woodwork. However there was evidence that some of the oak frames were cracked prior to the breakup of the vessel on the 11th September. Frames that were broken by wave action showed a clean light coloured break (See Appendix 7.1 photograph No. 3) of a port side frame close to the deck. There is some staining from metal fittings but the break is recent and clean. By comparison the breaks on the frames under the starboard bulwark are dark and stained, (See Appendix 7.1 photographs Nos. 4 & 5). All the eight frames under the starboard bulwark (which had the aluminium capping) exhibit evidence of being cracked for some time before the 11th September.

Photograph No. 3: Frame from port side, showing fresh break.

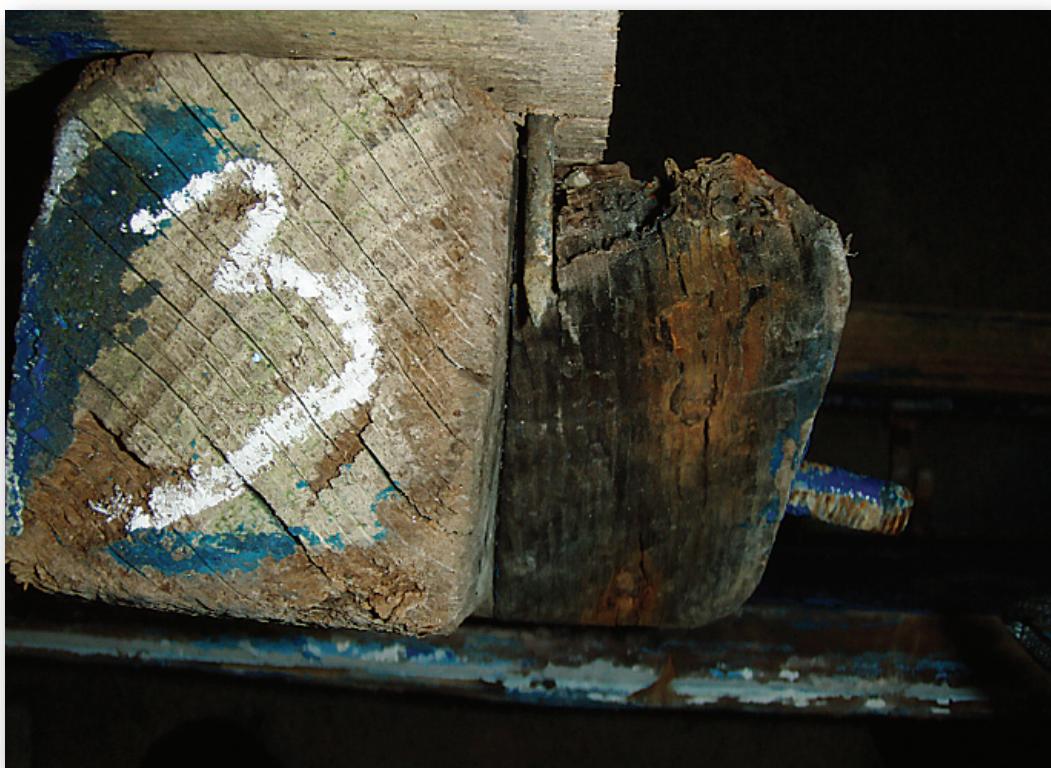
Photograph No. 4: Frame from Starboard side, showing old break.

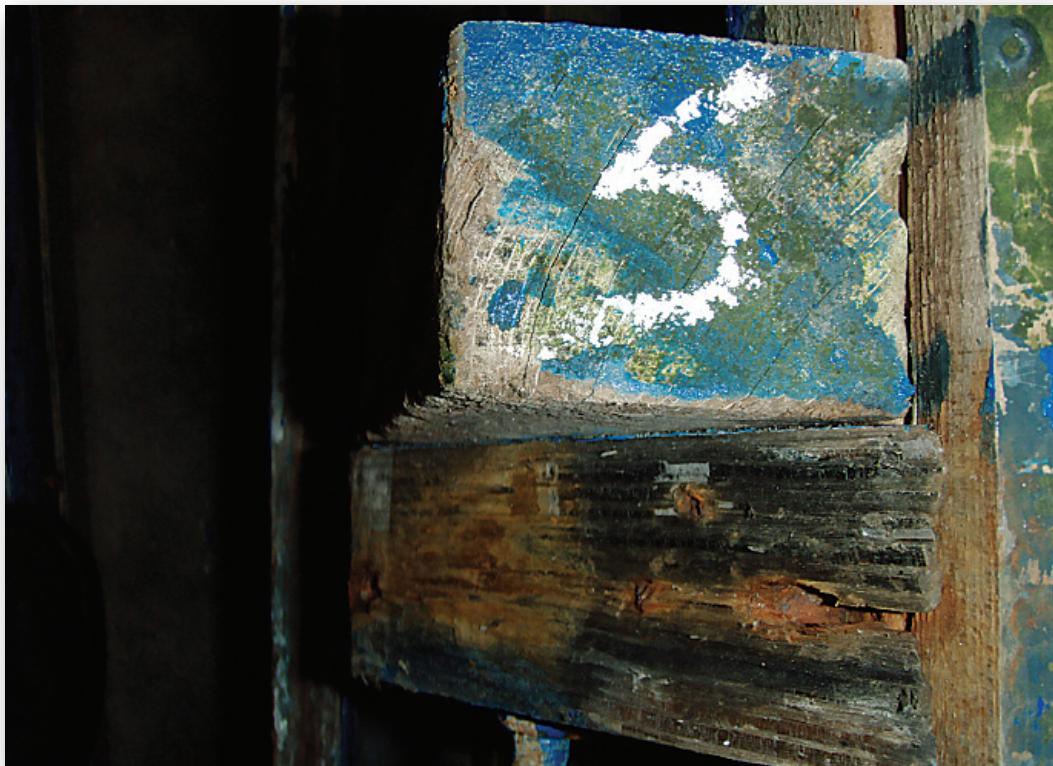
Photograph No. 5: Another frame from Starboard side, showing old break.

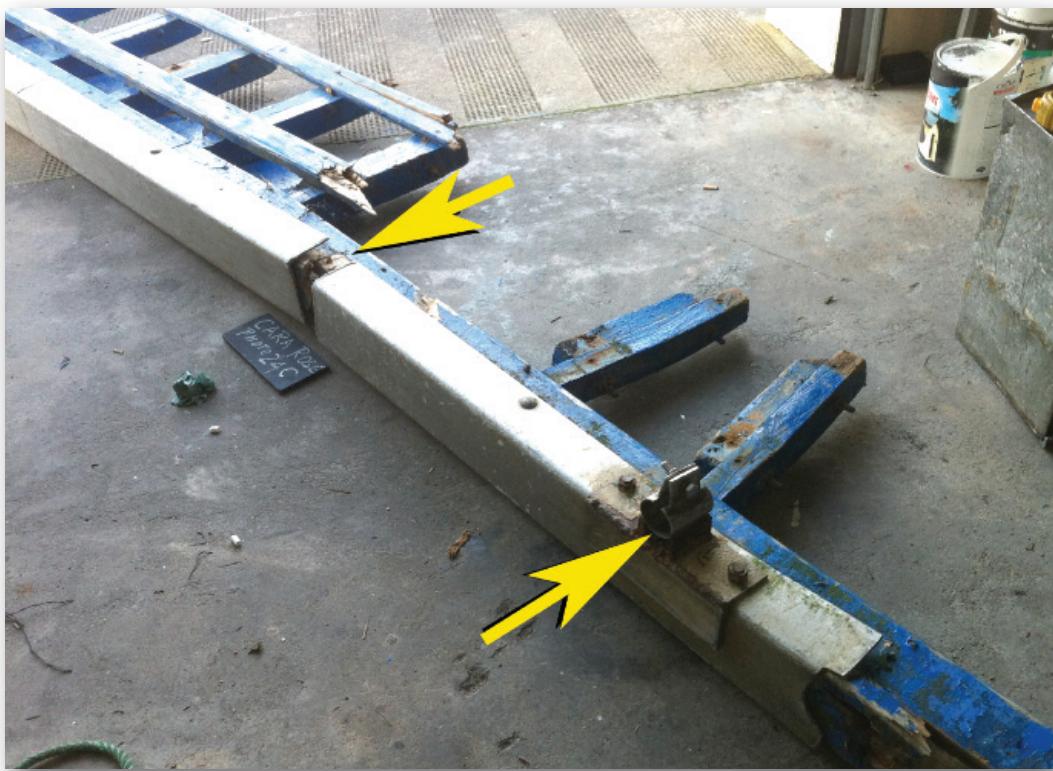
- 3.12 The starboard bulwark was recovered from the water. It was in two sections (See Appendix 7.1 Photograph No. 6). The forward section had the upper fitting which supported the pot-hauler. The bulwark was capped with an aluminium alloy channel bar which was in three sections welded together. The wood parts of the bulwark were broken at the forward welded joint. Inspection of the weld showed that it had failed before the 11th September as the edges of the aluminium were dull and rounded (See Appendix 7.1 Photograph No. 7). Close inspection of the wooden side planking show that it had been broken with some force in an outboard direction (See Appendix 7.1 Photograph No. 8). Examination of the other pieces of side and bottom planking did not show impact damage from the outside indicating that the vessel may have come in contact with rocks before becoming stranded on the beach.

4.1.2 The cause of the failure can be attributed to the fitting of the pot-hauler. From photographs of the vessel it can be seen that the top of the hauler gantry is about 800mm above the gunwale with all the strain being borne by the top of the gunwale. This 800mm acts as a lever magnifying the load applied. At some point the weld in the aluminium channel bar aft of the hauler failed. The strain was now borne by the wooden structure underneath which would move when put under strain and transfer this to the oak frames at the base of the structure leading to the cracking observed in the oak frames (Ref. 3.11). The stress on this structure was not only that imposed by the power of the hauler alone, but also the shock loads imposed as the vessel moved in a seaway under the influence of sea, wind and tides. Over time the structure had weakened until it failed. Once the arm of the hauler was not vertical the base was pulled from the socket in the deck and the hauler was pulled overside, tearing the reservoir tank loose and ripping the hoses off.

Photograph No. 6: Remains of Starboard Bulwark (inboard side) showing fracture point (upper arrow) - upper socket for pot hauler (lower arrow).

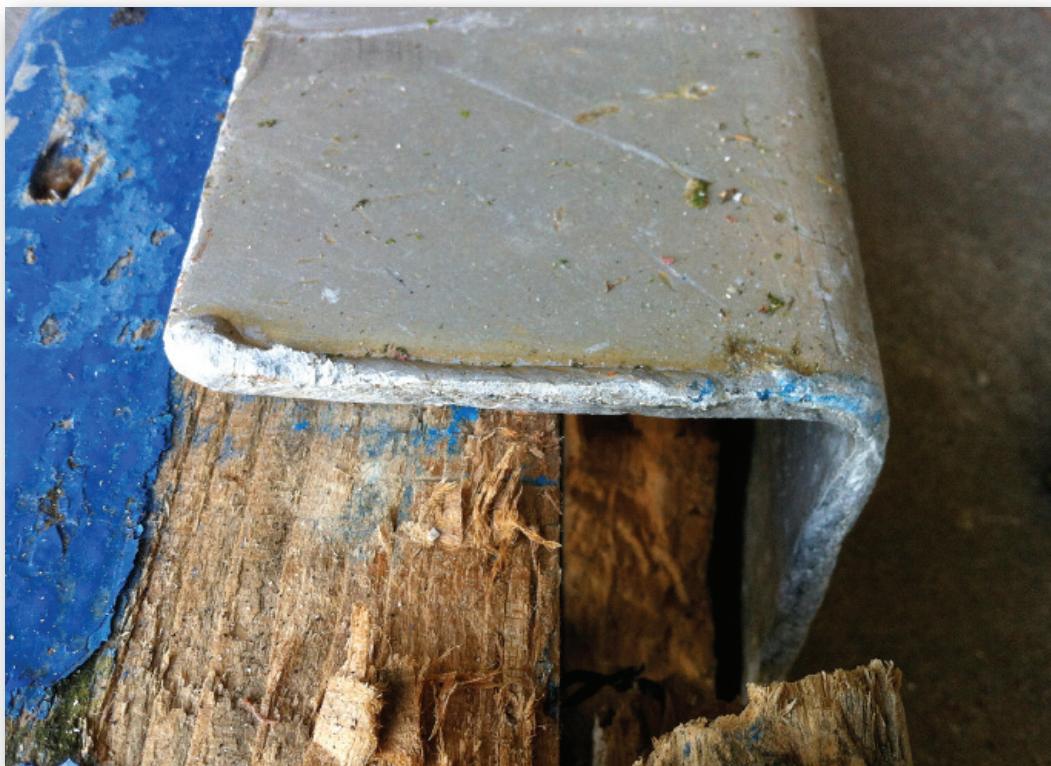
Photograph No. 7: Close up of fracture - note dull appearance of aluminium weld fracture.

MCIB RESPONSE: All items were in the water and would have changed to some degree. This has been taken into account. If the aluminium weld had broken during the incident the edge would have been sharp and rough, as it was worn smooth it is more likely that it was due to the two sections rubbing together.

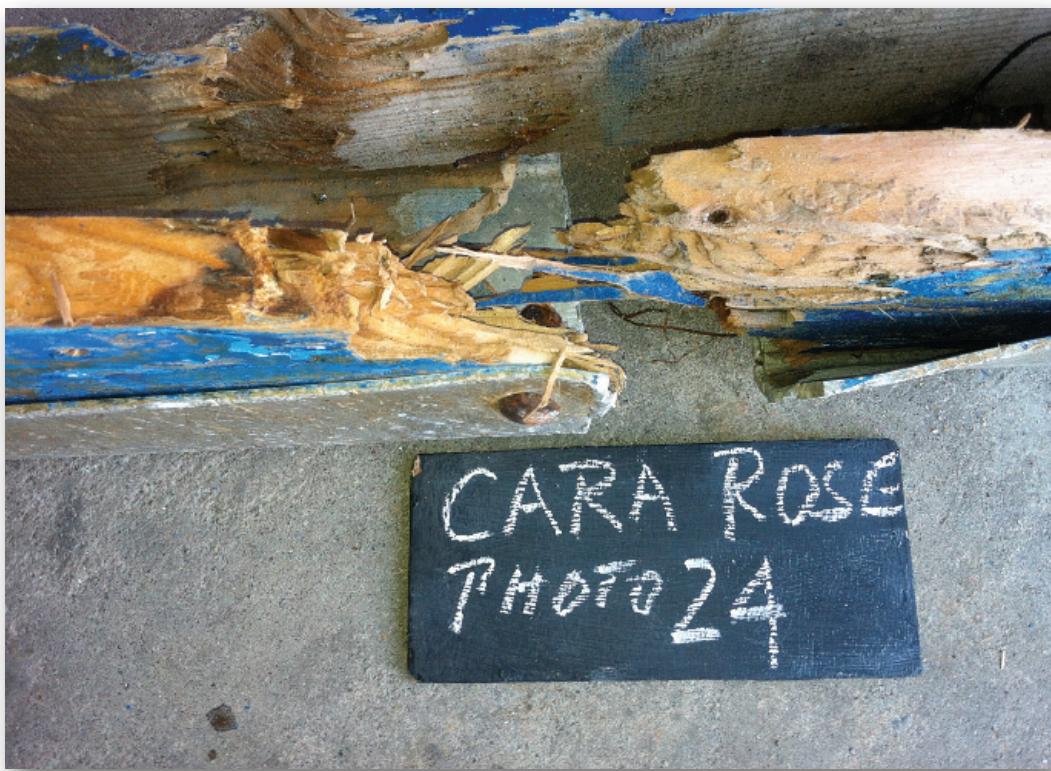
Photograph No. 8: Fractured bulwark wood - Splinters in outward direction.

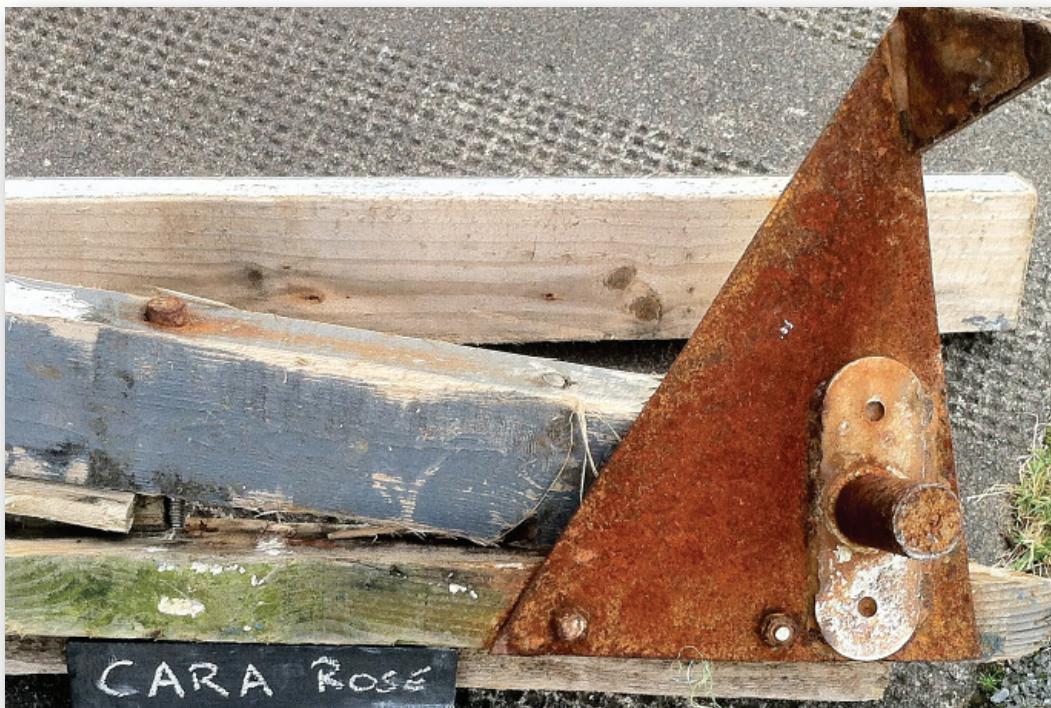
- 3.13 Sections of deck beams were recovered and the lower fitting for the pot hauler was attached to one of these. Examination shows that there was no hole for a retaining pin or securing arrangement (See Appendix 7.1 Photograph No. 9).

Photograph No. 9: Lower Socket for pot hauler secured to deck beam.

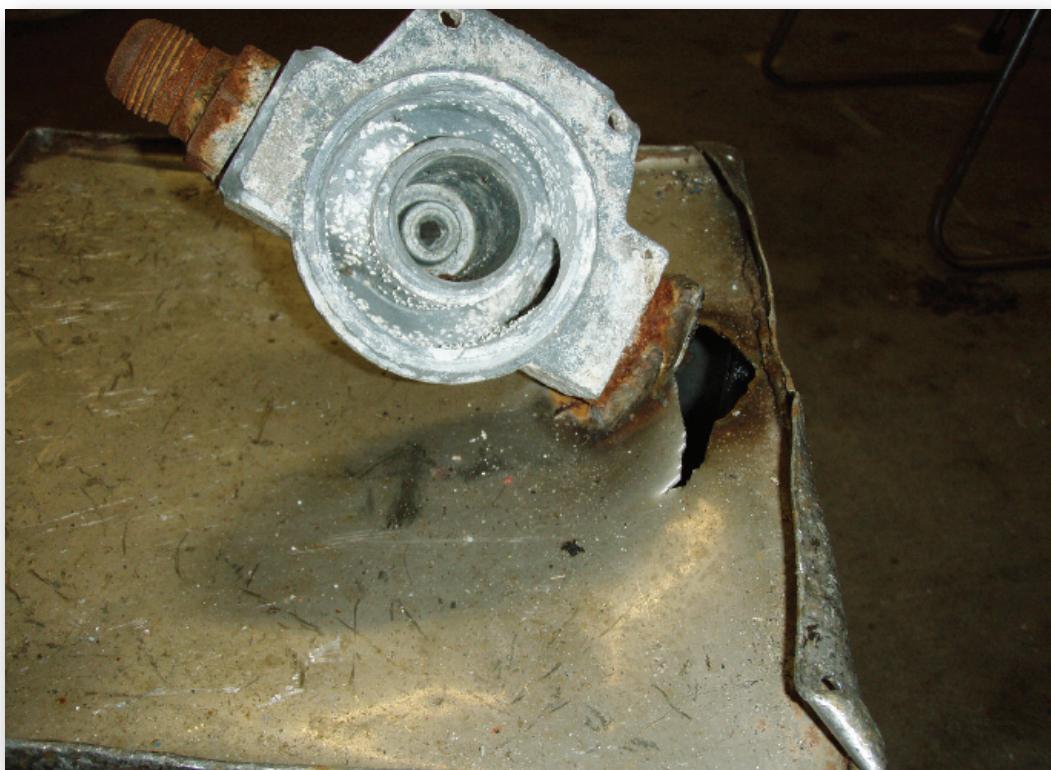
- 3.14 The stainless steel reservoir for the hydraulic winch hauler was recovered by divers close to the main wreck. This was a 430 x 300 x 300 mm tank welded in 3mm thick stainless steel. There were no hydraulic hoses attached to the tank and its securing points were bent and distorted. The filter casing on the tank had been pulled sideways so the tank had fractured and torn (See Appendix 7.1 Photograph No.10).

Photograph No. 10: Hydraulic oil reservoir for pot hauler - pipes torn off and steel torn by force.
