**REPORT OF THE INVESTIGATION
INTO THE BOTTOM CONTACT
OF THE
'M.V. CIELO DI MONACO'
AT GREENORE PORT
ON
28th SEPTEMBER 2015**

**REPORT NO. MCIB/250
(No.8 OF 2016)**

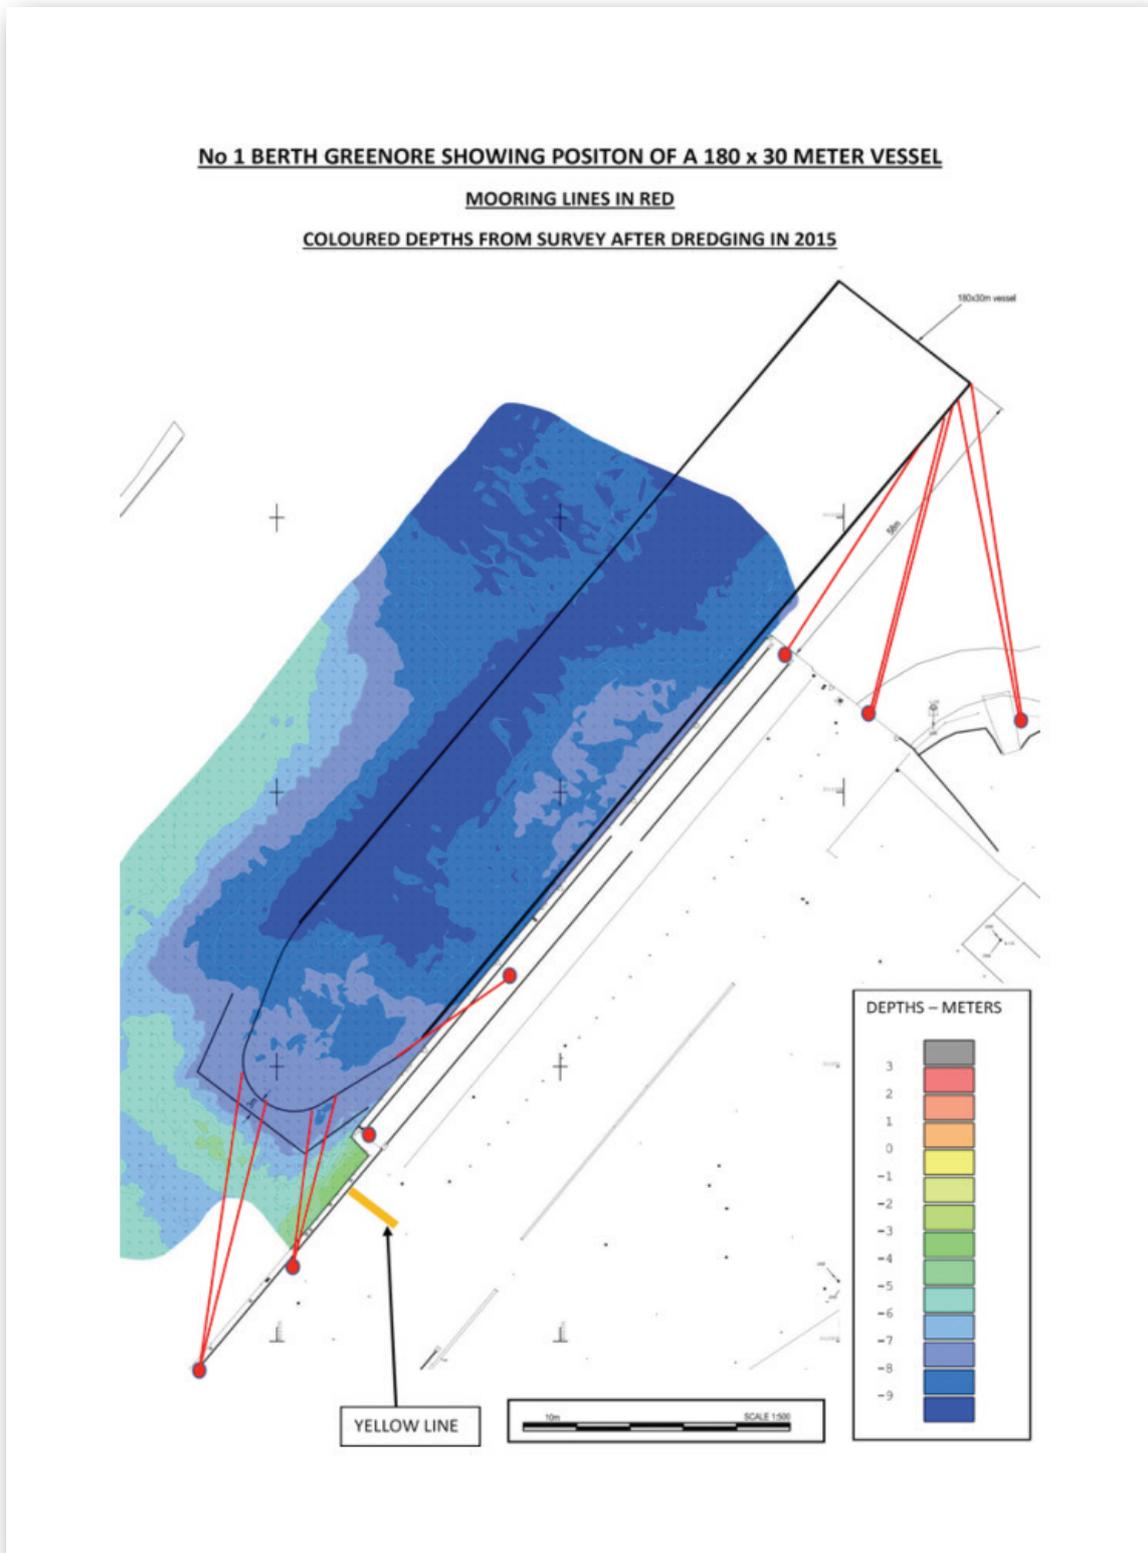
Appendix 7.2 Plan of No. 1 Berth.

- 3.1.5. The vessel was secured with four headlines, two forward springs, four stern lines and two stern springs (see Appendix 7.2 Plan - note only single spring lines are shown for clarity). The stern of the vessel extended 58 m beyond the end of the quay.

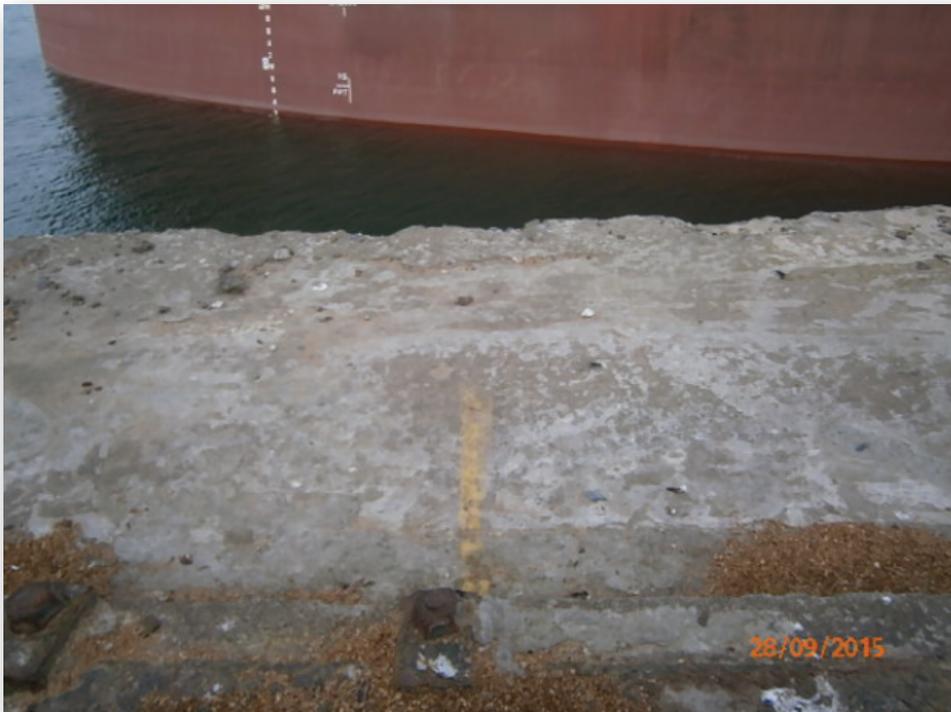
- 3.1.6. There was a yellow line painted on the quay wall to indicate the limit of the deep water berth. Neither the linesmen present on this occasion nor the Pilot were aware of this line. The line was obscured by dust and not visible to the vessel's crew on the forecastle (See Appendix 7.3 Photograph No. 1).

3.2.3. The Master informed the Agent of the owners of the situation at 07.50 hrs who informed the Stevedoring Manager who checked the vessels position alongside the quay and noted that the bow of the vessel was nine meters beyond the limit mark on the quay. This limit mark was a yellow line painted on the quay (see Appendix 7.3 Photograph No. 1).

- 4.2.5. The yellow line was obscured by dust.
- 4.2.6. When berthing the Pilot had no reference points on the shore which would assist him in determining the position of the vessel relative to the quay.

Photograph No. 1: View taken on 28th September at 12.55 hrs just before the move astern at 13.00 hrs. The yellow line has been brushed free of debris.

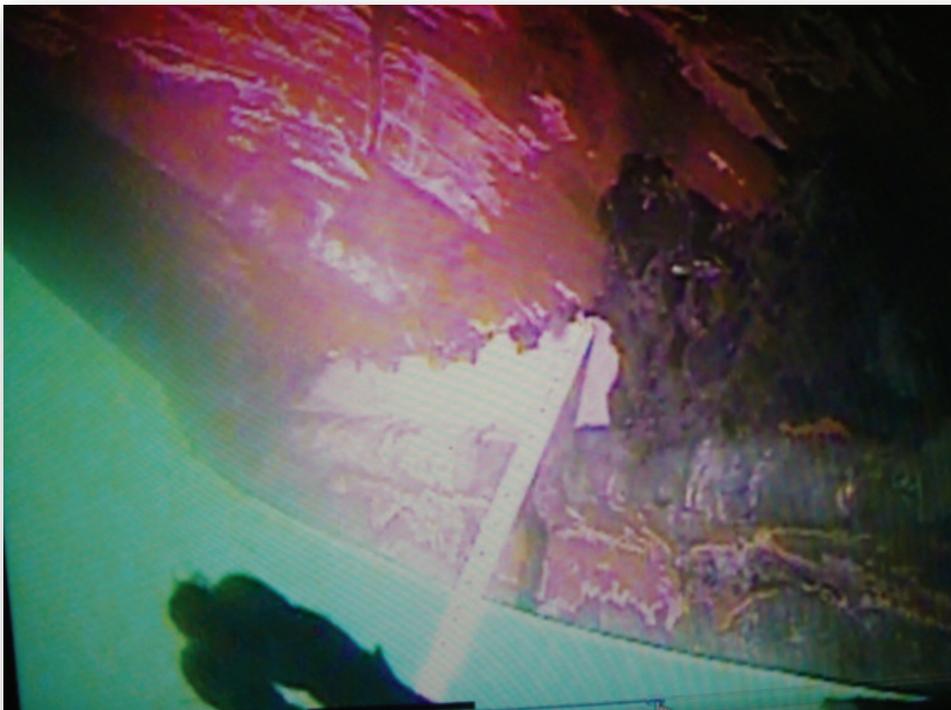
3.3.1. Divers were engaged to examine the bottom and they reported damage about 2 m Aft of the stem. The hull plating was set up and there were splits in the shell plating either side of the keel bar (see Appendix 7.3 Photograph No. 2).

Photograph No. 2: External damage showing one of the splits in shell plating.

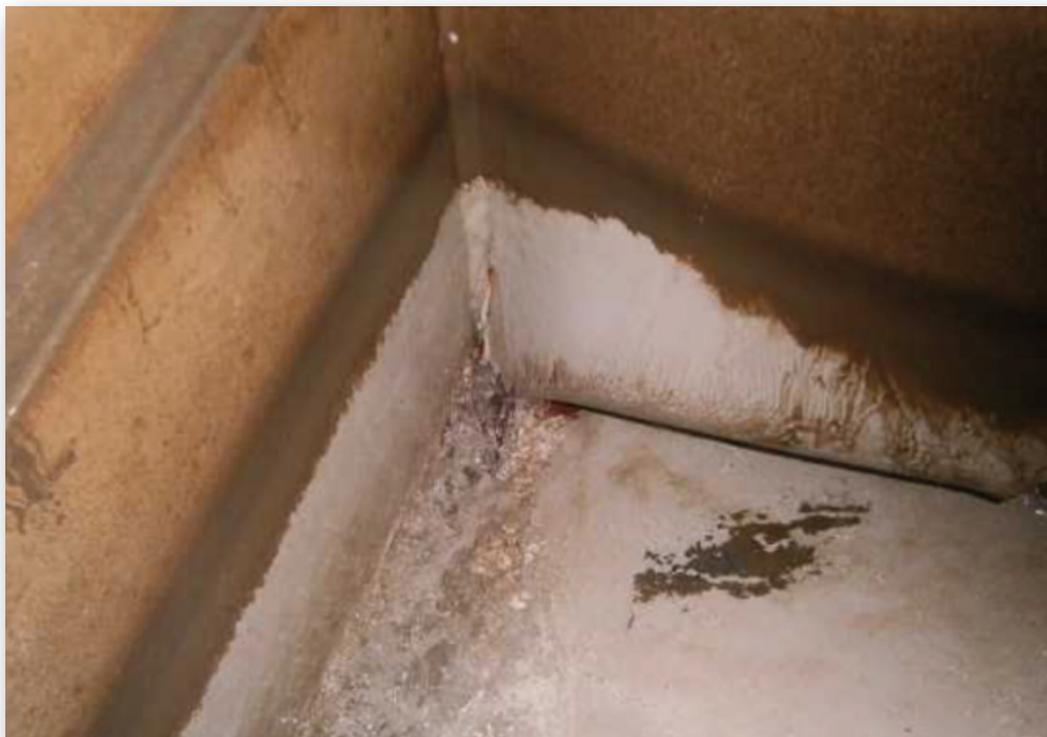
3.3.2. Inspection inside the forepeak tank found internal damage where the frames were distorted (see Appendix 7.3 Photograph Nos. 3 and 4). A Classification Society Surveyor from RINA attended and proposed temporary repairs which were commenced on the 30th September.

Photograph No. 3: Internal damage, distortion of internal frames.

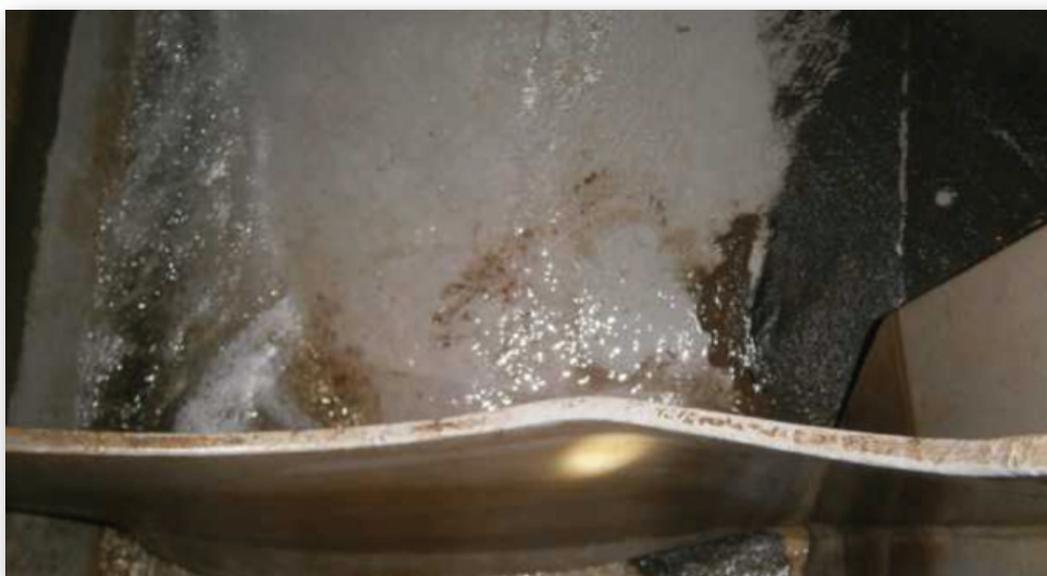
Photograph No. 4: Internal damage, distortion of internal frames.

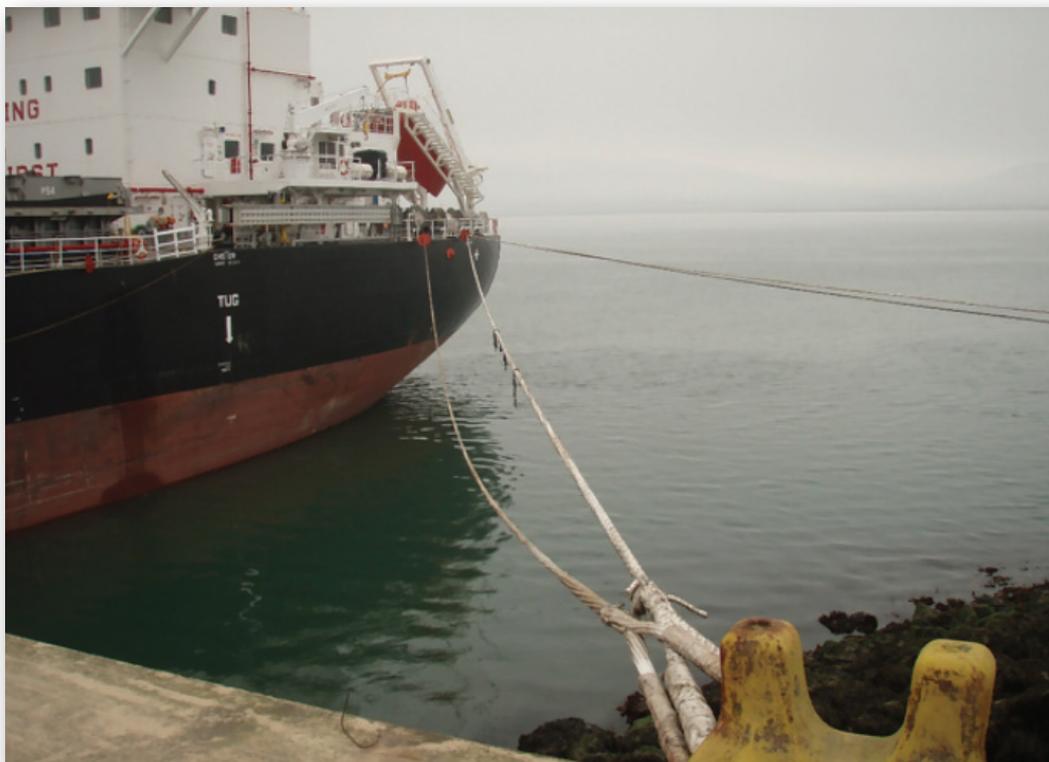
- 4.7.1. The causal factors for this incident were due to:
 - 4.7.1.1. At Greenore Port large vessels cannot lie completely alongside the quay wall and they project beyond the end of the quay (see Appendix 7.2 Plan). This vessel projected 58 m beyond the quay (see Appendix 7.3 Photograph No. 5).

Photograph No. 5: View of after mooring lines - note all 4 lead in a forward direction.

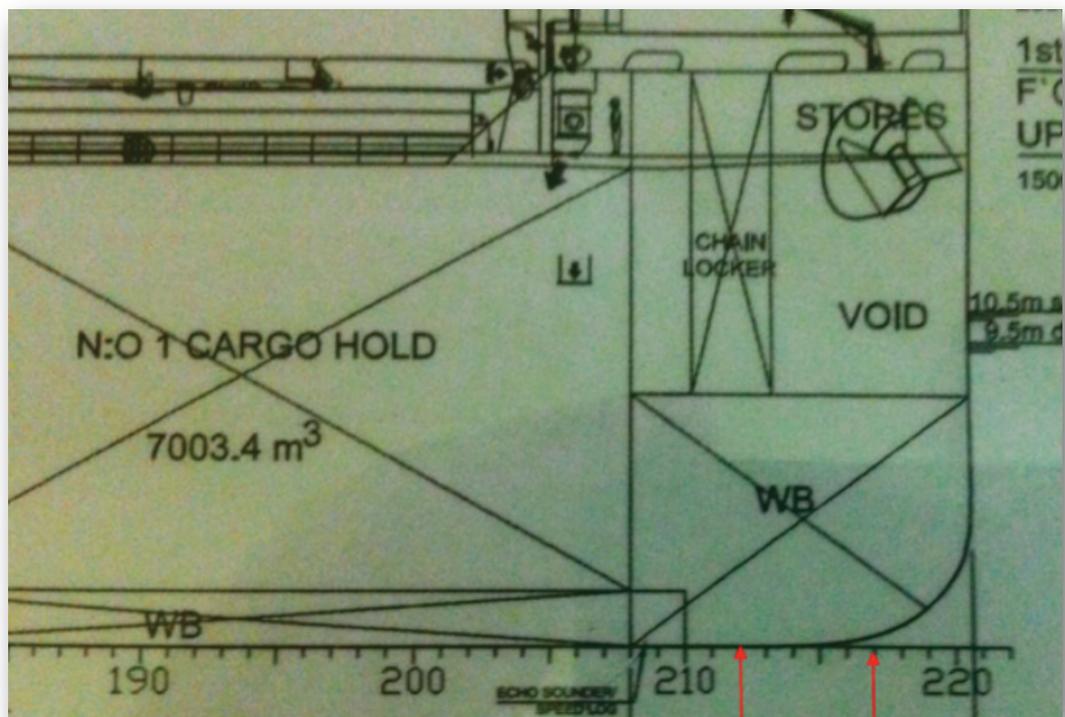
Appendix 7.5 Elevation of Forward part of vessel.

- 4.1. The Contact with the bottom by the vessel on the 27th and 28th September.
 - 4.1.1. The vessel was berthed at high water with the bow of the vessel about 9 m Forward of the limit of the deep water marked by a yellow line on the quay placing the Forward 6 m of the vessel over shallow water. On the next low tide at 17.30 hrs, the tidal height was 0.3 m and the depth of water would have been about 4.3 m. With a draft of 7.3 m Forward the bow section would have gently rested on the bottom as the tide receded. The damage was between frames 213 and 217, from 2.8 m from the bow to 6 m Aft of the bow (See Appendix 7.5 Elevation of Forward part of vessel).

- 4.2.3. The Pilot who boarded the vessel had no information about the limit of the vessels position on the berth. He was unaware of the yellow line on the quay showing this limit. Consequently the Master and crew were not informed of the possible danger to the vessel. The use of the vessel's Forward echo sounder would not have alerted the Master of the shallow water under the bow as the echo sounder was located between frames 207 and 208. From the vessel's plans this places the transducer 10 m Aft of the bow, too far Aft to detect the shallow water under the bow (see Appendix 7.5 Elevation of Forward part of vessel).

Frame spacing was at 800mm
Damage occurred between frames 212 and 217.
