Marine Casualty Investigation Board
Bord Imscrúdú Taisní Muirí

**REPORT OF THE INVESTIGATION
INTO THE GROUNDING OF
'FV SEAN ANTHONY'
AT
KINSALE HARBOUR,
ON
10th APRIL 2016**

**REPORT NO. MCIB/255
(No.3 OF 2017)**

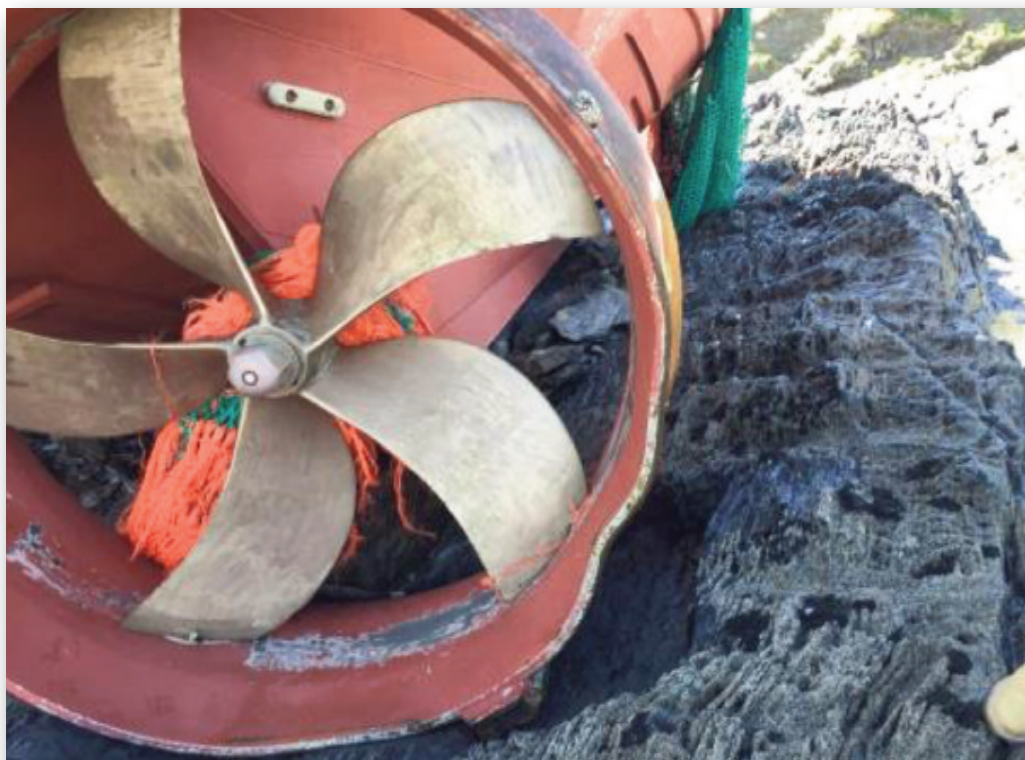
- 3.12 Both trawl beams were housed and secured. The port net cod-end was lying on the ground beside the vessel and it was established that the rope tails attached to the net were of the same material that fouled the propeller. The foremast had sheared at its base and lay at an angle to the main support. The propeller had been fouled by the vessel's fishing gear.

- 4.8 The evidence indicates that the vessel drifted over the cod-end, because of the wind strength. The 'dolly ropes' attached to the port net cod-end became entangled in the propeller, between the stern tube and the inner end of the propeller boss.
- 4.9 The propeller entanglement caused the engine to stall, and the associated restriction was such that it was not possible to engage the drive as the entangled rope prevented the drive from engaging thus causing the continuing stalling of the engine.

- 5.3 The rope tails attached to the cod-end of the port trawl net became entangled in the propeller and stopped it from rotating. This in turn stalled the main engine. To restart the engine, it was necessary to leave the wheelhouse and enter the engine room for each attempt. However, the level of entanglement was such that it was not possible to restart the engine. Valuable time was lost in these attempts to restart the engine and find drive. The vessel was in a narrow channel and adrift.

Photograph No. 1: Rope wrapped around inboard part of propeller.

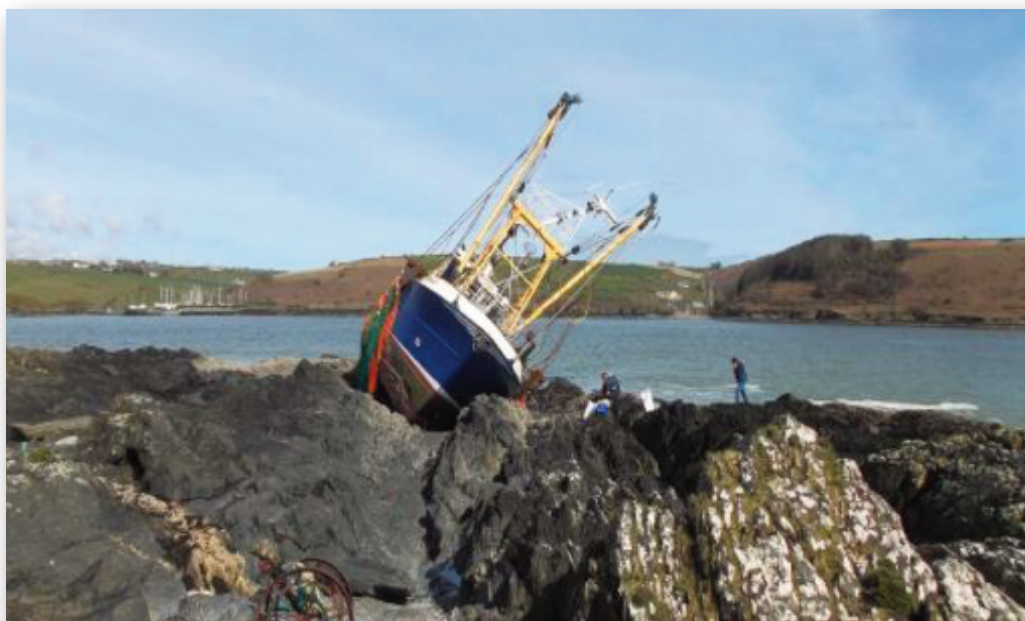
- 3.11 The site where the vessel lay aground was examined. The vessel was found lying high and dry on a rocky foreshore of slate (see Appendix 7.3 Photograph No. 2). There was no evidence of pollution. The vessel lay head to south west and heeled over to port at an angle of approximately 30 to 40 degrees. The vessel had a five blade manganese bronze fixed pitch propeller with a nozzle. There was evidence of rope wrapped around the tail shaft between the forward end of the propeller boss and the stern gland. There was no evidence of rope fouling between the blade tips and the stern nozzle. The flat blade rudder lay on the ground at the stern (See Appendix 7. 3 Photograph No. 3).

Photograph No. 2: View of vessel aground.

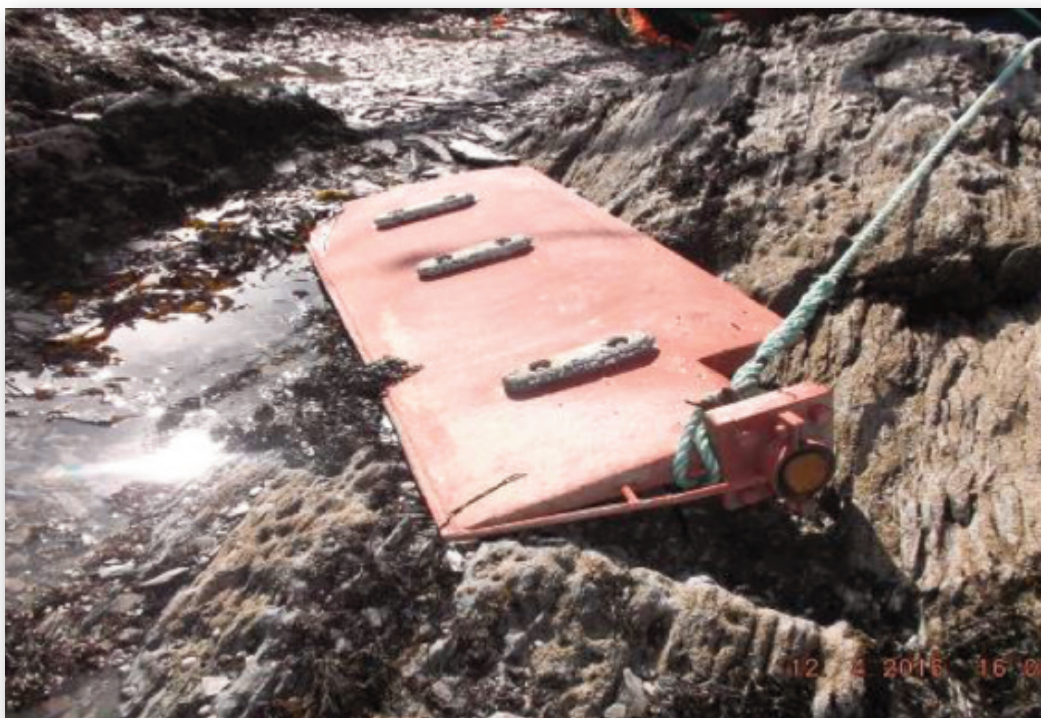
Photograph No. 3: Rudder lying on rocks beside vessel.
