**REPORT INTO THE FATAL
INCIDENT ON THE
'FV CU NA MARA'
APPROXIMATELY
130 NAUTICAL MILES WEST
OF SLEA HEAD
ON 30th JUNE 2016**

**REPORT NO. MCIB/261
(No.3 OF 2018)**

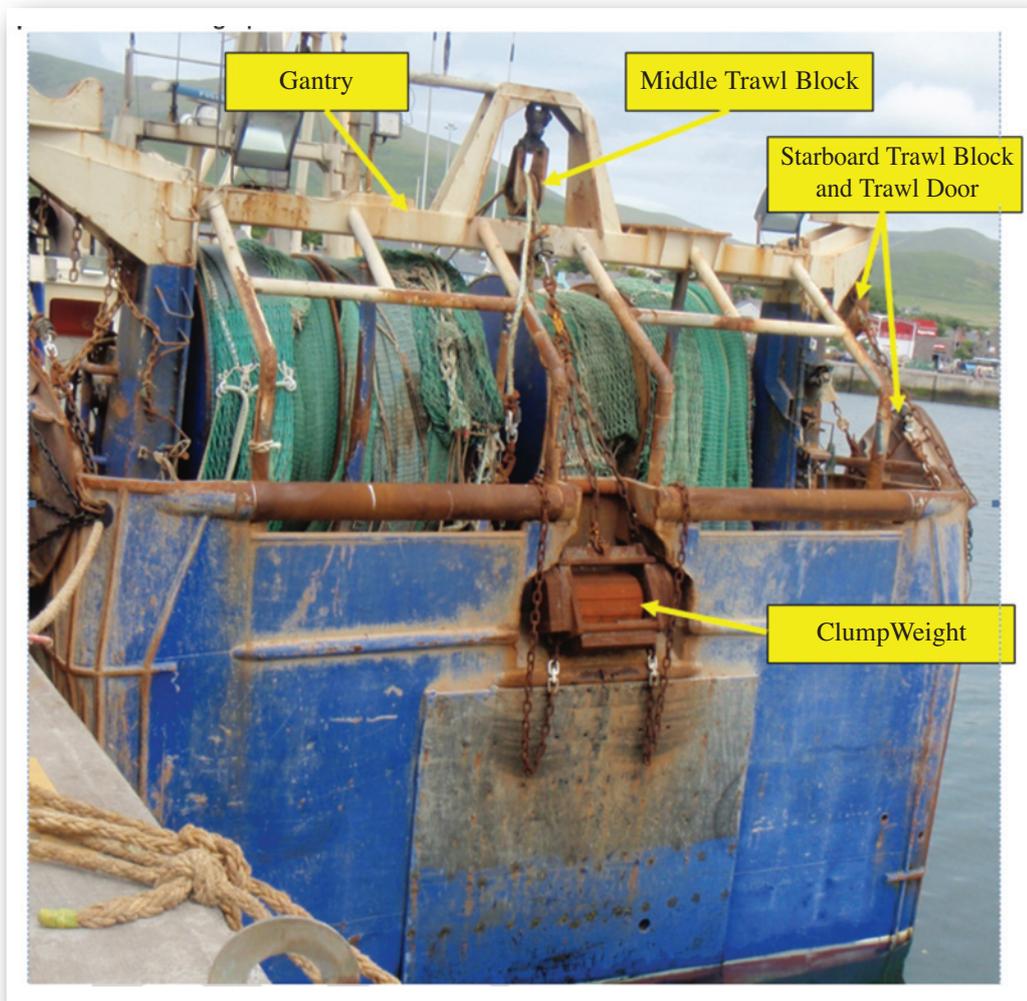
Photograph No. 2: Stern of vessel. Annotated to indicate the Gantry, Middle Trawl Block, Clump Weight and the Starboard Trawl Block and Trawl Door.

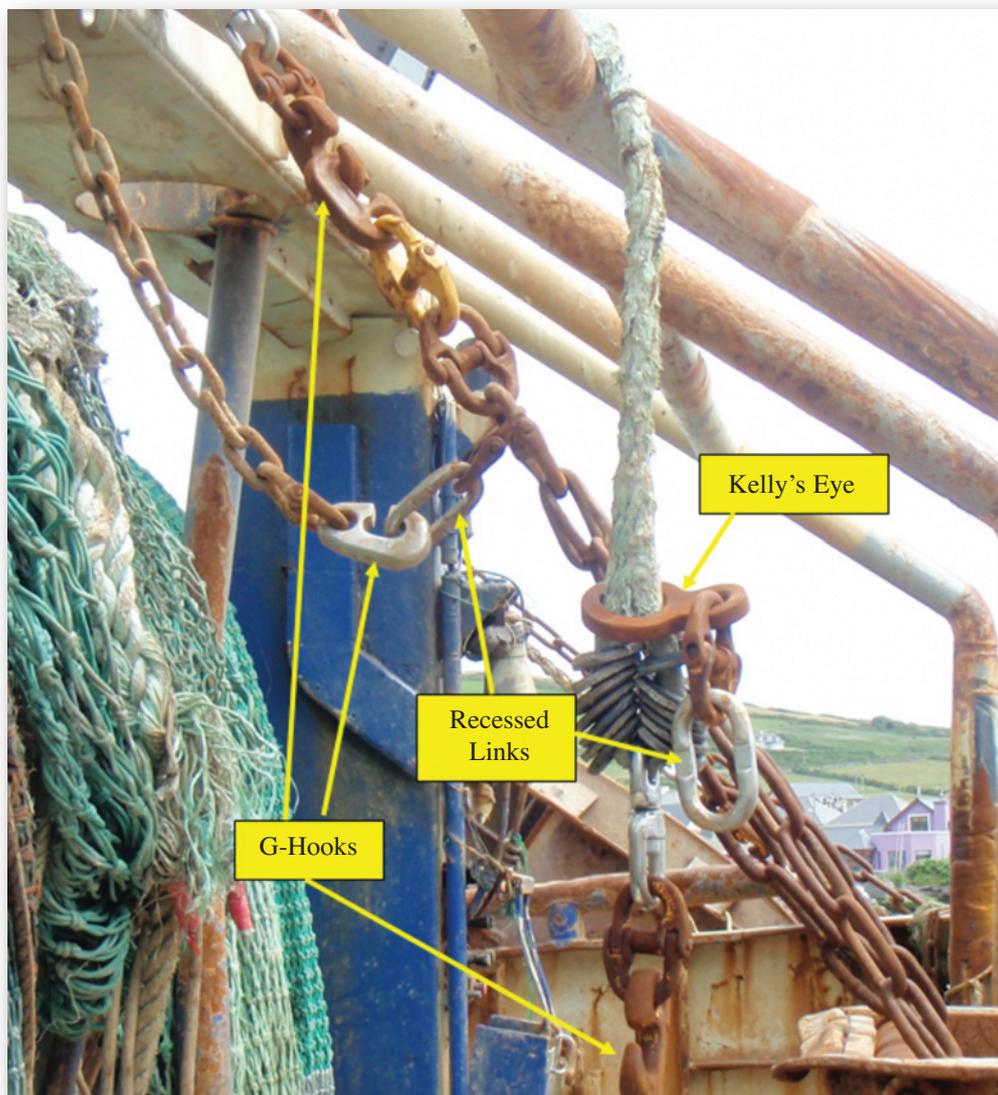
- 3.8. The disconnection procedure involves manually reaching up and unclipping the slack G-hook connections from the recessed links to which they are attached (see Appendix 7.1 Photograph No. 3 showing examples of G-hooks and recessed links).

Photograph No. 3: G-Hooks, Recessed Links and Kelly's Eye.

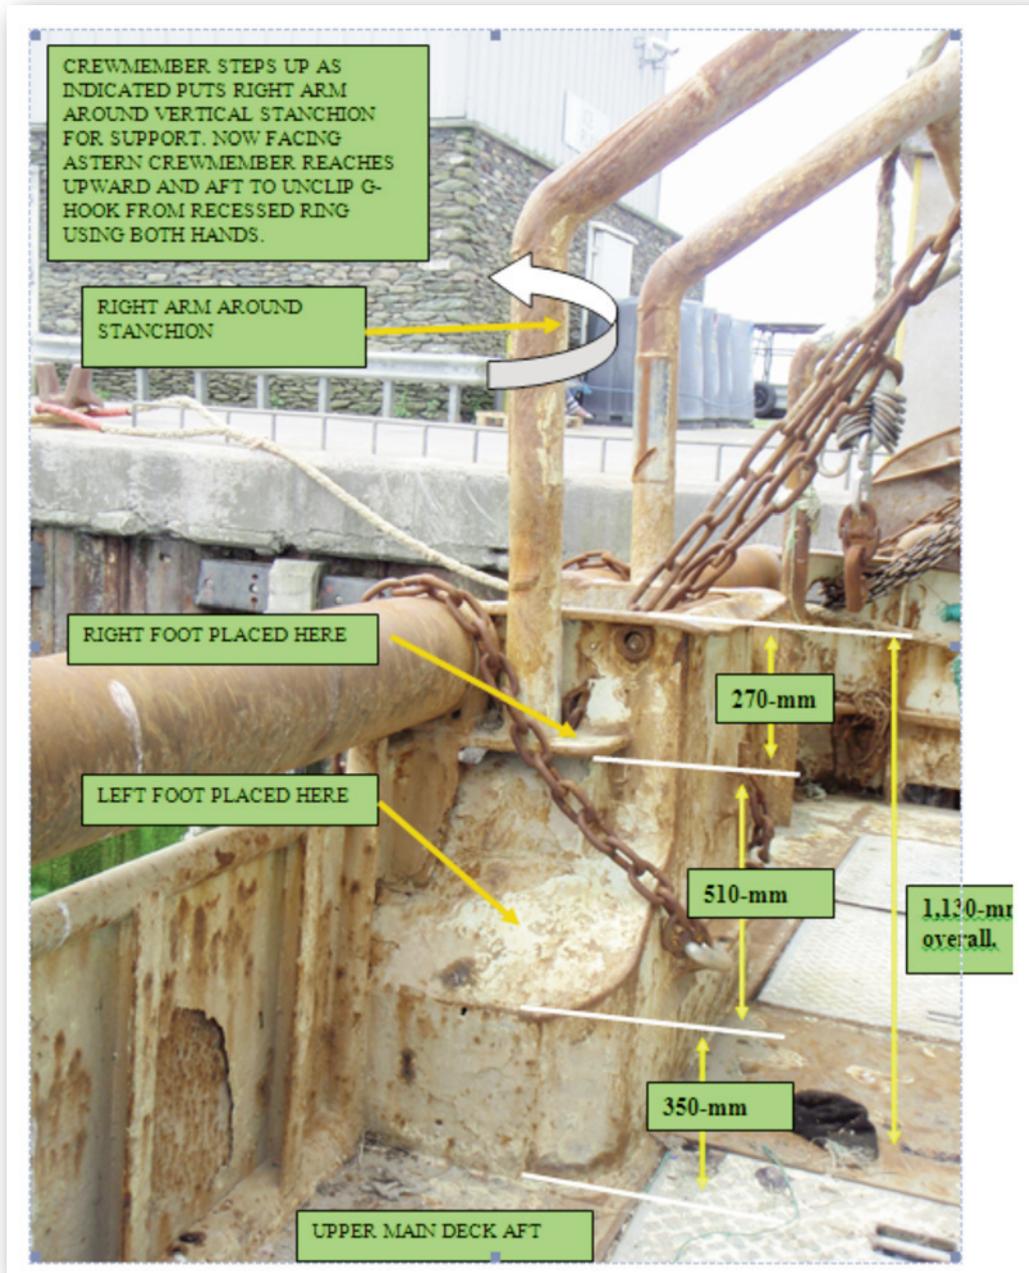
- 3.13. Crewmember 1 stepped up either partially or fully onto the after rail in order to unclip the G-hook. He was using a stanchion for support and reaching out for the G-hook but he got into difficulties, lost his balance and fell over the stern rail into the water. He may have struck his head on the clump weight as he fell. See photograph No. 2 showing the clump weight and photograph No. 4 of the upper main deck middle with indicative location for Crewmember 1.

- 4.7. The practice on board to reach the G-hooks at stern middle station is for the crewmember to step up onto the steelwork at the stern rail of the vessel, hold onto one of the stanchions and then use two hands to unclip the relevant G-hook.

Photograph No. 4: Upper main deck middle with indicative locations for Crewmember 1.

- 6.1. The owner/skipper should ensure that safety documentation for the vessel takes into account a risk assessment and hazard analysis in respect of shooting and hauling the nets, and the use of personal fall protection systems by the crew.
- 6.2. The owner/skipper of the vessel should ensure that all crew are in compliance with the training and instruction on health and safety requirements as set out in S.I. No. 640 of 2007

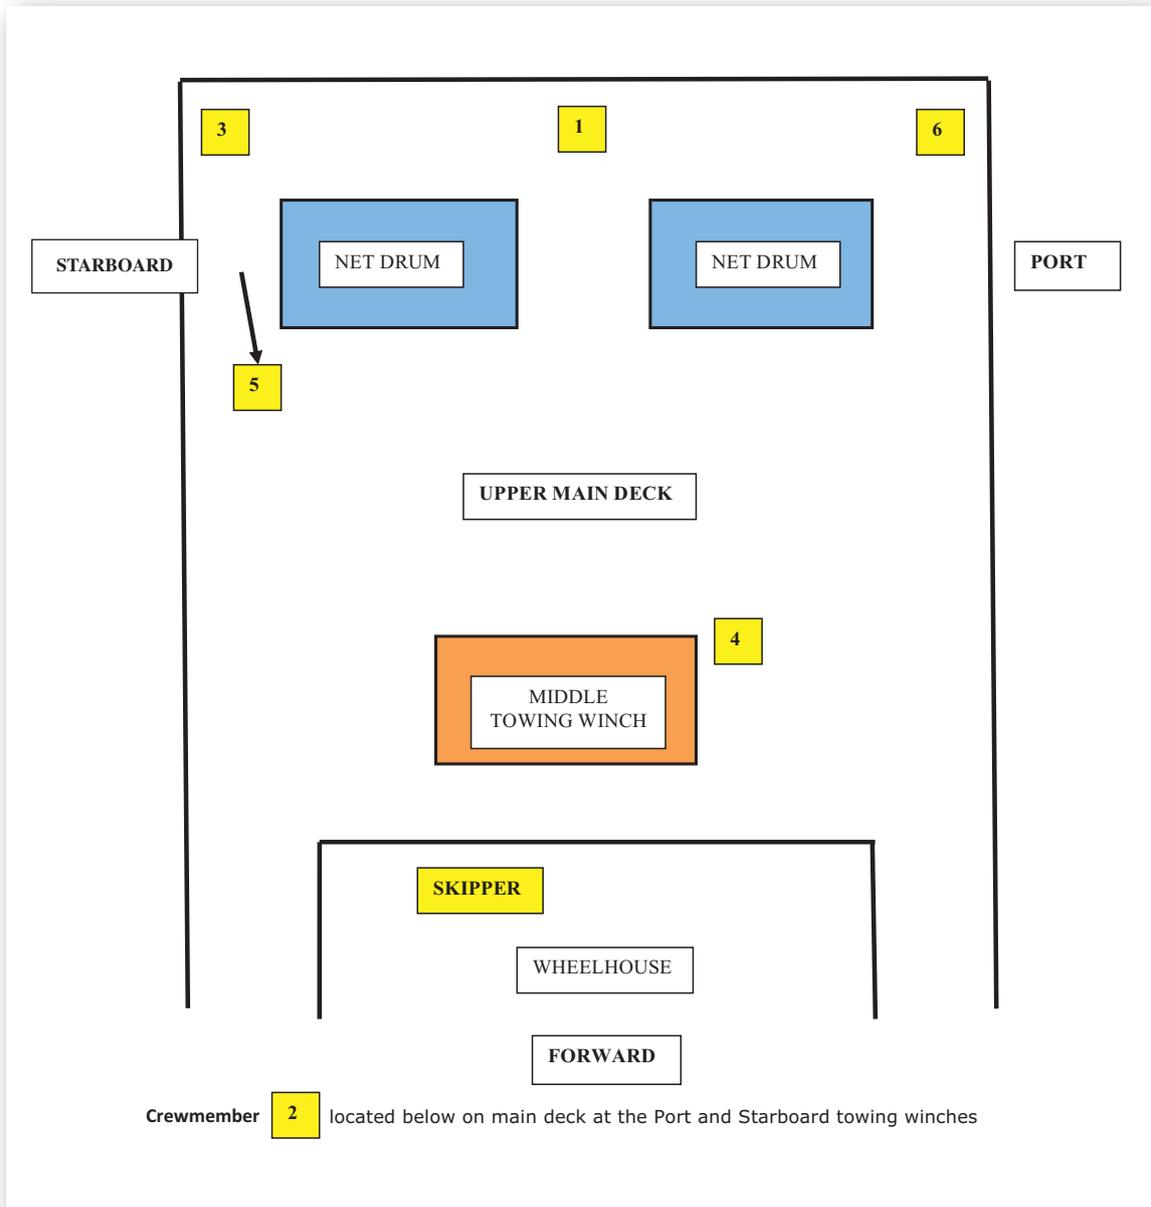
Appendix 7.4 Location of Crew on Board.

- 3.9. At the time of the incident the crew were deployed as shown in Appendix 7.4 which is a plan view sketch of the vessel's upper main deck showing the locations of the Skipper and crewmembers at the time of the incident.
