**REPORT INTO A FATAL
INCIDENT INVOLVING THE
MFV ELLIE ADHAMH
AT ROSSLARE EUROPORT
19th MAY 2019**

**REPORT NO. MCIB/292
(No.4 OF 2020)**

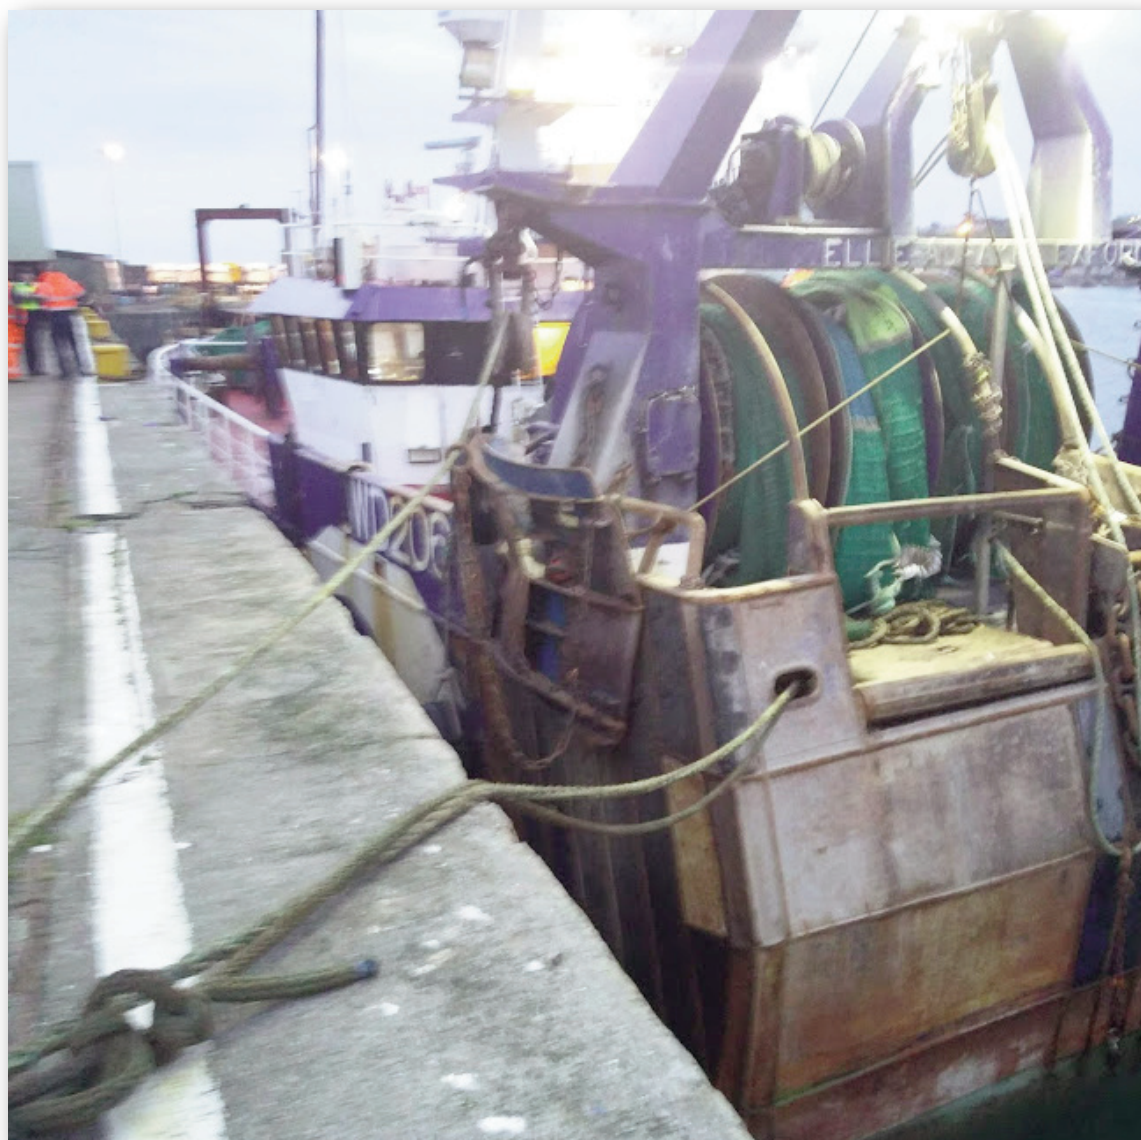
- 3.7 The mooring lines from the 'MFV Ellie Adhamh' to the quay wall would have been slackest at time of the incident (see Appendix 7.1 Photographs No. 1 and No. 2). Fixed ladders for No. 4 berth had recently been removed and were

- 4.6 The *'MFV Ellie Adhamh'* was seen to be between 1.5m and 1.8m off the quay wall shortly after the incident indicating the ropes were at their slackest at around half tide. The close proximity of the *'MV Stena Nordica'* (Gross tonnage 24,206) manoeuvring at the time of the incident most likely had an effect on the vessel being drawn out from the quay wall, caused by the large vessel displacing a considerable volume of water in a relatively shallow area and possibly the use of bow thrusters. The distance between the vessel and the quay wall together with the lack of a safe access point would have made the transit from the quay to the vessel difficult. Had the Casualty been wearing an automatic PFD it would have improved his chance of survival.

Photograph No. 1. Mooring lines from the 'MFV Ellie Adhamh' to the quay wall.

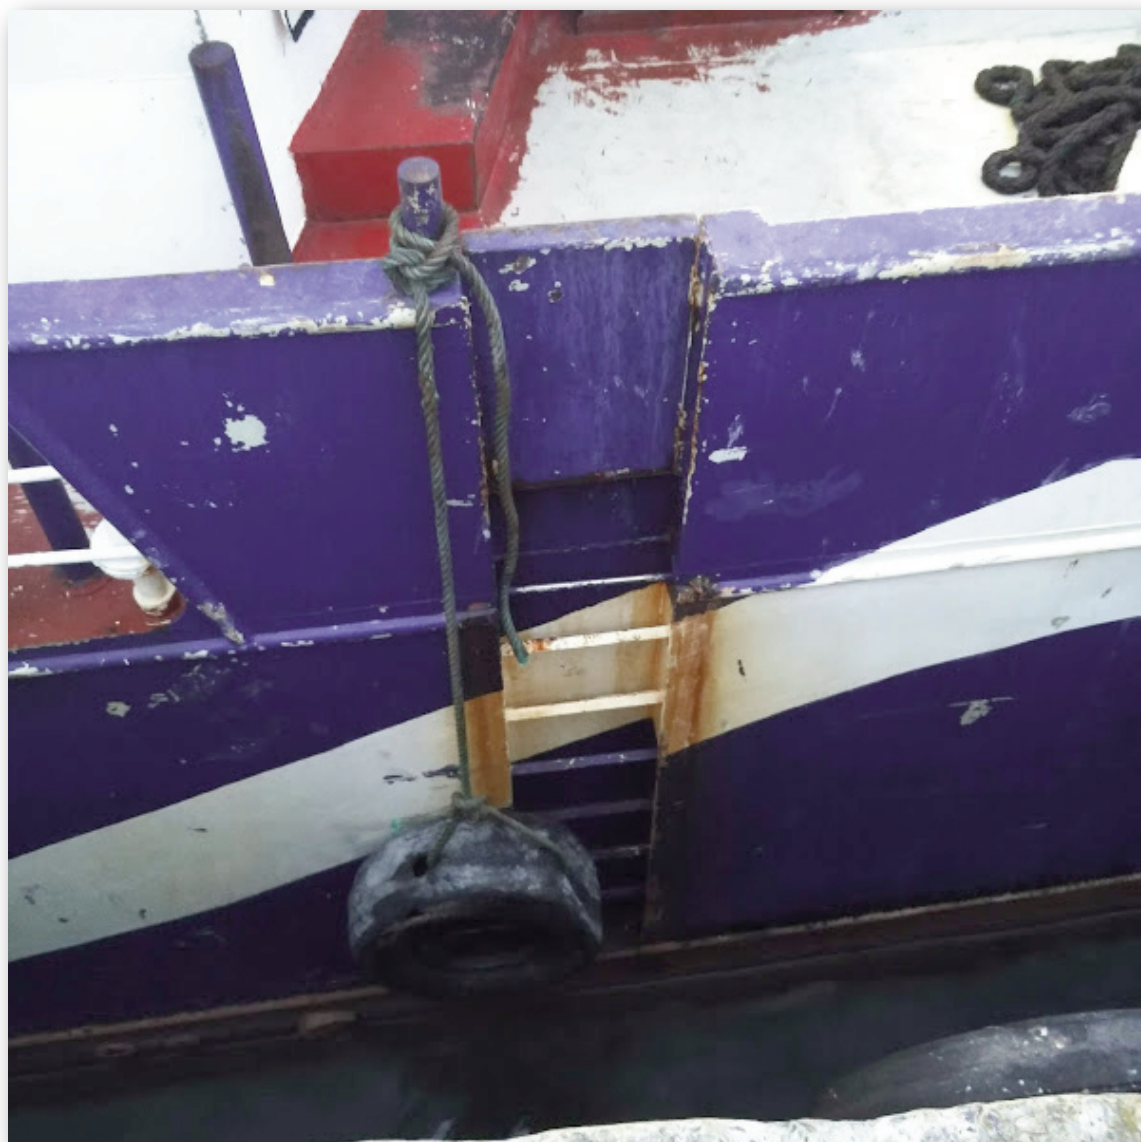
due for replacement. The *'MFV Ellie Adhamh'* has boarding ladders built in on both sides of the main hull (see Appendix 7.1 Photograph No. 3). No gangway or safety net were rigged and there is no clear designated access point between the *'MFV Ellie Adhamh'* and the quay wall (see Appendix 7.1 Photographs No. 4 and No. 5).

Photograph No. 3. Fixed boarding ladders built in on both sides of the hull of the 'MFV Ellie Adhamh'.

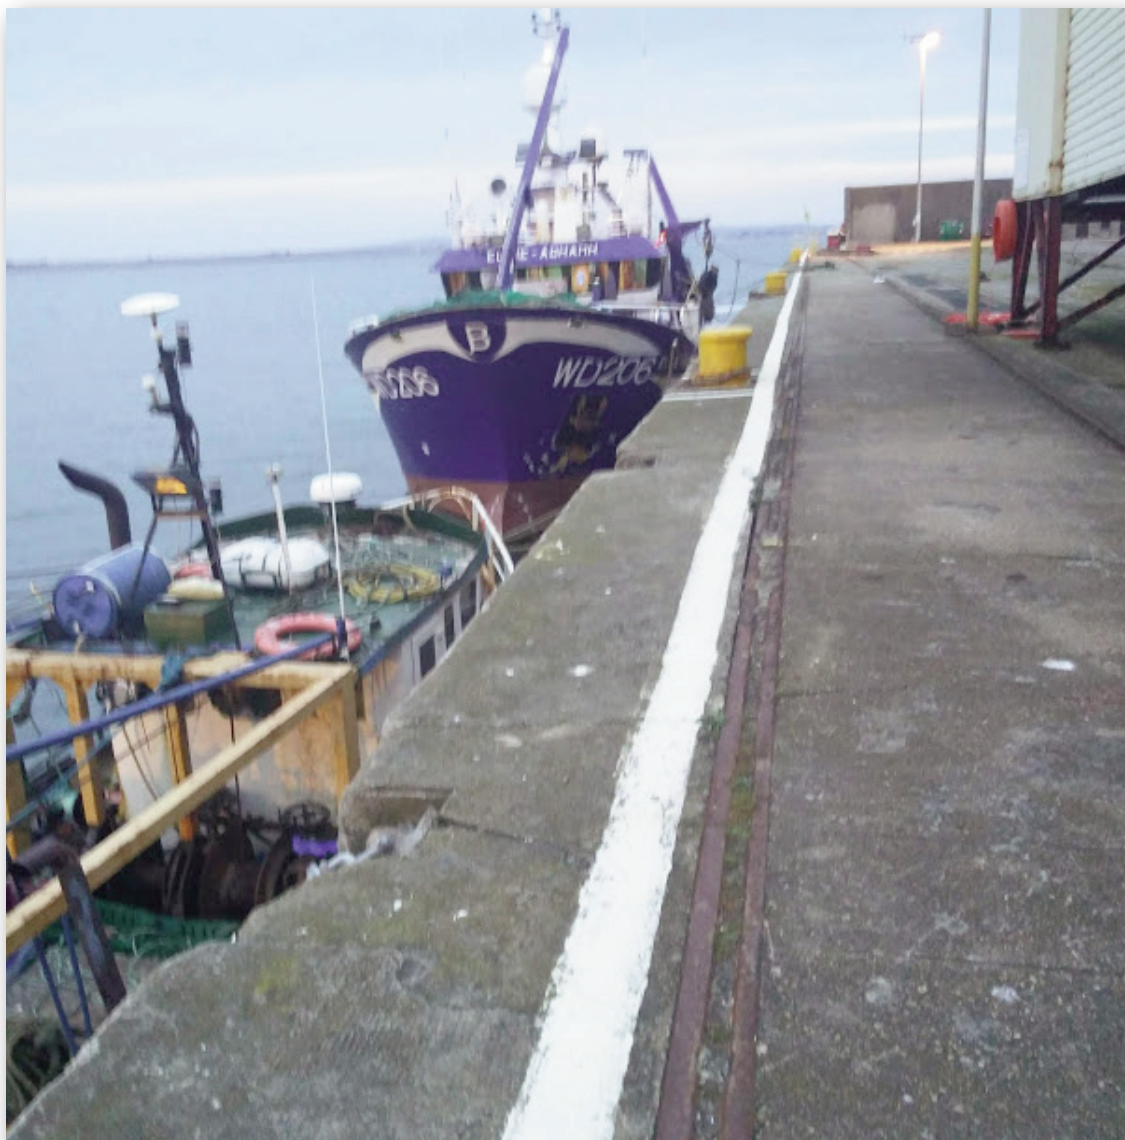
- 3.8 The Merchant Shipping (Safety of Fishing Vessels) (15-24 metres) Regulations 2007 require that a gangway or other suitable means providing an appropriate and safe means of boarding the vessel shall be available (Regulation 106).
- 3.9 The initial postmortem report supplied to the MCIB indicates death was caused by drowning, however, this verdict will be determined by the coroner. The toxicological analysis in the report indicated a very high level of ethanol in the Casualty's blood.

- 5.2 Safe means of access to the vessel at all states of tide was not evident.
- 5.3 No PFD was worn by the Casualty.
- 5.4 It is likely that there was considerable movement of the vessel due to manoeuvring of the *'MV Stena Nordica'* in close proximity to it. As the much larger vessel went astern into its berth it would have caused considerable water flow in the vicinity of the *'MFV Ellie Adhamh'*

Photograph No. 4. No gangway or safety net were rigged and there is no clear designated access point between the 'MFV Ellie Adhamh' and the quay wall.

- 6.2 It is recommended that the Minister for Transport, Tourism and Sport issue a Marine Notice reminding fishing vessel owners and skippers of the duty of care to provide safe means of access to vessels while in harbour.
