**REPORT INTO THE  
COLLISION BETWEEN  
A TANKER 'VARKAN EGE'  
AND  
A SAILING VESSEL 'MEDI MODE'  
23rd AUGUST 2019**

**REPORT NO. MCIB/293  
(No.7 OF 2020)**

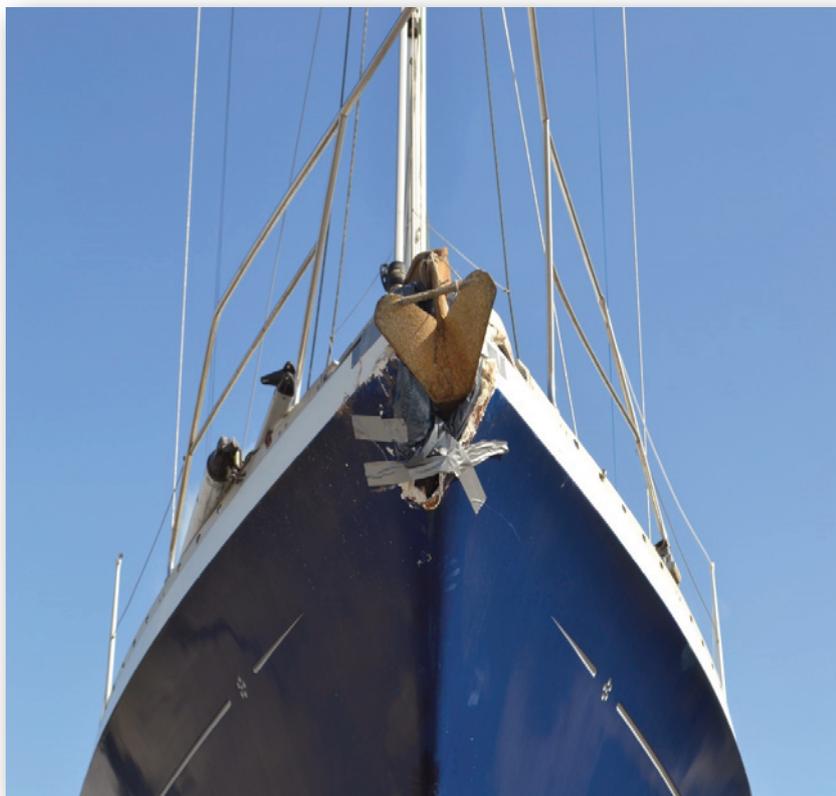
- the stem head fitting was torn away, the pulpit, toe rail and surrounding area was severely deformed;
- the mast was held upright by the baby stay forward;
- rudder control was restricted by damage and was unable to use the full range;
- there was damage to the aft bulkhead and door to the aft cabin; and
- the starboard sheet winch was driven down through the cockpit coaming.

Photograph No.3 - Damage to bow of 'Medi Mode'.

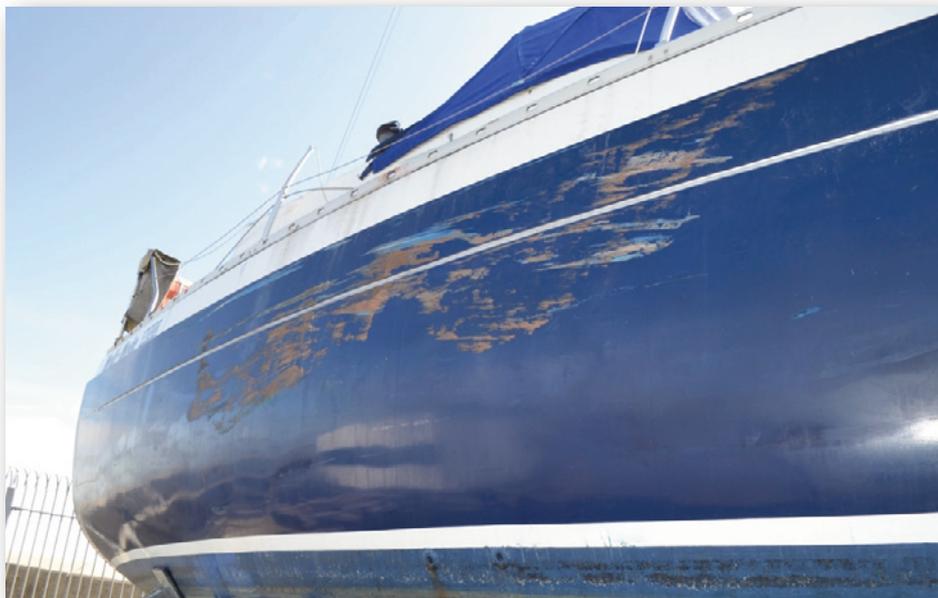
Photograph No.4 - Damage to hull, starboard side.

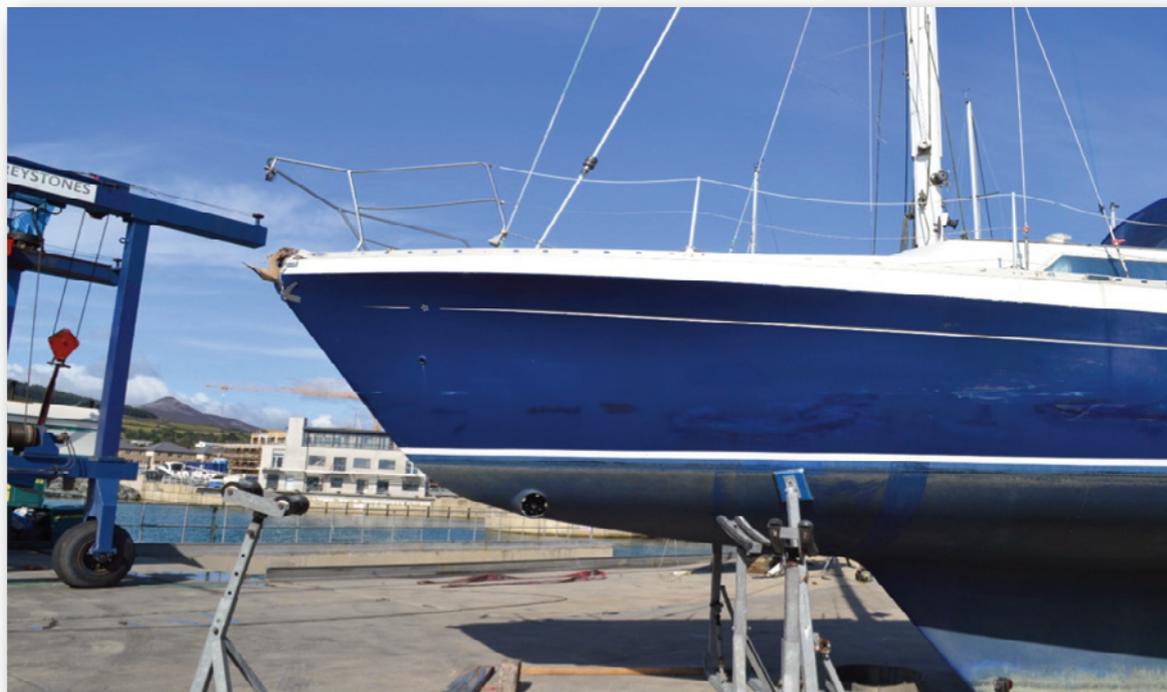
- 5.5 The '*Varkan Ege*' states in its report that it observed the '*Medi Mode*' altering its course to port just before the collision. '*Medi Mode*' states in its report that it kept its course. This cannot be determined definitively as the '*Medi Mode*' does not have the technology to record this. However, the two vessels were on a collision course before this happened. The collision occurred with the prow of the '*Medi Mode*' striking the port bow of the '*Varkan Ege*'.

Photograph No.5 - Damage to port bow of 'Medi Mode'.

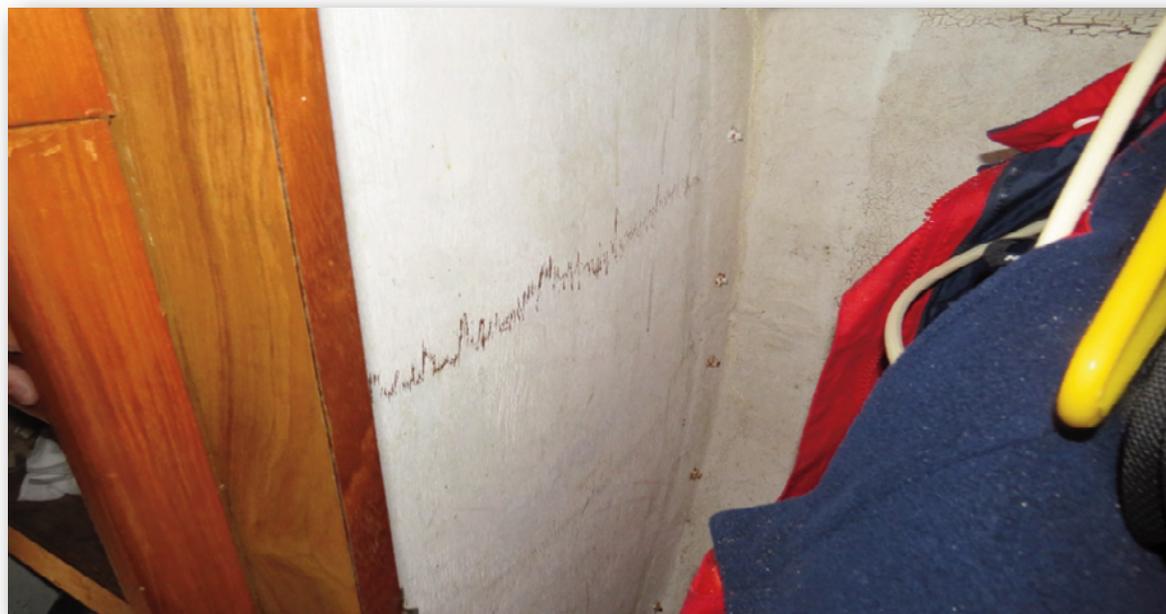
Photograph No.6 - Internal damage to bulhead.

Further damage to aft bulkhead & door to aft cabin.

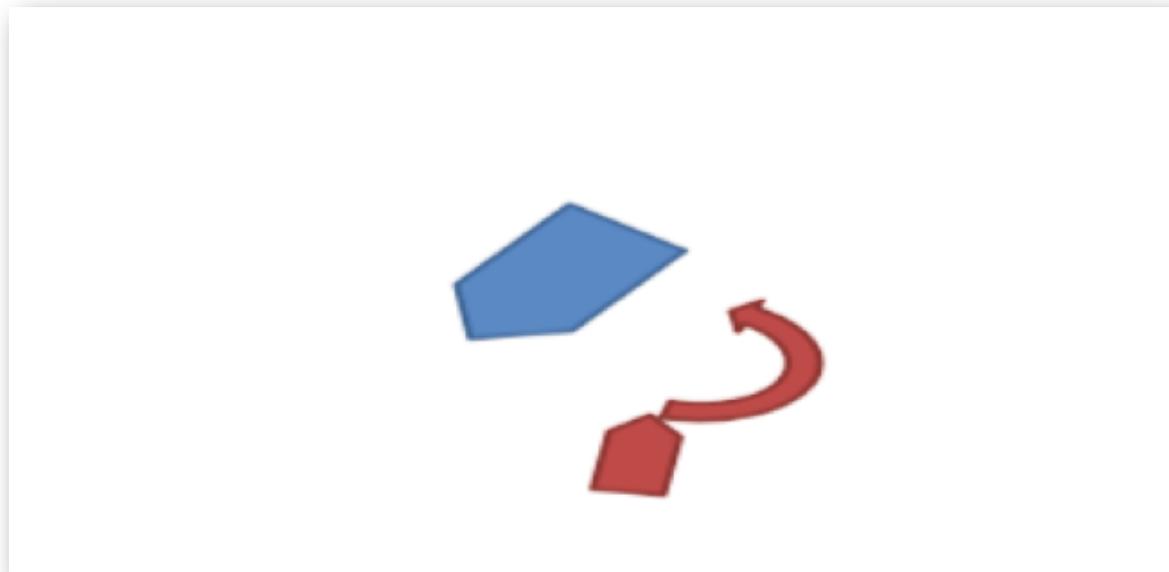
### Appendix 7.5 Demonstration of Incident as Described by 'Varkan Ege'

As 'Varkan Ege' was altered course to Starboard 'Medi Mode' altered to Port.
