**REPORT INTO THE SINKING
OF
“FV ALIZE”
OFF HOOK HEAD,
CO. WEXFORD
4 JANUARY 2020**

**REPORT NO. MCIB/297
(No.2 OF 2021)**

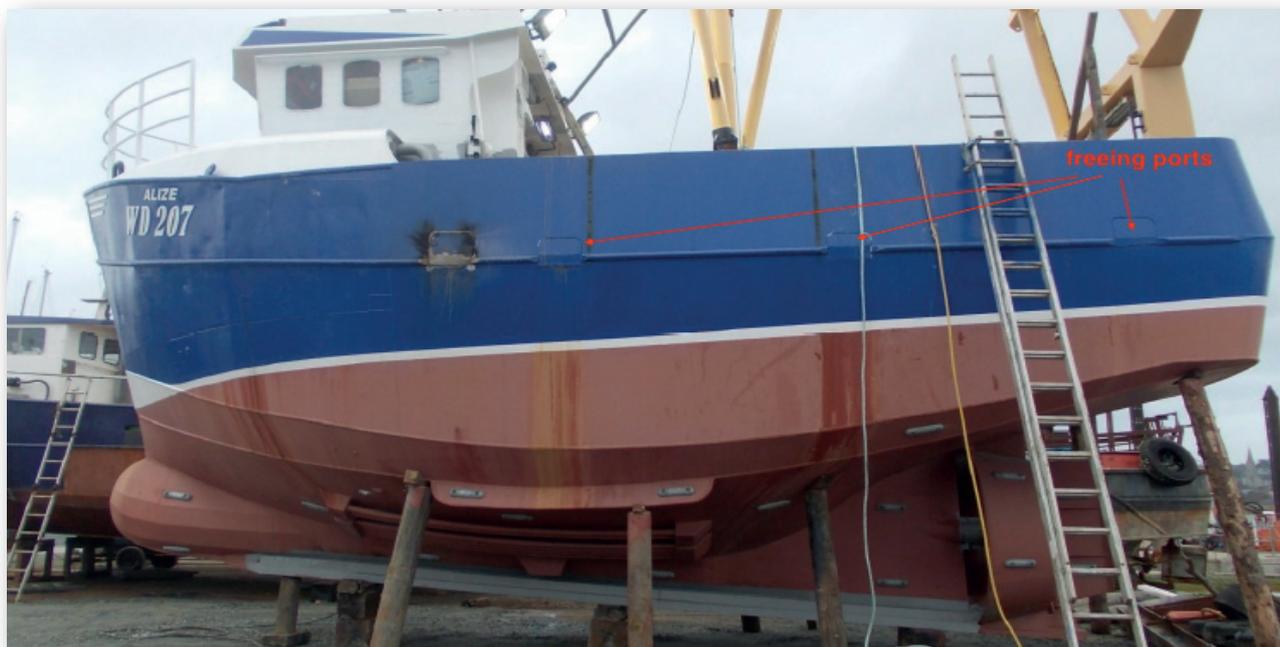
Appendix 7.4 Photograph No.3 - "FV Alize" freeing ports (port side)

time of the incident the vessel was operating in night time conditions, and wind, seas and tide was in the same direction, the environmental conditions would not be considered abnormal. However, the motion of a vessel stopped in the water and drifting while hauling its dredges would be considerably worsened by shortcomings in its freeboard or if the vessel was lying beam on to prevailing weather and seas. The vessel's rolling motion with a limited freeboard would run the risk of allowing seawater to enter the working deck area through the vessel's freeing ports if they were open or malfunctioning.

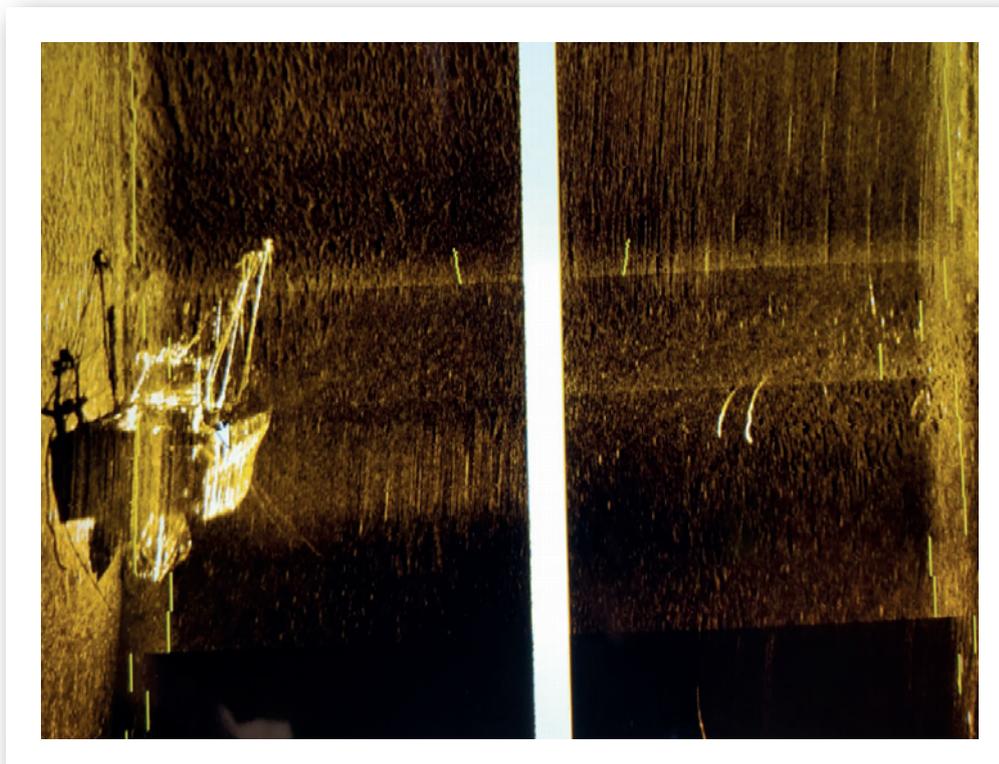
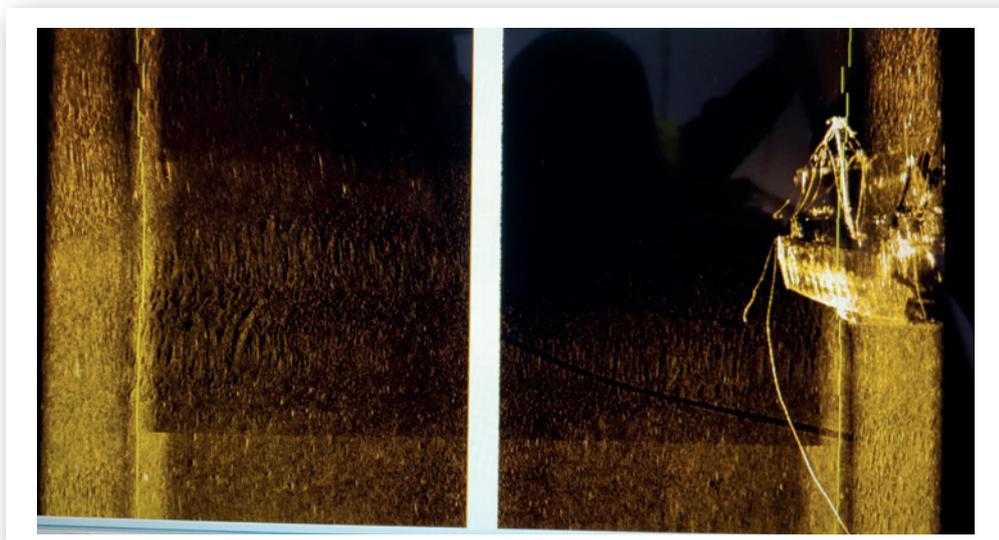
Appendix 7.15 Photographs No. 5 & 6 - Sonar Scan images “FV Alize” -
Stern view and Bow view

4.1.2 Considering damage to the hull (scenario 4.1 ‘d’): Sonar images of the wreck show that “*FV Alize*” is lying on its port side. The sonar scan images of the wreck indicates that the vessel appears to be intact with no significant damage to the hull.

Images from the sonar scans show the starboard derrick is in the housed position and therefore the trawl wire is wound in. The port derrick is not visible in the scan and is likely lost in the images background clutter. A witness reported that the trawl handling and topping-lift equipment was totally renewed during the 2014 refit. Even so, it would be reasonable to deduce that if a topping-lift component failed then the derrick would descend, lowering the weight from the derrick head which would have a nett positive effect on the vessel's dynamic stability at that moment in time. It is reasonably deduced that a component failure in the lifting equipment rig would result in a positive effect on the vessel's stability condition and would therefore not be a factor in causing the loss of the vessel.

Photograph No.5 - Sonar Scan image “FV Alize” - Stern view.

Photograph No.6 - Sonar Scan image “FV Alize” - Bow view.

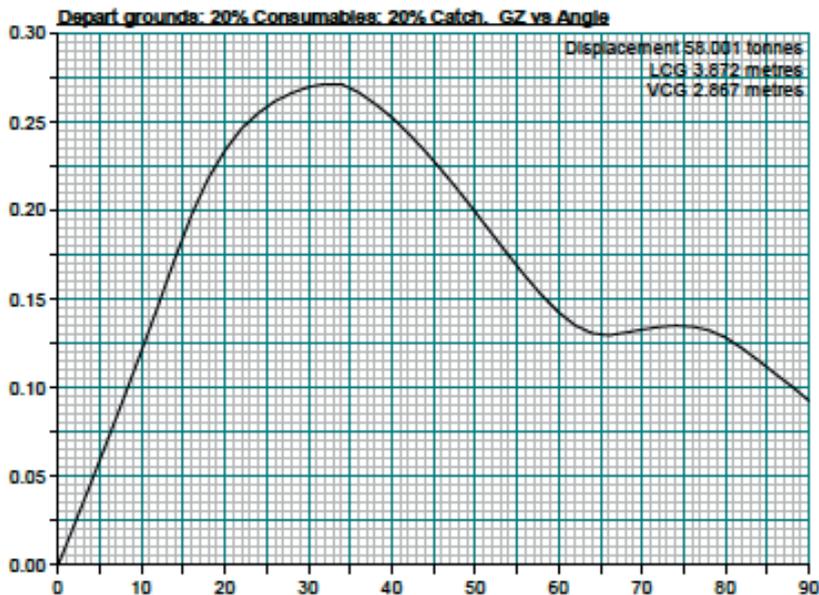
Appendix 7.17 Figure No.8 “FV Alize” Stability Information Booklet, Condition 6 ‘Departure Grounds’

No.	Criteria	Actual	Requirement	Pass/Fail
1	The area under the GZ curve from 0.0 degrees to 30 degrees	0.087 m.rad	0.066 m.rad	pass
2	The area under the GZ curve from 0.0 degrees to 40.0 degrees	0.134 m.rad	0.108 m.rad	pass
3	The area under the GZ curve from 30.0 degrees to 40.0 degrees	0.046 m.rad	0.036 m.rad	pass
4	The maximum value of GZ occurs at	32.7 degrees	25 degrees	pass
5	The value of GZ at an angle of heel of 32.7 degrees	0.272 metres	0.24 metres	pass
6	The value of the upright GM	0.673 metres	0.42 metres	pass
