**REPORT OF AN
INVESTIGATION INTO THE
FIRE ON AND LOSS OF THE
'FV KAYLEIGH'
SOUTHWEST OF
SHEEPS HEAD, CO. CORK
4th MARCH 2020**

**REPORT NO. MCIB/298
(No.11 OF 2020)**

Report MCIB/298 published by the Marine Casualty Investigation Board.
Produced 22nd December 2020.

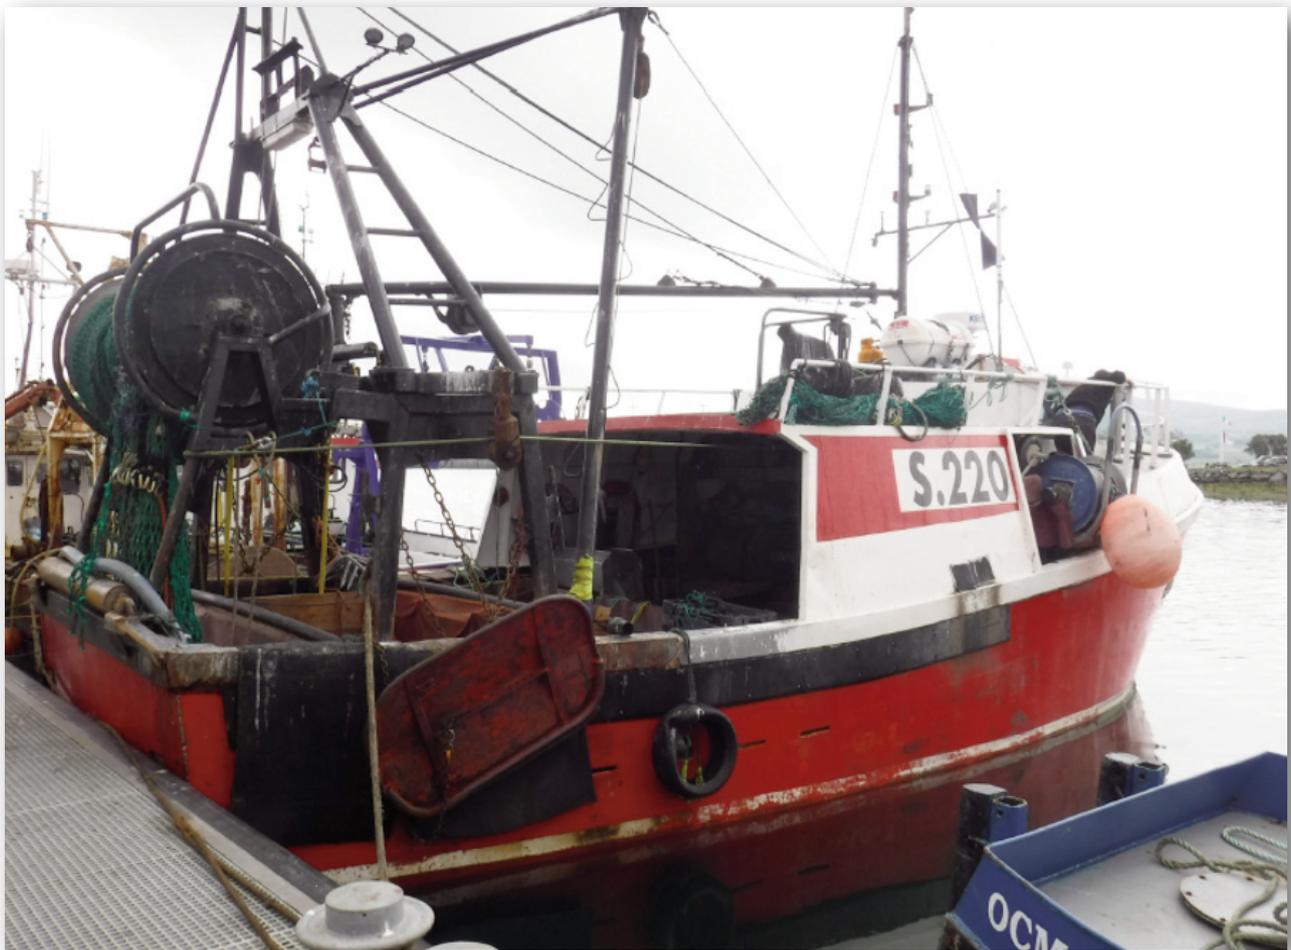
Photograph No. 2 - Fishing trawl gear and nets.

2.7.2 Fishing gear pollution: The '*FV Kayleigh*' was fishing at the time of the fire. A fishing trawl net was deployed from the vessel and remained attached to the vessel when it was presumed sunk and therefore remains on the sea bottom in close proximity and attached to the wreck.

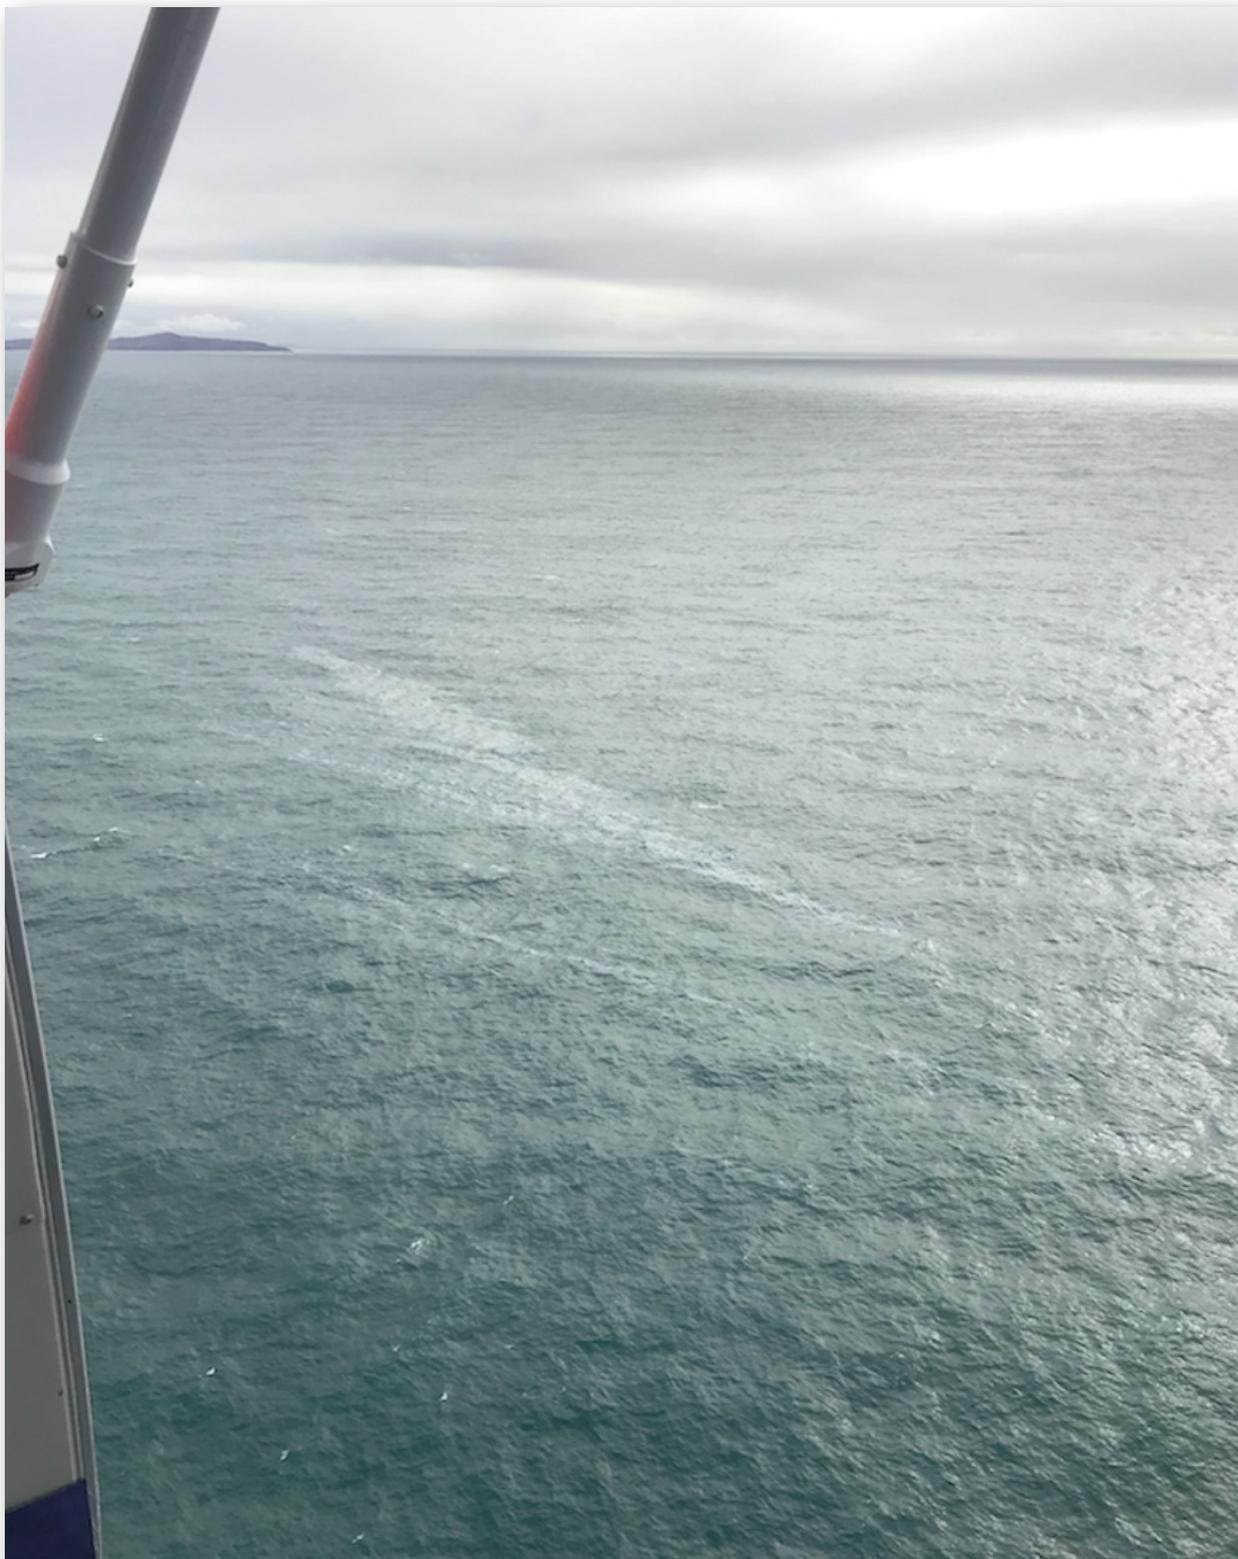
Photograph No.3 - Oil pollution

IRCG rescue helicopter R117 reported oil on the sea in the area of the last known position of the '*FV Kayleigh*' and that the vessel was presumed sunk. There was no debris found.

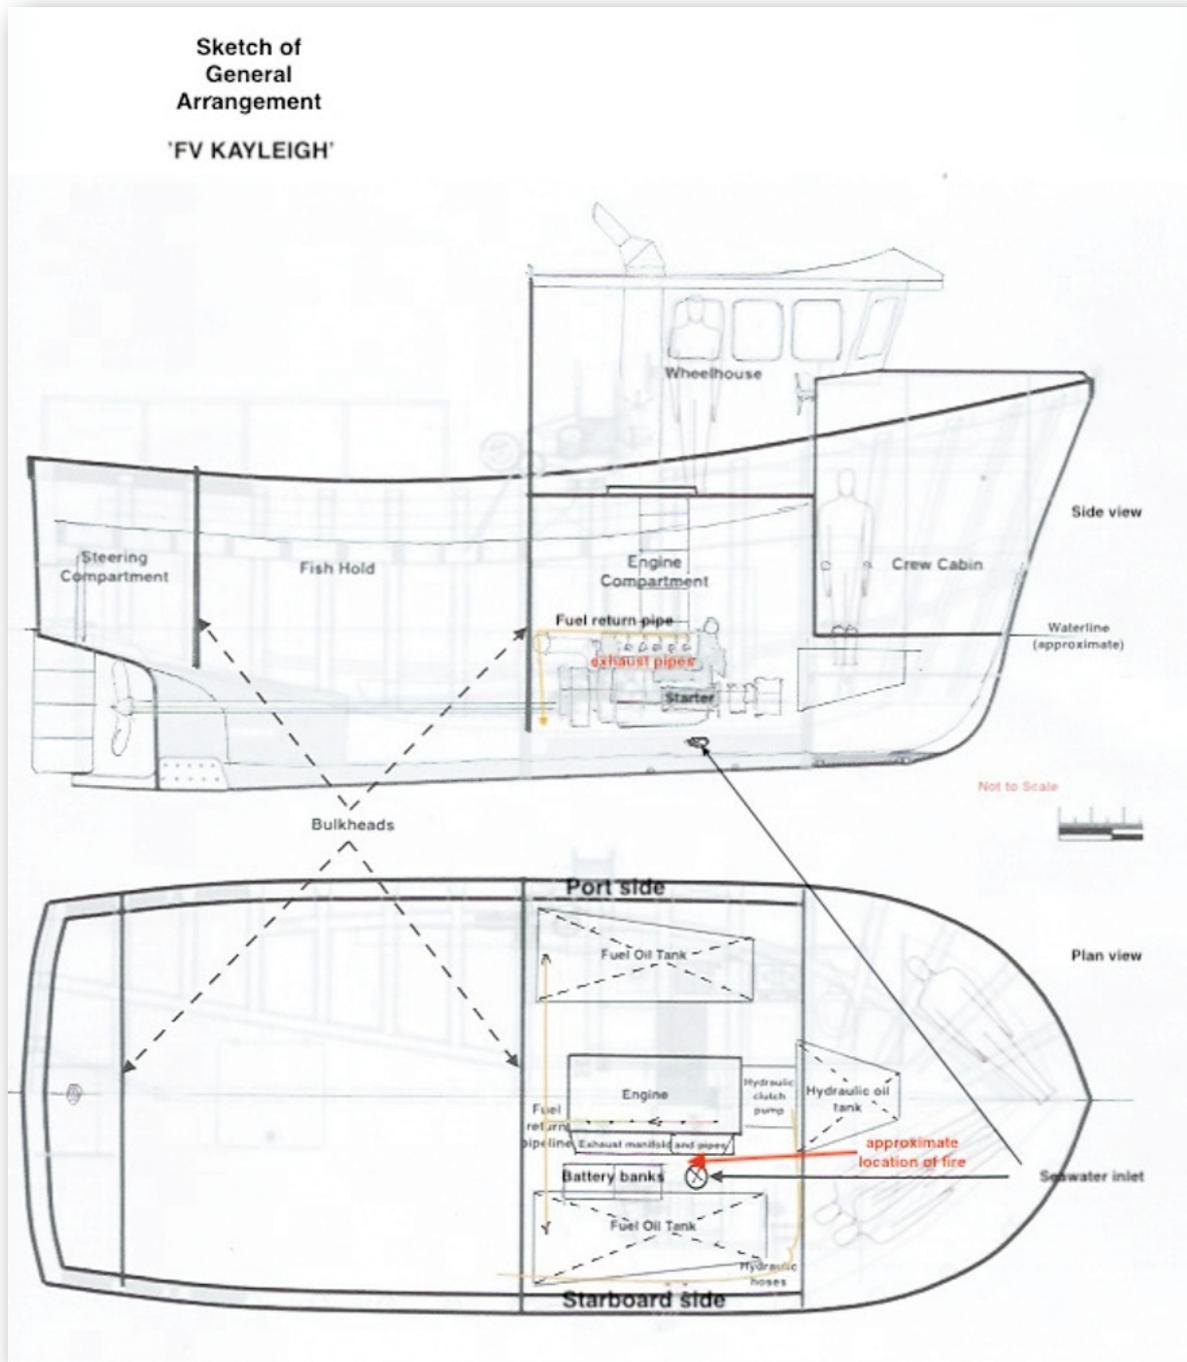
Fig.1 - Sketch: General arrangement 'FV Kayleigh'.

The '*FV Kayleigh*' was constructed in the UK by Cygnus Marine Ltd and it is not known as to what damage stability criteria this fishing vessel was constructed. The vessel may have been fitted with two watertight bulkheads each separating the engine compartment from the crew cabin forward and the fish hold aft. The minimum standard of 'one compartment flooding' would require watertight bulkheads and thereby allow the vessel to remain afloat unless flooding occurred in some other compartment.

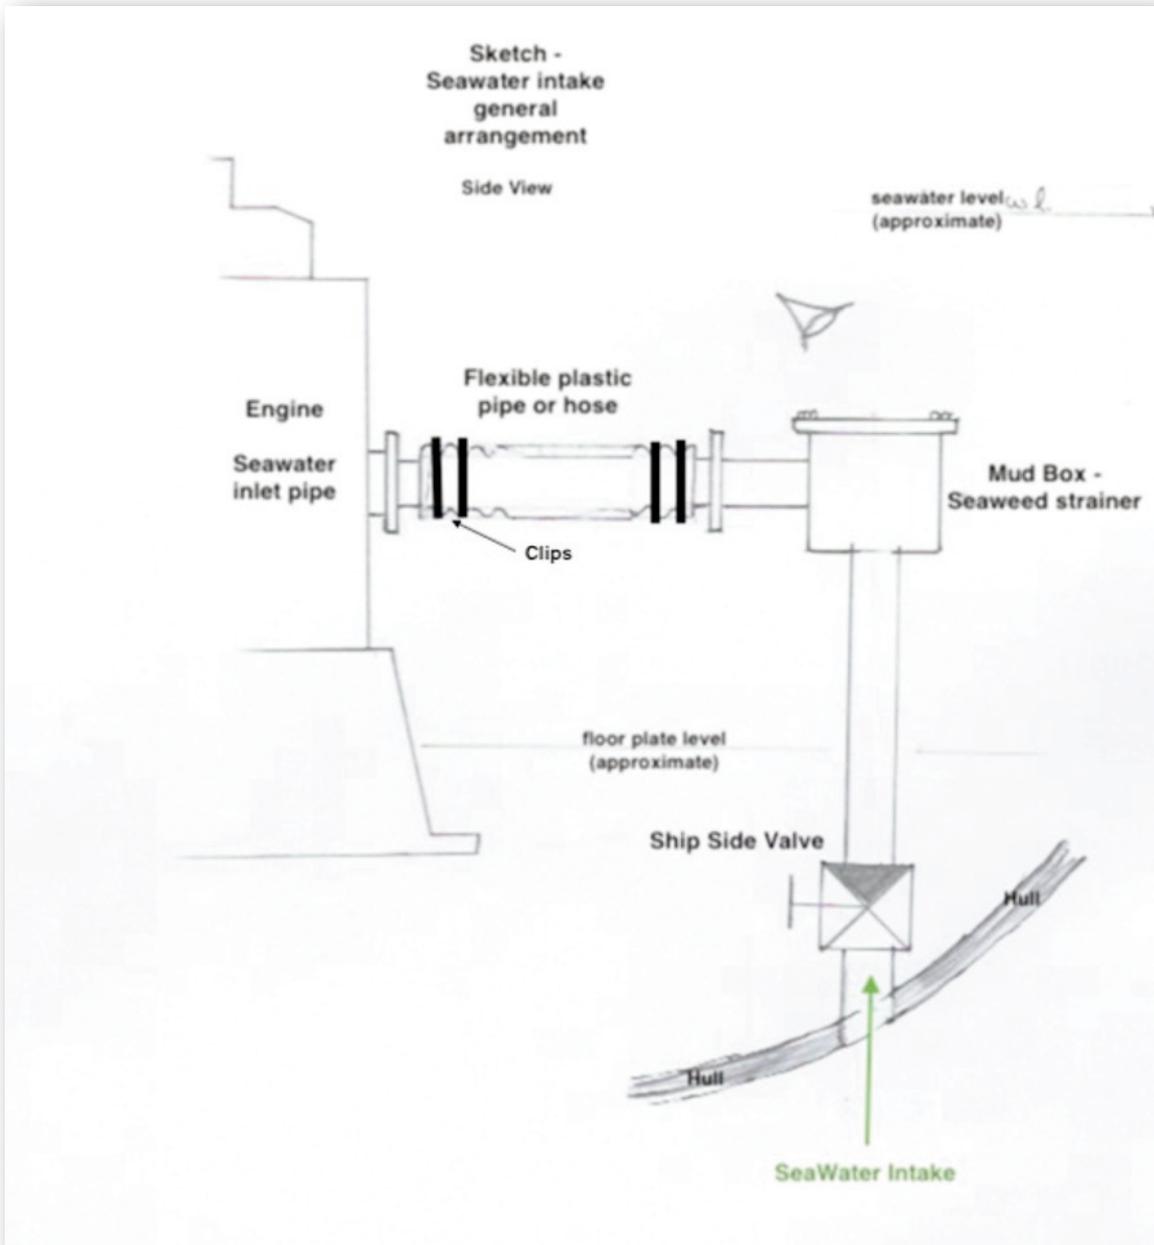
Fig.3- Sketch: Seawater Intake Pipe arrangement

diameter stainless steel pipe to the intake mud box/seaweed strainer located at floor level between the engine starter and starter battery bank. The seawater pipe was then directed inboard towards the engine and connected to a flexible plastic hose attached directly to the engine seawater cooling intake at the starboard forward end of the engine under the engine mounted seawater circulating pump. The seawater intake arrangement was below the vessels water line.
