INVESTIGATION INTO AN
INCIDENT INVOLVING THE
GROUNDING OF THE VESSEL
'MV ALTA'

AT BALLYANDREEN BAY,
BALLYCOTTON, CO. CORK

16 FEBRUARY 2020

REPORT NO. MCIB/299
(No.1 OF 2021)

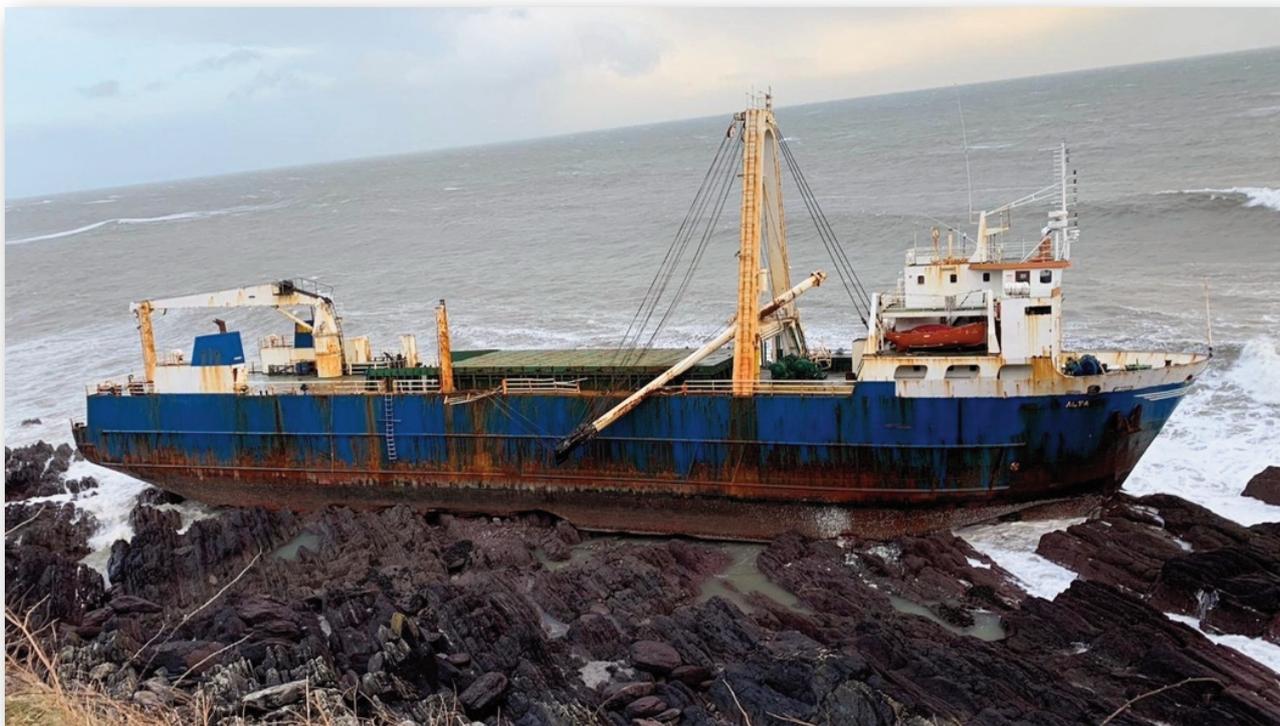
- 3.3 The vessel continued drifting across the North Atlantic influenced by the Gulf Stream, until it entered European waters and came ashore on the coast of Ireland. On 16 February 2020, during Storm Dennis, members of the public (MoP) alerted the Irish Coast Guard (IRCG) Marine Rescue Co-ordination Centre, Valentia (MRCC Valentia) when the ship was sighted ashore on the rocks at Ballyandreen Bay, position 51°48.98'N 008°02.86'W.

In its present position stranded ashore near Ballycotton, the wreck has a visual impact to the casual observer due to its location and appearance. The wreck lies on a known tourist route (The Wild Atlantic Way) and while the wreck remains an identifiable ship and an object of curiosity, as time passes the wreck, if not removed, will inevitably deteriorate to an unsightly collection of rusting plates and plastic wreckage. The *'MV Alta'* poses a potential for environmental pollution, both materially and visually.

Photograph No.1 - 'MV Alta' aground in Ballyandreen Bay, Co. Cork.

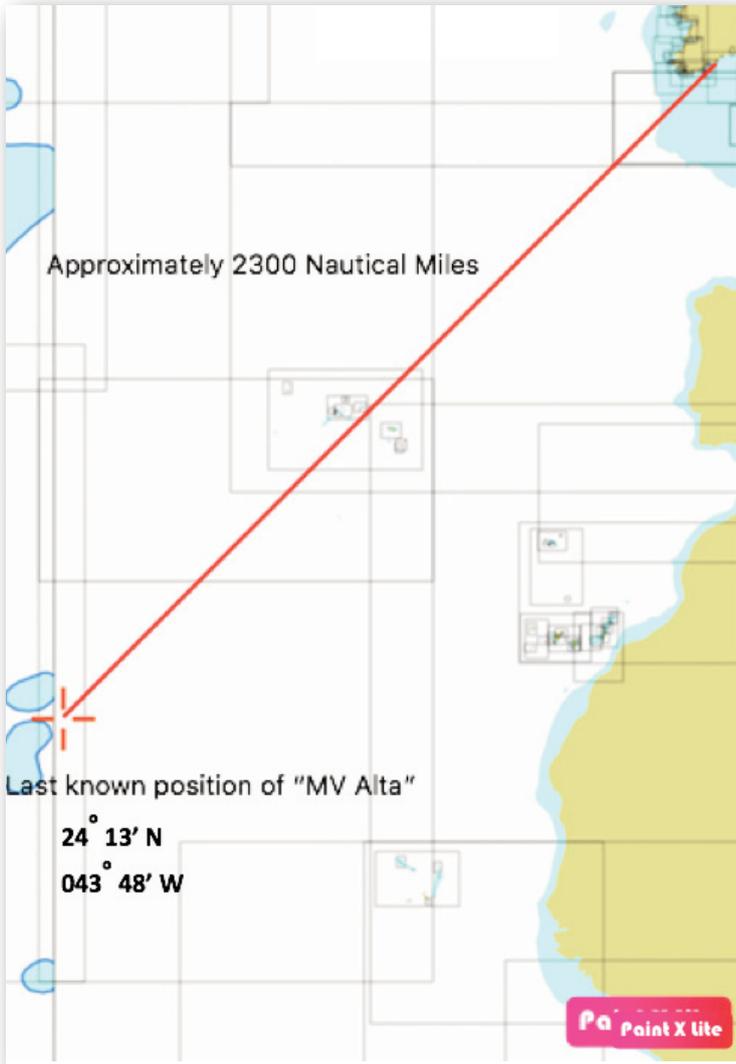
Appendix 7.3 Chart of Distance Travelled

3.7 From the ships recorded position of abandonment, the ‘MV Alta’ drifted for 496 days over a distance of 2,300 nautical miles (NM) to its current position in Ballyandreen Bay. The vessels exact position and distance travelled during this time is unknown and unrecorded and can only be estimated.

Although the track of the vessel was circuitous, an estimate of the daily average distance travelled was 4.63 NM per day towards the Irish coast. Ireland’s territorial waters extend to 200 NM from its territorial sea baselines. In theory the vessel may have spent approximately 43 days in Irish territorial waters without being reported.

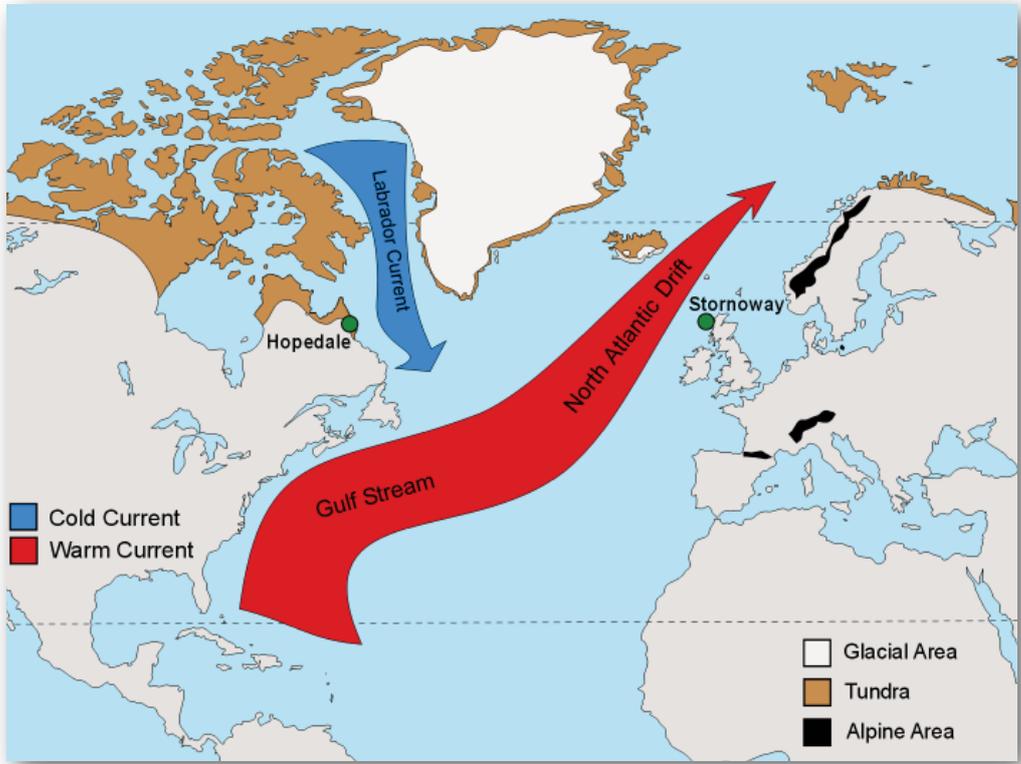
Figure 1 - Gulf Stream.

- 4.1 The vessel was abandoned and adrift in the Gulf Stream (see Appendix 7.5 Currents and Winds in the North Atlantic Ocean - Figure 1 - Gulf Stream). Being abandoned and adrift, the vessel was a derelict by virtue of definition. Derelict vessels, on the high seas, are a danger to navigation to other vessels, particularly during times of restricted visibility. The Gulf Stream influenced the derelict's meanderings across the seas, initially northwards along the eastern seaboard of the United States of America and then westwards as its meandering direction became influenced by the mid latitude westerly winds.

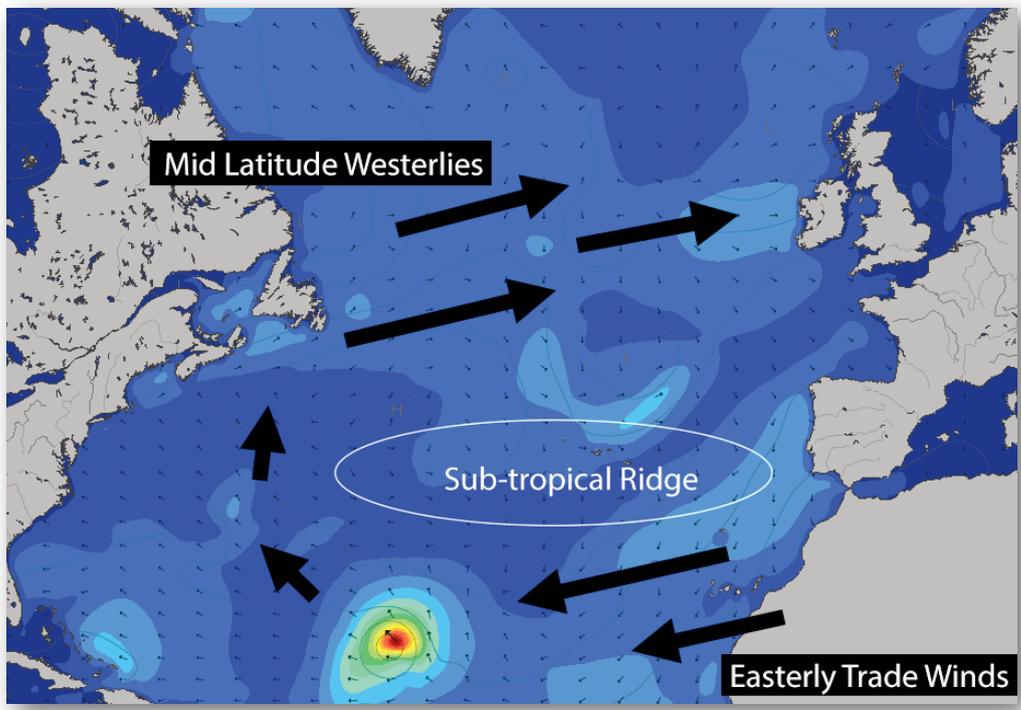
Figure 2 - Atlantic Trade Winds.

The combination of dynamic influences of the Gulf Stream currents and the mid latitude westerly winds pushed the derelict towards Europe and the seas off Ireland.
