**REPORT OF INVESTIGATION
INTO AN INCIDENT
OFF THE NORTH COAST OF
SPAIN INVOLVING THE
IRISH REGISTERED YACHT
'LOA ZOUR'
ON THE 6th JUNE 2019**

**REPORT NO. MCIB/300
(No.10 OF 2020)**

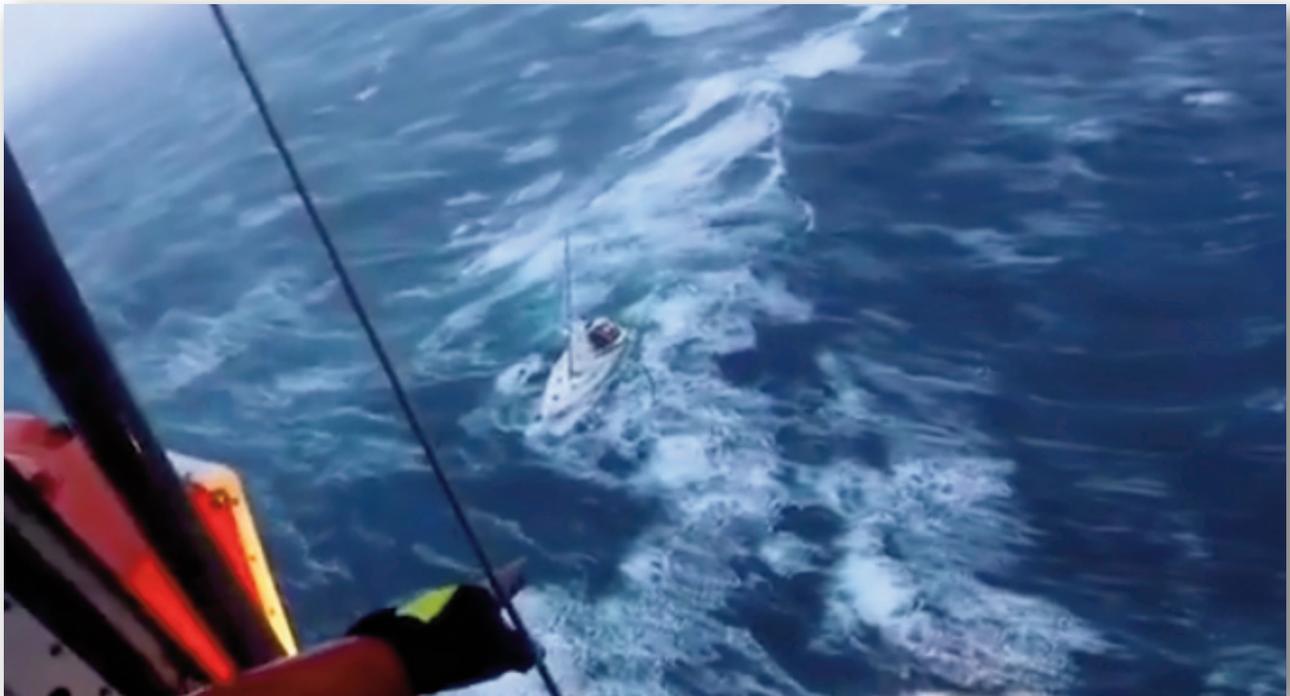
Photograph No. 2 - Yacht 'Loa Zour' in the seas of Storm Miguel.

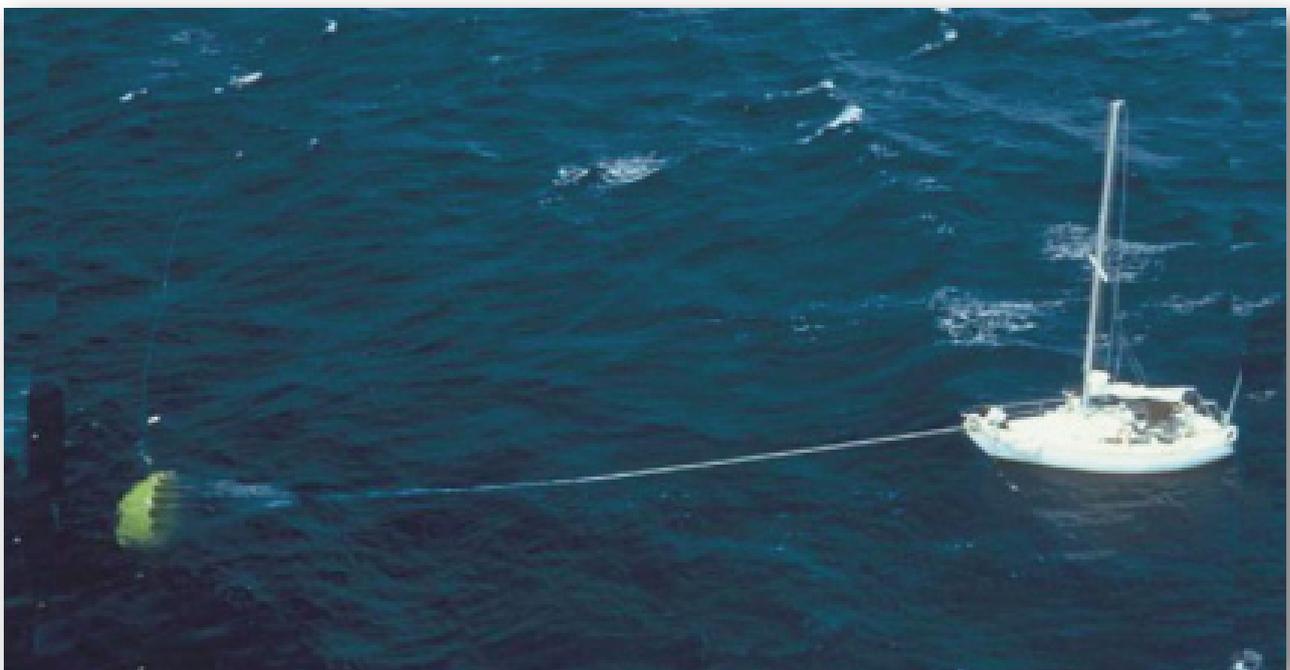
(See Appendix 7.1 Photograph No.3 Deployment of a Sea Anchor).

Photograph No. 3 - General equipment (offshore) deployment of a Sea Anchor.

- 6.3 The Minister of Transport and the Irish Maritime Administration should include the use of sea anchors and provision of a set of storm sails as part of the recommended equipment described in CoP Chapter 2, Table E.8 'General Equipment' for category 'A' and category 'B' recreational craft, (sea anchors are included in equipment lists for SOLAS approved liferafts (reference: Life Saving Appliances (LSA) - Code of life-saving appliance (MSC. 48(66) Chapter IV 4.1.5.1 Equipment)).

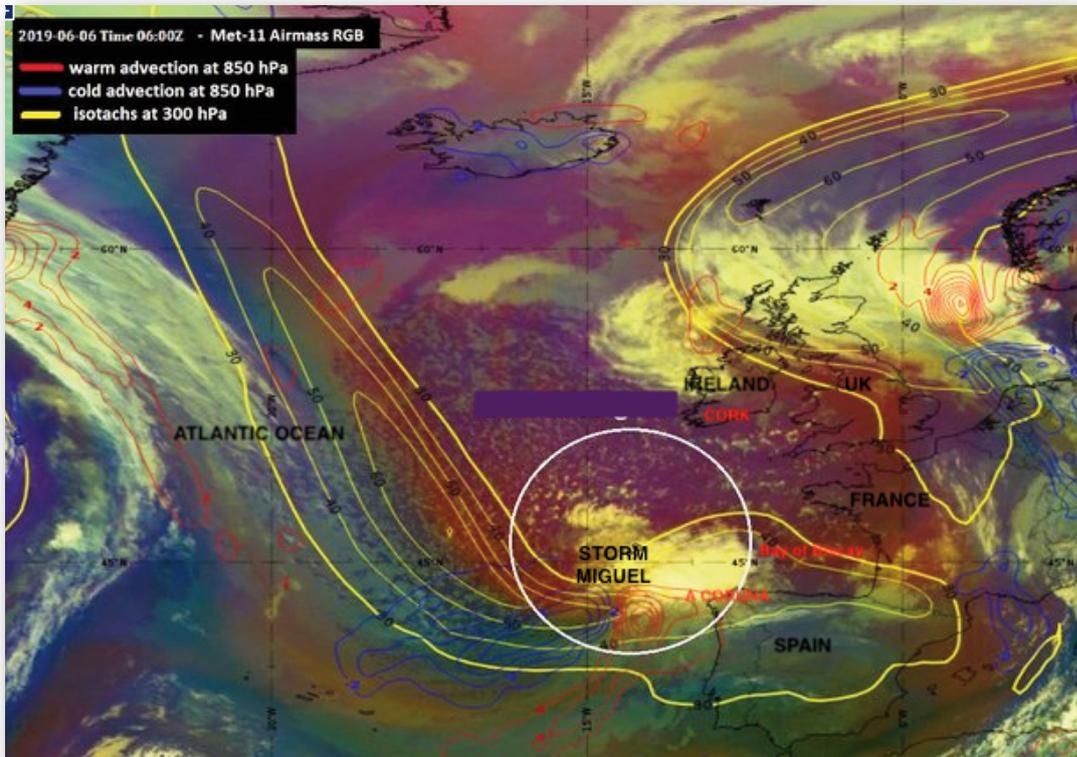
Fig.7. Storm Miguel 0600 UTC 6th June Satellite image (Meteosat-11).
