**REPORT INTO AN INCIDENT
INVOLVING THE
'FV DEARBHLA'
AT THE BLASKETS,
CO. KERRY
14th MAY 2020**

**REPORT NO. MCIB/301
(No.12 OF 2020)**

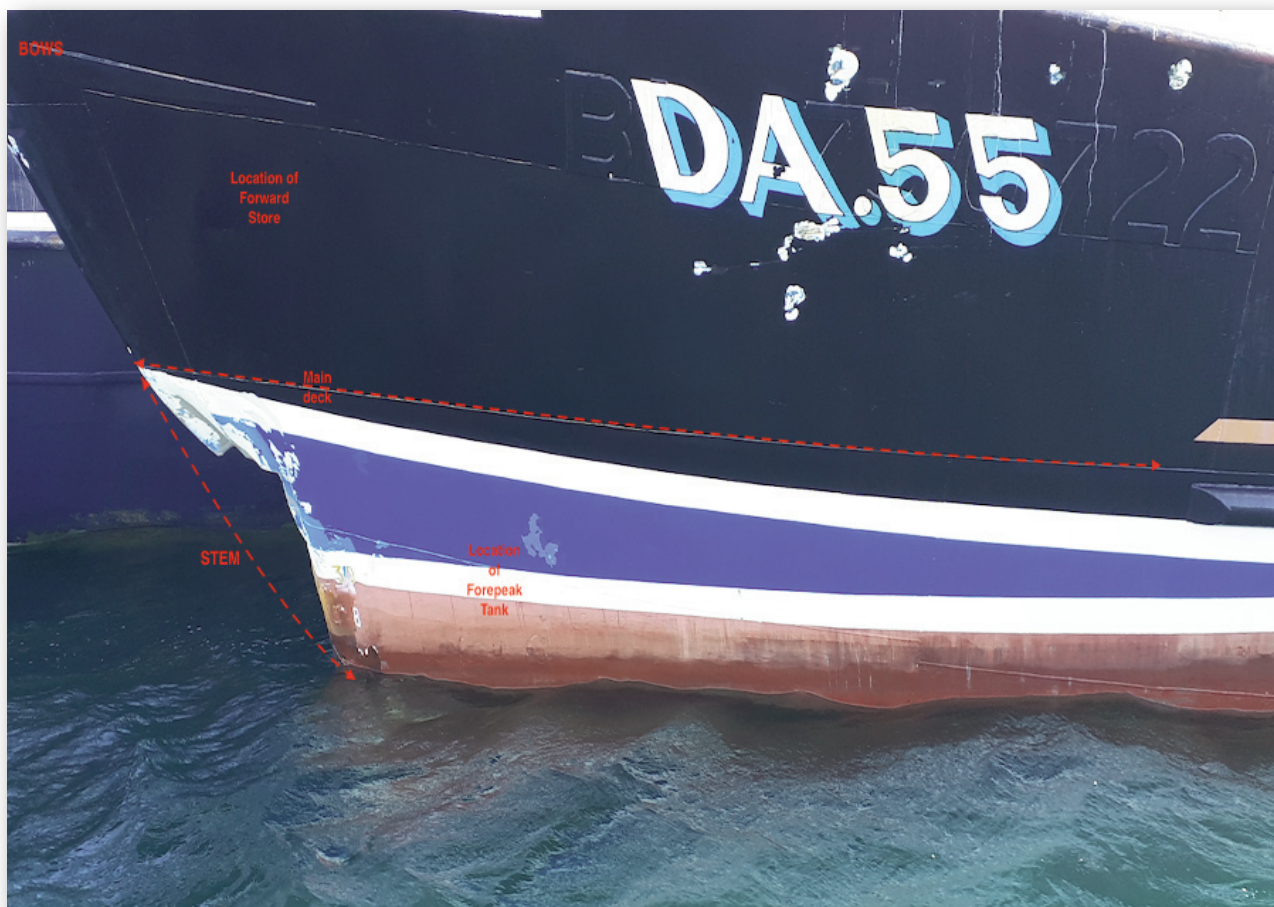
- 1.3 The vessel's owner was informed of the incident at approximately 08:00 hrs that day. The owner arranged for the vessel to proceed to Castletownbere for an inspection of the damage and repairs. The inspection revealed that the vessel had considerable contact damage to its stem at the waterline and was holed above the waterline under the bows.

Damage found to the bows and stem was extensive. The hull plating was ruptured above the waterline and internal frames, beams, brackets and floors in the forepeak tank were deformed and buckled. The deck in the forward store was buckled. There was evidence of hard contact along the starboard chine and on the leading edge of the bilge keel.

Photograph No.2 - Bow damage above the waterline.

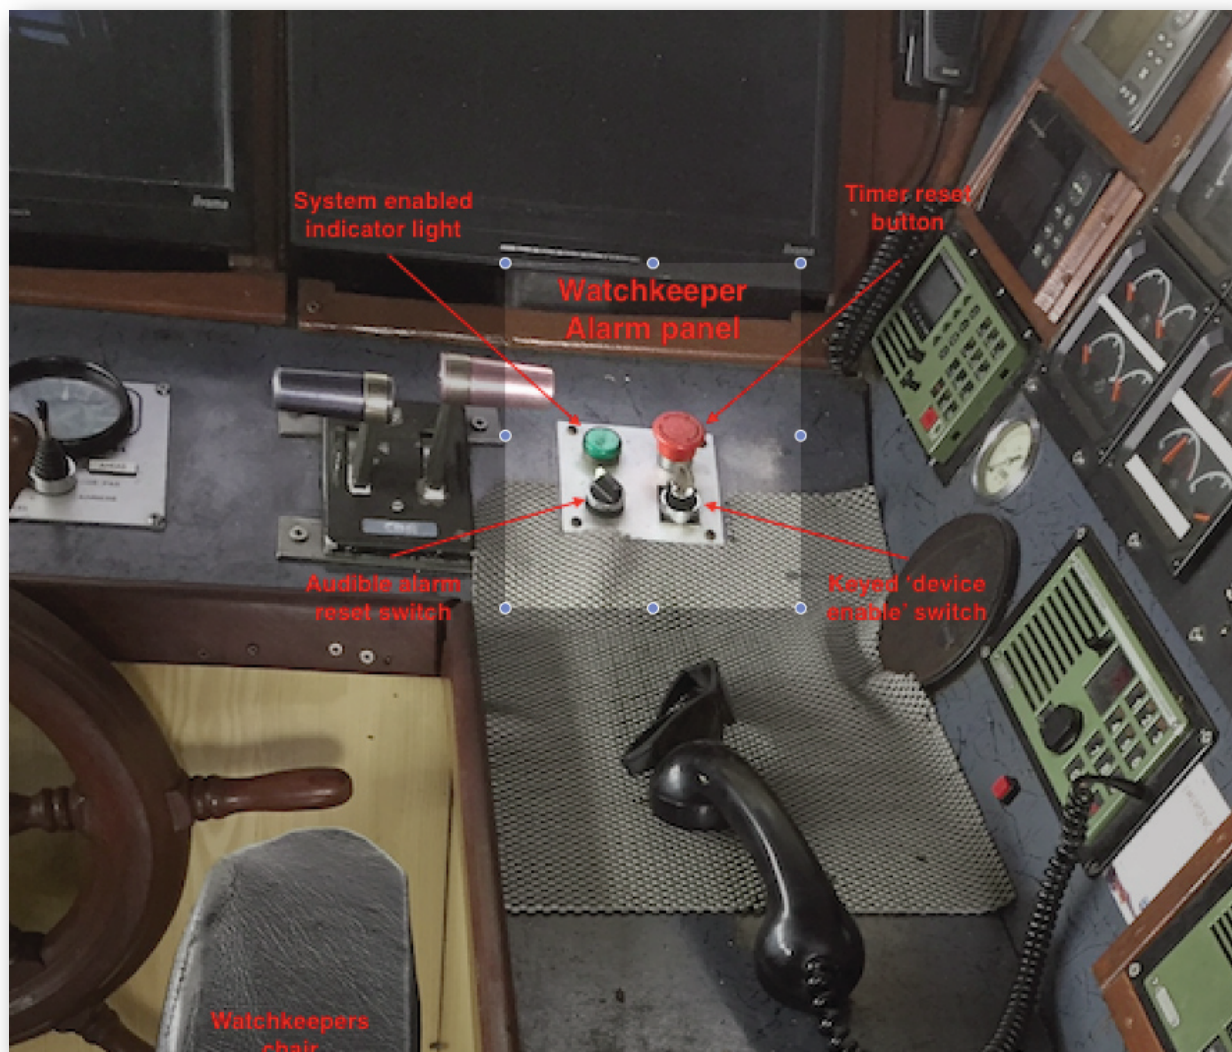
3.3 Shortly after taking over the watch Crewmember 'A' went down to the tea station in the crew mess to make a cup of tea. Before leaving the wheelhouse, Crewmember 'A' switched 'OFF' the 'Watchkeeper Alarm', a timer device designed to give an audible sound in the wheelhouse every ten minutes. The device's function is to ensure the watchkeeper remains alert and in the wheelhouse. The Watchkeeper Alarm panel is located on the main wheelhouse console to the starboard side of the helm immediately in front of the watchkeeper's chair.

Crewmember 'A' switched off the alarm so as not to awaken the crew if he was delayed in making the tea.

After making the tea Crewmember 'A' returned to the wheelhouse and resumed the watch. Crewmember 'A' stated that he forgot to switch the Watch Alarm back 'ON' after he returned to the wheelhouse.

- 4.3 The Watch Alarm panel has a keyed ‘ON/OFF’ switch. The key is removable and may be taken away leaving the panel either locked in the ‘ON’, (enabled) position or locked in the ‘OFF’, (disabled) position (see paragraph 3.3). It would have been good practice for a senior watchkeeper onboard the fishing

vessel to switch 'ON' the Watch Alarm Panel switch, remove the key and keep the key remote from the panel. By doing so the Watch Alarm system would be locked in operation, always enabled and active during the voyage.

Photograph No. 3 - Watchkeeper Alarm Panel.

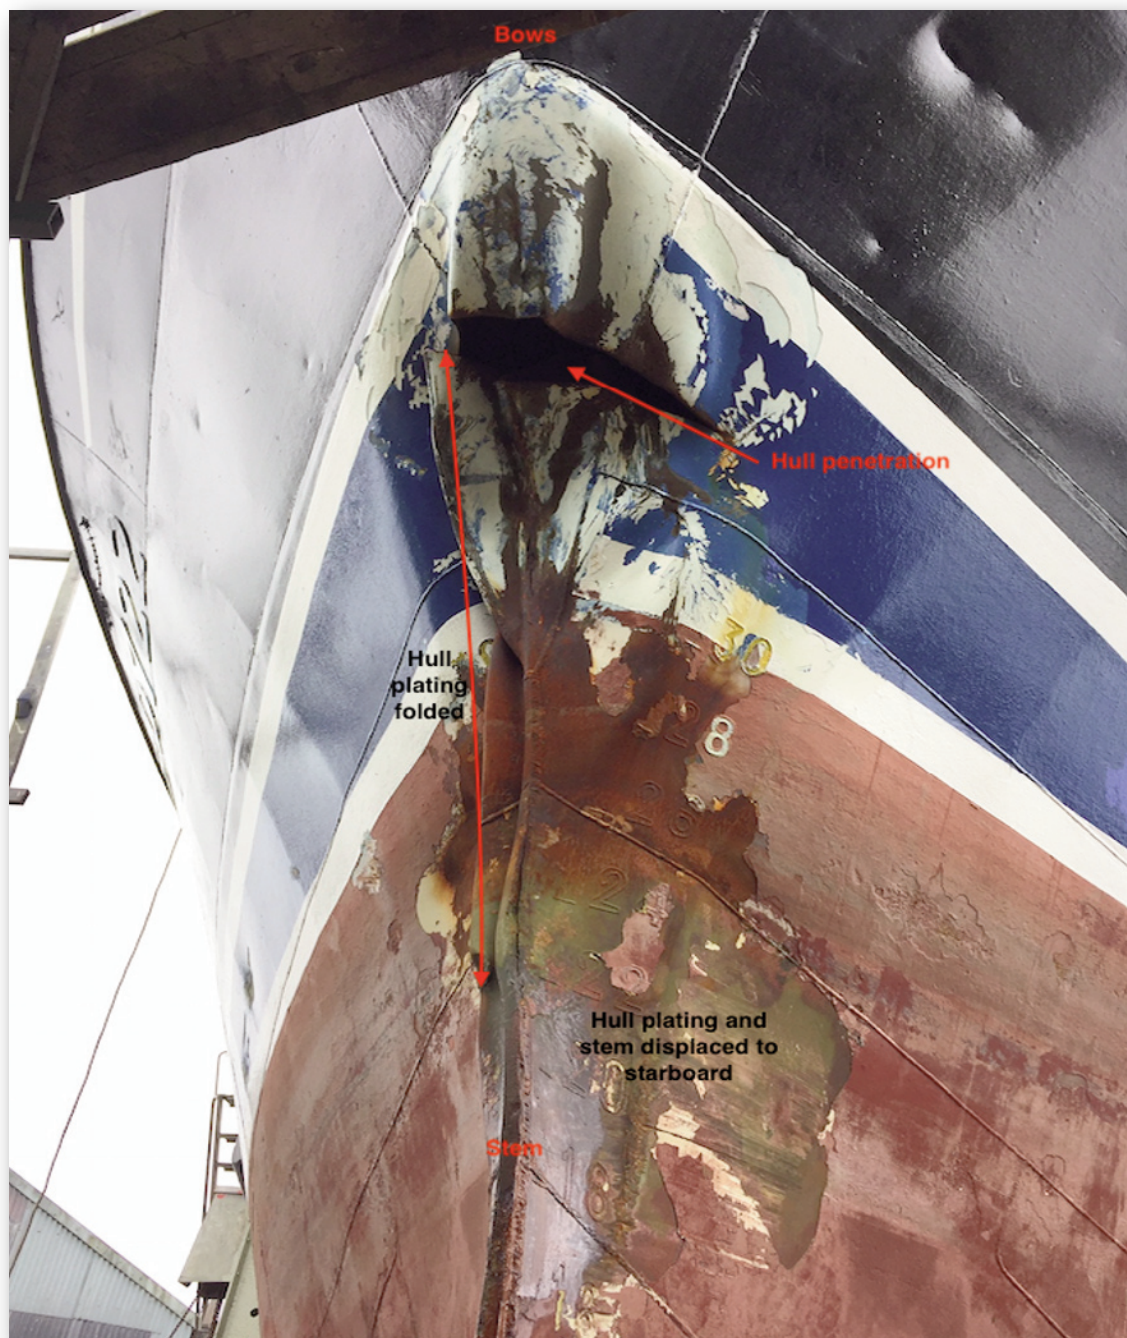
Photograph No.4 - Stem damage below the waterline.

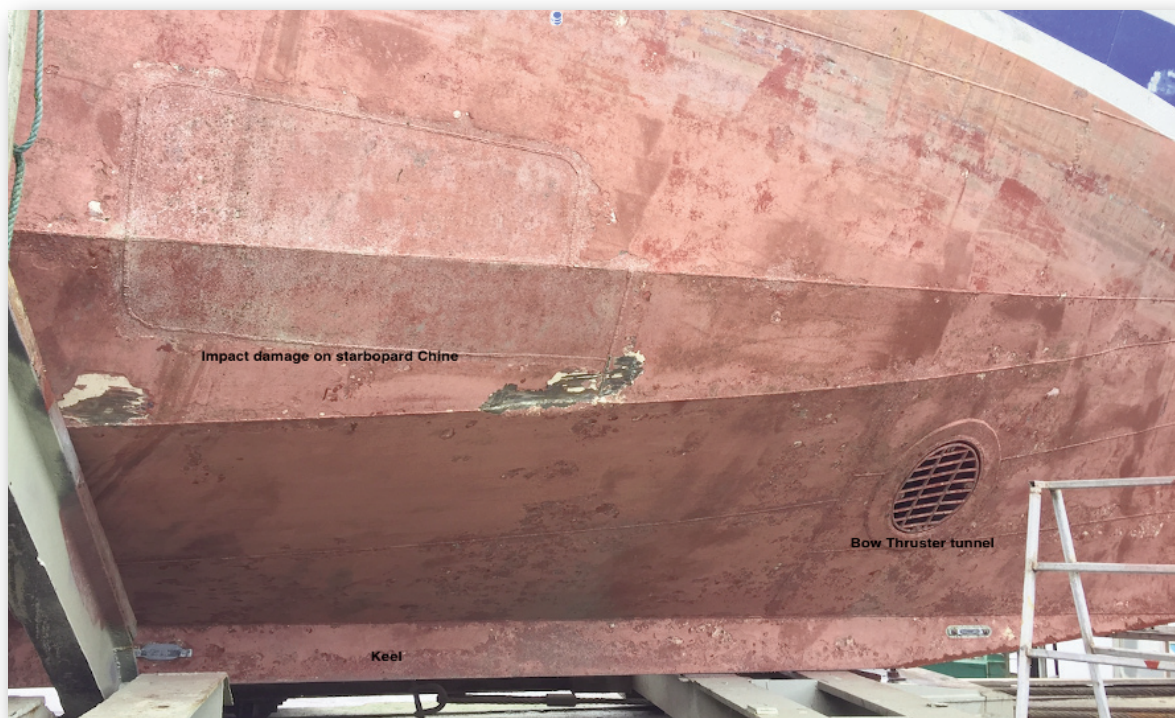
Photograph No. 5 - Starboard Chine damage below the waterline.

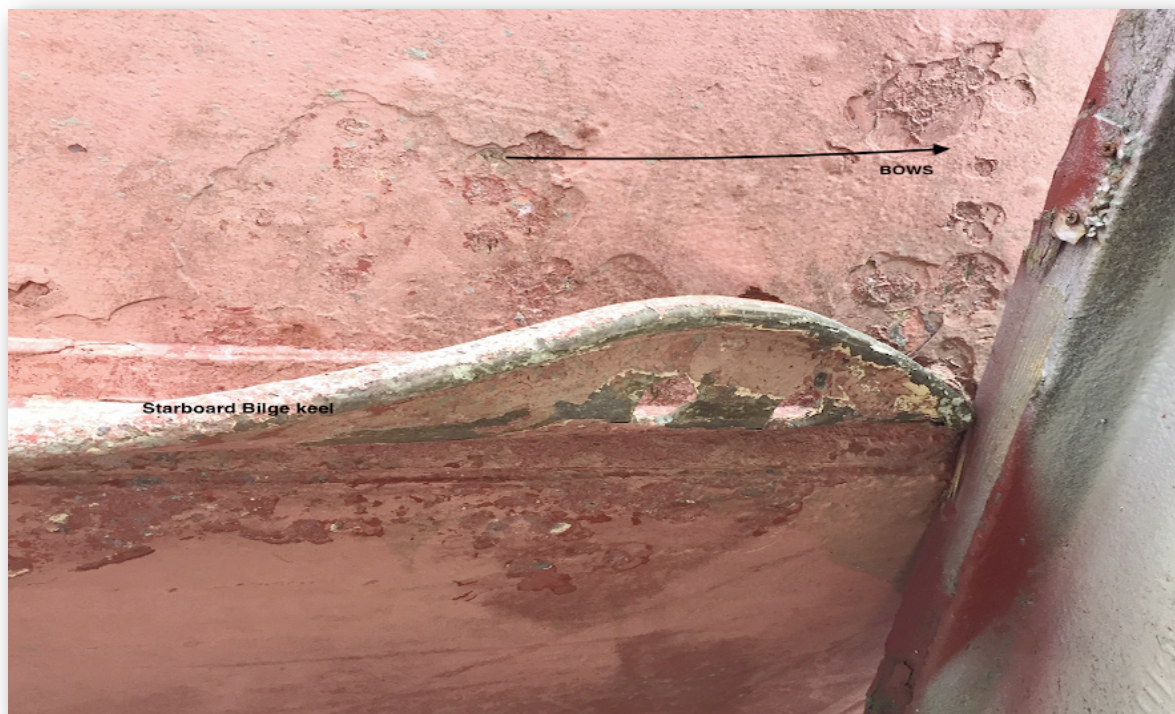
Photograph No.6 - Bilge Keel damage below the waterline.

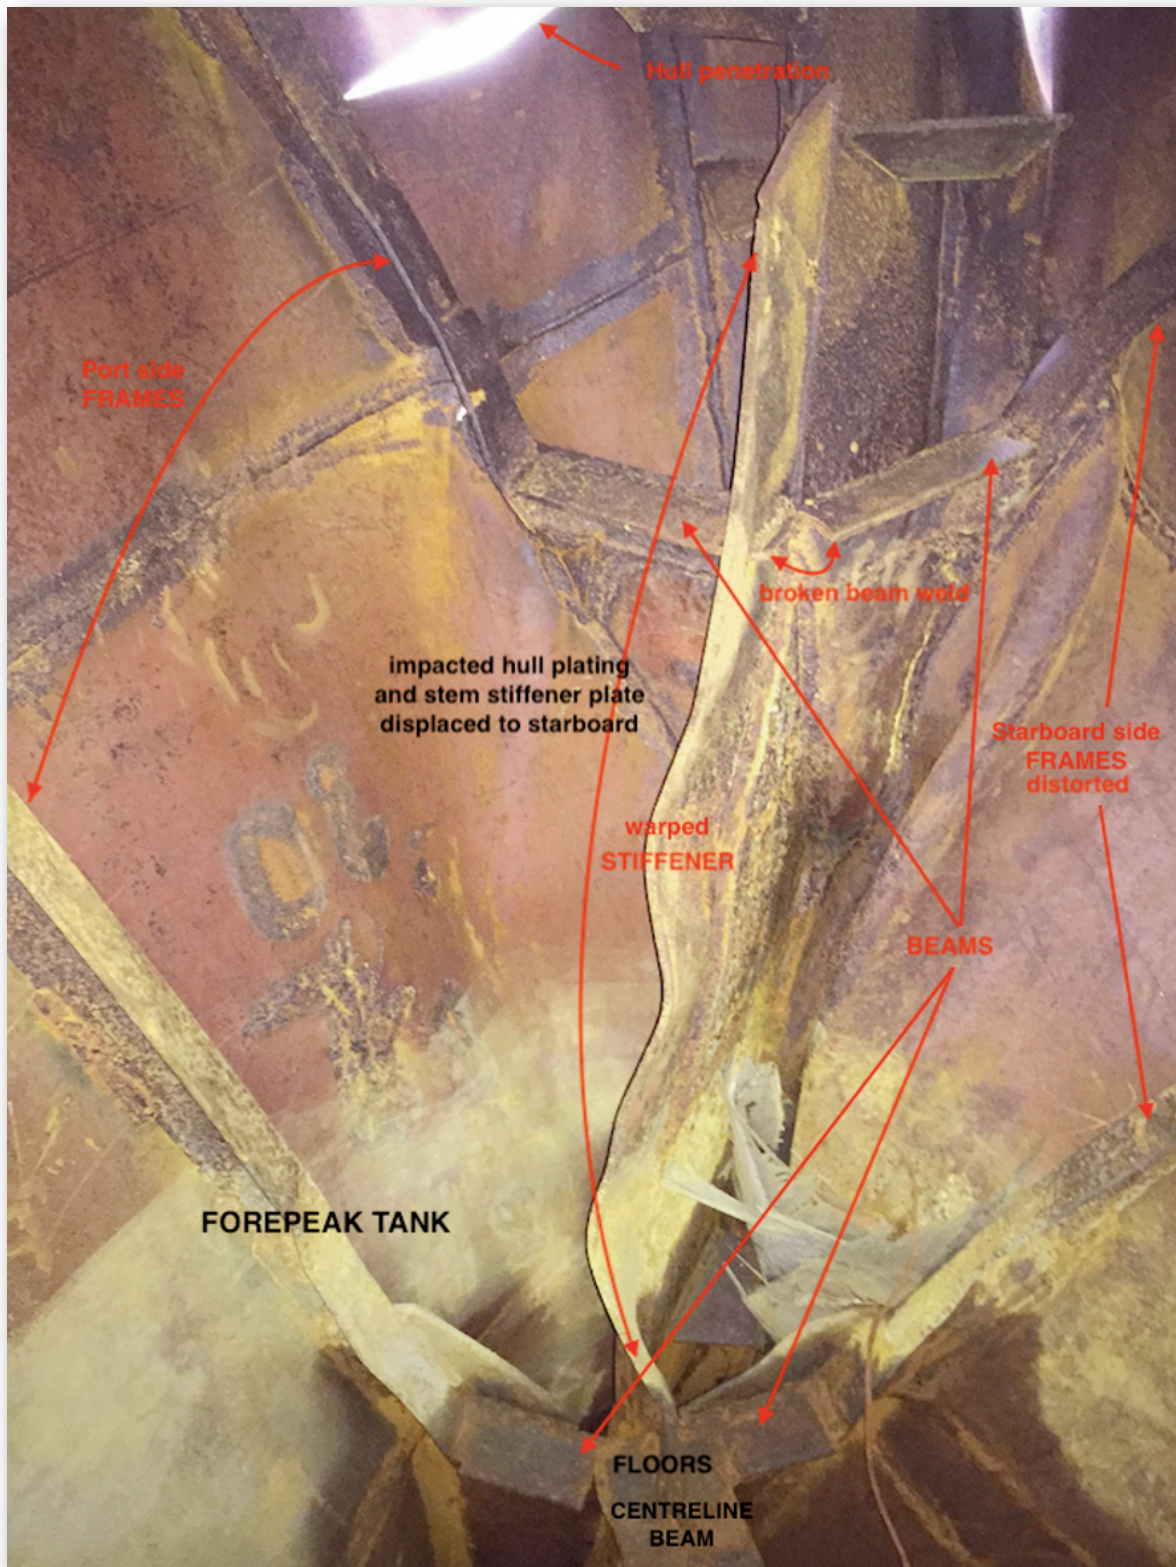
Photograph No. 7 - Forepeak Tank damage.

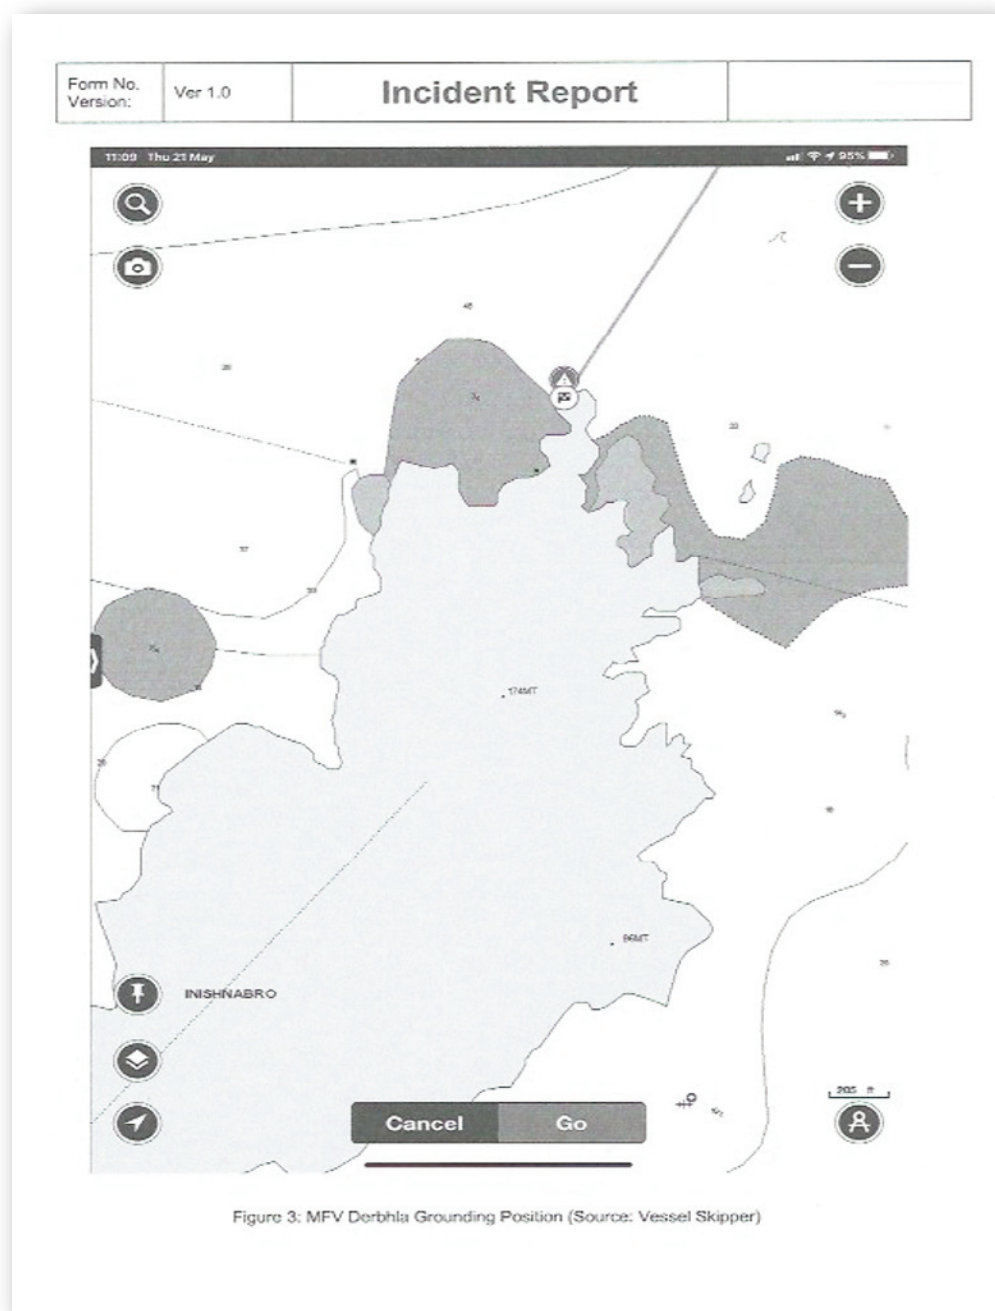
Chart No. 3. 'FV Dearbhla' Grounding Position.

At approximately 03:00 hrs the following morning, 14th May, the Skipper called Crewmember 'A' to take over the navigation watch in the wheelhouse. The Skipper instructed Crewmember 'A' to continue and proceed through Blaskets Sound. The Skipper left the wheelhouse and proceeded to his bunk for rest. At approximately 04:10 hrs the vessel grounded on rocks in approximate position Latitude 52° 03.820'N Longitude 010° 36.296'W which is on the north west peninsula of Inish na Bró island.

- 3.5 According to the vessels AIS track at 04:10:05 the vessel's speed was 8.7 kn. Sometime shortly after and according to the Skipper's incident report the fishing vessel grounded on rocks on the northwest peninsula of Inish Na Bró.

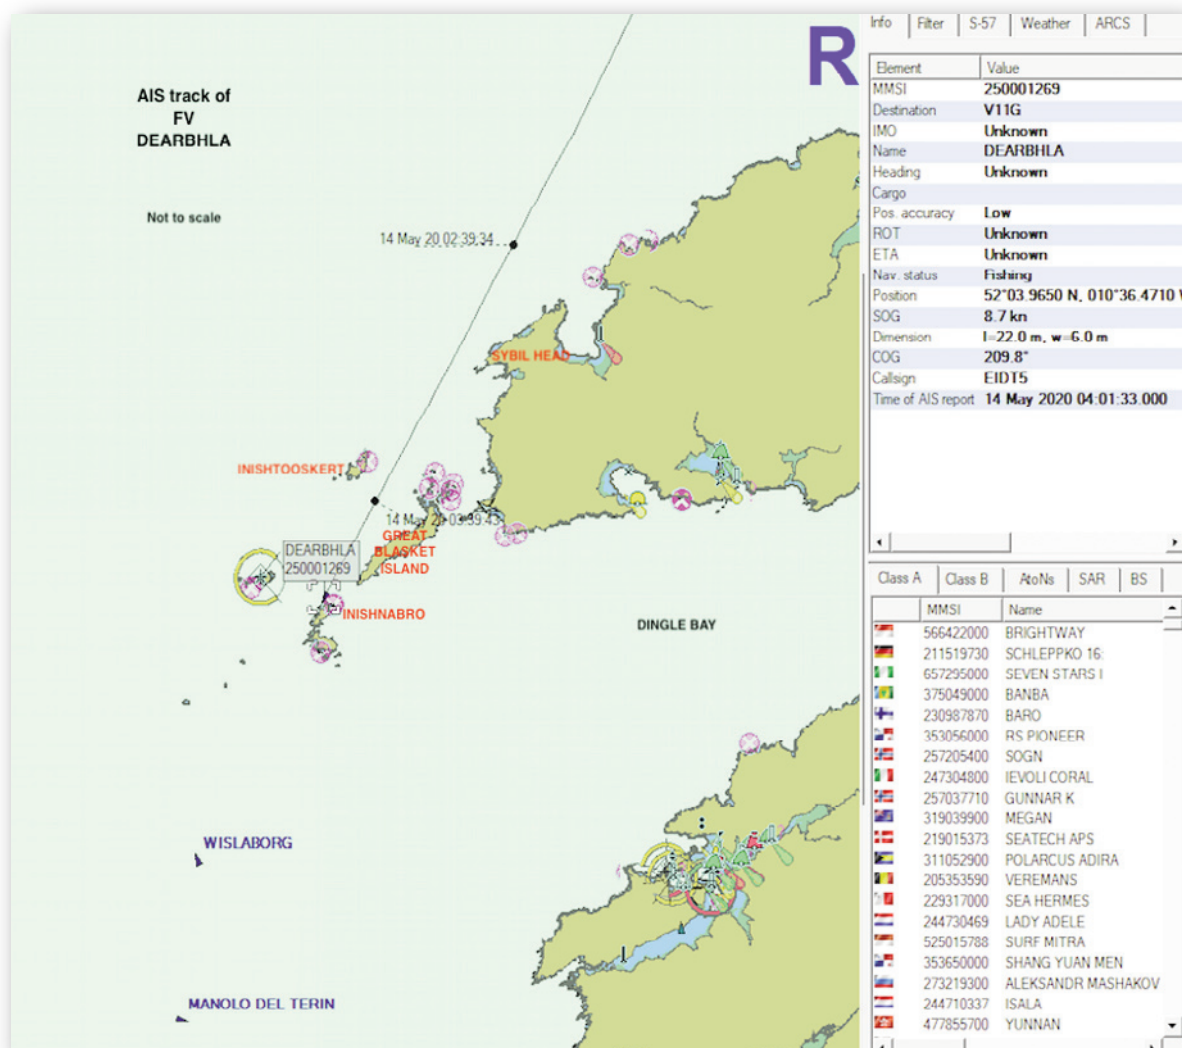
Chart No. 7. 'FV Dearbhla' AIS track to 04:01 hrs.

At 04:01 hrs the vessel's position was 52° 03.9650'N, 010° 36.4710'W in immediate proximity to Inish na Bró; the vessels COG was 209.80, SOG 8.7 kn and unless the watchkeeper made a safe course change the vessel was standing into danger of grounding on the island of Inish na Bró.
