**REPORT OF AN INVESTIGATION
INTO A FATAL INCIDENT
INVOLVING THE FISHING VESSEL
“MIRROR OF JUSTICE”
TEELIN, CO. DONEGAL
26 AUGUST 2020**

**REPORT NO. MCIB/302
(No.2 OF 2022)**

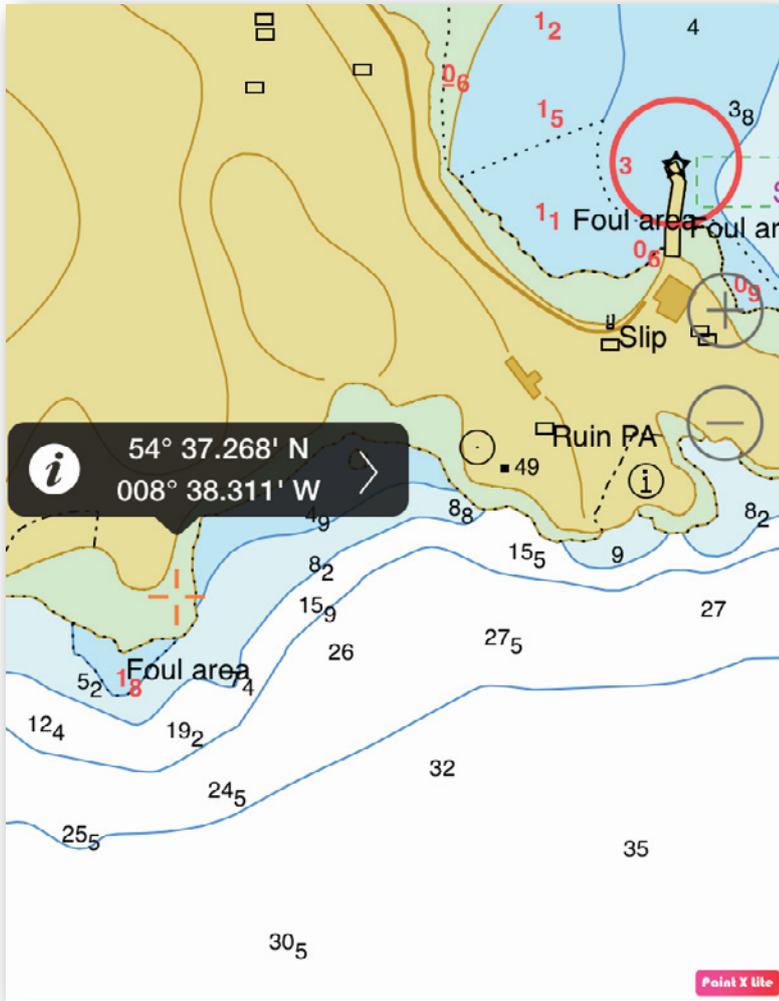
Appendix 7.7 Chart Grounding Point

3.6 Prior to this time two anglers fishing at the back of Teelin Pier had observed the “*FV Mirror of Justice*” drifting. They watched the vessel for approximately 15 minutes and became concerned that the vessel was too close to the shore and that there did not appear to be anyone on board. They clearly heard the “*FV Mirror of Justice*” making contact with the rocks, and called a local fisherman to relay this information, only to realise that the alarm had already been raised and they could see that the “*FV Girl Denise*” was already on site. One of the anglers interviewed noted that the time the “*FV Mirror of Justice*” made contact with the rocks was approximately 20.15 hrs

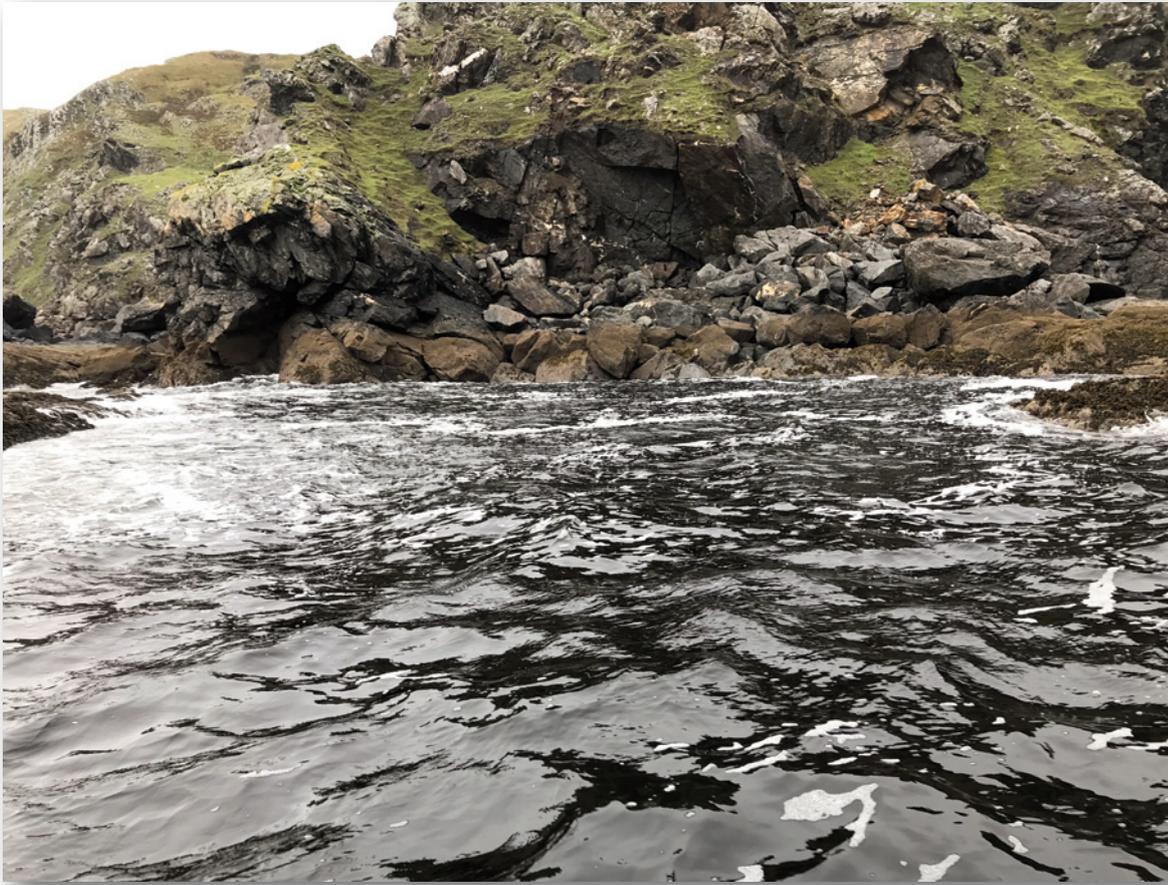
Appendix 7.8 Photograph No. 3 - Wreck Site

3.8 At 21.02 hrs the Killybegs CG Delta RIB arrived on the scene. By this time several local vessels had also arrived to assist. The “*FV Mirror of Justice*” was on the rocks in a position making it very difficult for any attending vessels to reach it due to a 1 m sea swell.

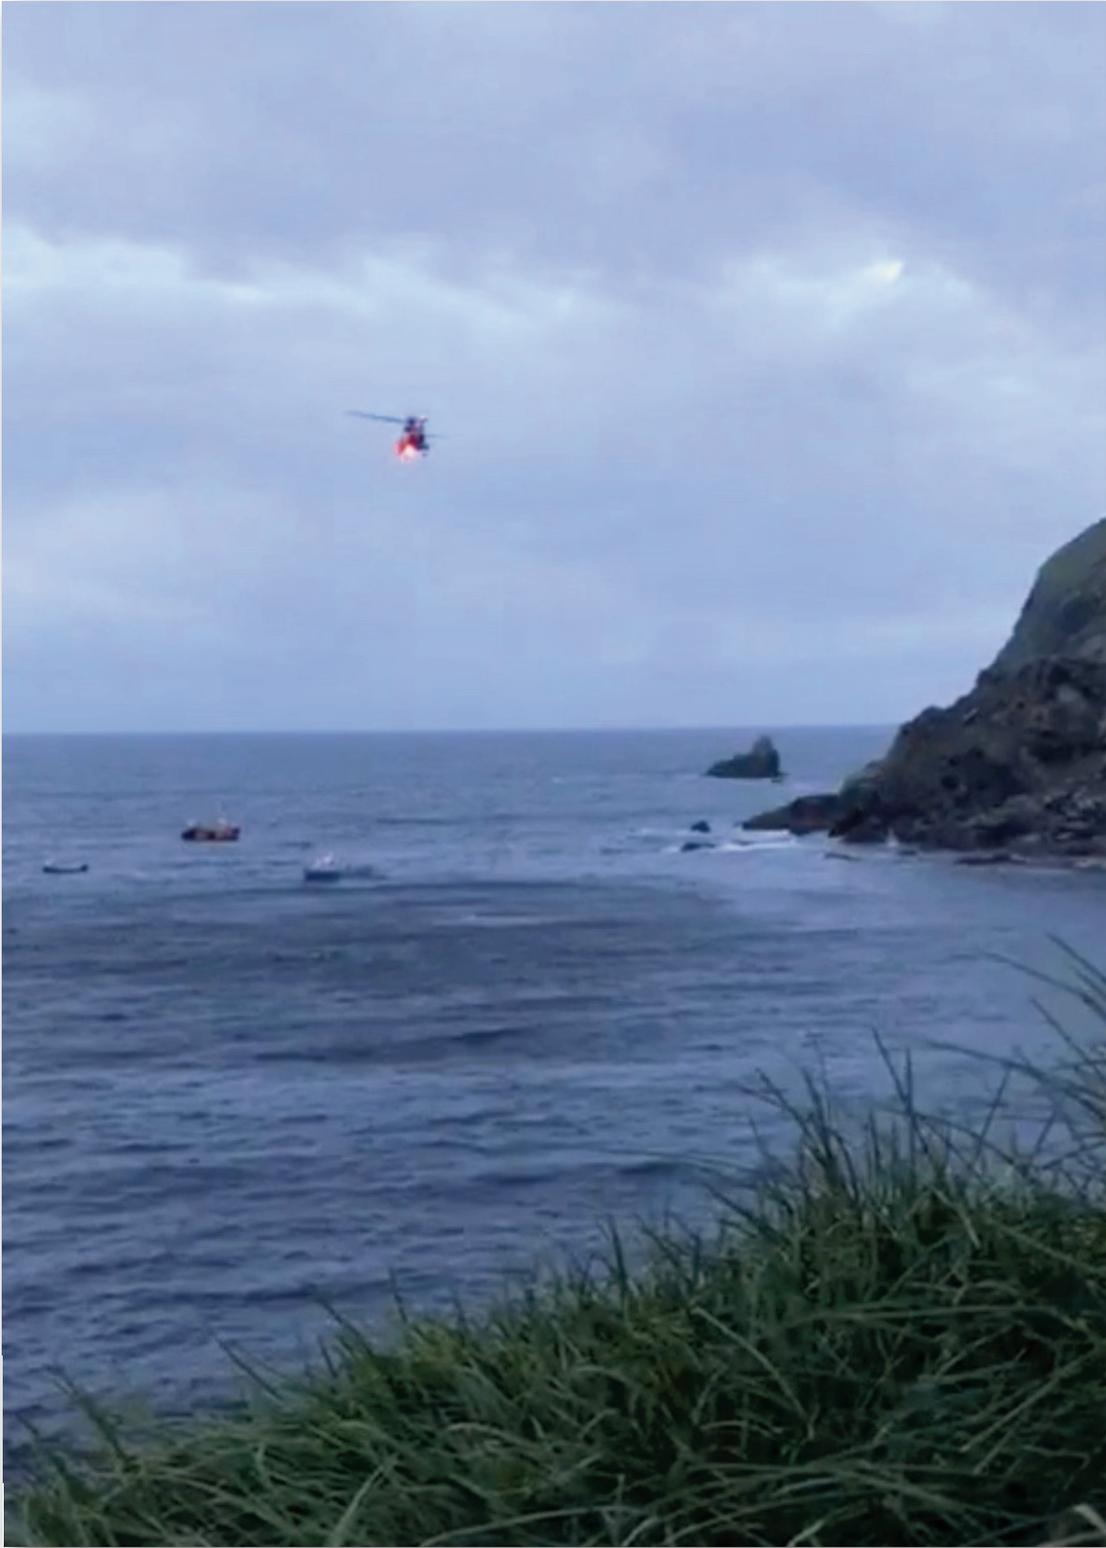
Appendix 7.10 Photograph No. 4 - Search Operation

3.9 At 21.08 hrs, having searched the area surrounding the vessel, Rescue Helicopter R118 lowered a winchman onto the deck of the “*FV Mirror of Justice*”. At this stage the vessel’s deck was awash and the deck boards were starting to float. The winchman could not see anyone on the deck or in the wheelhouse, and the helicopter reported to MRSC Malin that “*there was nobody in the cabin, on the rocks or on the cliffs nearby.*” He also reported that his PLB got wet.

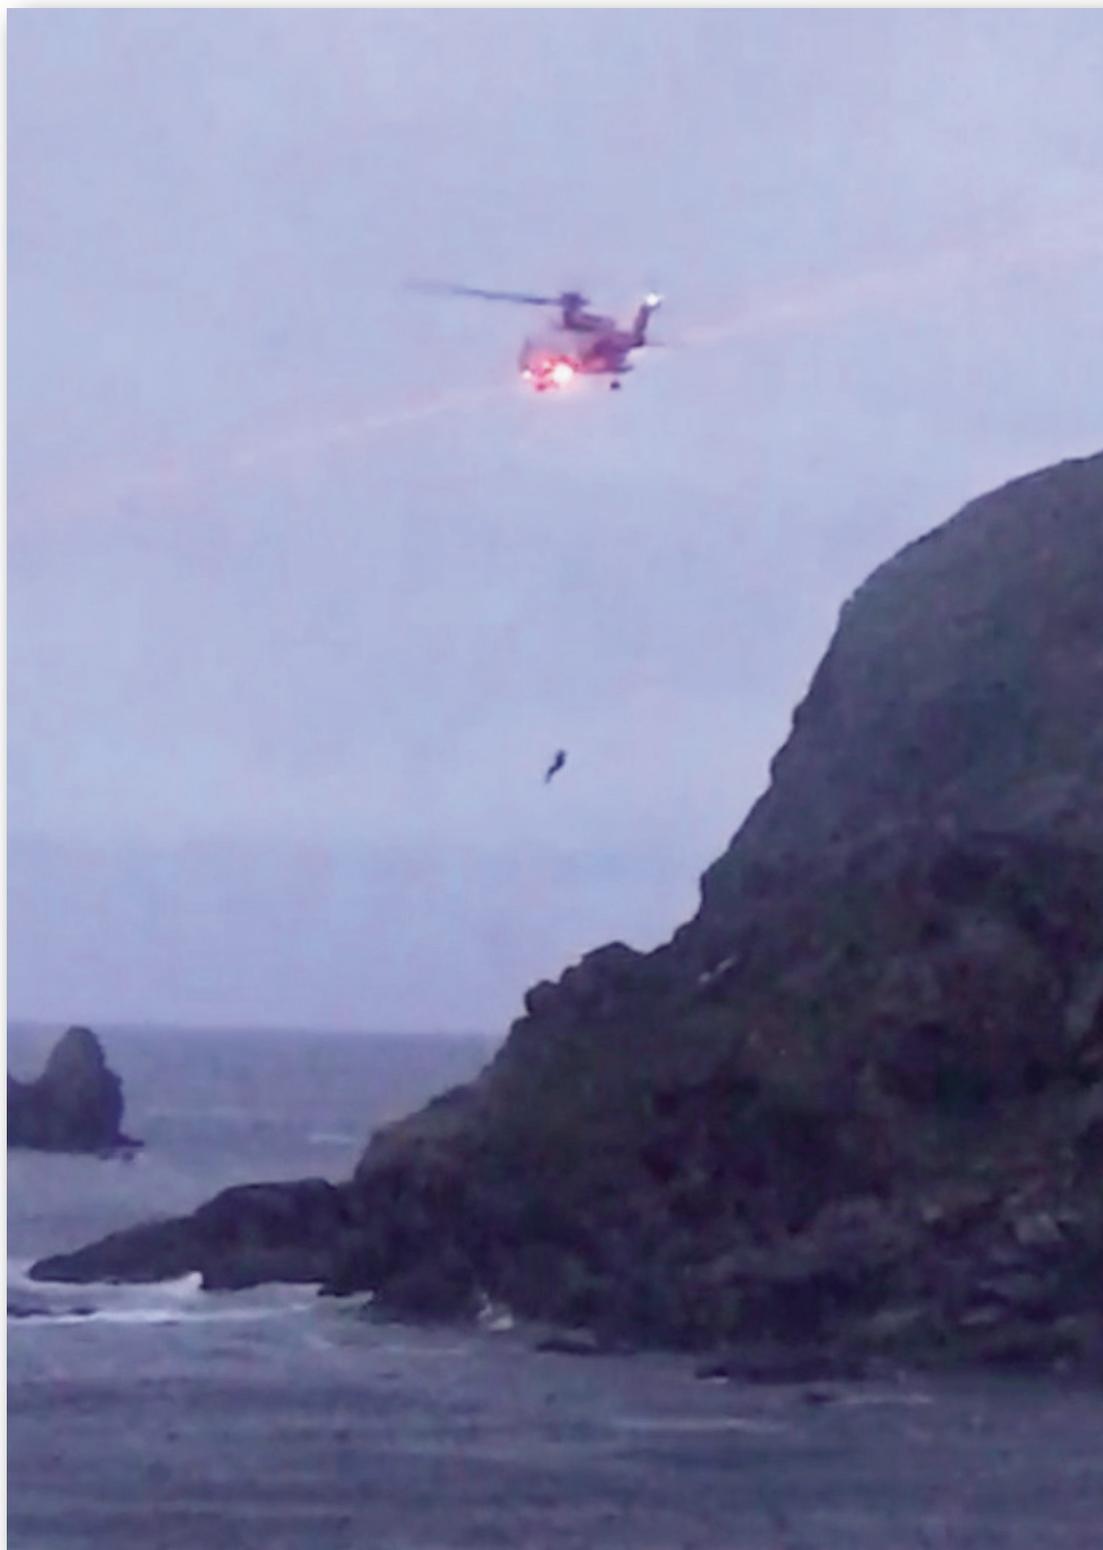
Appendix 7.11 Photograph No. 5 - Winchman being Lowered

- 4.4 The rescue helicopter lowered a winchman onto the deck of the “*FV Mirror of Justice*” at 21.08 hrs after it arrived on the scene. At this stage the vessel’s deck was awash and the deck boards were starting to float. In the case of a wooden half decked vessel, one or more boards (planks) will have been damaged very soon after the vessel made contact with the rocks and the

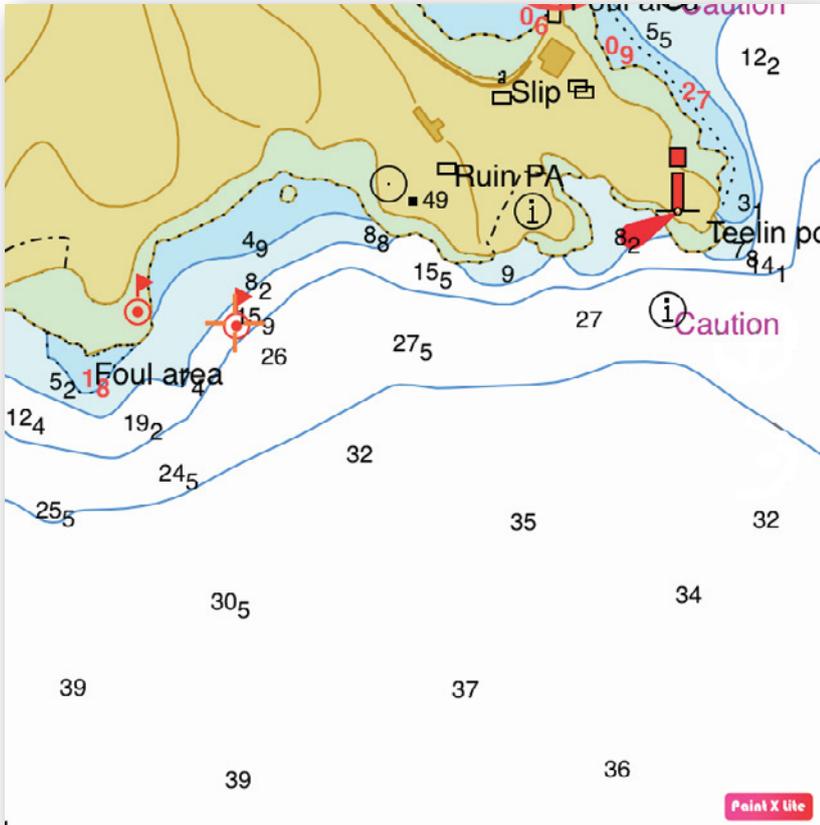
Appendix 7.14 Chart Wreck and Recovery Points

- 3.15 At 23.14 hrs one of the local vessels involved in the search found a body in position 54°37.26’N 008°38.21’W among debris from the vessel. This was approximately 110 m from the position that the “*FV Mirror of Justice*” grounded on the rocks. The body was transferred onto the Killybegs Delta RIB and brought ashore at Teelin Pier. The Casualty, later confirmed as the Skipper of the “*FV Mirror of Justice*”, was wearing flotation type oil skin bottoms but no PFD. He was fully clothed including wellington boots. He was found with his mobile phone in his possession.

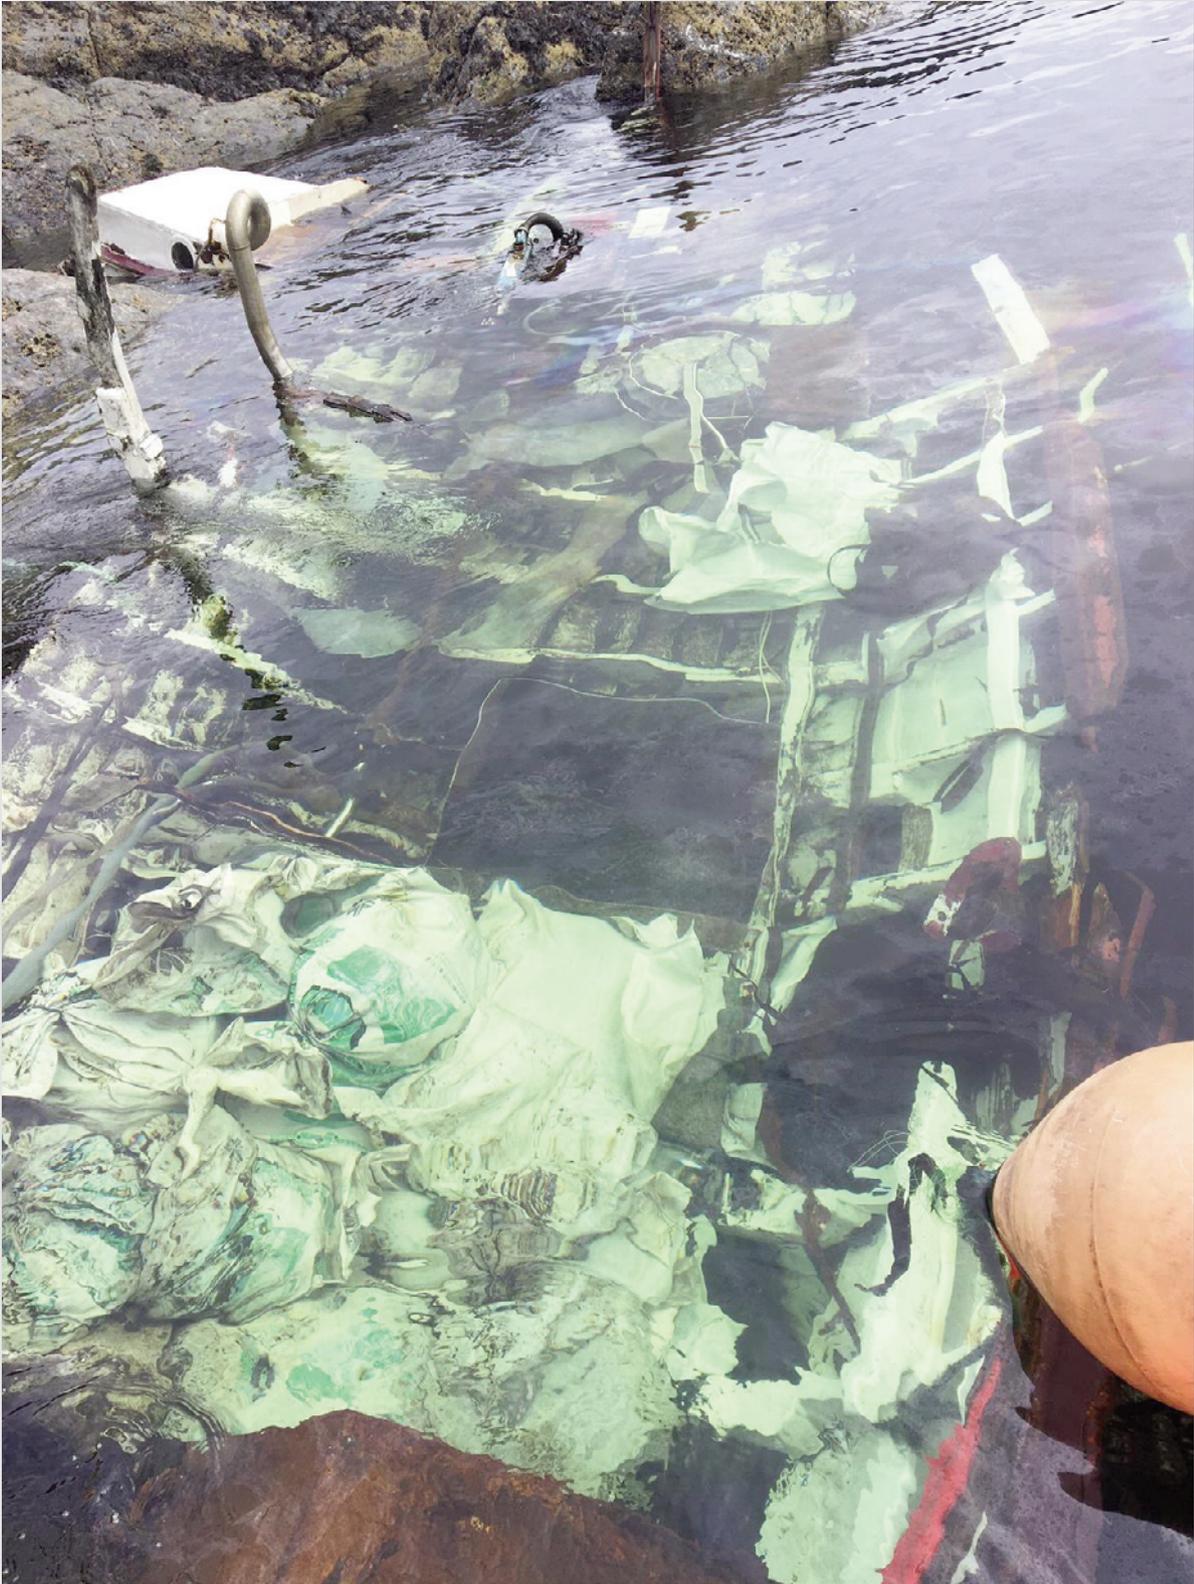
Appendix 7.16 Photograph No. 6 - "FV Mirror of Justice" Wreck

- 3.13 The “*FV Mirror of Justice*” broke up on the rocks due to the continued swell between 21.08 hrs when the helicopter winchman was lowered and 22.42 hrs when the EPIRB belonging to the vessel, having floated free, automatically activated.

- 3.17 Family members inspected the scene at the wreckage site a couple of days after the event during calm weather and could see what remained of the vessel in 1 m of water. They took the photographs shown in Appendices 7.16, 7.17 & 7.18. The MCIB investigator visited the site on a later date and weather conditions on the day prevented close access to the site.
