**REPORT OF AN INVESTIGATION INTO  
THE SINKING OF  
“FV AZTEC”  
OFF DUNCANNON  
CO. WEXFORD  
11 JANUARY 2021**

**REPORT NO. MCIB/305  
(No.6 OF 2021)**

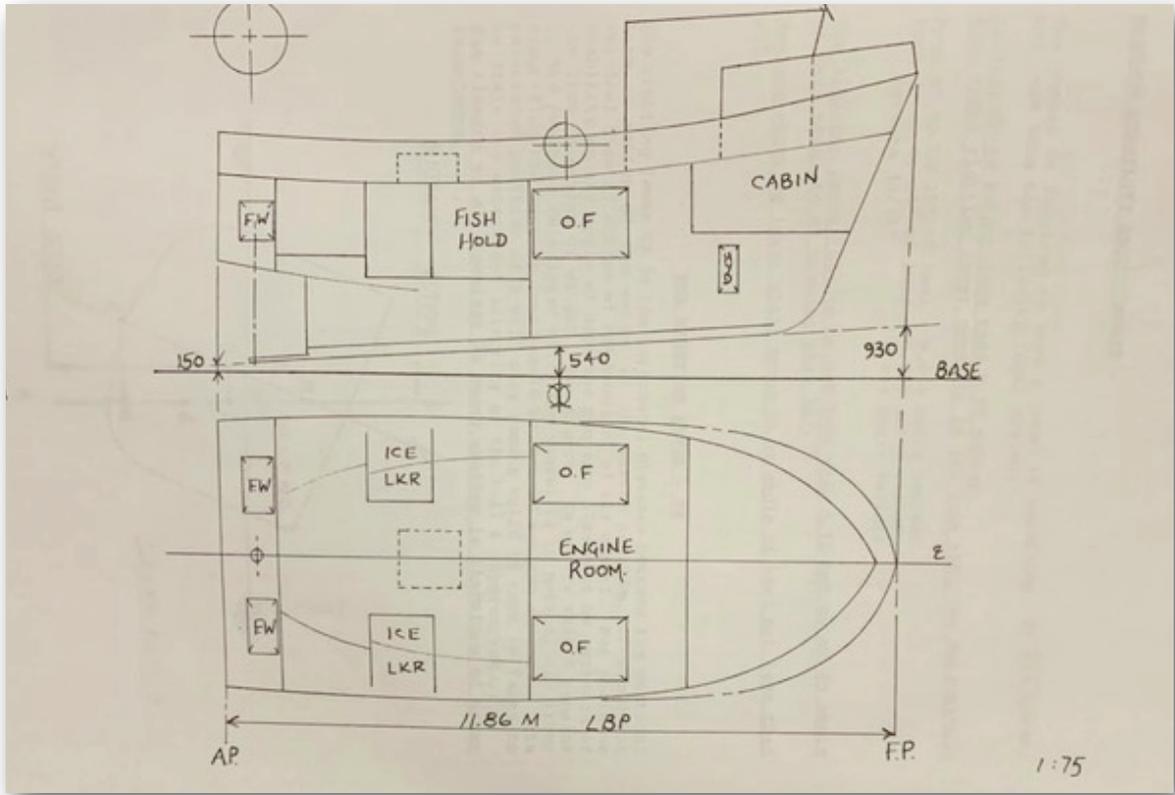
Appendix 7.2 Figure No. 1 General Arrangement - "FV Aztec"

“*FV Aztec*” registered number S12, is a small trawler rigged for mid-water sprat fishing with paired vessel “*FV Western Dawn*”.

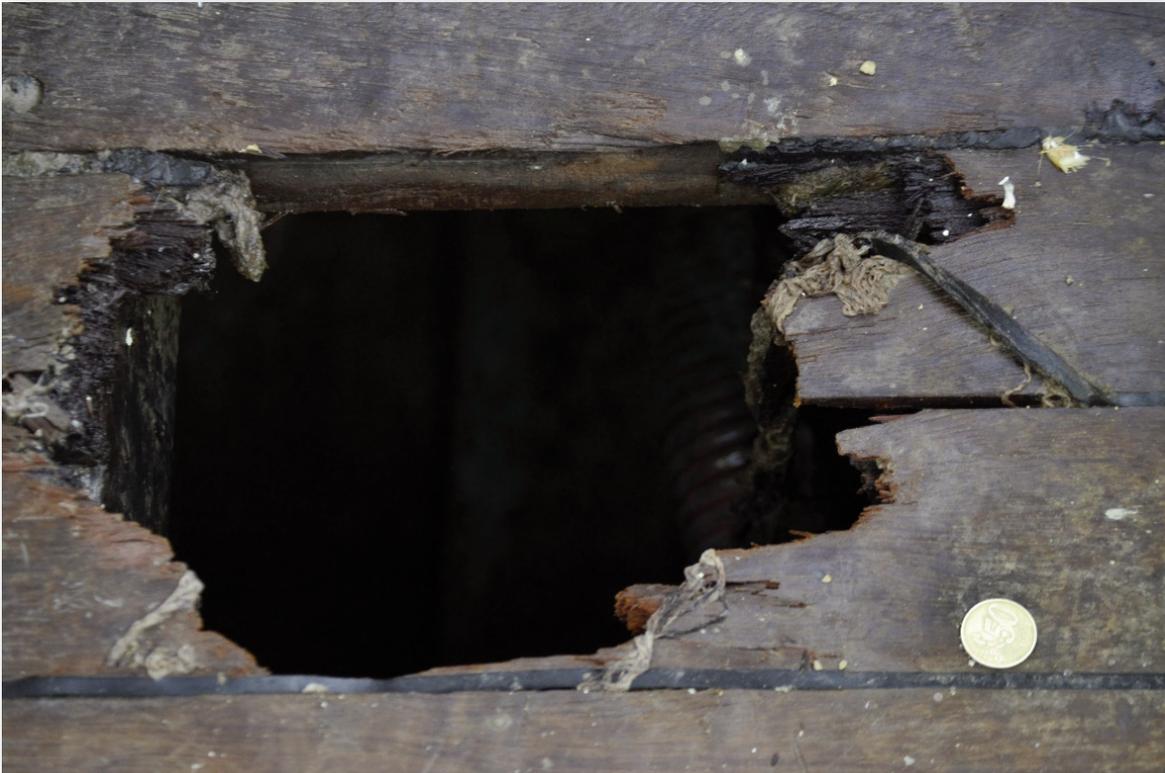
Appendix 7.6 Photograph No. 2 - Hole in Deck

- 4.3 As the “*FV Western Dawn*” shot its net for the “*FV Aztec*” to take the end for the next tow the towing weight for the net dropped from the gunwale of the “*FV Aztec*” onto the starboard aft deck. This action punched a hole through the deck of approximately 300 cm<sup>2</sup>. This went unnoticed by the crew at this time due to the amount of gear located around this area of the deck.

These actions combined caused the after deck on the starboard side to dip into the water. This action resulted in the steering compartment starting to flood through the hole in the deck. The lack of a bilge alarm in the steering compartment meant this was not picked up until it was noticed by one of the crew. Despite attempts by the crewmember to stem the flow, the steering compartment continued to flood resulting in loss of buoyancy in the after end of the vessel. The steering compartment consisted of a free area of approximately five cubic meters and provided the majority of the buoyancy to the after end of the vessel. This caused the vessel to settle further by the stern ultimately leading to flooding of the fish hold through deck scuppers and open hatch.

- 5.4 The hole in the deck went unnoticed when it occurred but the incident should have merited further investigation.
- 5.5 No alert was sent out by the “*FV Aztec*” or by the “*FV Western Dawn*”. First notification of foundering of the vessel to MRCC Dublin was from the shore. Although there was no imminent danger to life, as a serious incident occurred, a Pan-Pan alert should have been raised with the Coast Guard.

- 6.2 The Minister for Transport should issue a Marine Notice to owners/skippers of fishing vessels reminding them that where an area of deck is subjected to regular working and shock loading, consideration should be given to re-enforcing and strengthening that area.

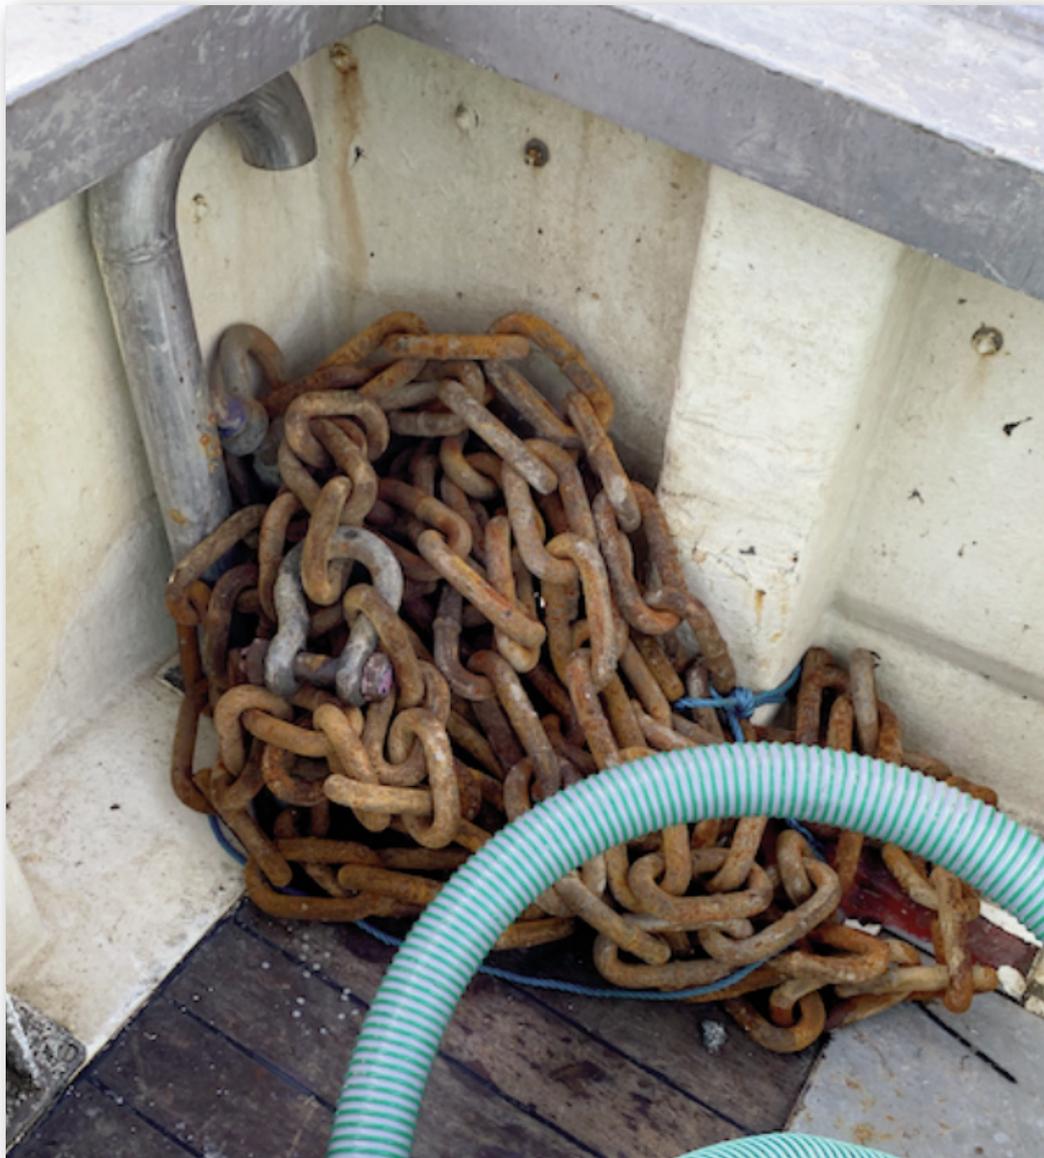
Appendix 7.7 Photograph No. 3 - Fishing Weight

- 3.2 At 10.00 hrs the “*FV Western Dawn*” shot its net for the “*FV Aztec*” to take the end for the next tow. During this operation, the towing weight for the net dropped from the gunwale onto the starboard aft deck of the “*FV Aztec*”. This punctured a hole of approximately 300 centimetres (CM)<sup>2</sup> in the deck roughly 200 cm forward of the transom (see Appendix 7.6 Photograph No. 2 - Hole in Deck). Due to the amount of gear around this area of the deck the damage went undiscovered at this time. The fishing weight was made up of a collection of chain and weighed 350 kg.

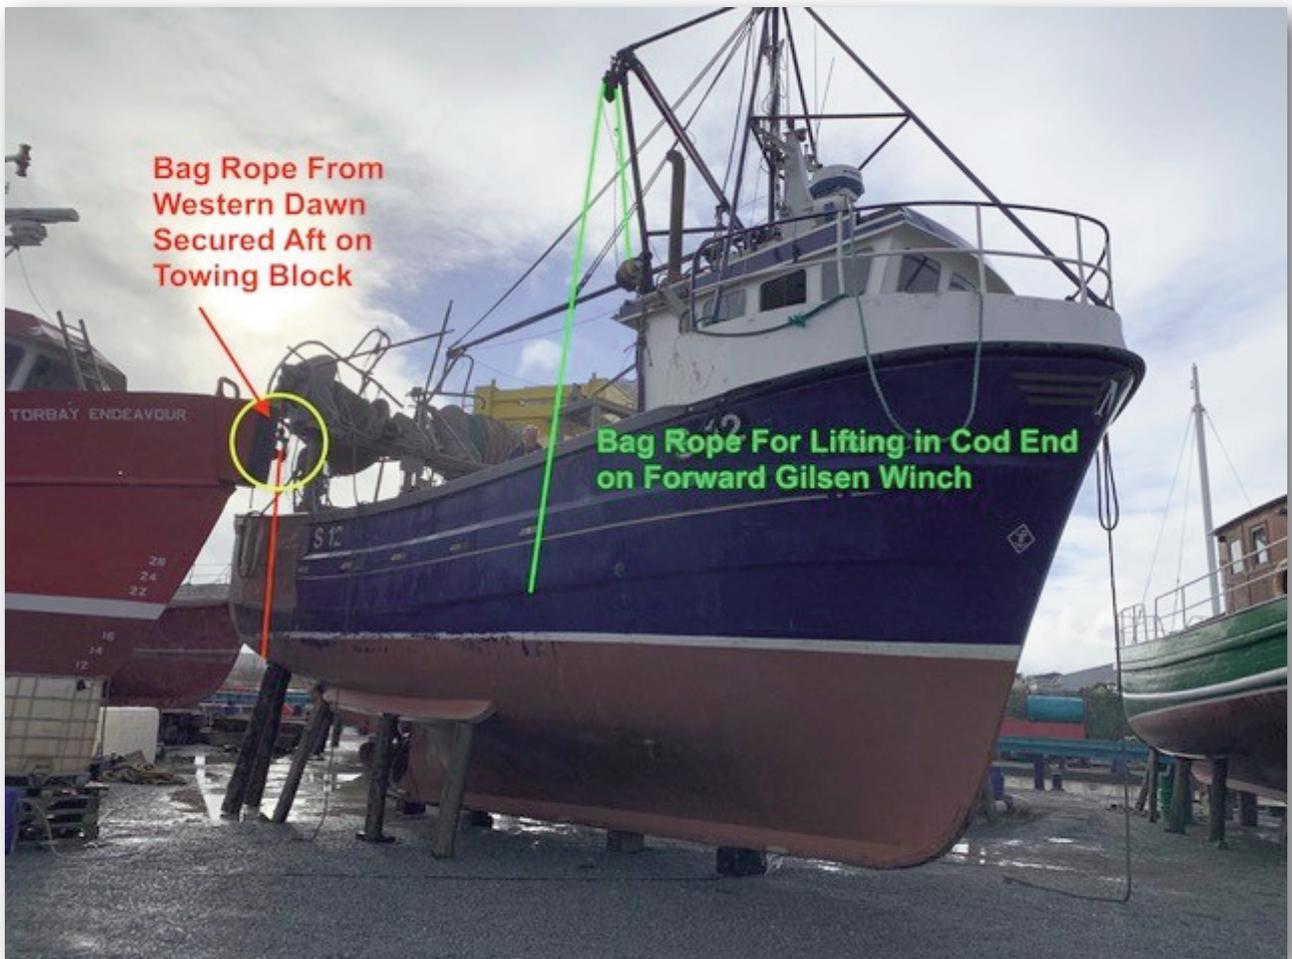
Appendix 7.8 Photograph No. 4 - Hauling Arrangement

- See Appendix 7.7 Photograph No. 3 - Fishing Weight.
- 3.3 At approximately 10.45 hrs the “*FV Western Dawn*” hauled its net and the “*FV Aztec*” passed back the end of the net to it. It was then decided to pass fish from the “*FV Western Dawn’s*” net to the “*FV Aztec*”. The crew of the “*FV Western Dawn*” passed over the bag rope and this was hauled up on the main winch aft. The bag rope from the “*FV Western Dawn*” was heaved across to the “*FV Aztec*” using the main winch through the aft starboard towing block. The Gilsen winch and lifting derrick are situated starboard forward. The Gilsen winch was then secured to the bag rope/lifting strop and the cod end was taken onboard, one lift at a time allowing the fish to enter the fish room via scuppers on the deck. The securing of the bag rope on the aft starboard hanging block and subsequent lifting of the cod end lift caused the vessel to list to starboard and immerse the hole on the aft starboard side of the deck.

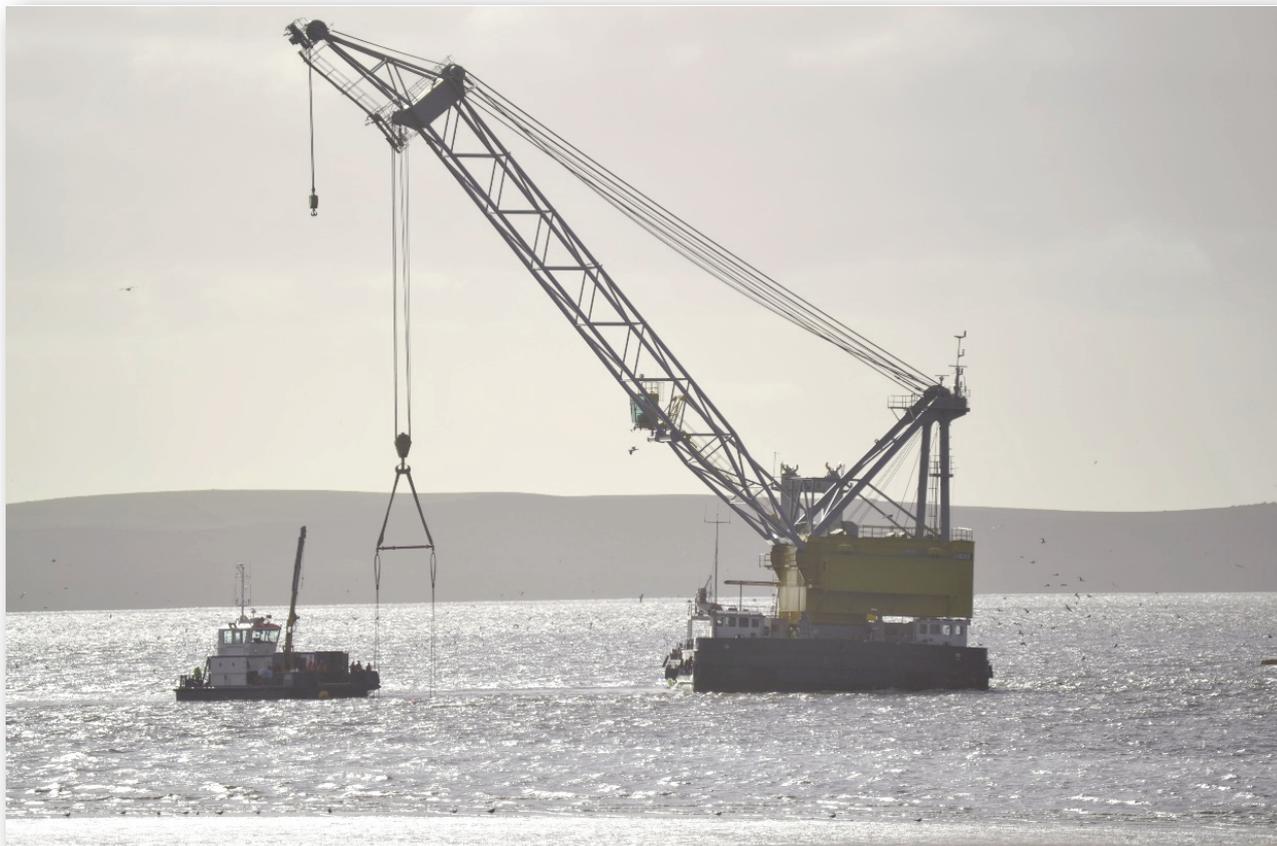
Appendix 7.9 Photograph No. 5 - Salvage

- 3.8 A salvage operation was commenced leading to the successful recovery of the vessel from the seabed at 20.00 hrs on 29 January 2021.

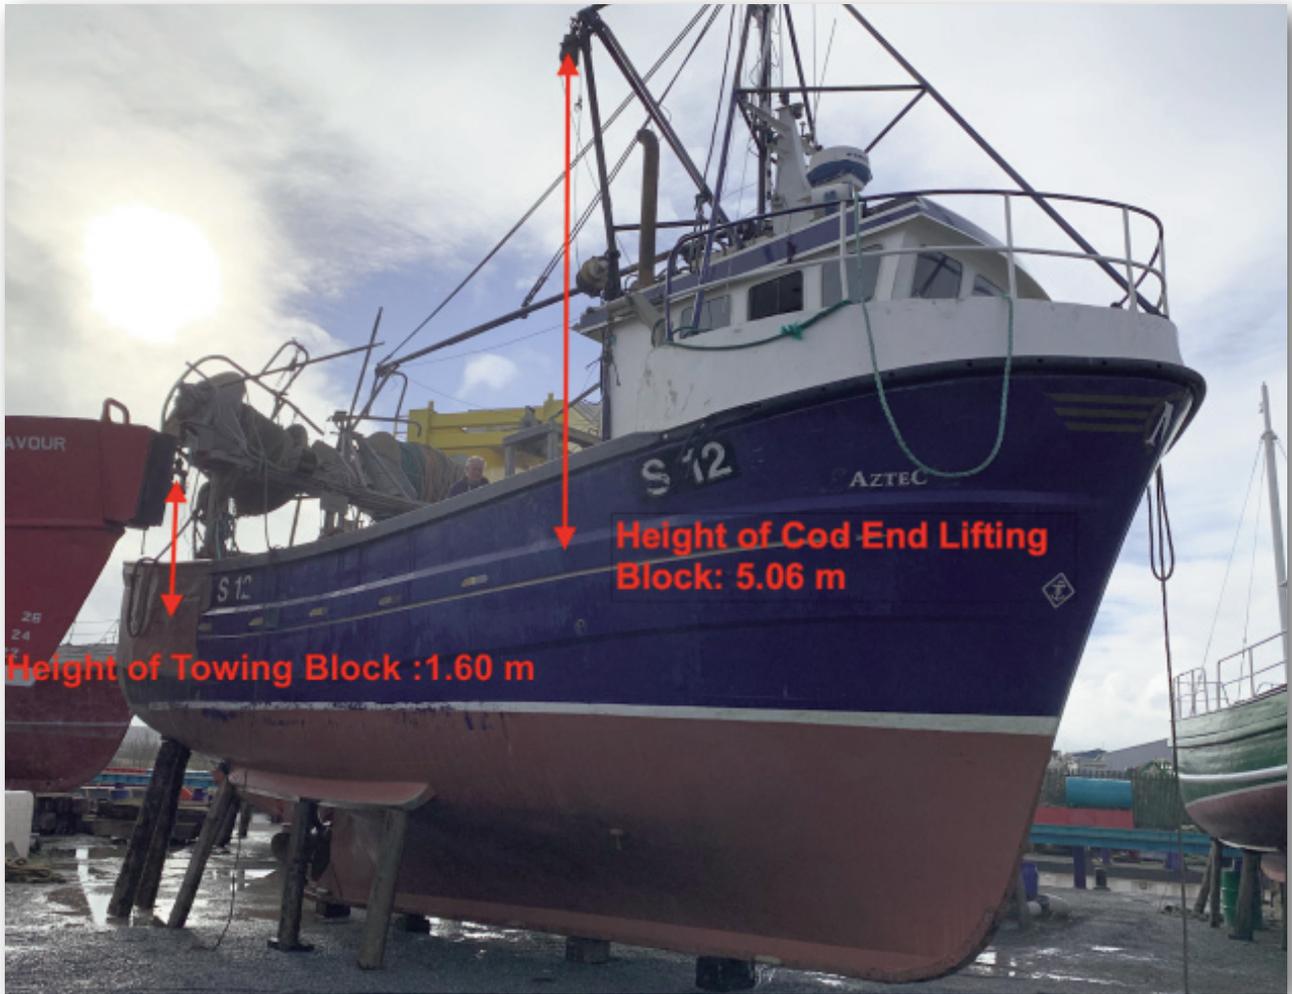
Appendix 7.10 Photograph No. 6 - Lifting Dimensions

- 4.4 After the “*FV Western Dawn*” recovered its net and took onboard part of the catch, it handed over the net to the “*FV Aztec*” to recover the remainder of the fish. During the operation to recover these fish, the net was hauled close to the starboard after end of the “*FV Aztec*”. The cod-end was then attached and lifted using the derrick. The height of side derrick for cod-end lift above deck level is 5.06 m and the distance from side derrick block head to centreline of vessel is 2.54 m. The height of aft towing block above deck level is 1.6 m.

- 6.3 The Minister for Transport should review the Code of Practice for Fishing Vessels under 15 meters to take into account heave loadings on decks during fishing operations.

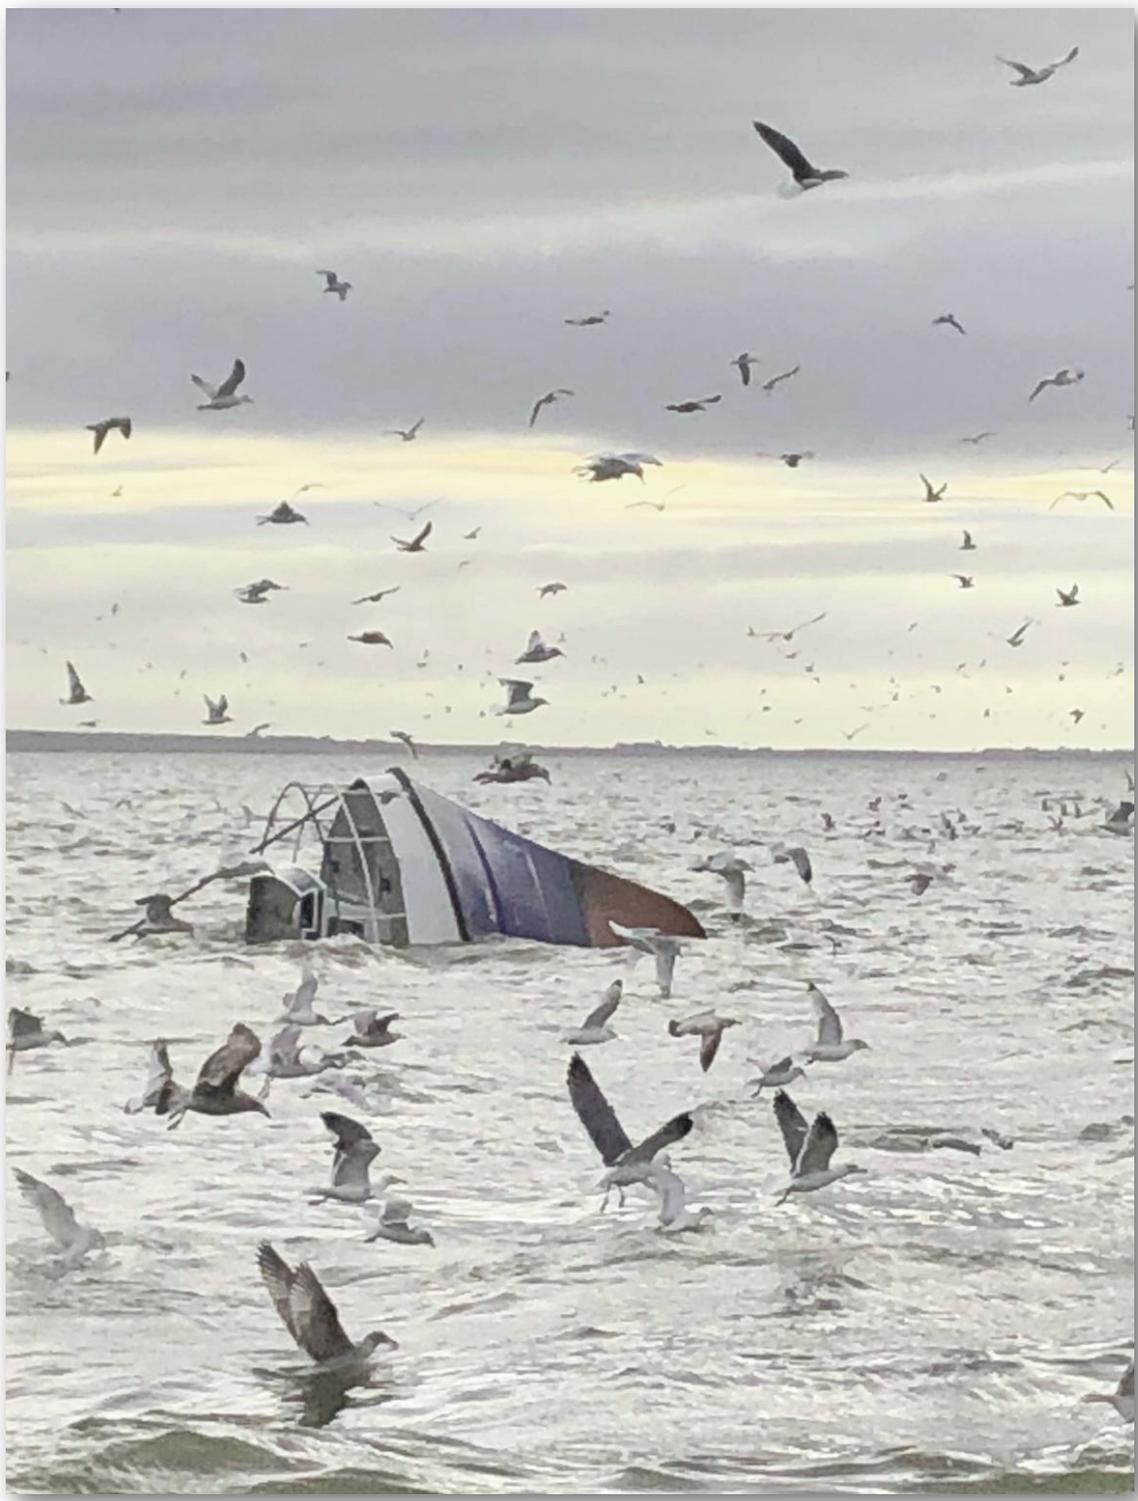
Appendix 7.11 Photograph No. 7

4.5 The Skipper quickly noticed the vessel was in peril and attempted to let go the net. As the stern began to settle below the surface, he brought the vessel alongside the “*FV Western Dawn*” and ordered the crew to abandon their vessel. The transfer of crew went smoothly and the “*FV Aztec*” sank in what was estimated to be less than a minute later. Time did not allow for operation of the bilge pumps and they would have been ineffective against the rate of flooding. As the fish hold flooded, the vessel sank quickly by the stern leaving only a small section of the bow above water.
